# Loreto College Temporary Accommodation

## Condition Report

October 2025

Site: Loreto Sixth Form College

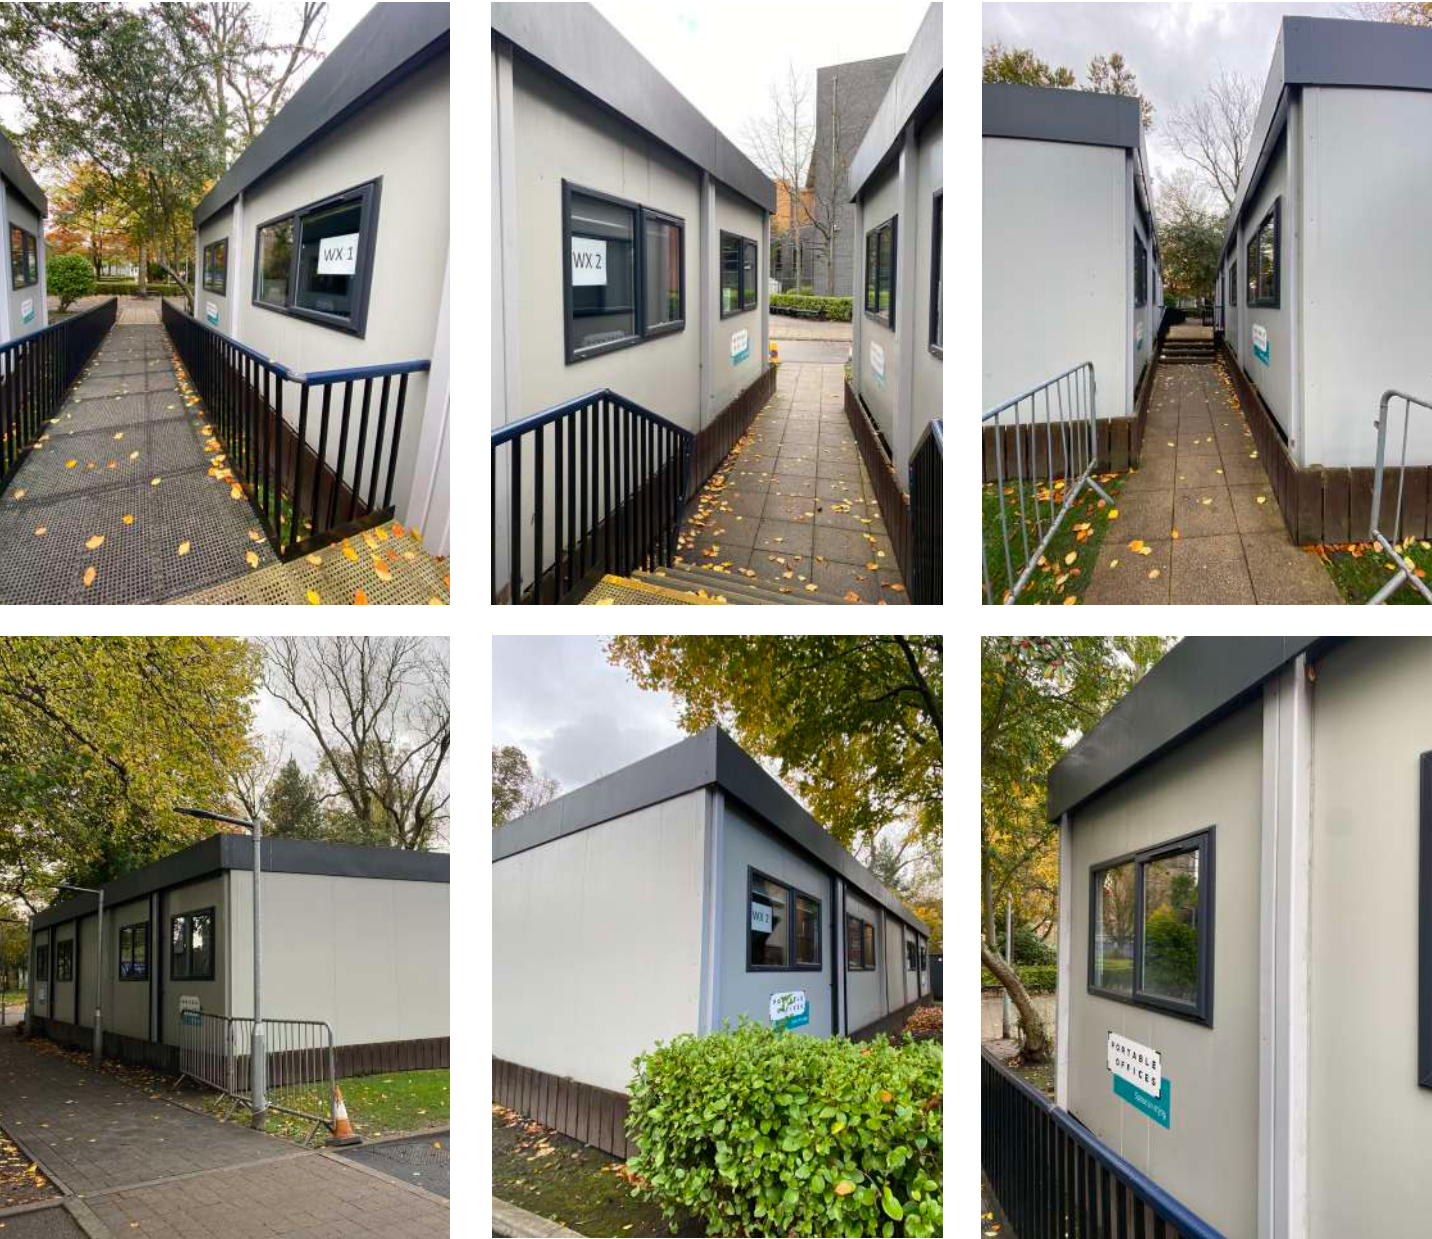
External Photos

| <u>Element</u> | <u>Observations</u> |
|---|---|
| External Appearance | Units present well, with no evidence of significant deterioration or neglect. |
| Foundations / Substructure | Timber skirting panels with only minor weathering consistent with age and exposure. |
| External Walls & Cladding | Panels and joints in sound condition; minor cosmetic wear consistent with age. |
| Roofing | No evidence of leaks or water ingress; roof coverings appear in good order. |
| Fascias & Rainwater Goods | Fascias in good condition, rainwater downpipes are securely fixed and functional. No signs of leakage or detachment. |
| Accessibility & Safety | Access ramps, handrails, and emergency exits compliant with current standards. Fire safety equipment in place and maintained. |

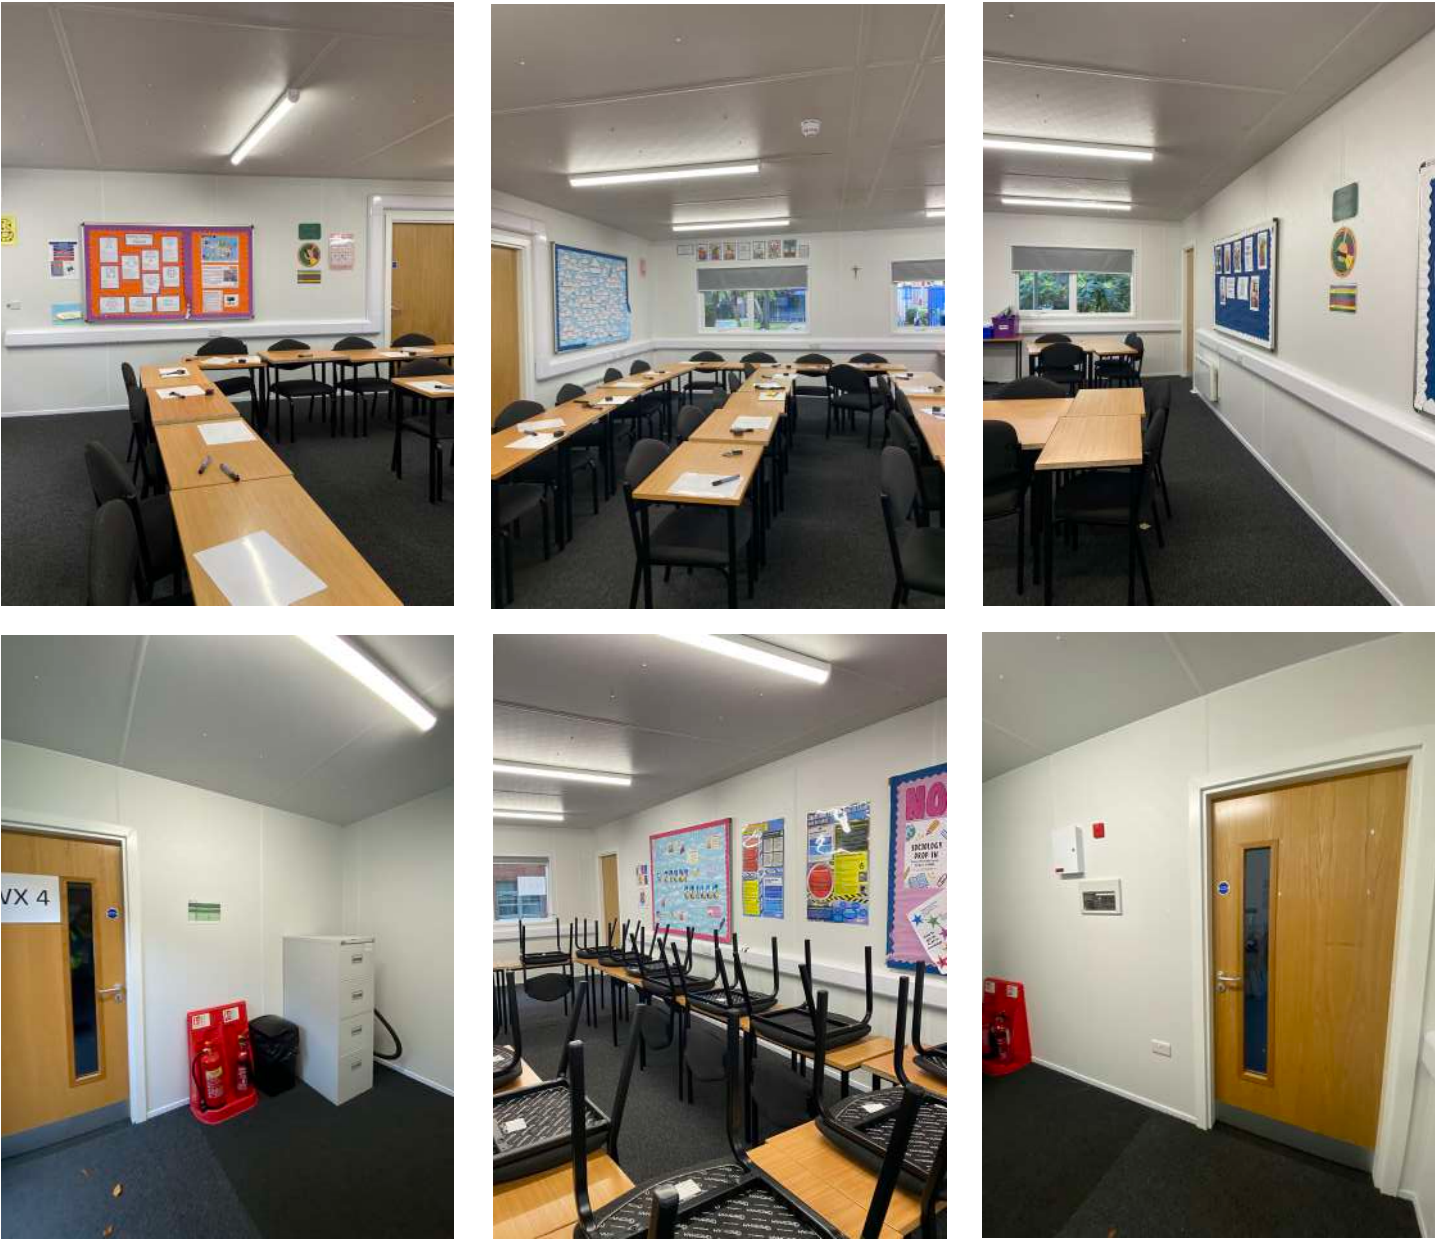
Internal Photos

| <u>Element</u> | <u>Observations</u> |
|---|---|
| Floor Structure & Finishes | Sound underfoot, no evidence of deflection or rot; finishes remain intact. |
| Internal Walls & Ceilings | Clean, dry, and free from cracks or damage. |
| Mechanical & Electrical Systems | Heating and lighting systems operational; no safety issues observed. |

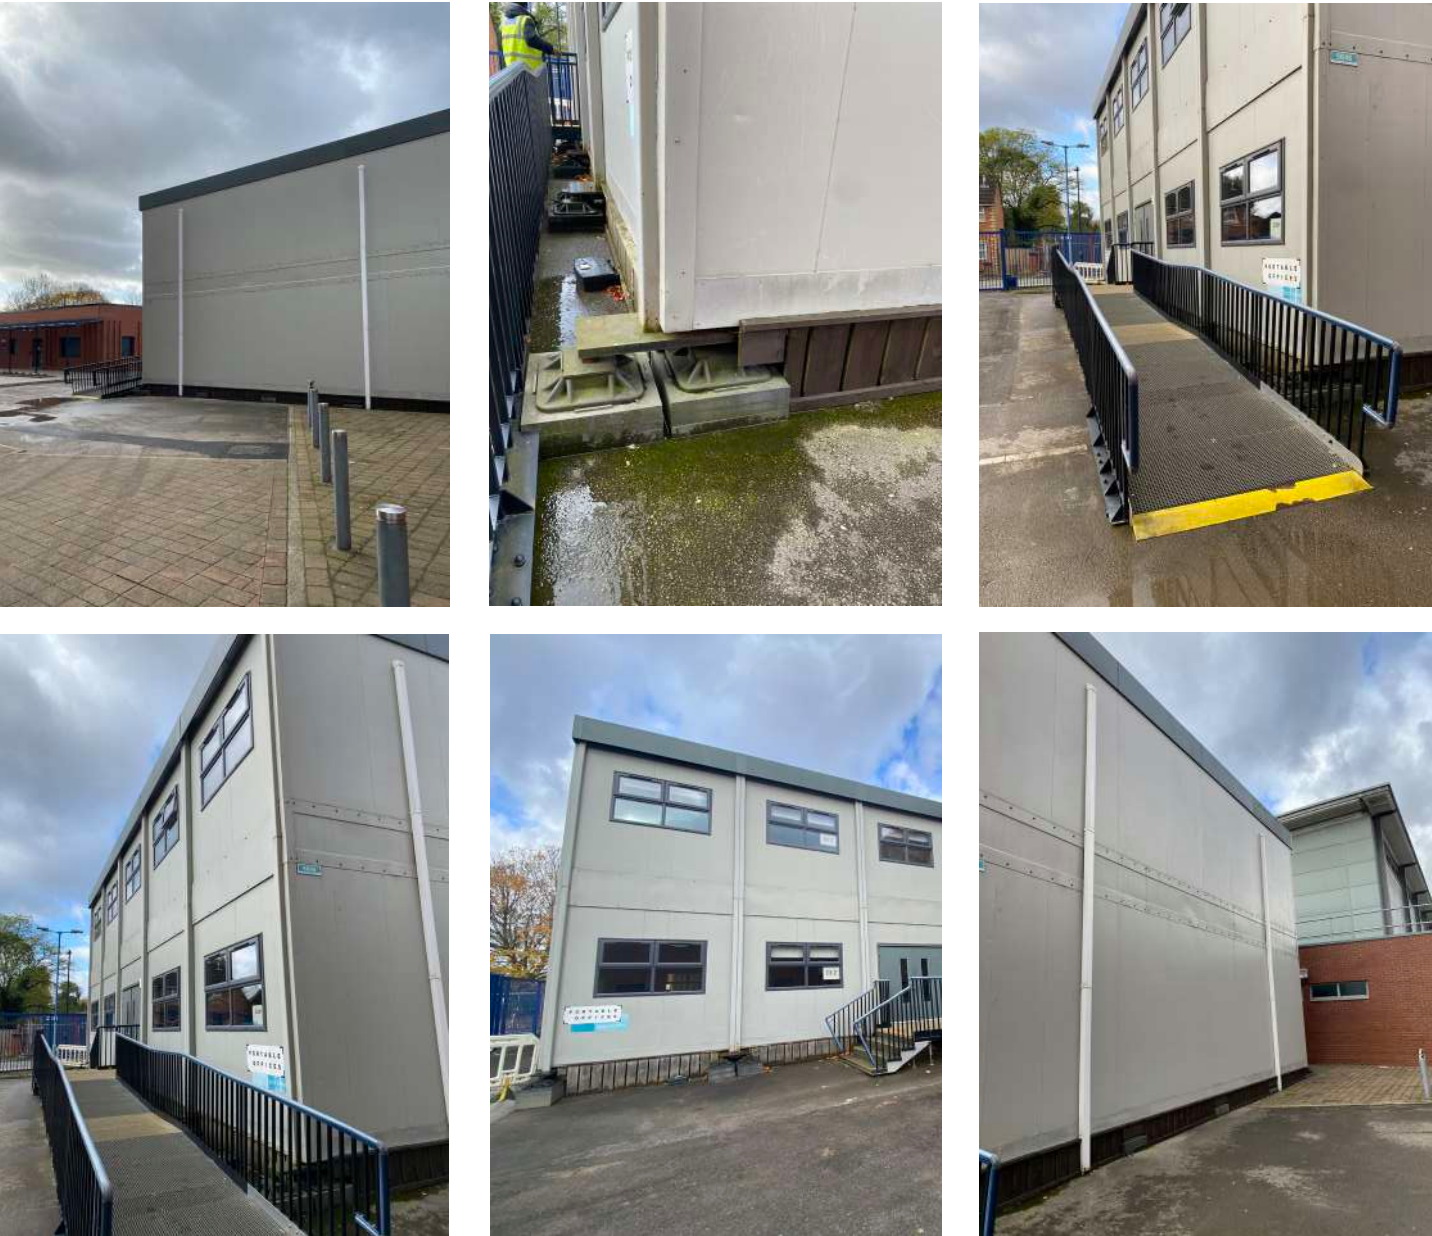
External Photos

| Element | Observations |
|---|---|
| External Appearance | Minor surface marks and limited weathering. |
| Foundations / Substructure | Timber skirting panels with only minor weathering consistent with age and exposure. Some localised moss and algae were noted on the surface of the pad foundations near the supports. |
| External Walls & Cladding | Wall panels appear generally in good structural condition, with no visible cracks or panel deformation. |
| Roofing | No evidence of leaks or water ingress; roof coverings appear in good order. |
| Fascias & Rainwater Goods | Fascias in good condition, rainwater downpipes are securely fixed and functional. No signs of leakage or detachment. |
| Accessibility & Safety | Access ramps, handrails are in good condition, showing no corrosion or mechanical defects. Fire safety equipment in place and maintained. |

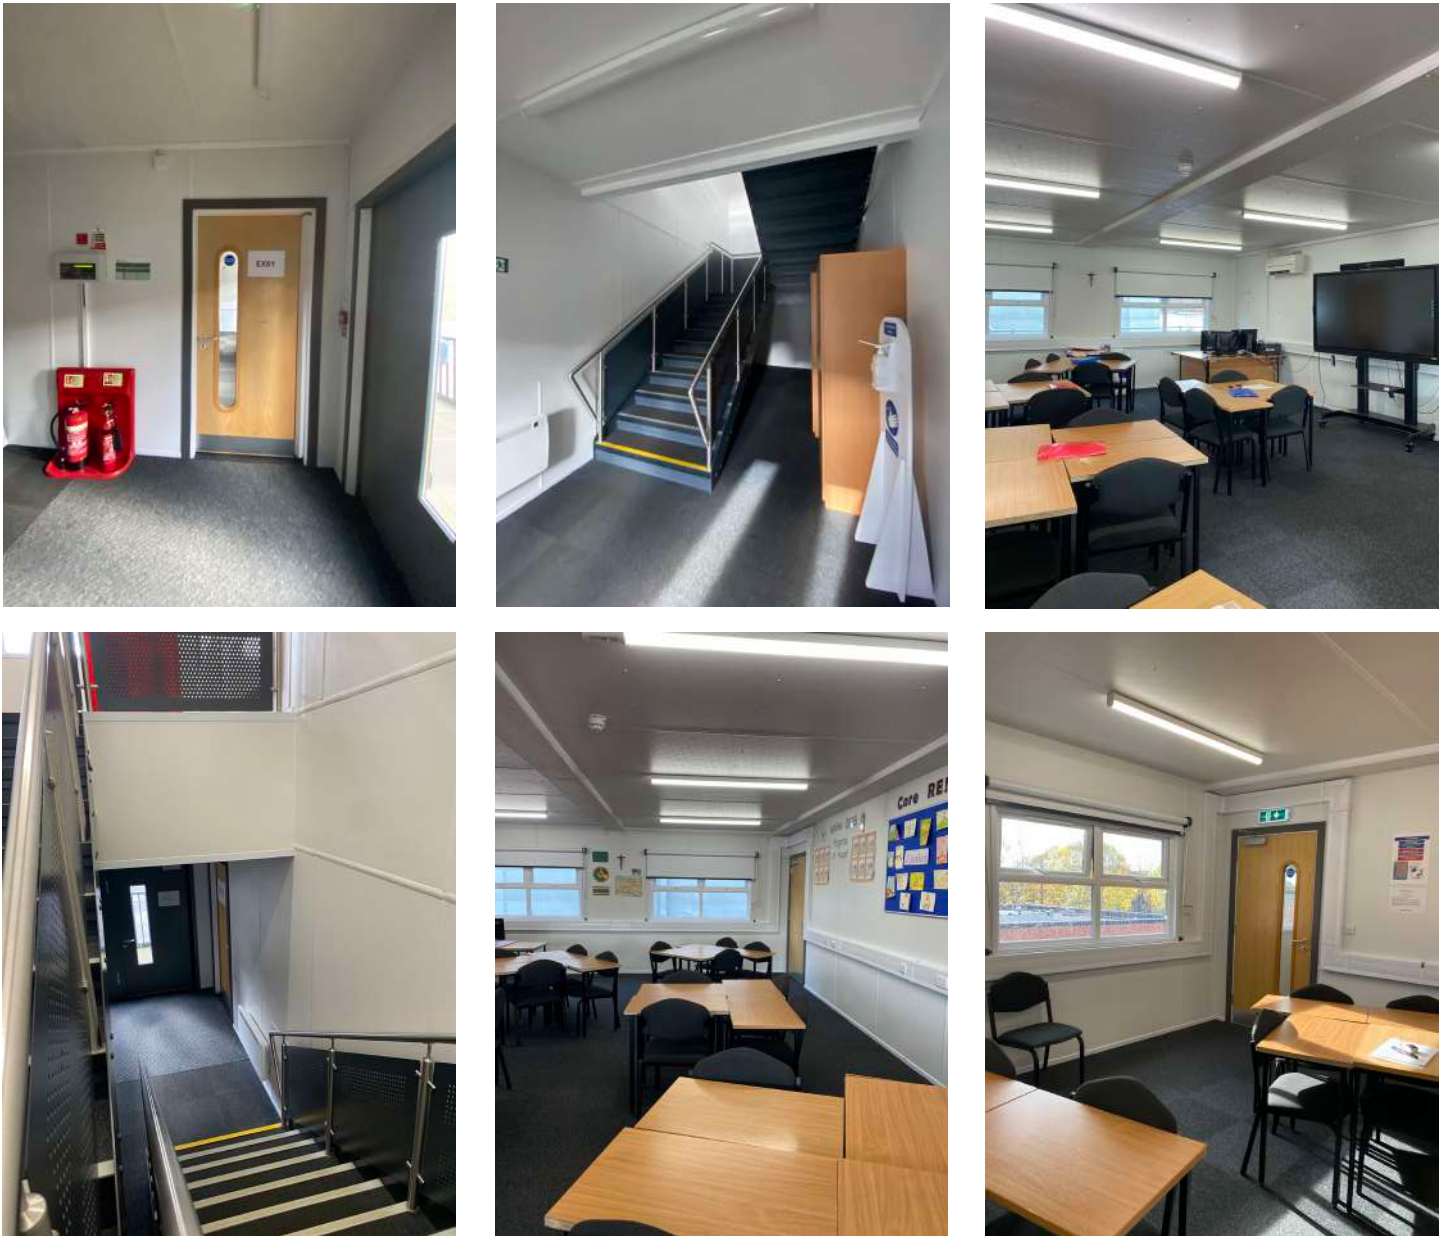
Internal Photos

| Element | Observations |
|---|---|
| Floor Structure & Finishes | Sound underfoot, no evidence of deflection or rot; finishes remain intact. |
| Internal Walls & Ceilings | Clean, dry, and free from cracks or damage. |
| Mechanical & Electrical Systems | Heating and lighting systems operational; no safety issues observed. |

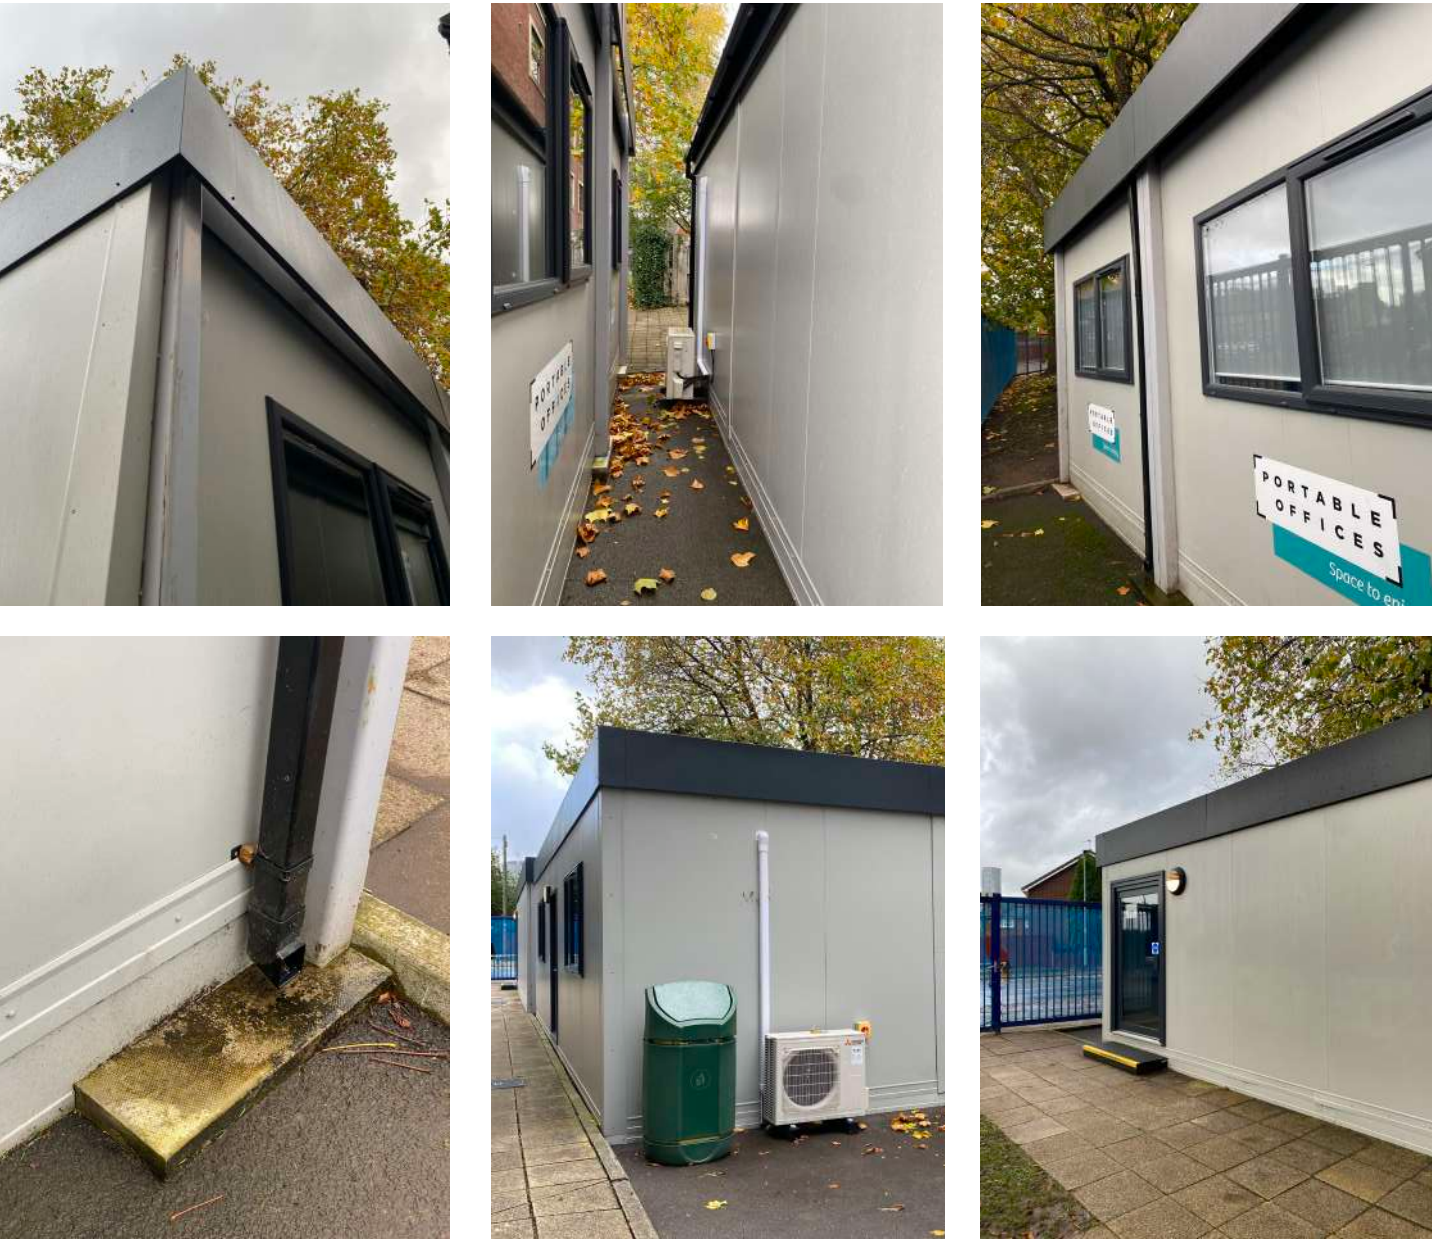
External Photos

| Element | Observations |
|---|---|
| External Appearance | Minor surface marks and limited weathering. |
| Foundations / Substructure | Timber skirting panels with only minor weathering consistent with age and exposure. Some localised moss and algae were noted on the surface of the pad foundations near the supports. |
| External Walls & Cladding | Wall panels appear generally in good structural condition, with no visible cracks or panel deformation. |
| Roofing | No evidence of leaks or water ingress; roof coverings appear in good order. |
| Fascias & Rainwater Goods | Fascias in good condition, rainwater downpipes are securely fixed and functional. No signs of leakage or detachment. |

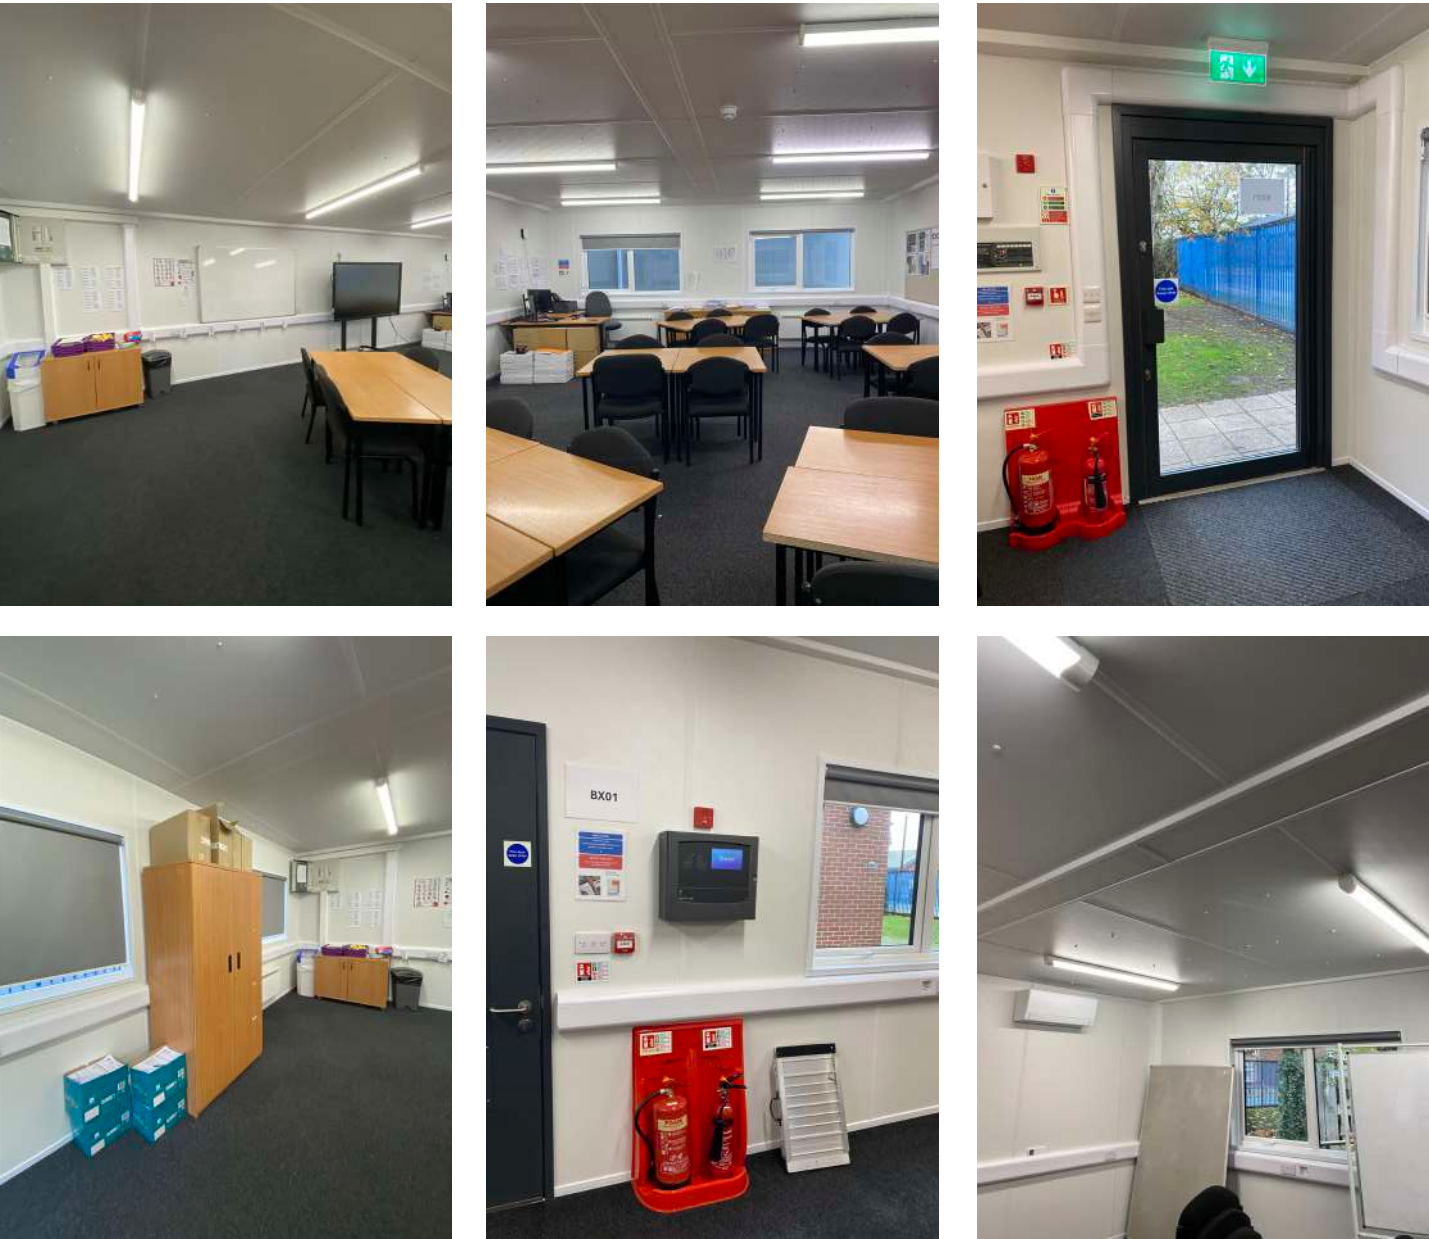
Internal Photos

| Element | Observations |
|---|---|
| Floor Structure & Finishes | Sound underfoot, no evidence of deflection or rot; finishes remain intact. |
| Internal Walls & Ceilings | Clean, dry, and free from cracks or damage. |
| Mechanical & Electrical Systems | Heating and lighting systems operational; no safety issues observed. |
