## GAS MEMBRANE VALIDATION

| <b>Site Name: Belle Vue Stadium</b> | <b>Project Number: 12-123</b> |
| <b>Company Name: Countryside</b> | <b>Date: 29-03-2022</b> |

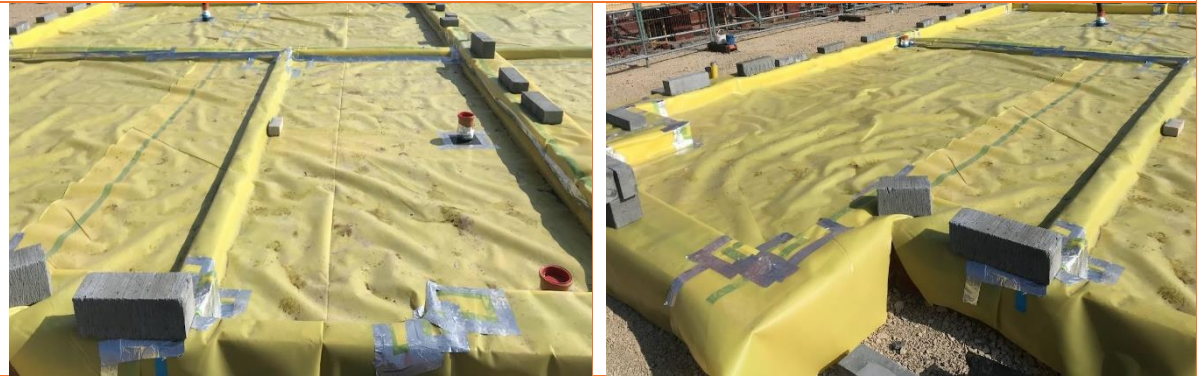
**Plot - 4**

**General Condition of Membrane-Good Condition**

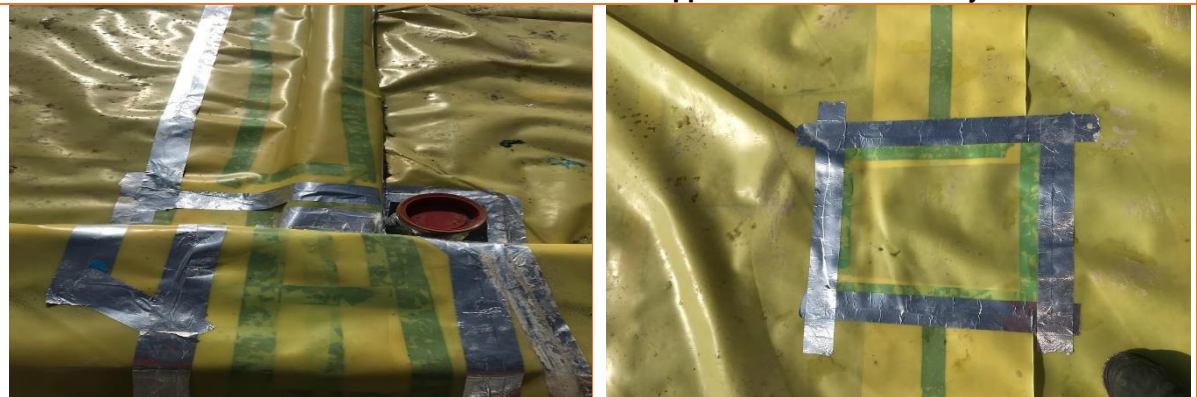
**Verification of Joints and Seals-Overlapped and sealed correctly**

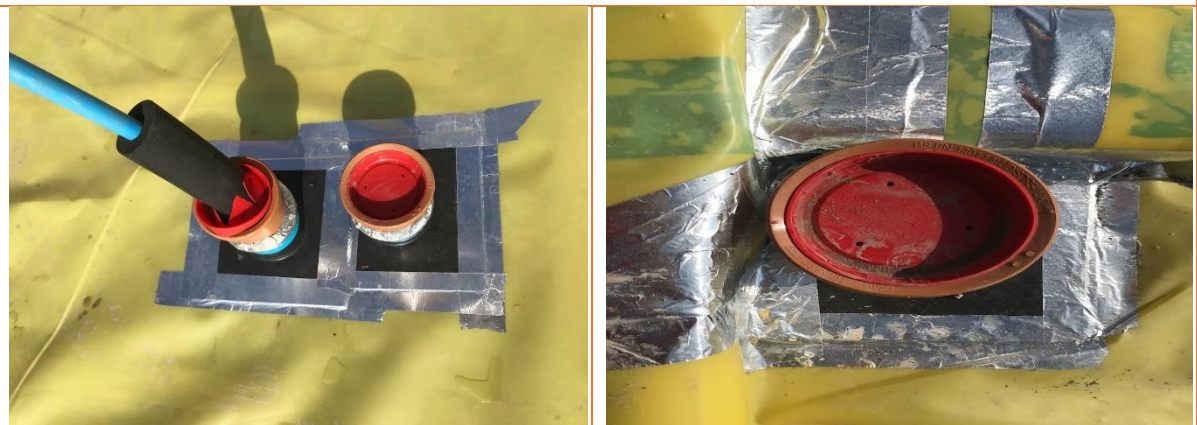
**Verification of Service Penetrations-Good Condition**

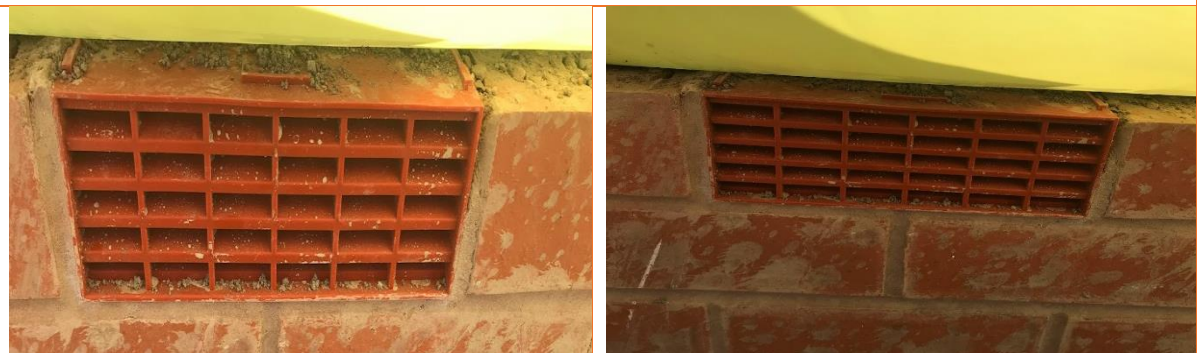
**Verification of Ventilation-Good Condition**

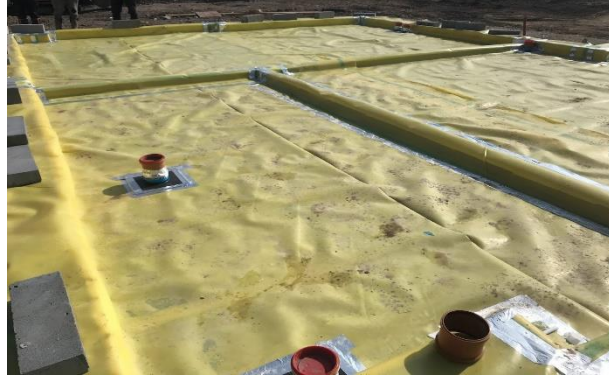
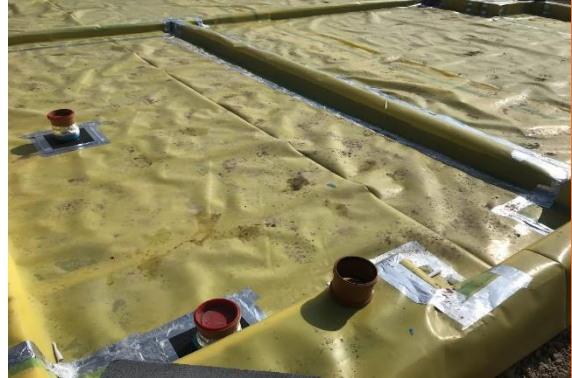
**Plot - 5**

**General Condition of Membrane-Good Condition**

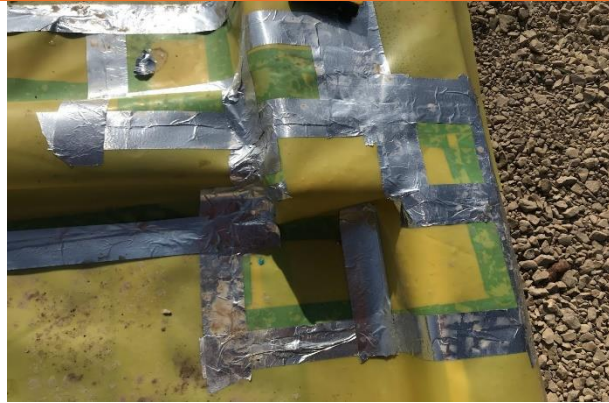
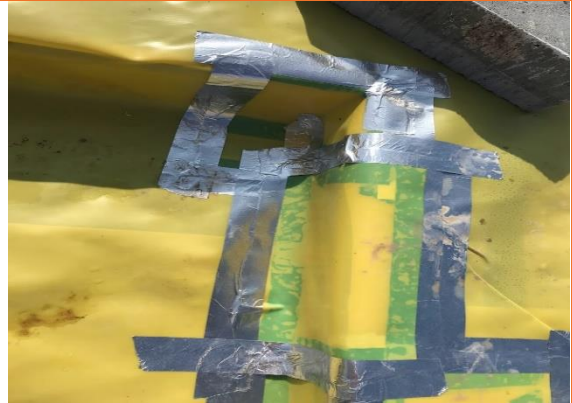
**Verification of Joints and Seals-Overlapped and sealed correctly**

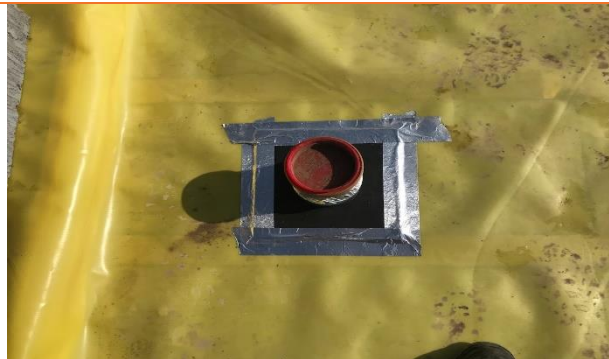
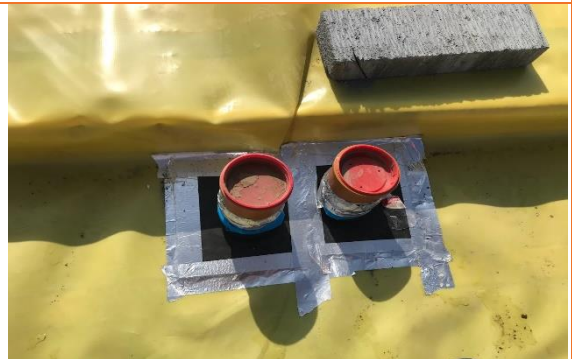
**Verification of Service Penetrations-Good Condition**

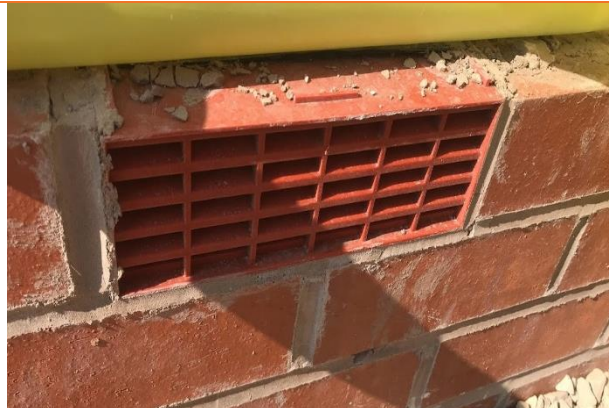
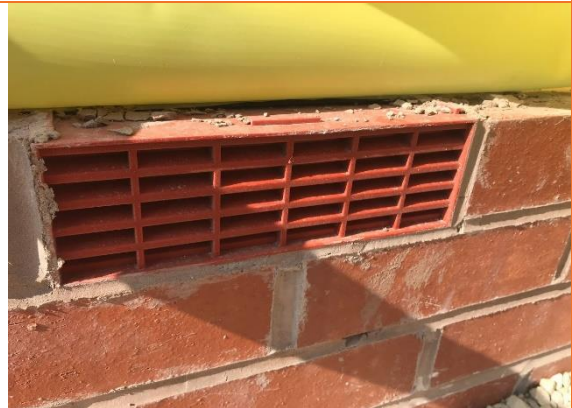
**Verification of Ventilation-Good Condition**
