EXISTING PHOTOS

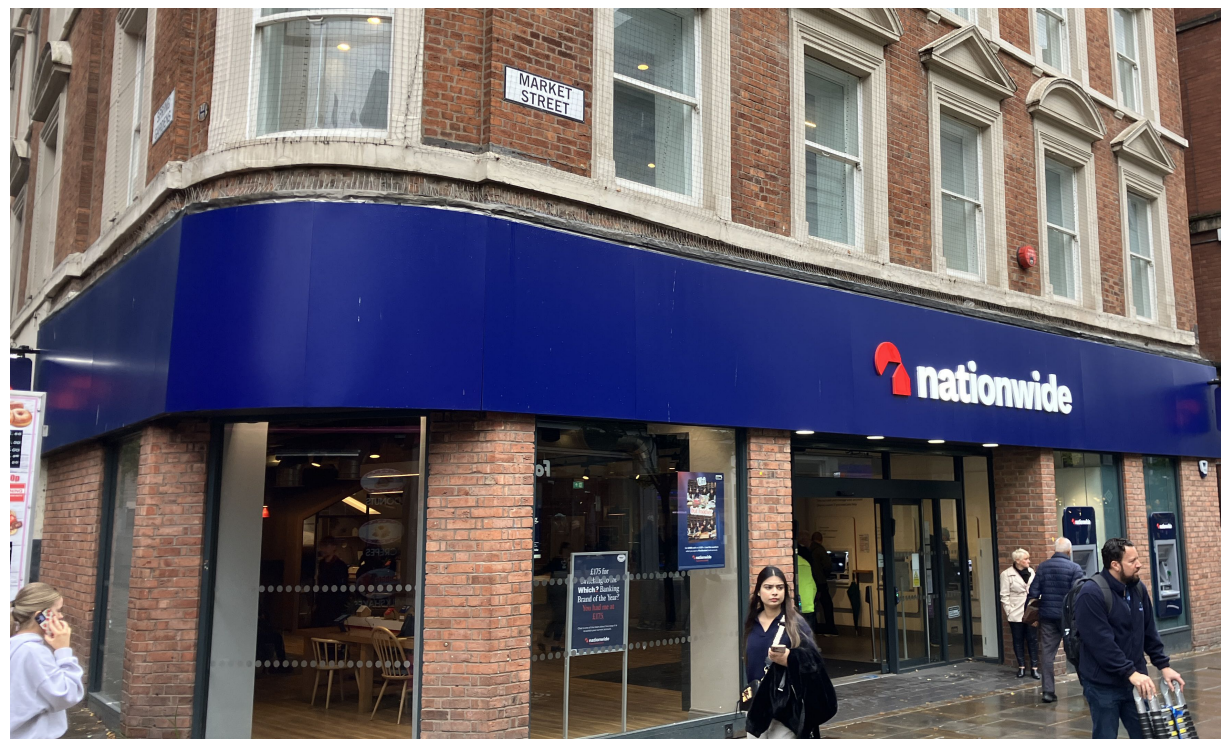
EXISTING FASCIA PANEL

Large expanse of featureless surface. Multiple sections of folded aluminium, poorly installed, joints visible.

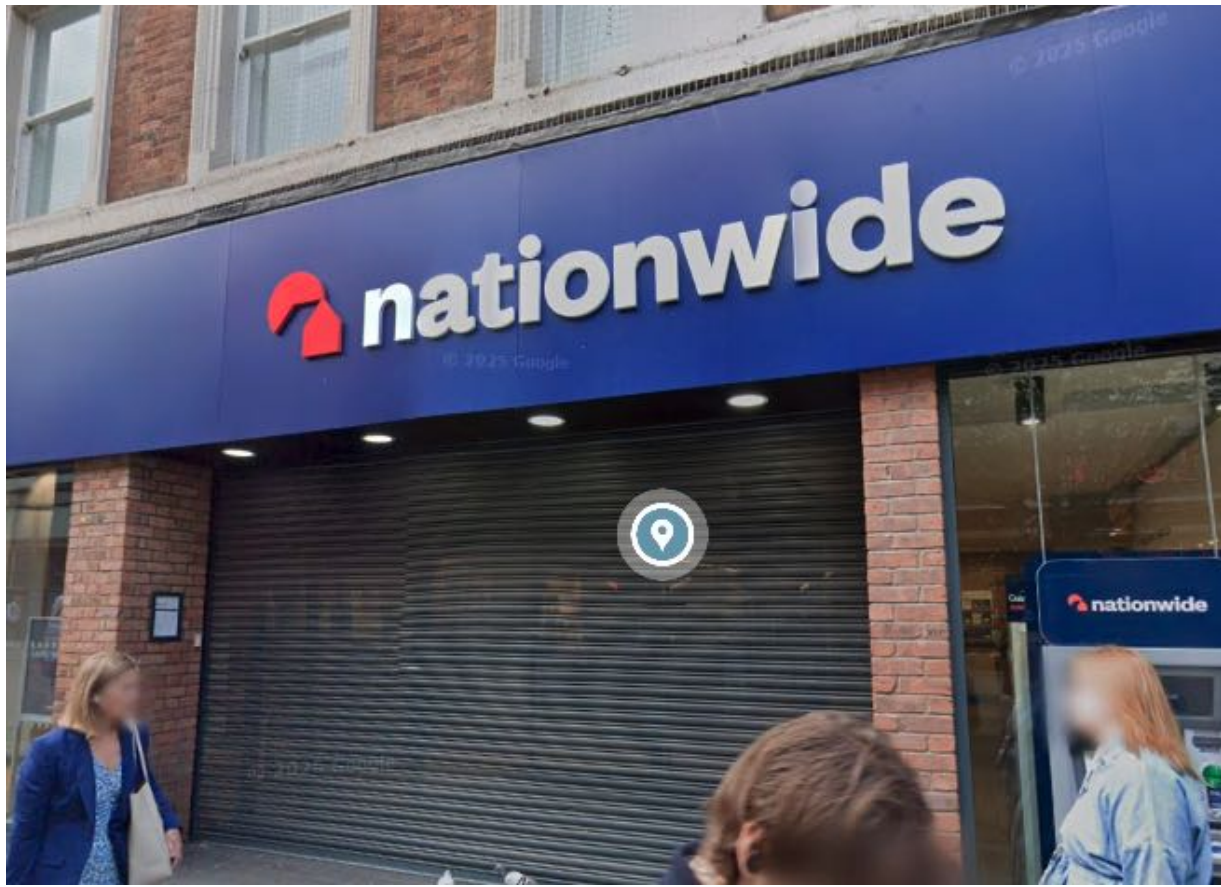
EXISTING FASCIA SIGNAGE

Not centred over door as drawings

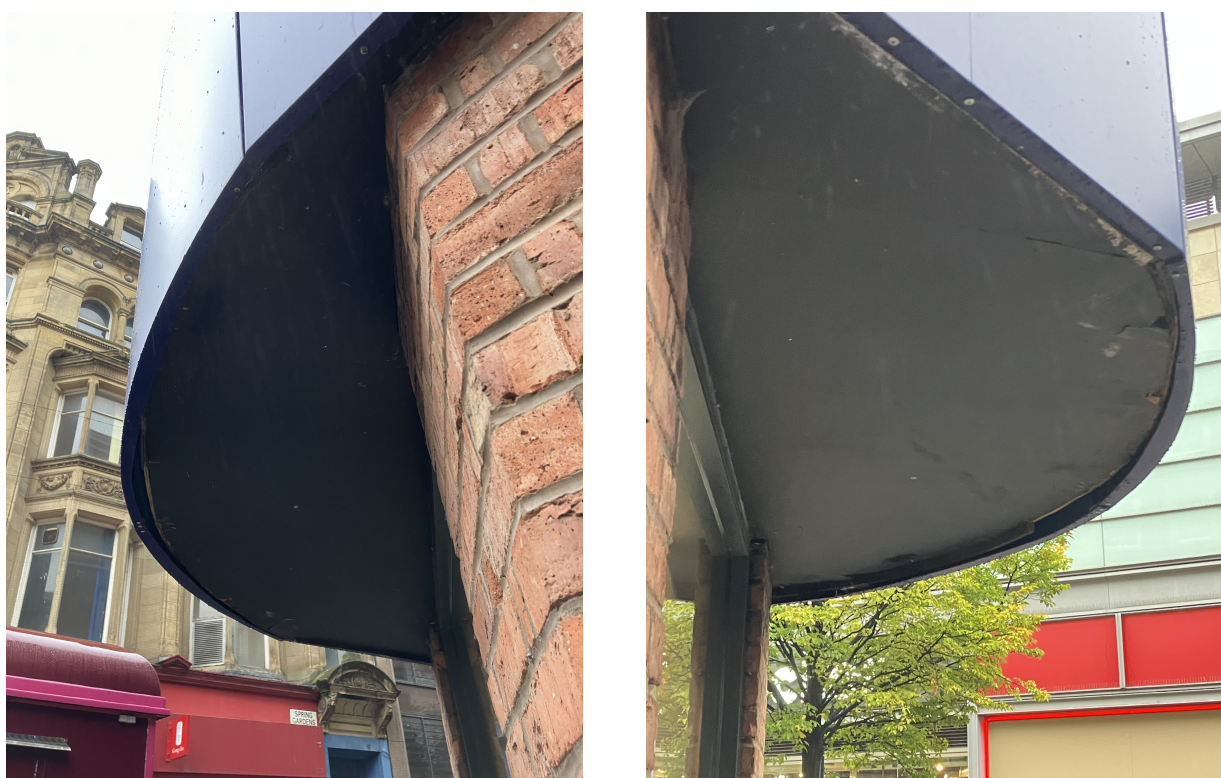
EXISTING FASCIA PANEL CORNER

Multiple sections of folded aluminium, poorly constructed, joints visible and not following a natural curve
