## GAS MEMBRANE VALIDATION

| <b>Site Name:</b> Belle Vue | <b>Project Number:</b> 12-123 |
| <b>Company Name:</b> Countryside Properties | <b>Date:</b> 12-12-2022 |
| Ground Gas Risk Assessment: <b>Amber 1</b> | |

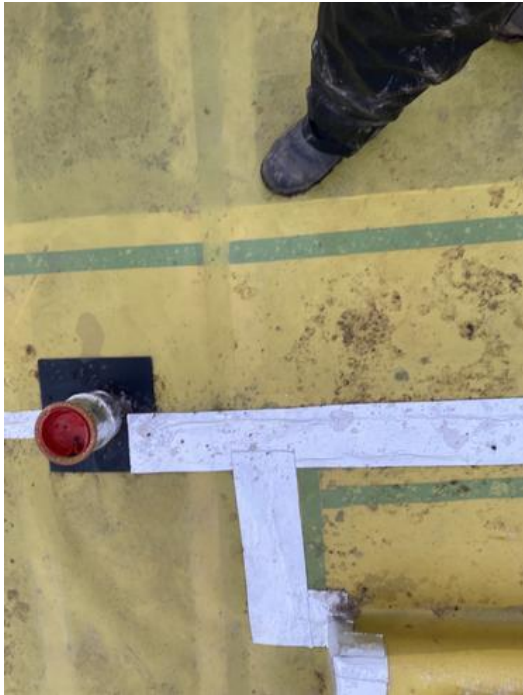
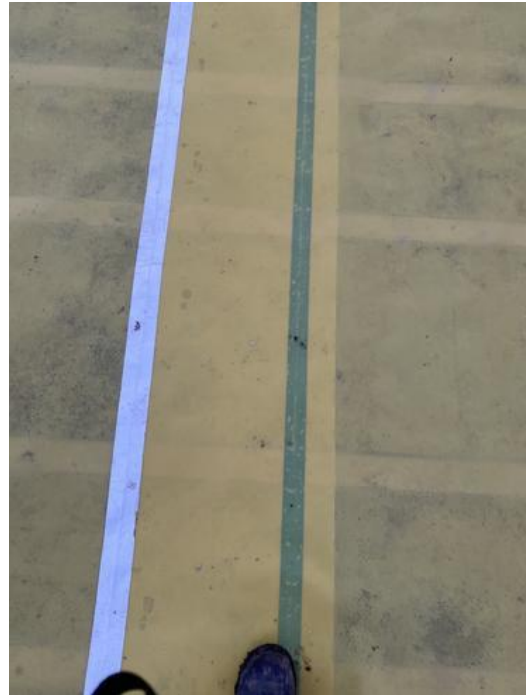
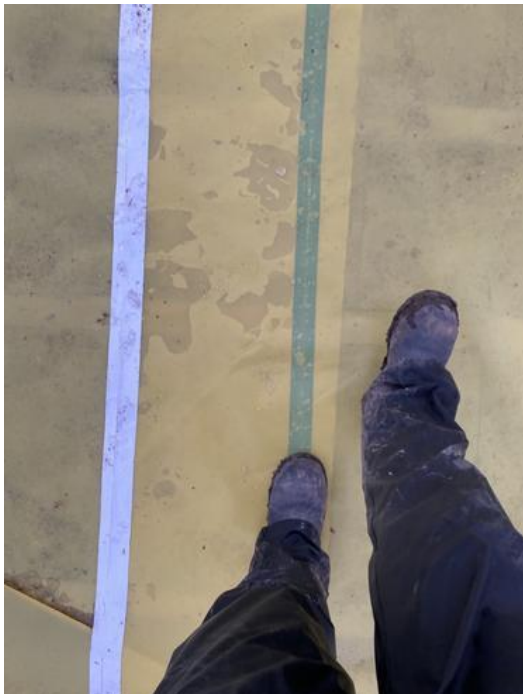
Laps, welds, and joints seals: Joints lapped and sealed in accordance with manufacturer's requirements/ specification? Minimum overlap insured? Sections taped twice? Are welds complete? Appropriate joining/double-sided tape used, Folds running in line with joints? (no joints cutting across folds)

Pass

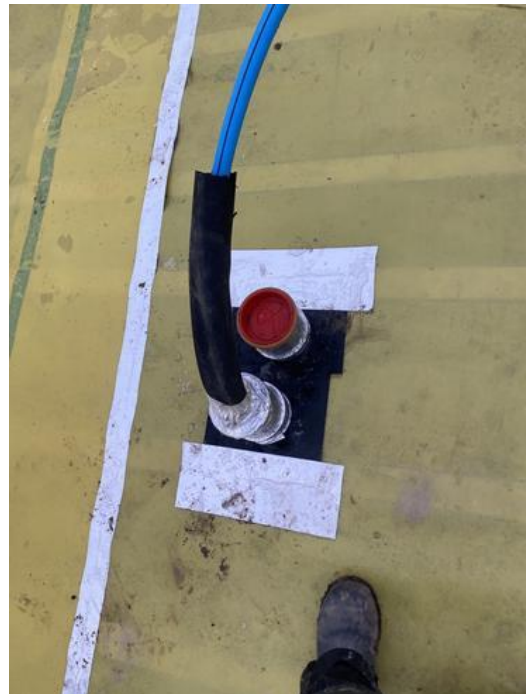
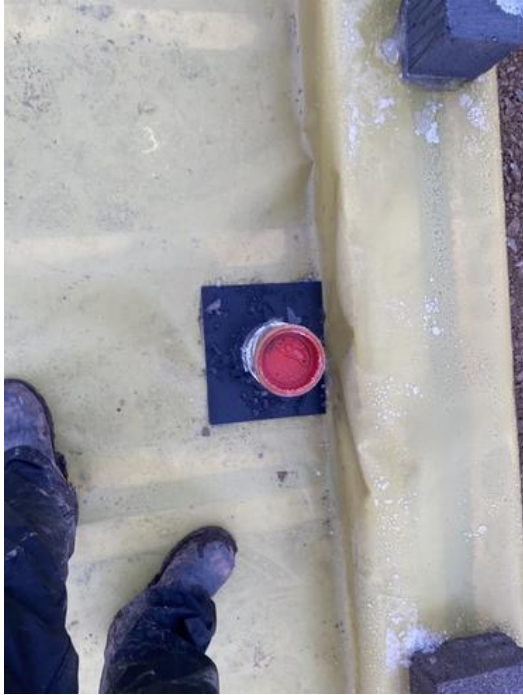
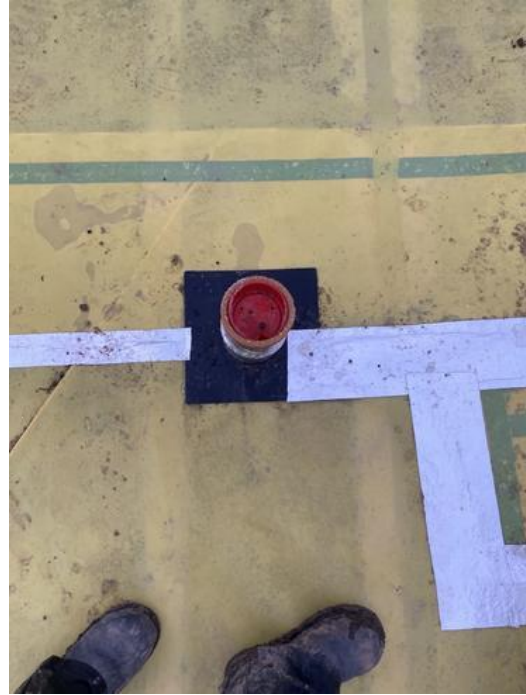
Service entries seals: Top hats seal arrangements fixed around service entries? Use of Jubilee clips?

Yes

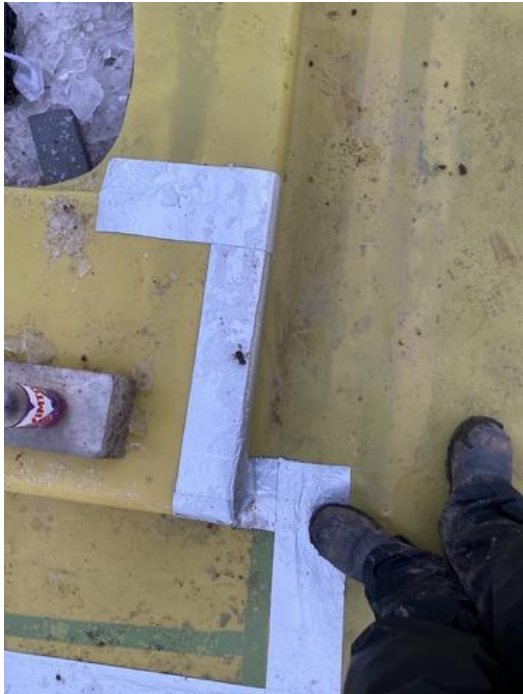
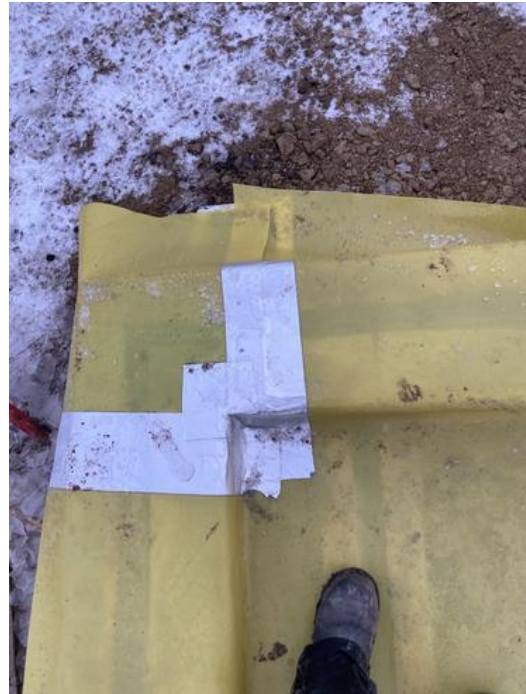
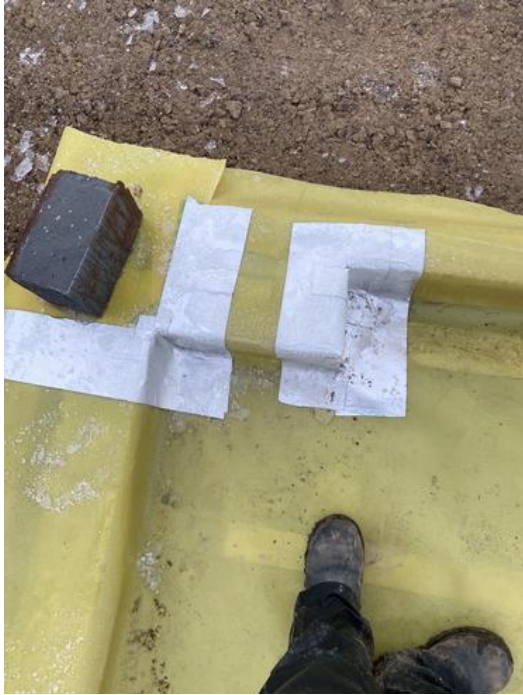
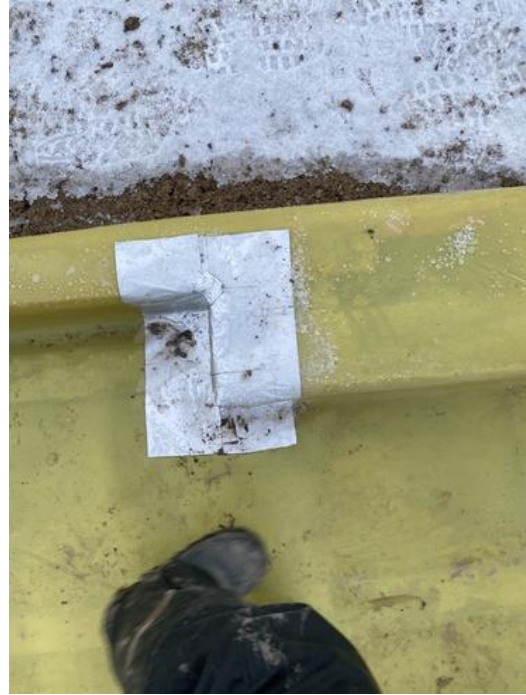
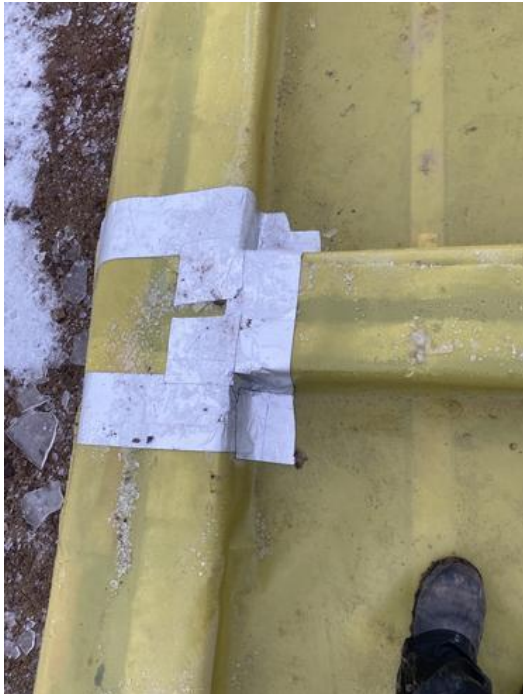
Corners / Internal joints: Check all corners are correctly formed or contractor has used performed corners.

Pass

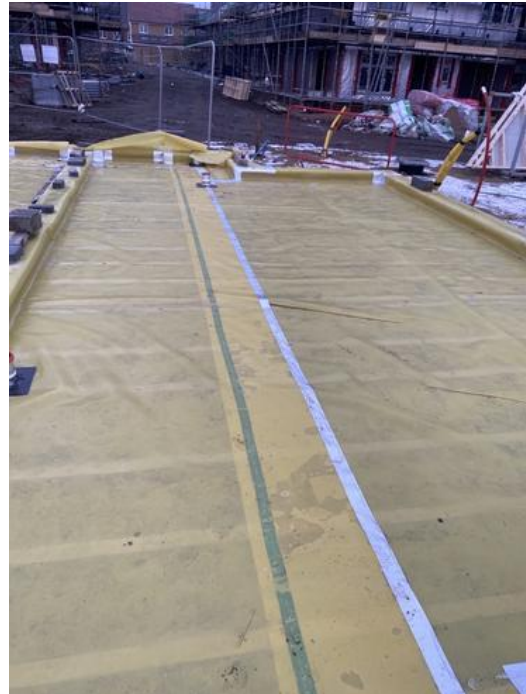
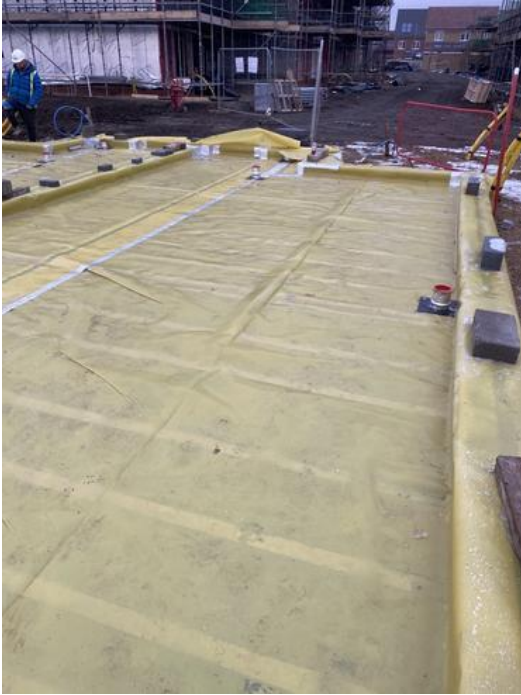
**Extent of Coverage: Is the membrane covering the entire plot? Does membrane span over outside walls?**

Yes

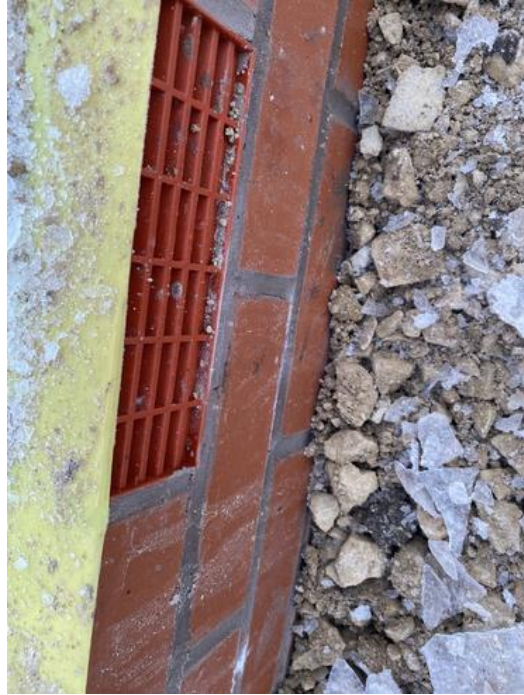
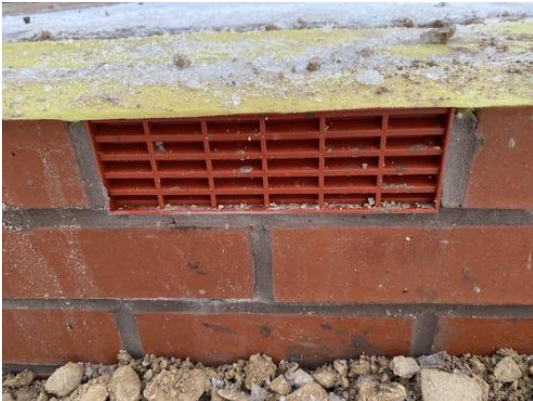
**External Wall Air bricks: Numbers, size. positions as design drawing? (Minimum of 3 walls)**

Pass

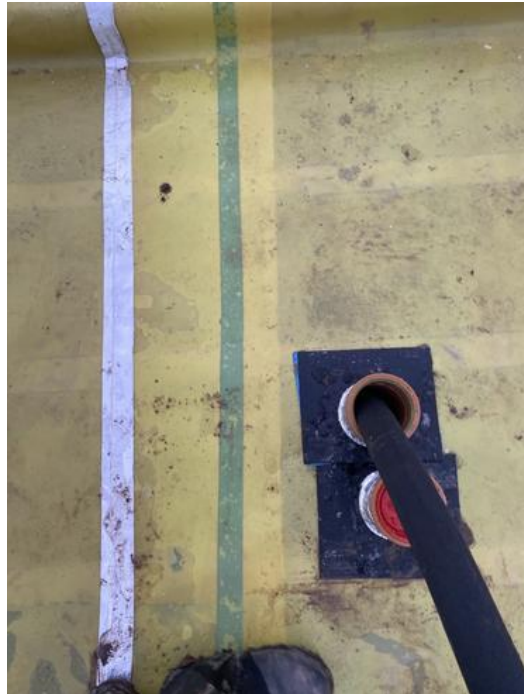
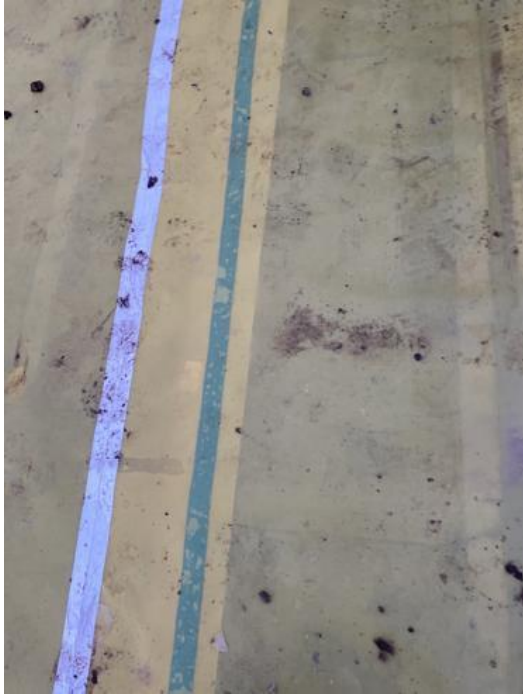
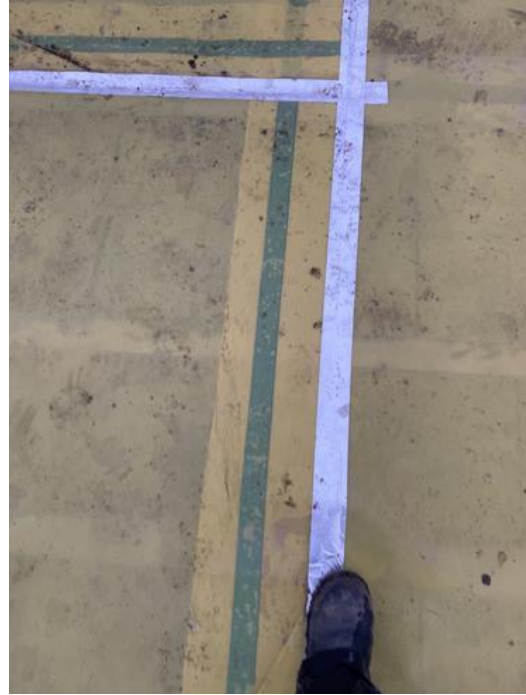
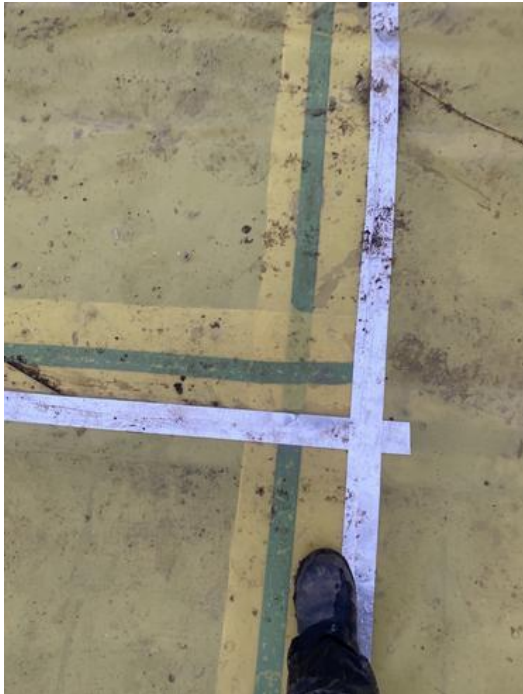
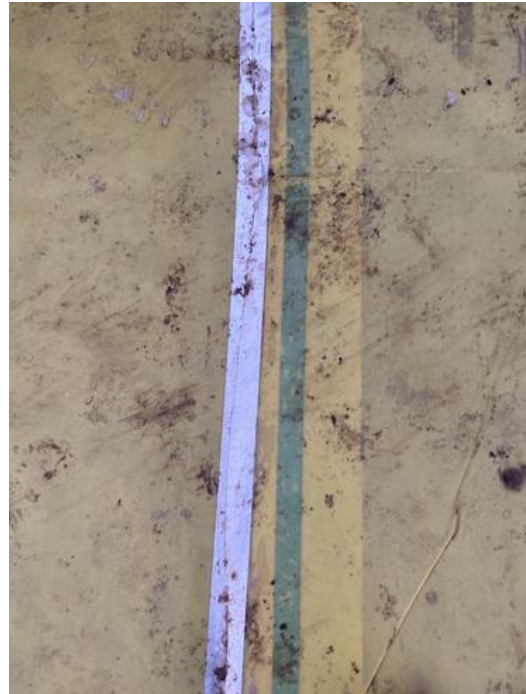
**Laps, welds, and joints seals: Joints lapped and sealed in accordance with manufacturer's requirements/ specification? Minimum overlap insured? Sections taped twice? Are welds complete? Appropriate joining/double-sided tape used, Folds running in line with joints? (no joints cutting across folds)**

Pass

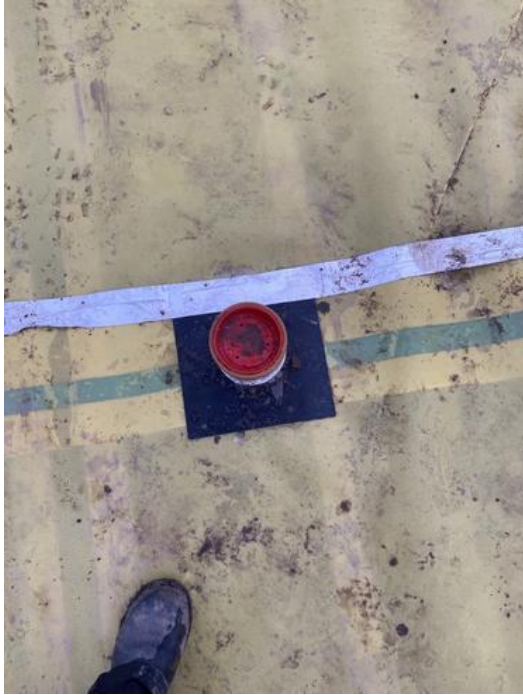
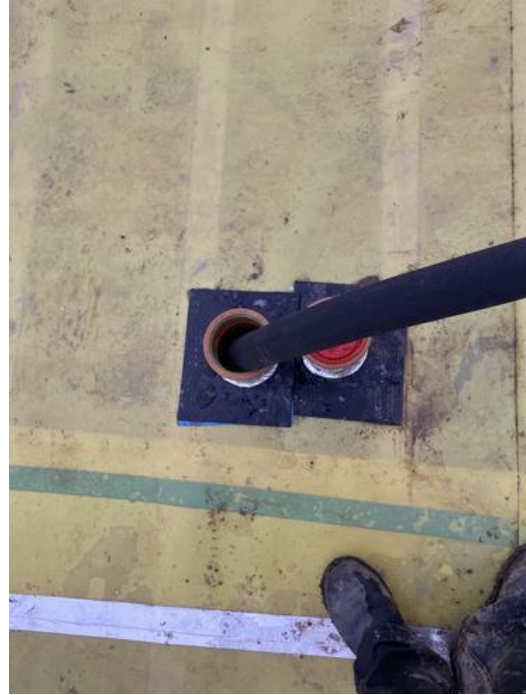
**Service entries seals: Top hats seal arrangements fixed around service entries? Use of Jubilee clips?**

Yes

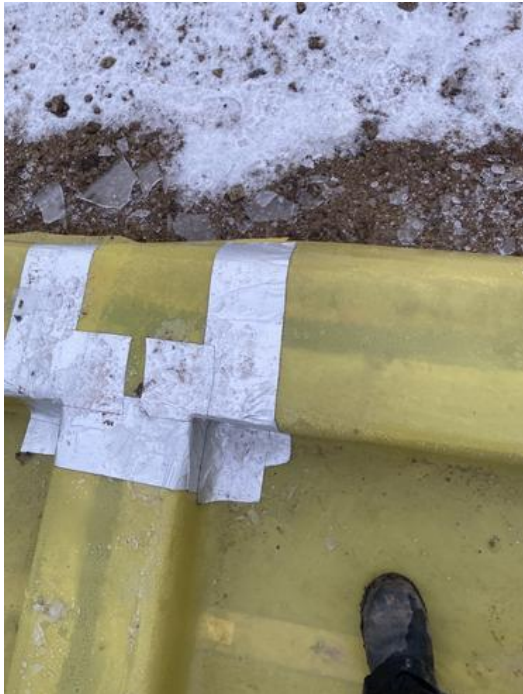
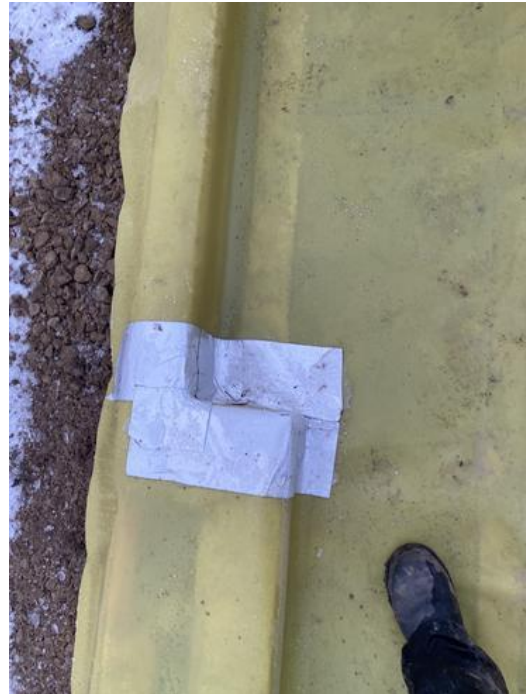
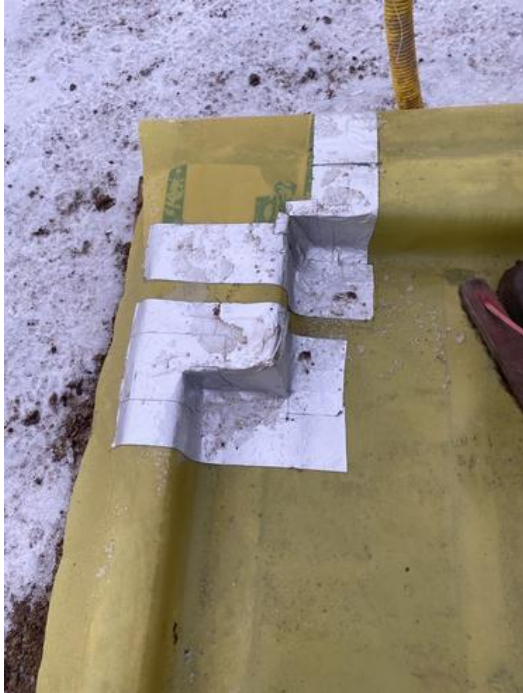
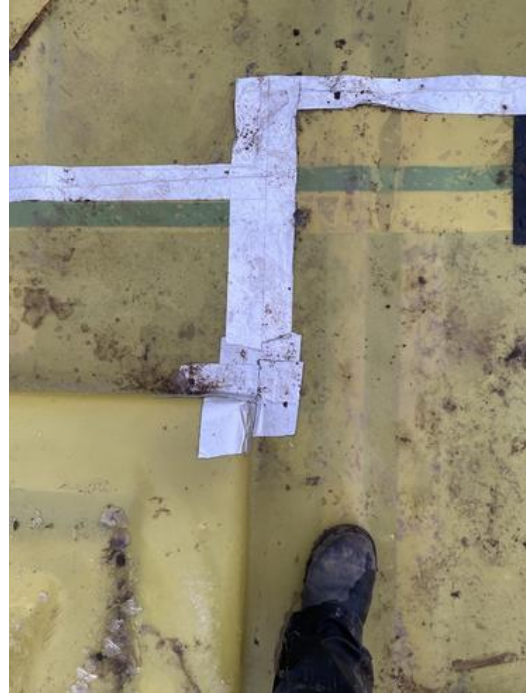
**Corners / Internal joints: Check all corners are correctly formed or contractor has used performed corners.**

Pass

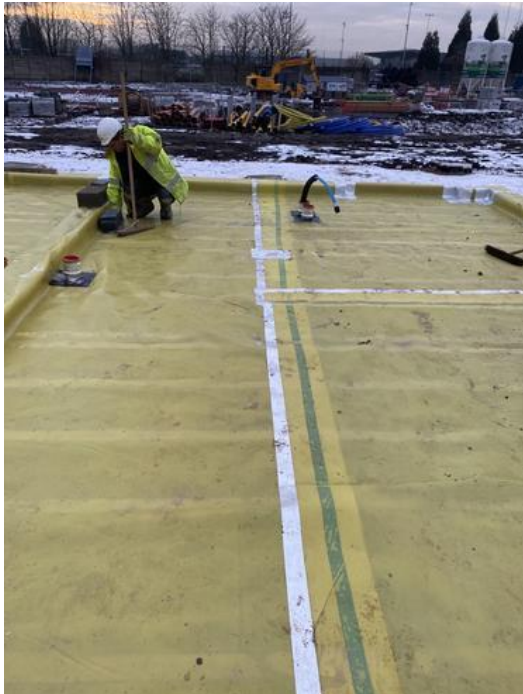
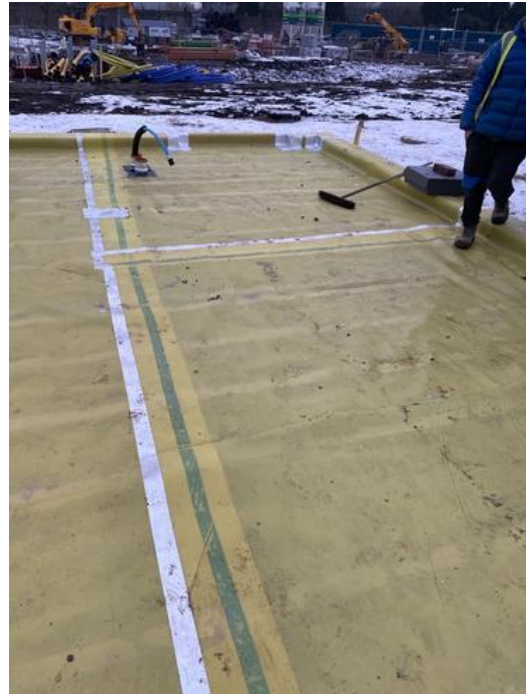
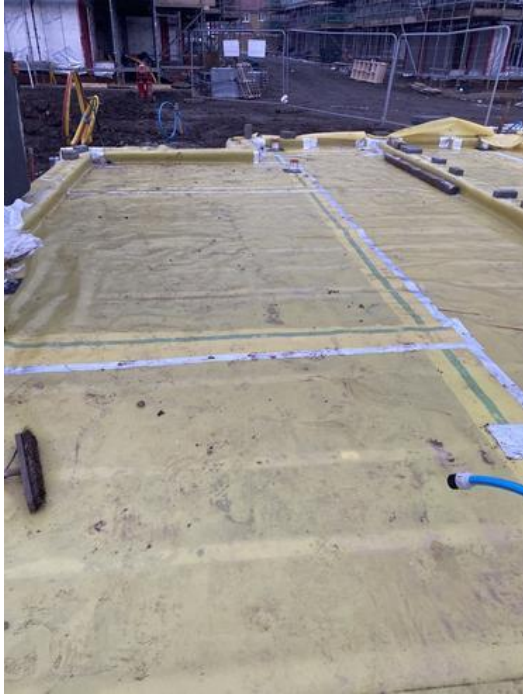
**Extent of Coverage: Is the membrane covering the entire plot? Does membrane span over outside walls?**

Yes

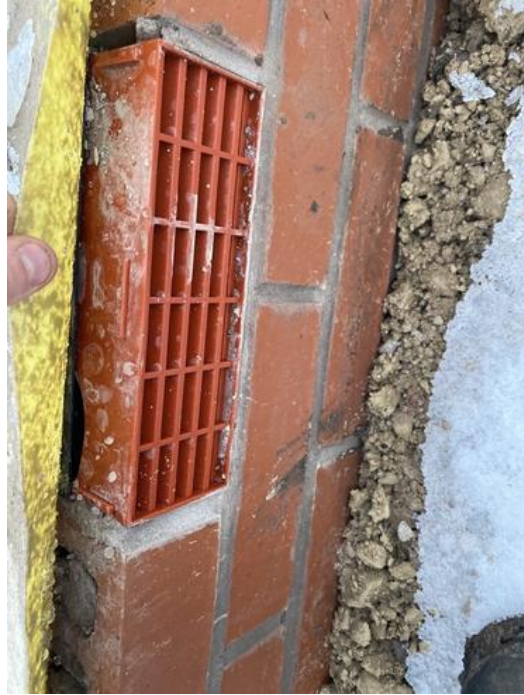
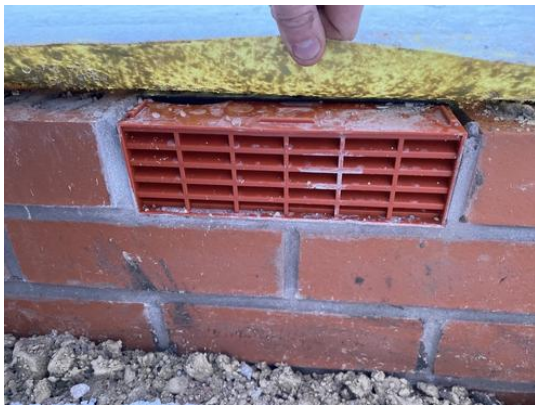
**External Wall Air bricks: Numbers, size. positions as design drawing? (Minimum of 3 walls)**

Pass
