**GAS MEMBRANE VALIDATION**

| Site Name: Belle Vue Stadium | Project Number: 12-123 |
| Company Name: Countryside | Date: 28-06-2022 |

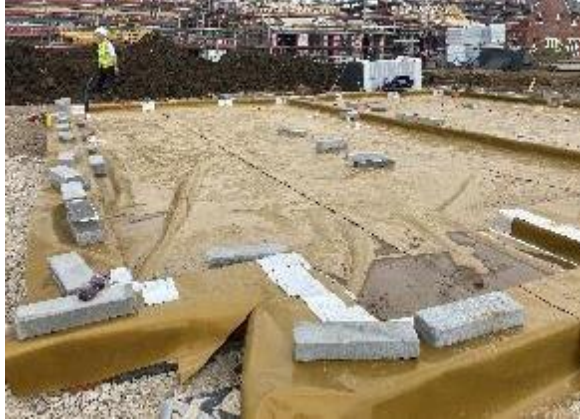
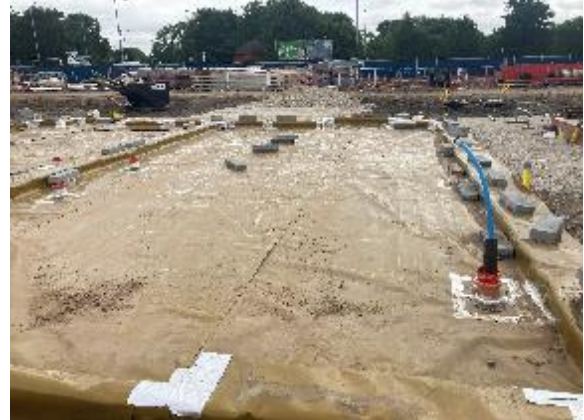
**Plot – 94**

**General Condition of Membrane-Good Condition**

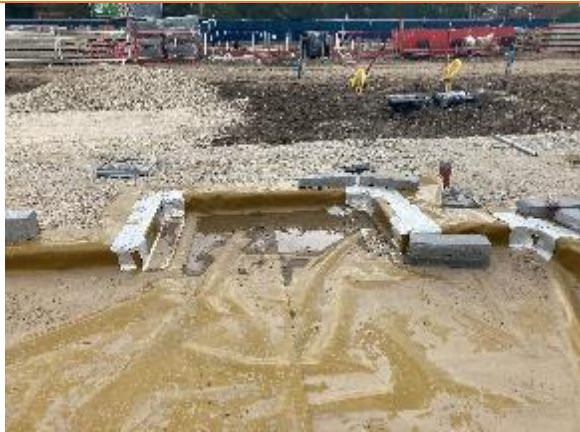
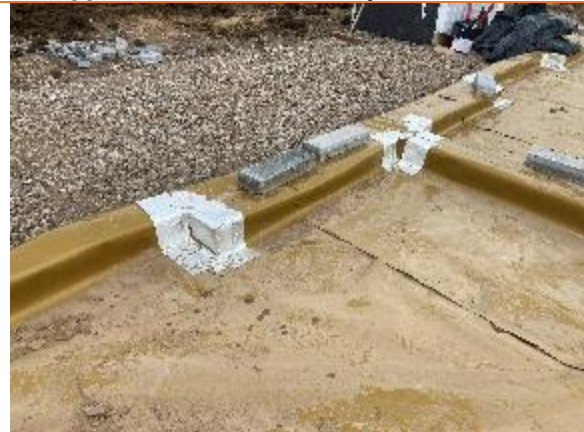
**Verification of Joints and Seals-Overlapped and sealed correctly**

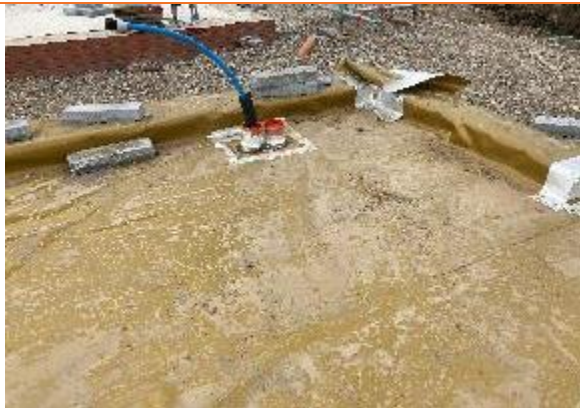
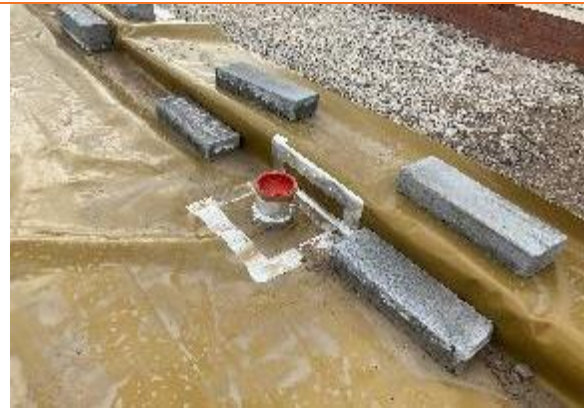
**Verification of Service Penetrations-Good Condition**

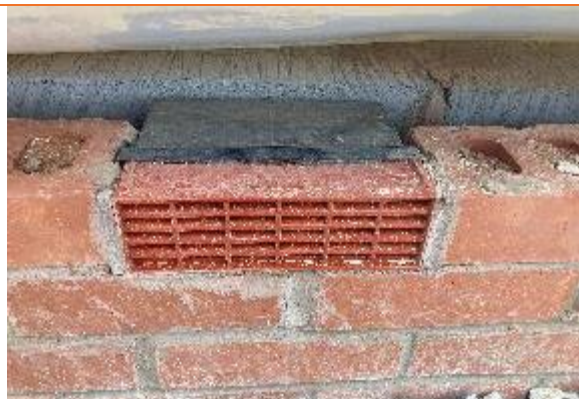
**Verification of Ventilation-Good Condition**

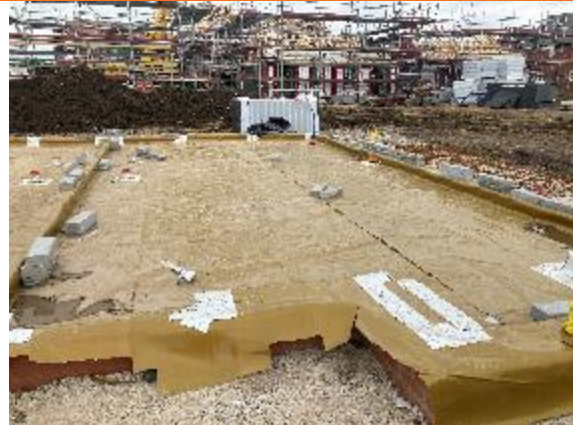
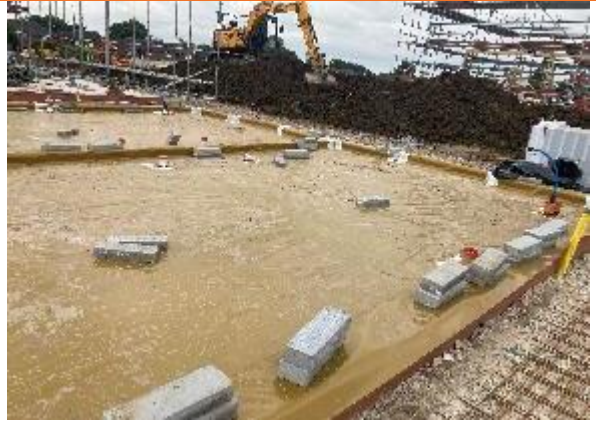
**Plot - 95**

**General Condition of Membrane-Good Condition**

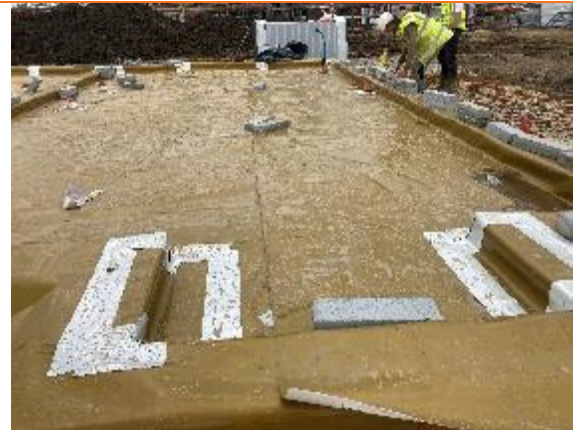
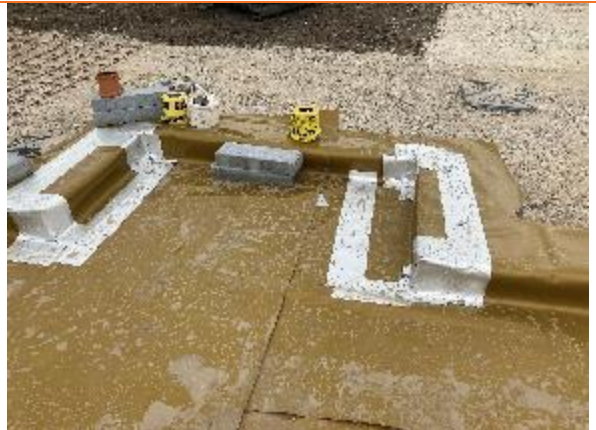
**Verification of Joints and Seals-Overlapped and sealed correctly**

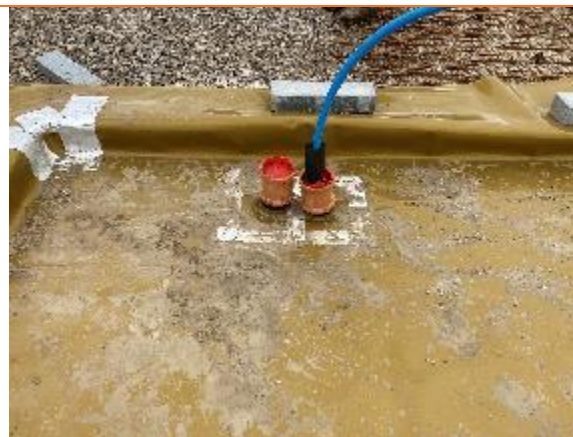
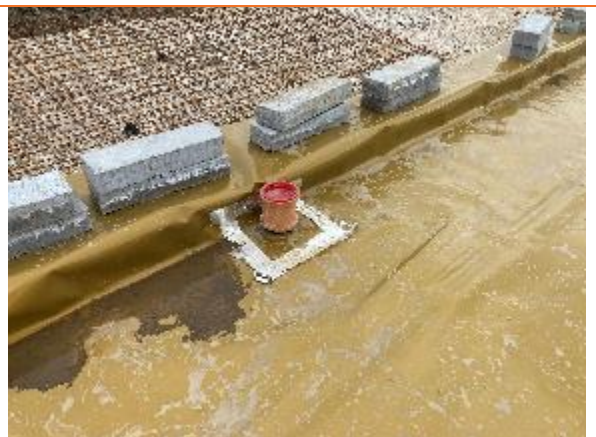
**Verification of Service Penetrations-Good Condition**
