## GAS MEMBRANE VALIDATION

| <b>Site Name:</b> Belle Vue | <b>Project Number:</b> 12-123 |
| <b>Company Name:</b> Countryside Properties | <b>Date:</b> 10-11-2022 |

178

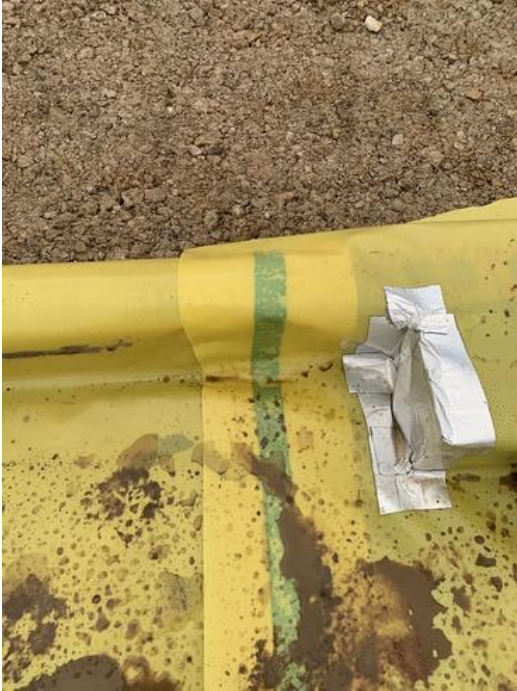
Photo 1

**Laps, welds, and joints seals: Joints lapped and sealed in accordance with manufacturer's requirements/ specification? Minimum overlap insured? Sections taped twice? Are welds complete? Appropriate joining/double-sided tape used, Folds running in line with joints? (no joints cutting across folds)**

Pass

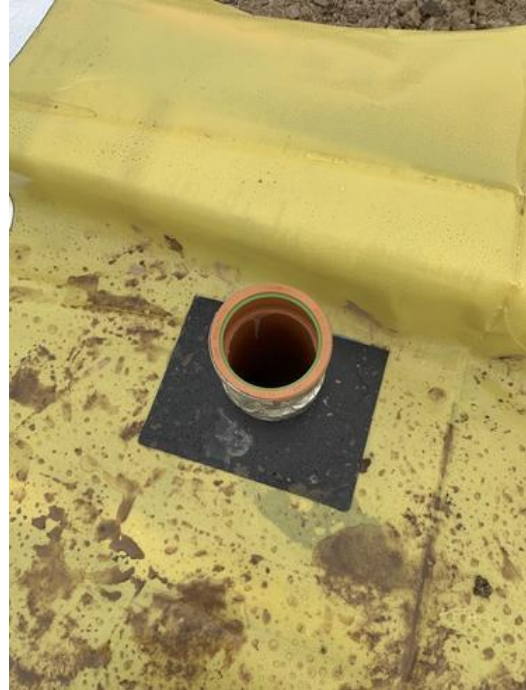
Photo 6

**Service entries seals: Top hats seal arrangements fixed around service entries? Use of Jubilee clips?**

Yes

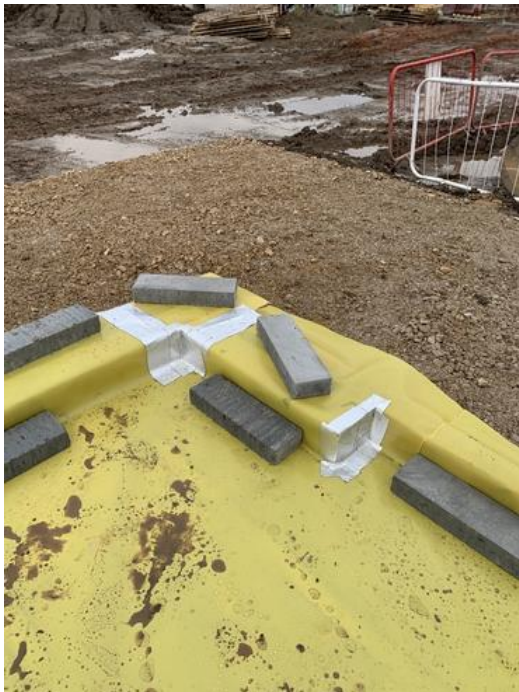
Photo 11

**Corners / Internal joints: Check all corners are correctly formed or contractor has used performed corners.**

Pass

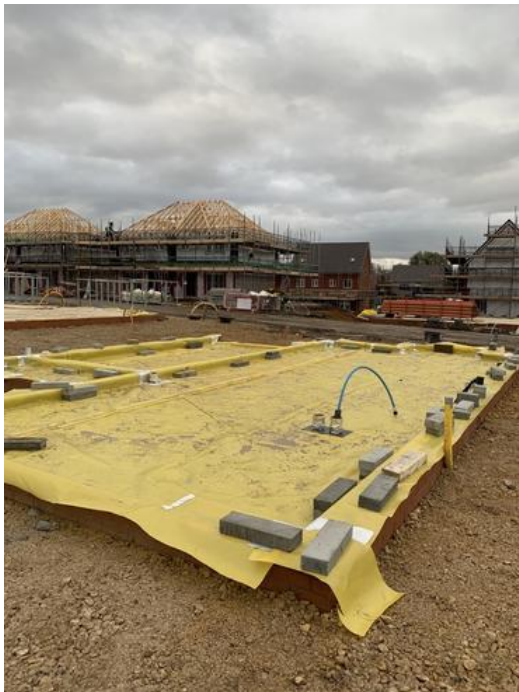
Photo 19

**Extent of Coverage: Is the membrane covering the entire plot? Does membrane span over outside walls?**

Yes

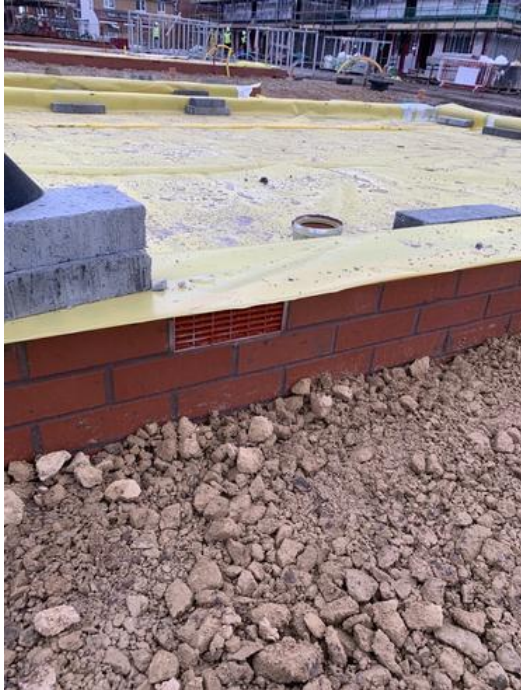
Photo 21

**External Wall Air bricks: Numbers, size. positions as design drawing? (Minimum of 3 walls)**

Pass
