## **Whitworth Art Gallery Spire Inspection**

16/04/2024

Client: NOVUS

| Project: | Whitworth Art Gallery – Spire Inspection |

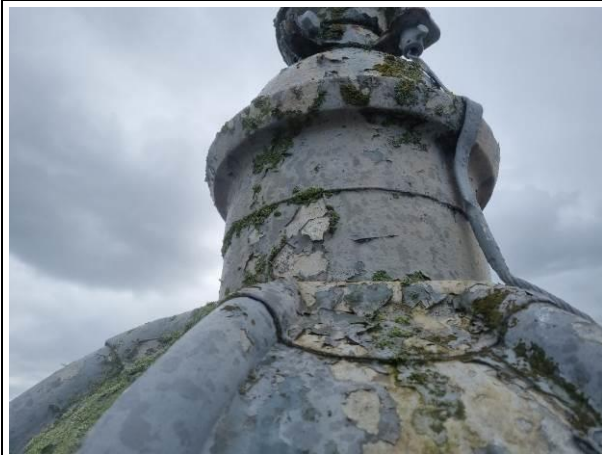
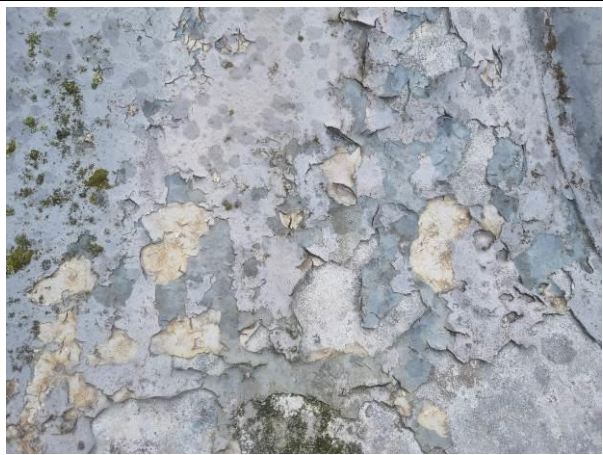
Coating failure to the lead cladding (upper part of the spire) present throughout. Lead appears to be generally in good condition.

Previous coatings to the lead have now exceeded their life expectancy and are therefore flaking / failing.

- Renew rotten / missing timber elements.
- Renew coatings.
- Repair damaged lead.

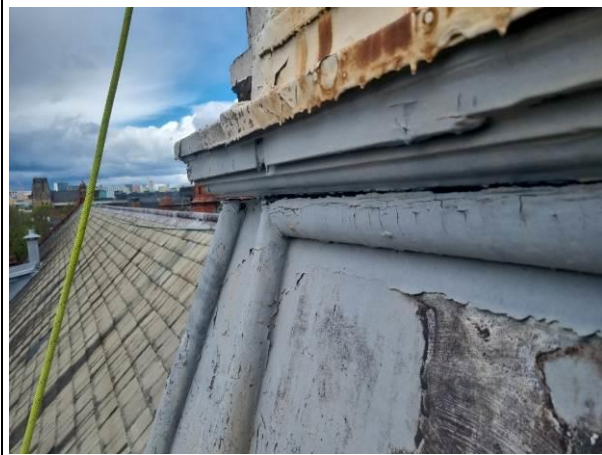
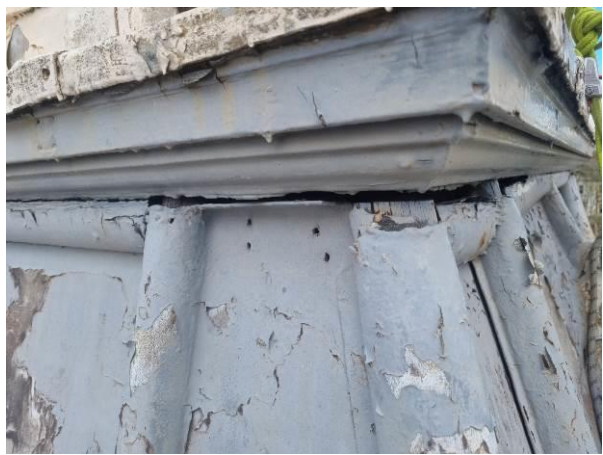
Possible flashing detail missing from top of lead apron. Water ingress has been reported in this area.

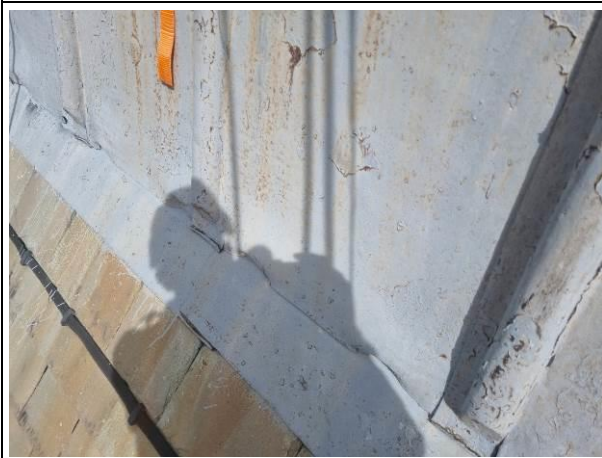
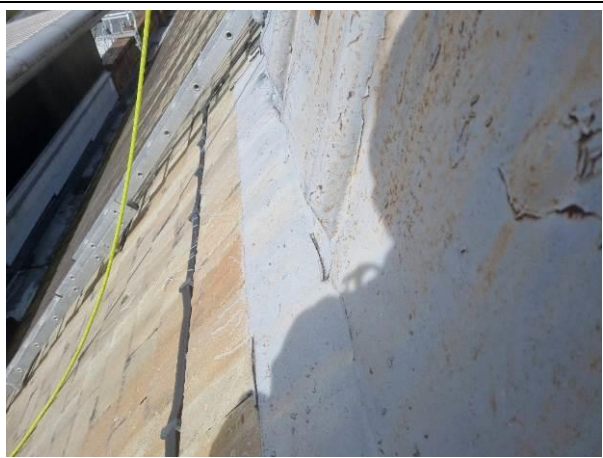
Evidence of lead slipping downwards at base of apron.

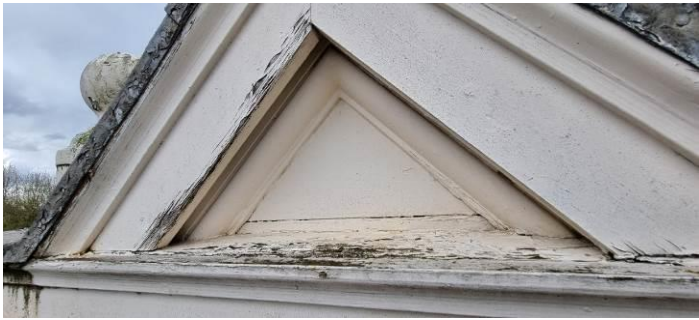
| Photos: | E1_1 | |

| Defect Descriptions: | Timber - Rotten | |
| Size: | 300x50 | |

| Ref. | Description | Quantity | Length (mm) | Width (mm) | Depth (mm) | Comments | Photos |
|---|---|---|---|---|---|---|---|
| 1 | Timber - Rotten | 1No. | 300 | 50 | | | E1_1 |

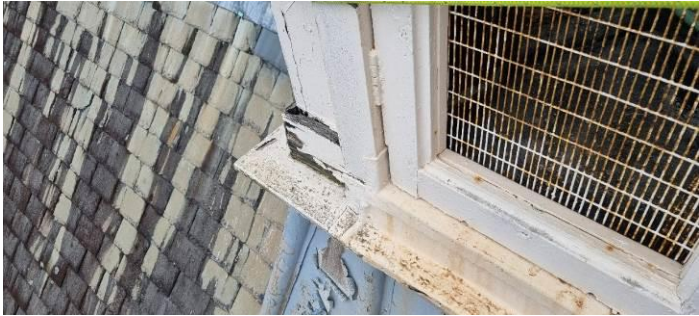
| Photos: | E4_1 | |

| Defect Descriptions: | Timber - Rotten | |
| Size: | 200x150 | |

| Ref. | Description | Quantity | Length (mm) | Width (mm) | Depth (mm) | Comments | Photos |
|---|---|---|---|---|---|---|---|
| 4 | Timber - Rotten | 1No. | 200 | 150 | | | E4_1 |

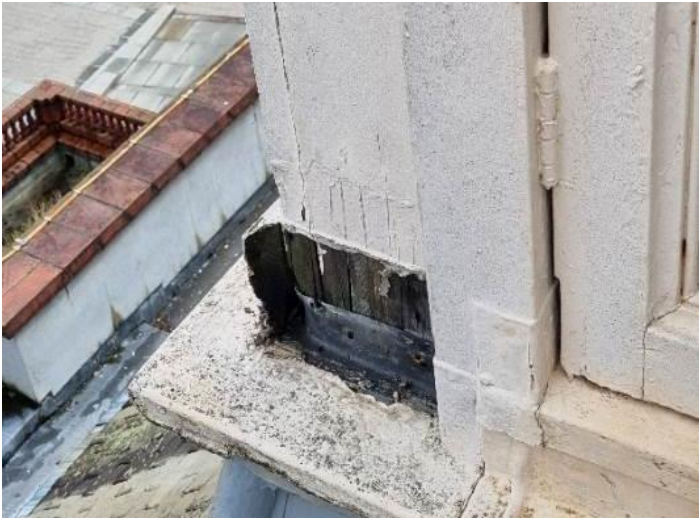
| Photos: | N1_1 | |

| Defect Descriptions: | Timber - Missing, rotten | |
| Size: | 200x150 | |

| Ref. | Description | Quantity | Length (mm) | Width (mm) | Depth (mm) | Comments | Photos |
|---|---|---|---|---|---|---|---|
| 1 | Timber - Missing, Timber - Rotten | 1No. | 200 | 150 | | | N1_1 |

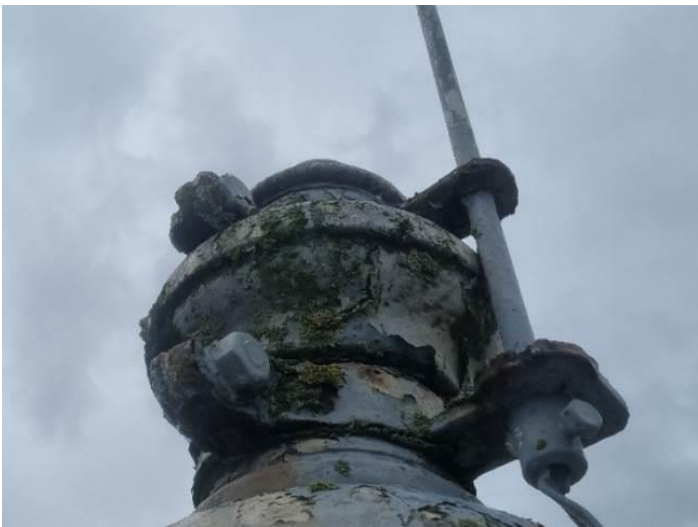
| Photos: | P1_1 | |

| Defect Descriptions: | Bracket – Corrosion. Corrosion and coating failure present on bracket holding the lightening rod | |
| Size: | 300x300 | |

| Ref. | Description | Quantity | Length (mm) | Width (mm) | Depth (mm) | Comments | Photos |
|---|---|---|---|---|---|---|---|
| 1 | Bracket - Corrosion | 1No. | 300 | 300 | | Corrosion and coating failure present on bracket holding the lightening rod | P1_1 |

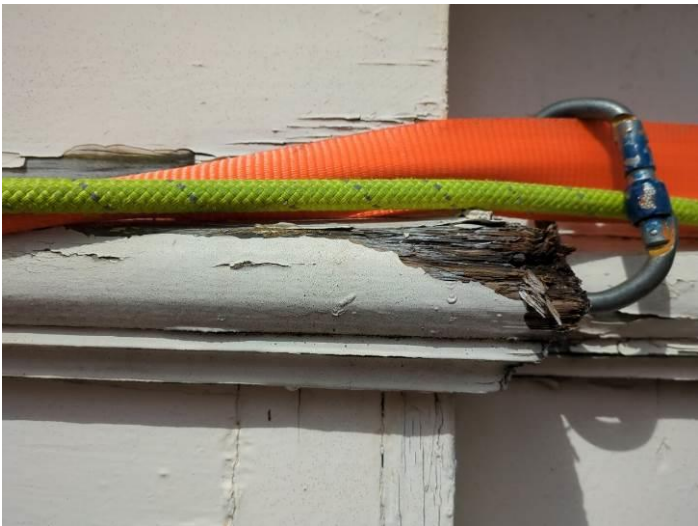
| Photos: | S2_1 | |

| Defect Descriptions: | Timber - Rotten | |
| Size: | 75x1600x60 | |

| Ref. | Description | Quantity | Length (mm) | Width (mm) | Depth (mm) | Comments | Photos |
|---|---|---|---|---|---|---|---|
| 2 | Timber - Rotten | 1No. | 75 | 1600 | 60 | | S2_1, S2_2, S2_3 |

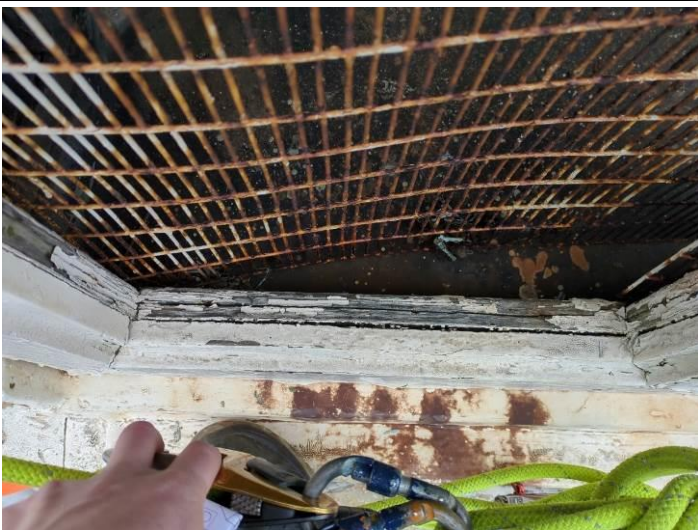
| Photos: | S3_2 | |

| Defect Descriptions: | Timber – Rotten. All 4 sections of door rotten on bottom side. | |
| Size: | 390x25x25 | |

| Ref. | Description | Quantity | Length (mm) | Width (mm) | Depth (mm) | Comments | Photos |
|---|---|---|---|---|---|---|---|
| 3 | Timber - Rotten | 4No. | 390 | 25 | 25 | All 4 sections of door rotten on bottom side | S3_1, S3_2, S3_3, S3_4 |

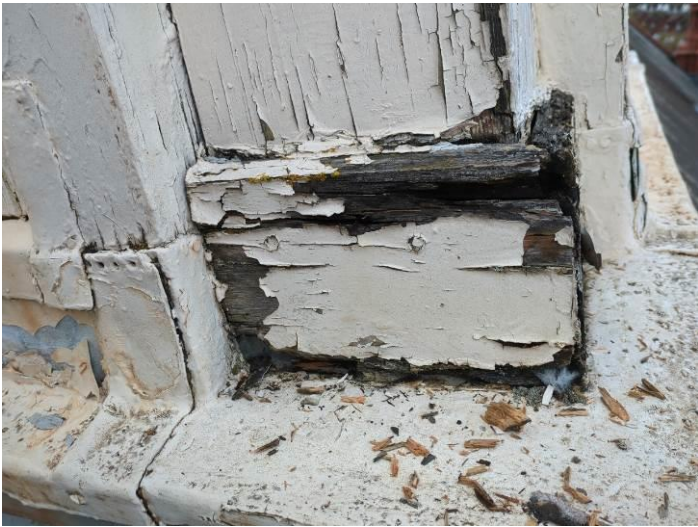
| Photos: | S5_1 | |

| Defect Descriptions: | Timber – Rotten | |
| Size: | 150x230x25 | |

| Ref. | Description | Quantity | Length (mm) | Width (mm) | Depth (mm) | Comments | Photos |
|---|---|---|---|---|---|---|---|
| 5 | Timber - Rotten | 1No. | 150 | 230 | 25 | | S5_1, S5_2 |

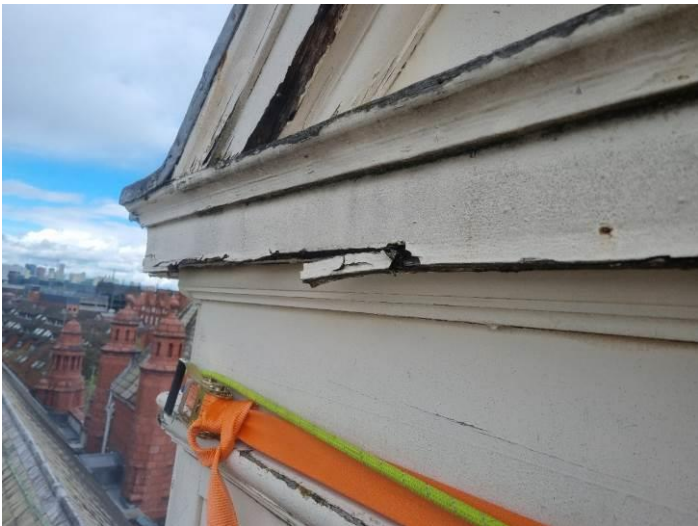
| Photos: | W3_1 | |

| Defect Descriptions: | Coating - Degraded, Timber - Rotten | |
| Size: | 900x100x20 | |

| Ref. | Description | Quantity | Length (mm) | Width (mm) | Depth (mm) | Comments | Photos |
|---|---|---|---|---|---|---|---|
| 3 | Coating - Degraded, Timber - Rotten | 1No. | 900 | 100 | 20 | | W3_1 |

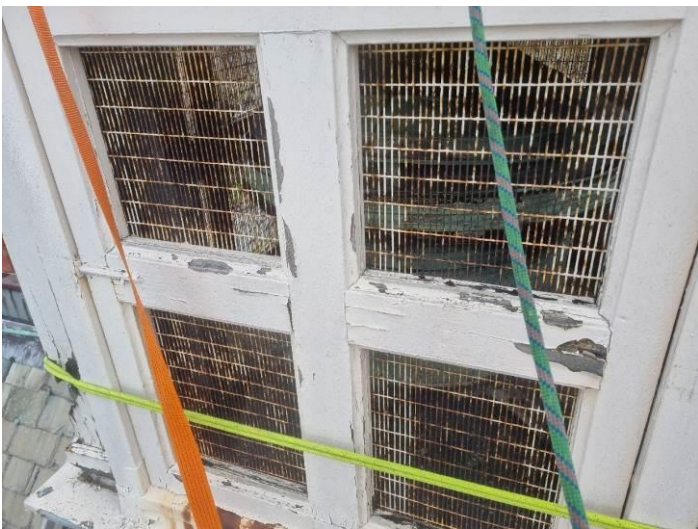
| Photos: | W6_4 | |

| Defect Descriptions: | Coating - Degraded, Timber – Rotten.<br>All beading to base area of each opening are rotten. | |
| Size: | 450x25 | |

| Ref. | Description | Quantity | Length (mm) | Width (mm) | Depth (mm) | Comments | Photos |
|---|---|---|---|---|---|---|---|
| 6 | Coating - Degraded, Timber - Rotten | 4No. | 450 | 25 | | All beading to base area of each opening are rotten | W6_1, W6_2, W6_3, W6_4 |

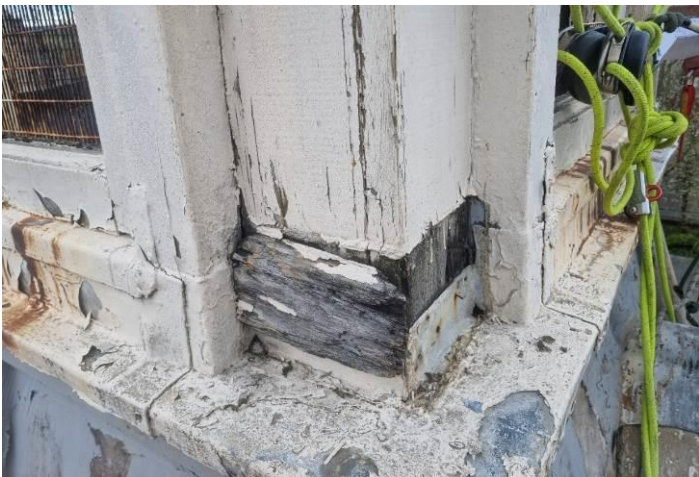
| Photos: | W8_1 | |

| Defect Descriptions: | Timber - Missing, Rotten, Split.<br>Timber boarding and moulding to corners rotten at base | |
| Size: | 800x400x25 | |

| Ref. | Description | Quantity | Length (mm) | Width (mm) | Depth (mm) | Comments | Photos |
|---|---|---|---|---|---|---|---|
| 8 | Timber - Missing, Timber - Rotten, Timber - Split | 1No. | 800 | 400 | 25 | Timber boarding and moulding to corners rotten at base | W8_1 |

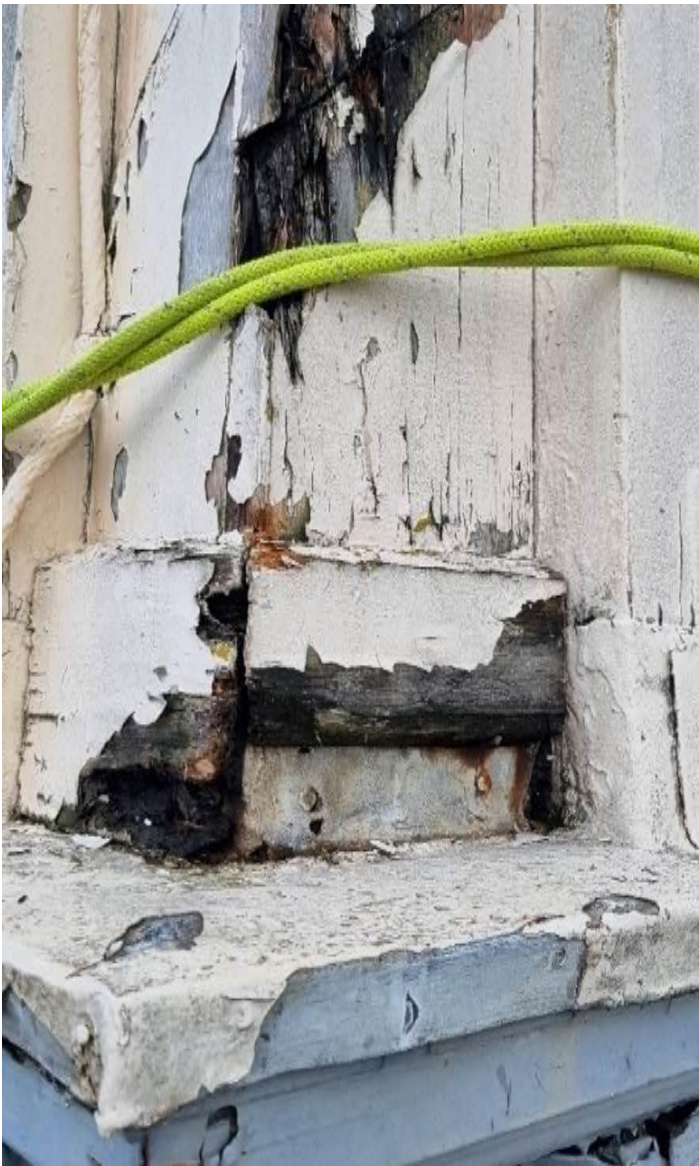
| Photos: | W9_1 | |

| Defect Descriptions: | Timber - Rotten | |
| Size: | 200x400 | |

| Ref. | Description | Quantity | Length (mm) | Width (mm) | Depth (mm) | Comments | Photos |
|---|---|---|---|---|---|---|---|
| 9 | Timber - Rotten | 1No. | 200 | 400 | | | W9_1 |
