Gas Membrane Installation  
Validation Report  
Kier  
Nelson Street  
Miles Platting  
Manchester  
M40 8BB

## Appendix 1 – Site Survey Sheets

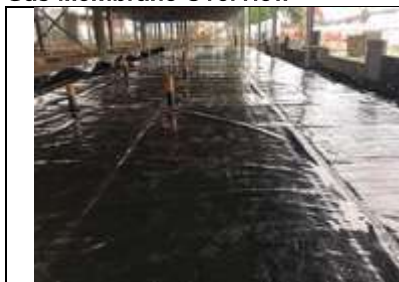
Overview of the pour area installed

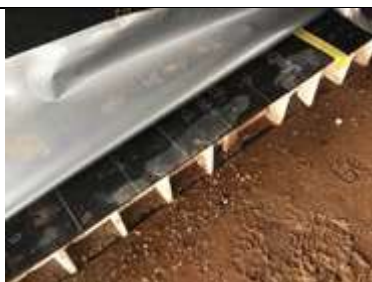
Heave board installed which the membrane is installed above

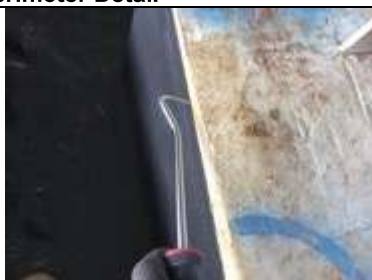
Internal perimeter concrete column retro fit detail testing

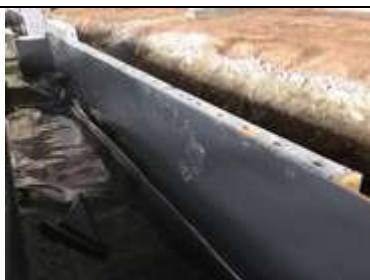
Membrane extended up the perimeter shuttering

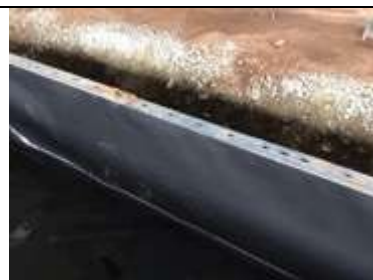
Membrane extended up the perimeter shuttering

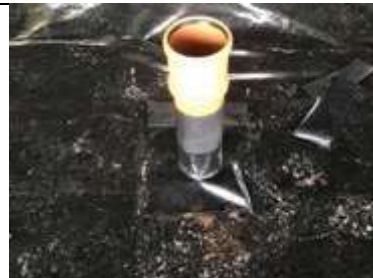
Pipe penetration sealed using hand welded preformed top hat and Juta GP1 SAM

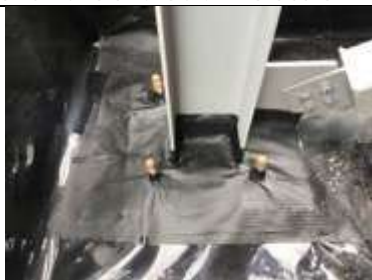
Stanchions sealed using Juta GP1 SAM

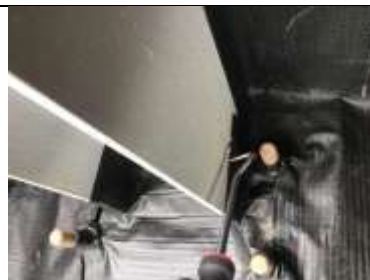
Testing stanchion detailing

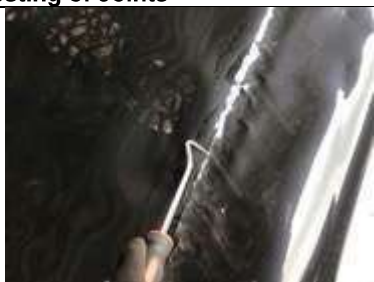
Testing sealed hand welded  
membrane lap joint

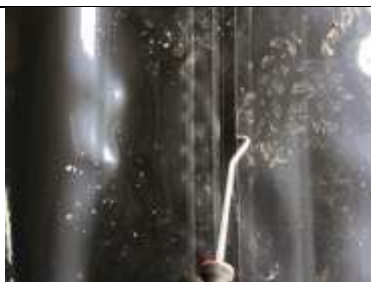
Testing sealed auto welded  
membrane lap joint

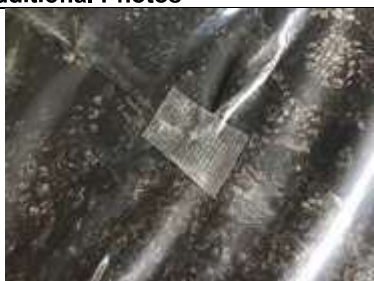
| <b>Leak/Hole Detection</b> | MEC Environmental Ltd carried out a thorough Visual Inspection to the available area at the time of our inspection |
|---|---|
| 4no weld defects were recorded by MEC. These areas were re welded by the installers during the inspection with an additional patch of Juta GP1 SAM placed over the weld. | No Action Required all Defects rectified at time of inspection |

Defect repaired sealed using Juta  
GP1 SAM

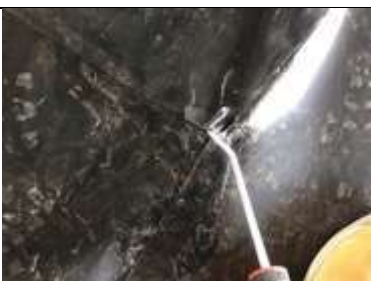
Recorded weld defect

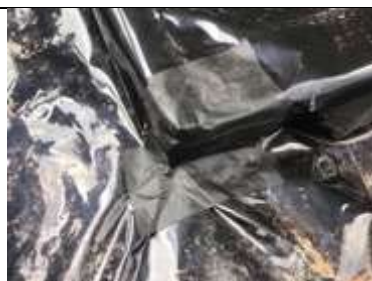
Corner detailing sealed sealed  
using Juta GP1 SAM

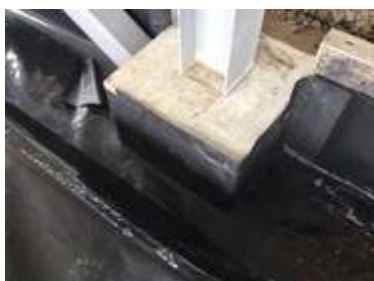
Stanchion concrete surround  
sealed sealed using Juta GP1  
SAM

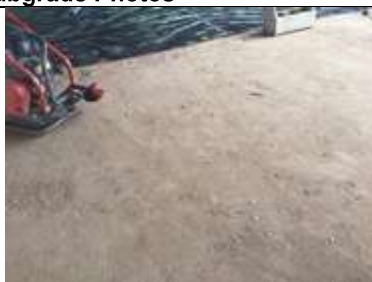
Blinding prior to the membrane installation

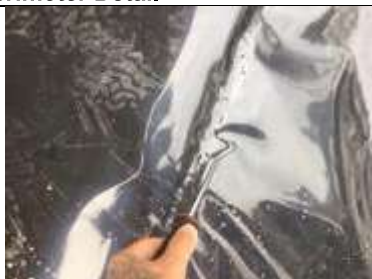
Testing perimeter membrane hand welded lap joint

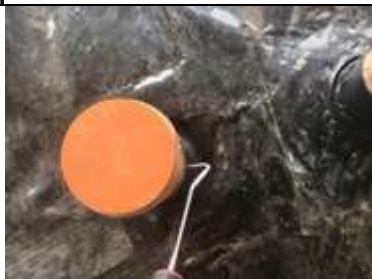
Probe testing pipe sealing

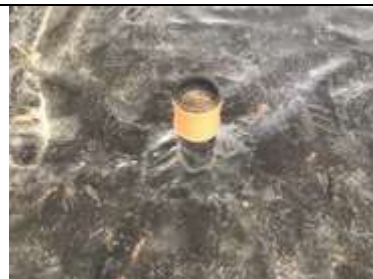
Sealed pipe penetration

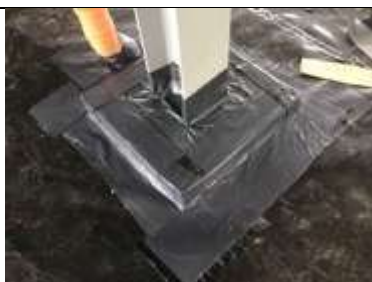
Sealed stanchion detailing

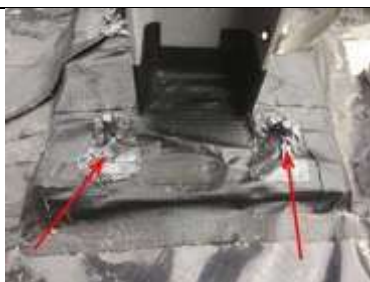
Butyl tape used to seal bolts

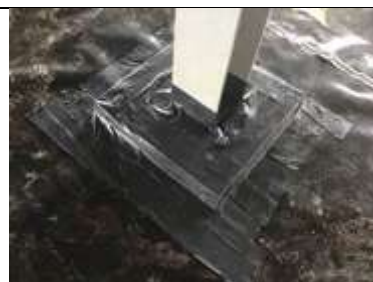
Sealed stanchion detailing

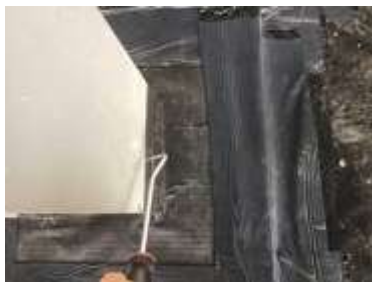
Probe testing stanchion detailing

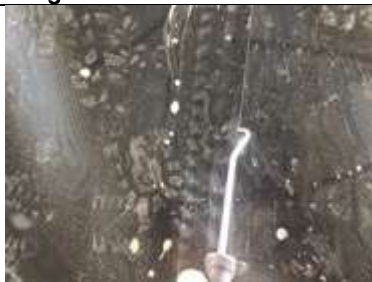
Probe testing auto welded  
membrane lap joint

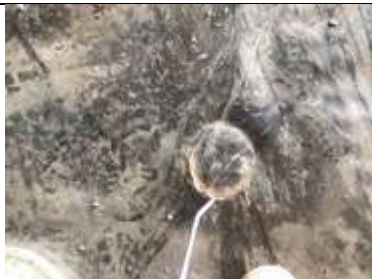
| (Section 2, Testing and Inspection Method) | |
|---|---|
| 3no recorded defects repaired by the installers during the inspection using Juta WP SAM. | No Action Required all Defects rectified at time of inspection |

Recorded defect

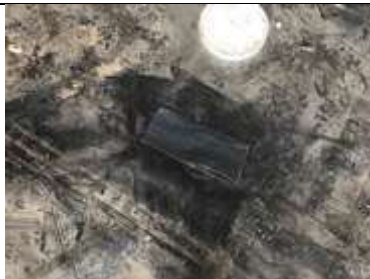
Repair made by the installers  
using Juta WP SAM

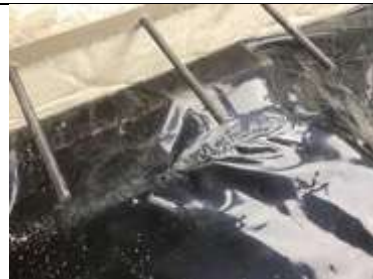
Membrane hand welded to the  
existing membrane from pour 1b

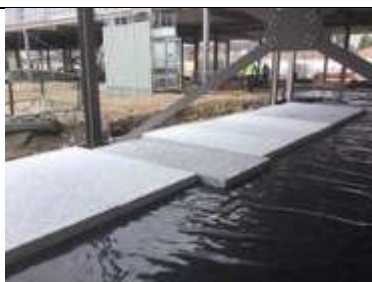
Insulation installed after the  
inspection

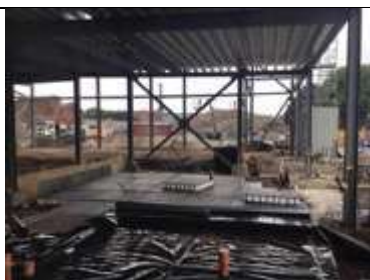
Remaining area of pour 3 yet to be installed

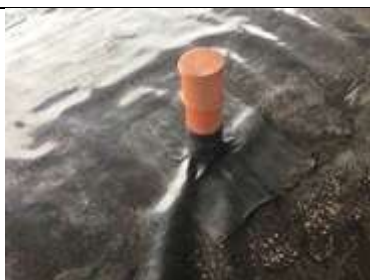
Sealed pipe penetration

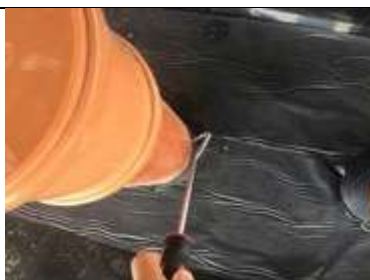
Probe testing pipe sealing

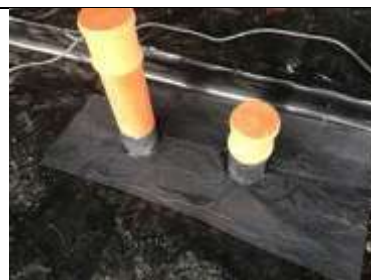
Sealed pipe penetrations

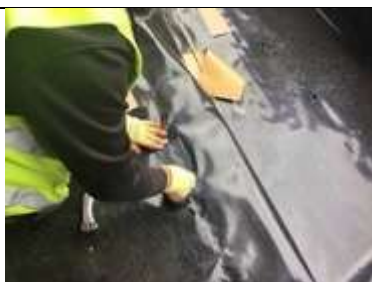
Installer repairing weld defect during the inspection

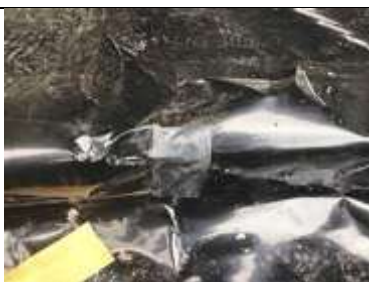
Recorded weld defect repair

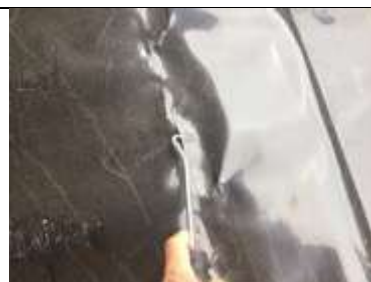
| <p>3no recorded weld defects were repaired by the installers during the inspection using Juta WP SAM.</p> <p>Due to groundworks not complete, the membrane could not be fully installed across the whole base of pour 3 at the time of our inspection. A return visit is required to inspect the membrane between Gridlines 21-23 / O-Q.</p> | <b>Action Required</b><br>No Action Required all Defects rectified at time of inspection |

Recorded hand weld defect

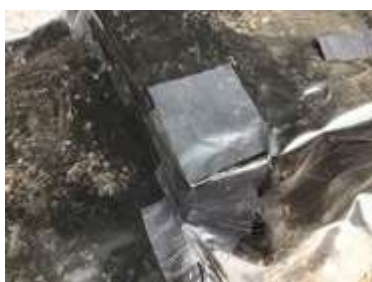
Sealed corner detailing

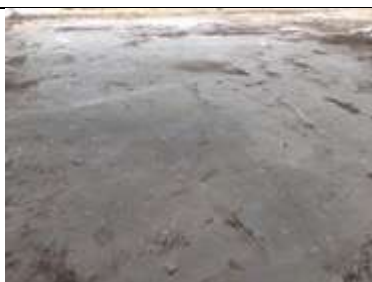
Sand blinded well rolled and compacted

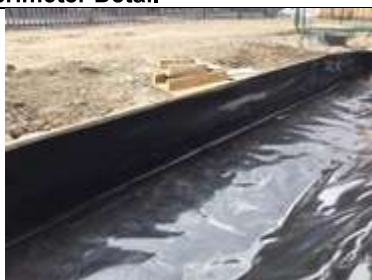
Membrane turned up the perimeter shutter and stapled at the top into place.

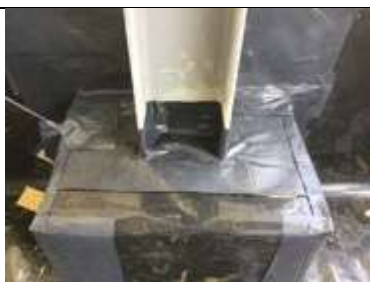
Sealed steel stanchion detail within pour area 3.

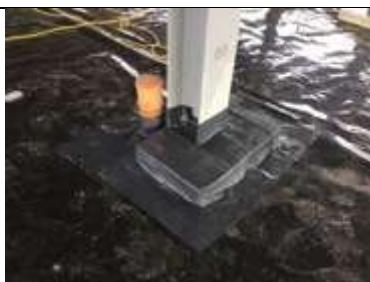
Steel stanchion detailing sealed within pour area 5.

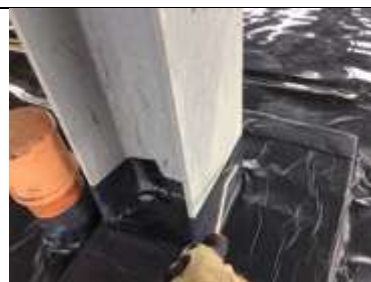
Pick testing to the stanchion detail within pour area 5.

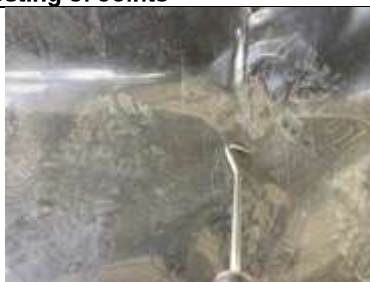
Pick testing to the hand welded Lap joint within pour area 3.

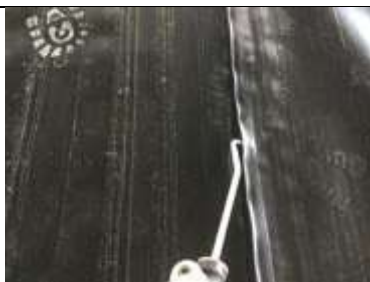
Pick testing along the auto welded lap joint within Pour area 5.

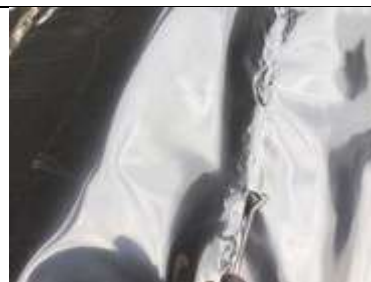
Pick testing carried out along the hand welded lap joint to pour area 5.

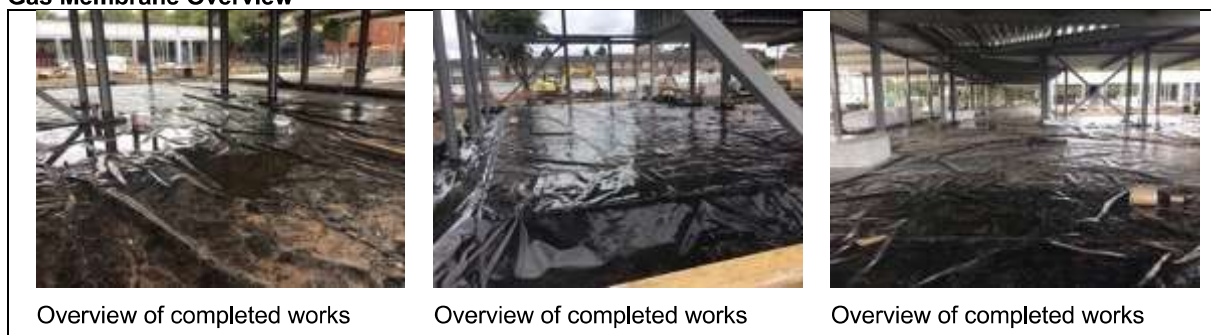
Overview of completed works

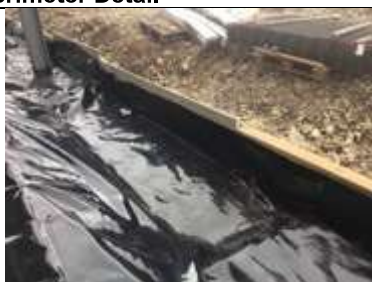
Perimeter membrane extended up the shuttering

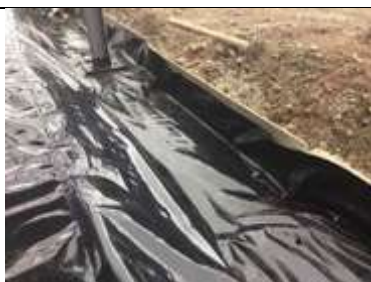
Perimeter membrane extended up the shuttering

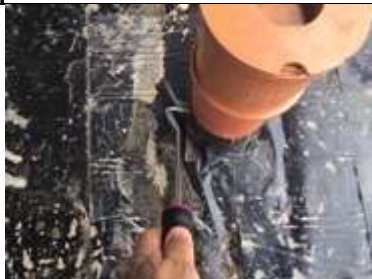
Testing pipe seals

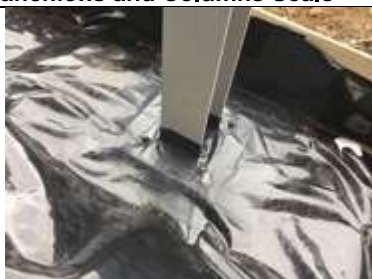
Sealed stanchion detailing

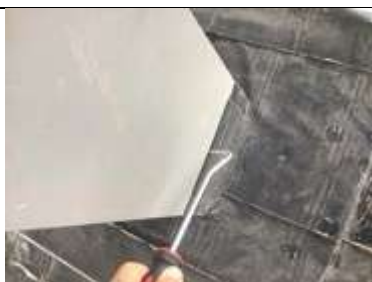
Probe testing stanchion detailing

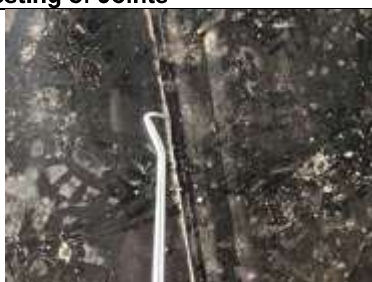
Probe test to auto welded  
membrane lap joint

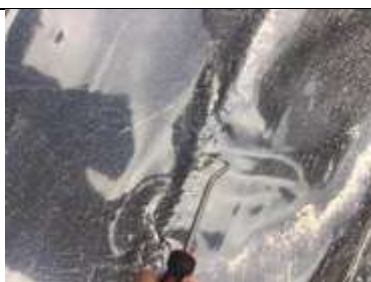
Probe test to hand welded  
membrane lap joint

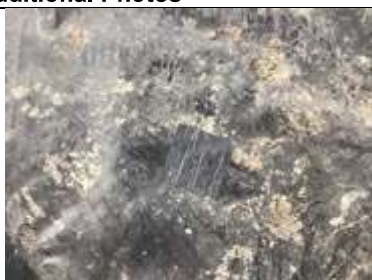
Defect patch repair

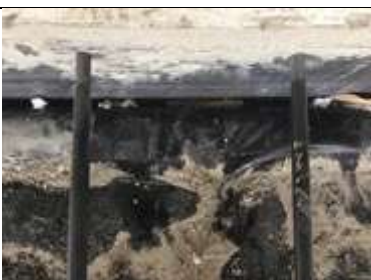
Defect patch repairs

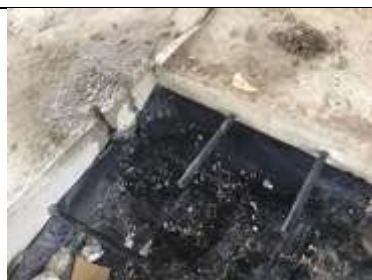
Defect repair

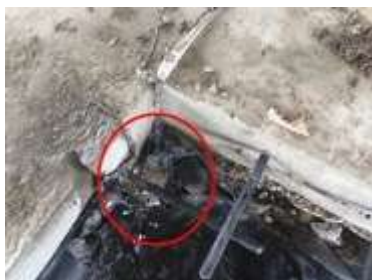
| <b>Leak/Hole Detection</b> | MEC Environmental Ltd carried out a thorough Visual Inspection to the available area at the time of our inspection |
|---|---|
| MEC recorded 17no defects largely throughout the existing membrane from previous pours. During the inspection the installers repaired the recorded defects using Juta GP SAM. Sections of detailing work required additional heat to adhere sufficiently which the installers did during the inspection to the areas noted by MEC | No Action Required all Defects rectified at time of inspection |

Recorded defect

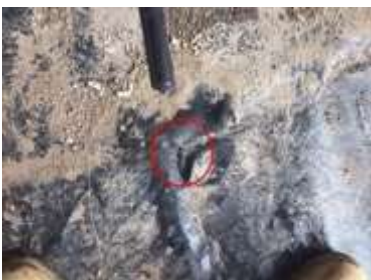
Recorded defect

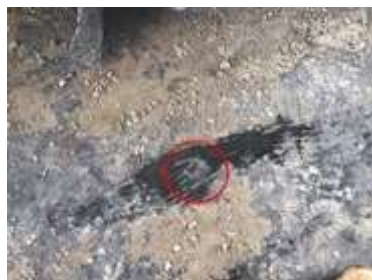
Recorded defect

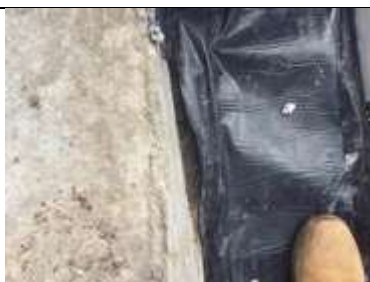
Recorded defect

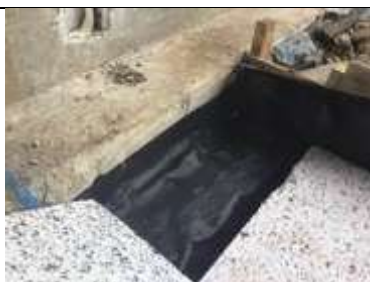
Defect repair
