## GAS MEMBRANE VALIDATION

| <b>Site Name: Belle Vue Stadium</b> | <b>Project Number: 12-123</b> |
| <b>Company Name: Countryside</b> | <b>Date: 31-05-2022</b> |

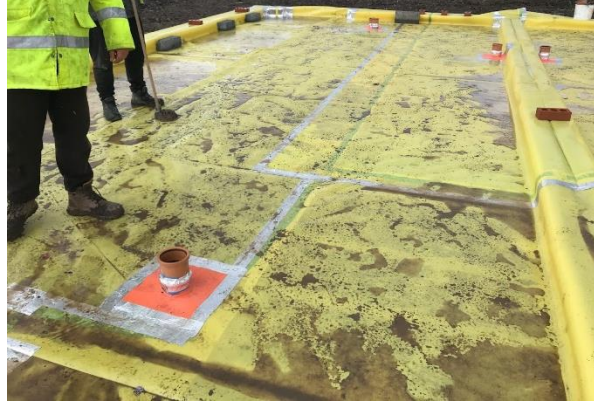
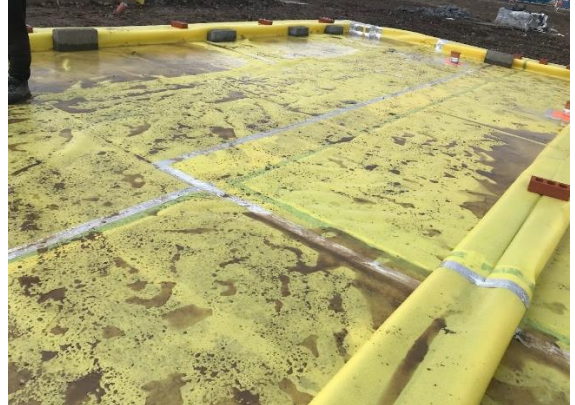
**Plot - 100**

**General Condition of Membrane-Good Condition**

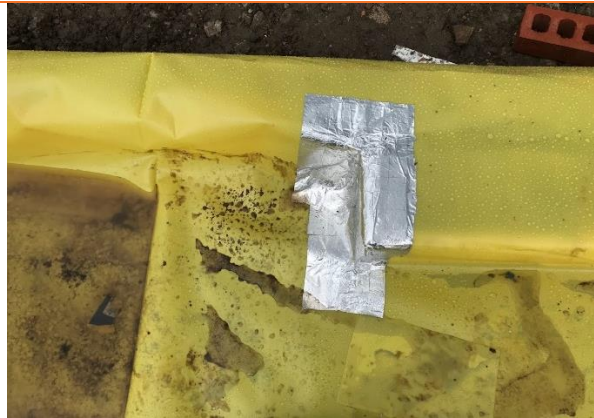
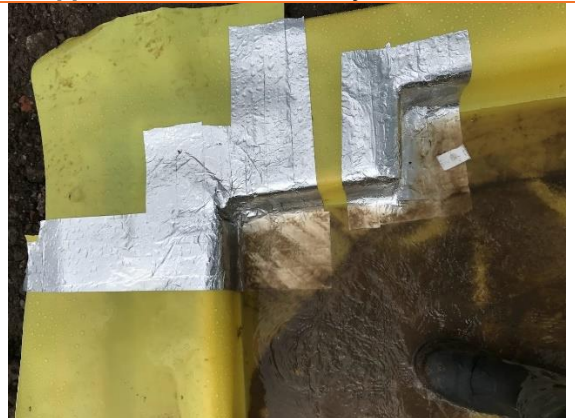
**Verification of Joints and Seals-Overlapped and sealed correctly**

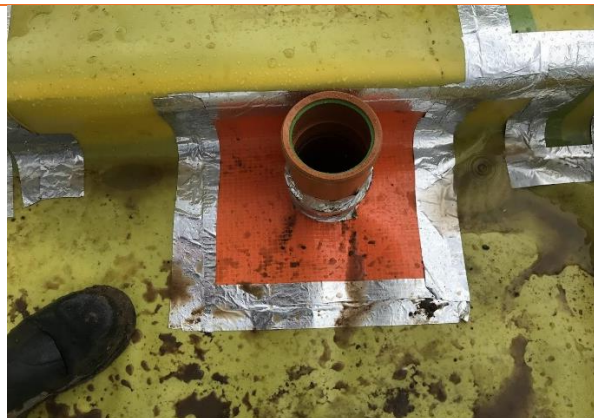
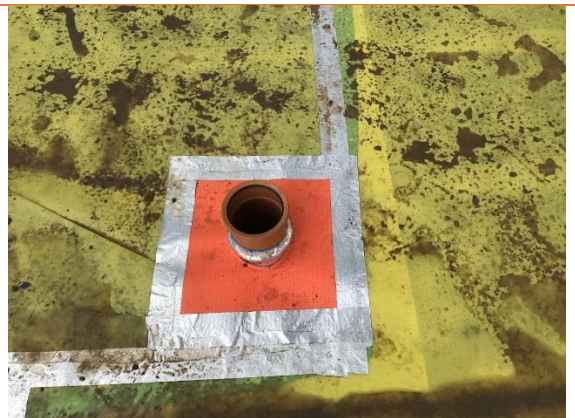
**Verification of Service Penetrations-Good Condition**

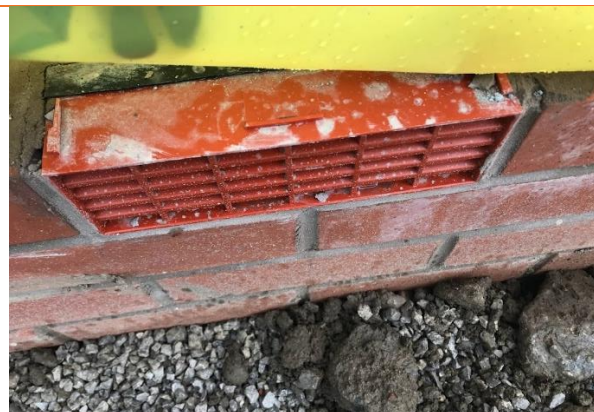
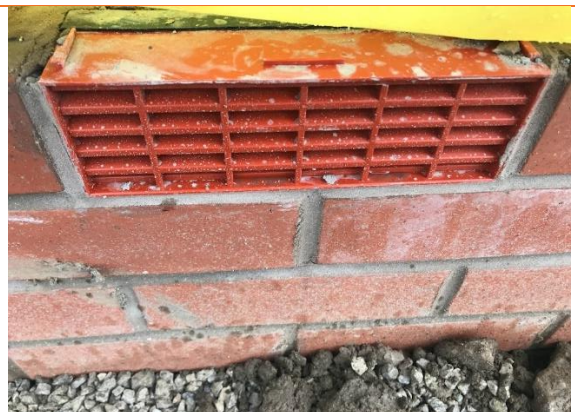
**Verification of Ventilation-Good Condition**

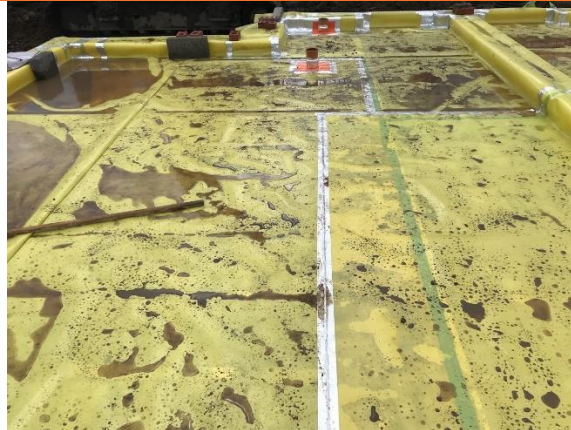
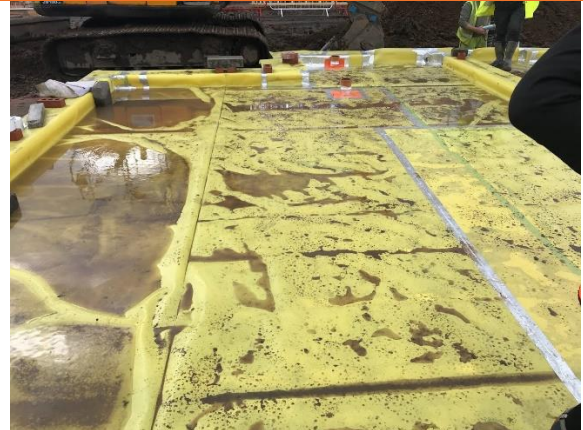
**Plot - 101**

**General Condition of Membrane-Good Condition**

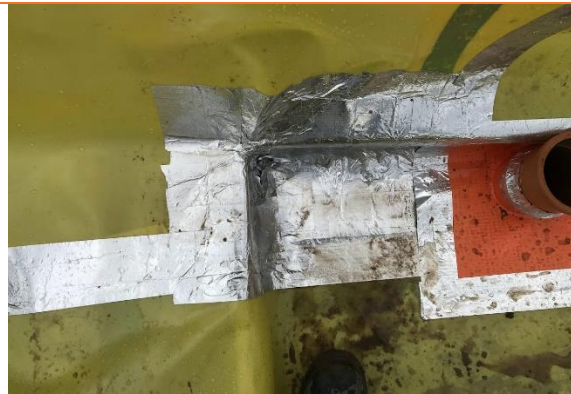
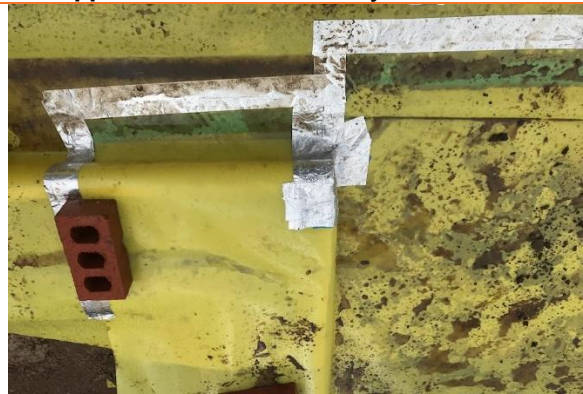
**Verification of Joints and Seals-Overlapped and sealed correctly**

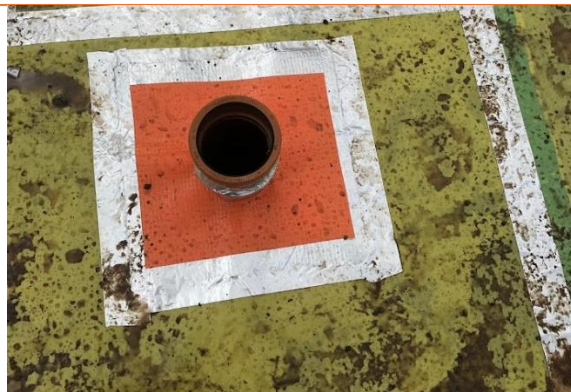
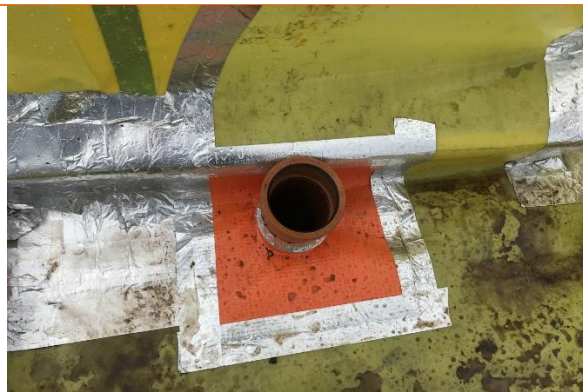
**Verification of Service Penetrations-Good Condition**

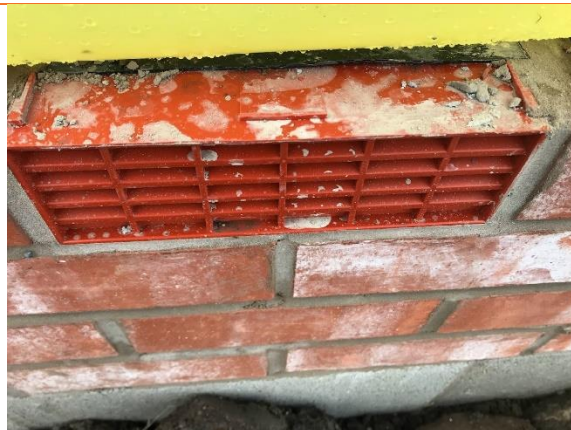
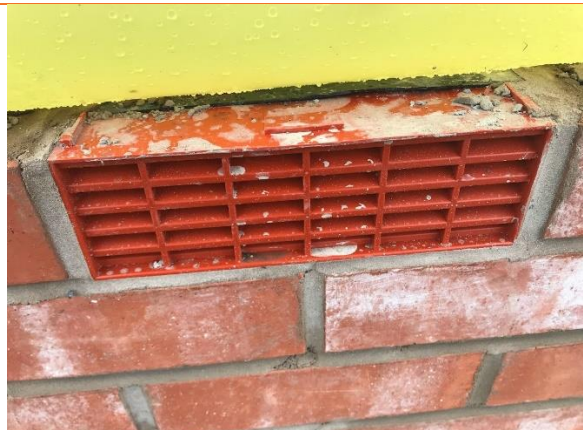
**Verification of Ventilation-Good Condition**
