## GAS MEMBRANE VALIDATION

| <b>Site Name:</b> Belle Vue | <b>Project Number:</b> 12-123 |

**Plot – 168-169**

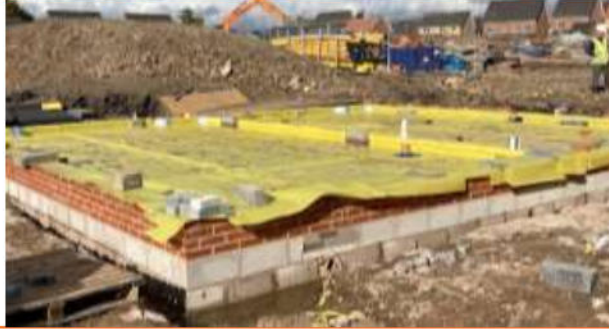
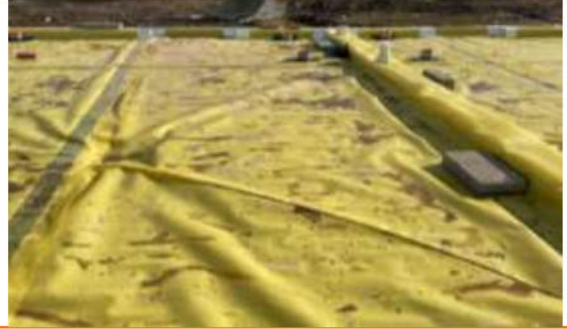
**General Condition of Membrane-Good Condition**

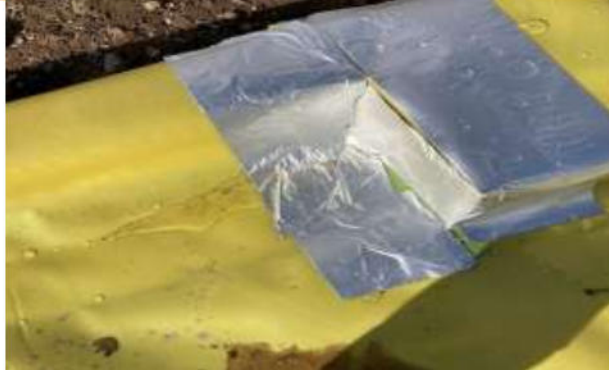
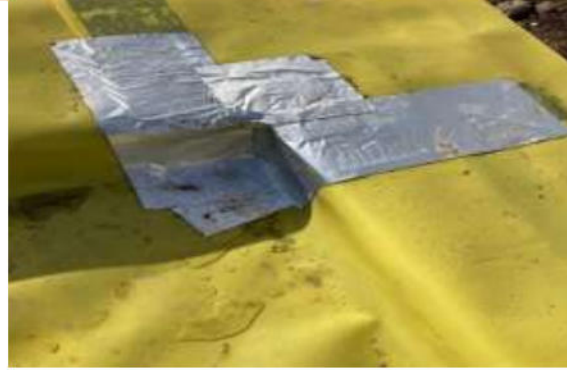
**Verification of Joints and Seals-Good Condition**

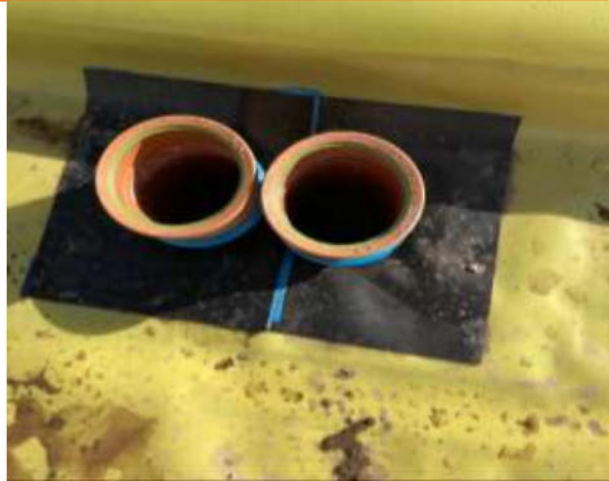
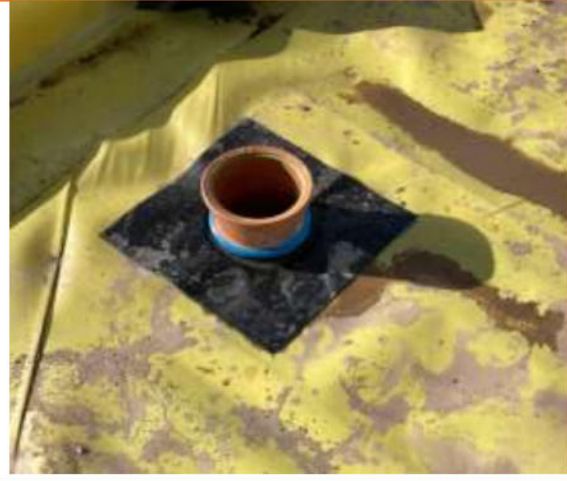
**Verification of Service Penetrations-Good Condition**

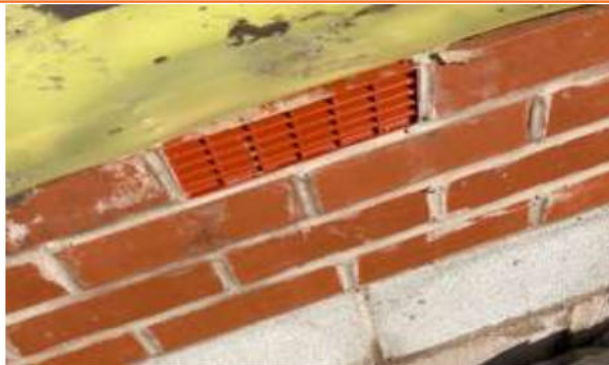
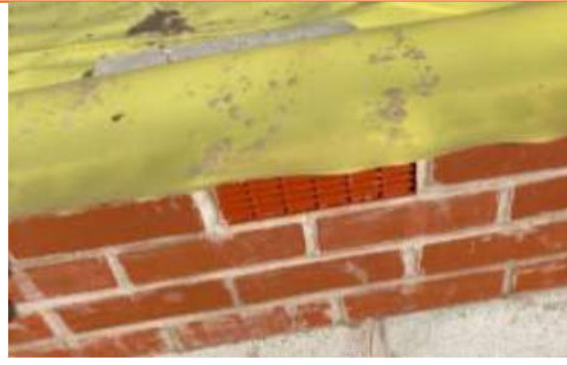
**Verification of Ventilation-Good Condition**
