## Technical Note

### Waste House Roof Assessment

**Project:** Brunswick Mill

**Document Number :** 23178-HWC-V1-zz-TR-S-004

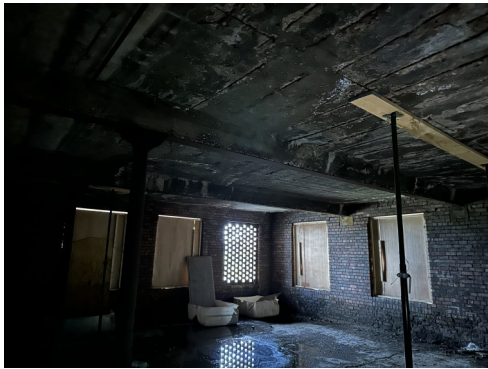
Photo 1 - Waste House Roof

Examples of roof deterioration - exposed reinforcement, corroded steels concrete spalling

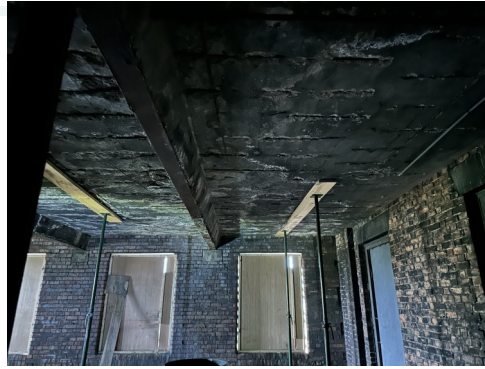
Photo 2 - Waste House Roof

Examples of roof deterioration - exposed reinforcement and concrete spalling

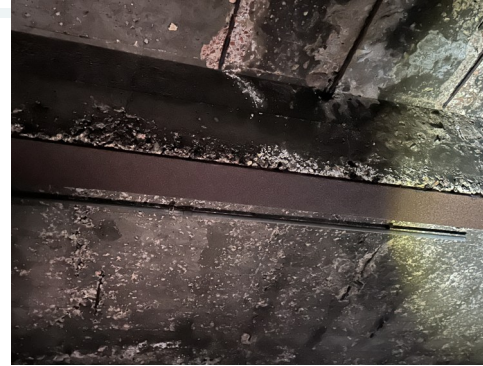
Photo 3 - Waste House Roof

Water staining and moss growth evident throughout

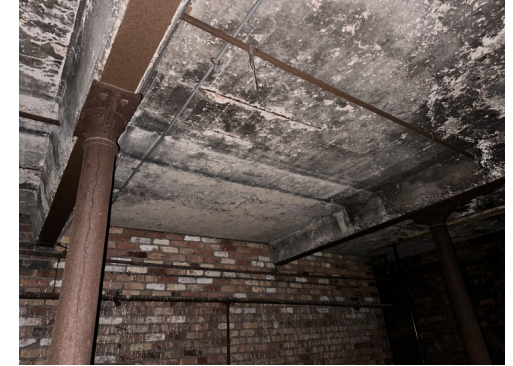
Photo 4 - Waste House Roof

Heavily corroded support steels throughout

Despite the extent of concrete degradation, the original supporting steel framework appears to be in a condition that may allow for salvage. To preserve these elements, it is recommended that all surrounding concrete be carefully removed to fully expose the steel members. Once accessible, corroded areas should be thoroughly cleaned—ideally using mechanical methods such as grit blasting—and subsequently treated with a high-performance anti-corrosion coating. This process will help extend the service life of the steelwork, provided that the concrete is reinstated using appropriate materials and detailing to prevent future water ingress and ensure long-term durability.

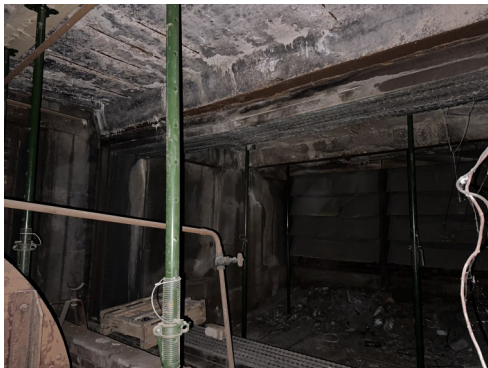
Photo 5 - Waste House Roof

Examples of roof deterioration - exposed reinforcement corroded steels concrete spalling.

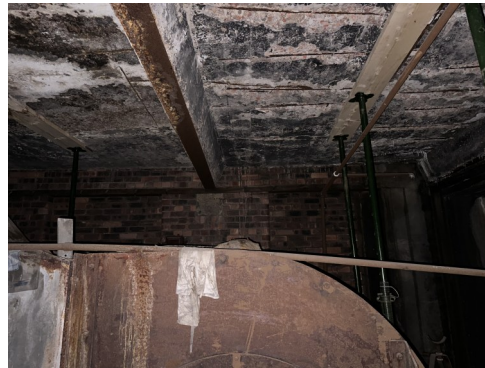
Photo 6 - Waste House Roof

Examples of roof deterioration - exposed reinforcement corroded steels concrete spalling.

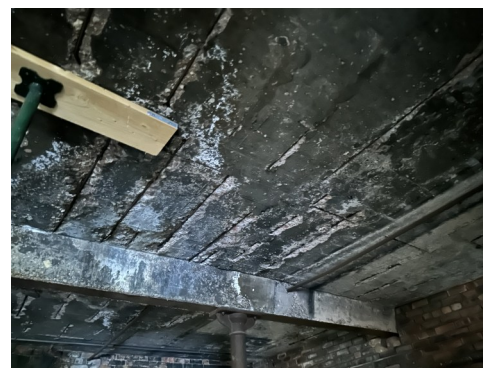
Photo 7 - Waste House Roof

Examples of roof deterioration - exposed reinforcement corroded steels concrete spalling.

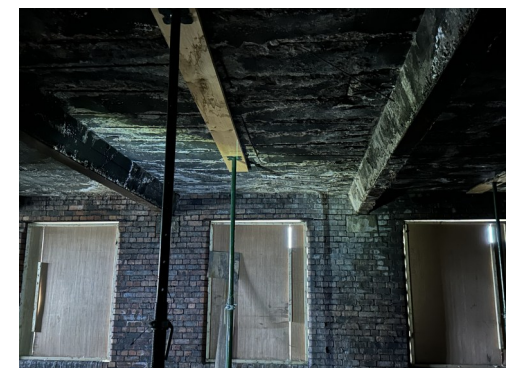
Photo 8 - Waste House Roof

Examples of roof deterioration - exposed reinforcement corroded steels concrete spalling.
