**GAS MEMBRANE VALIDATION**

| <b>Site Name: Belle Vue Stadium</b> | <b>Project Number: 12-123</b> |
| <b>Company Name: Countryside</b> | <b>Date: 24-01-2022</b> |

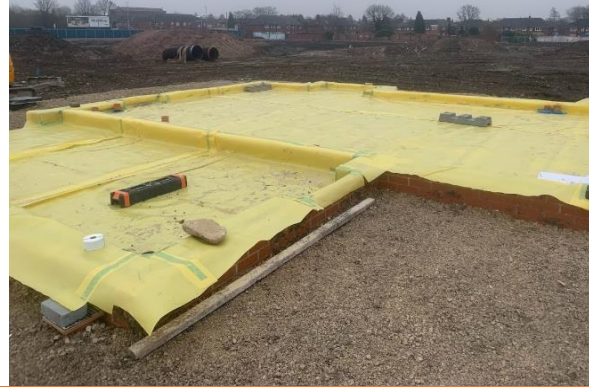
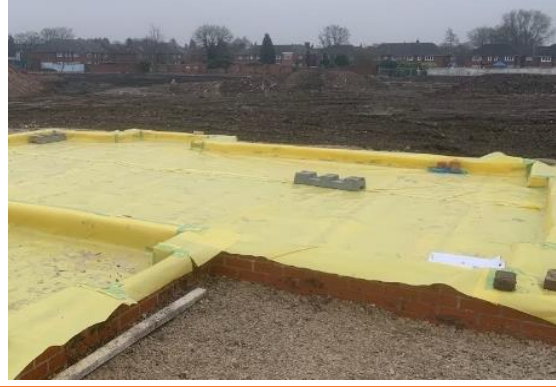
**Plot - 236**

**General Condition of Membrane-Good Condition**

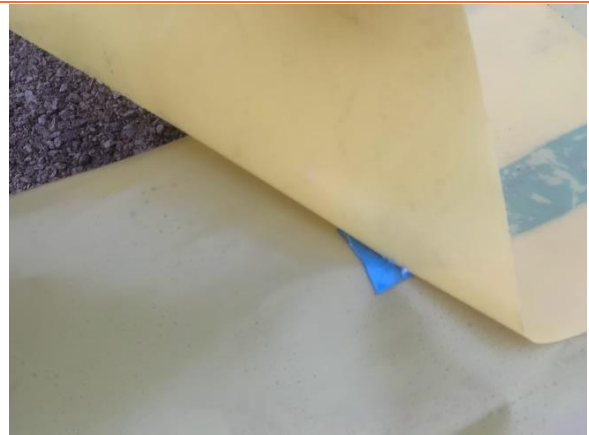
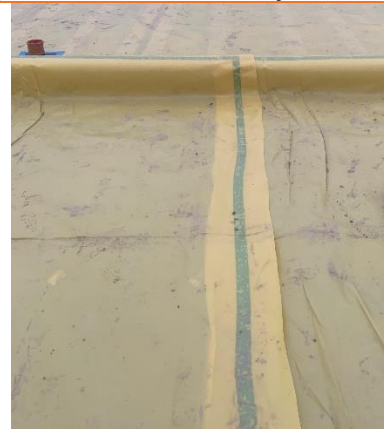
**Verification of Joints and Seals-Overlapped and sealed correctly**

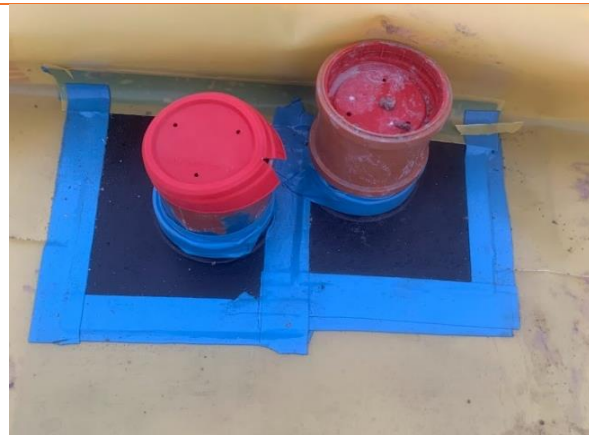
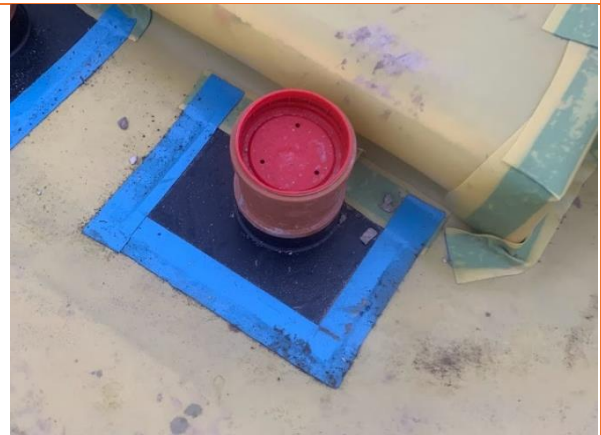
**Verification of Service Penetrations-Good Condition**

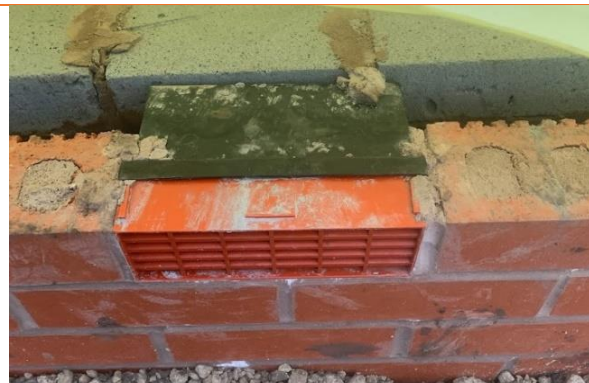
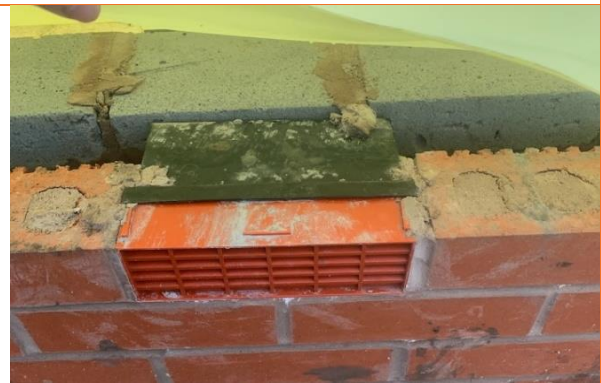
**Verification of Ventilation-Good Condition**

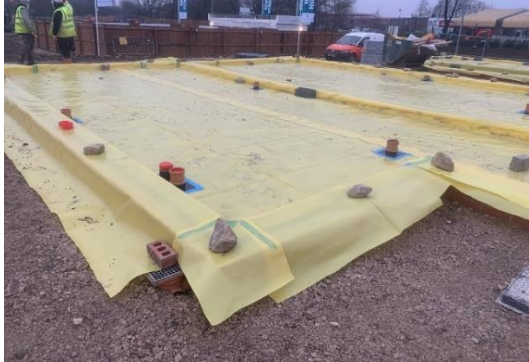
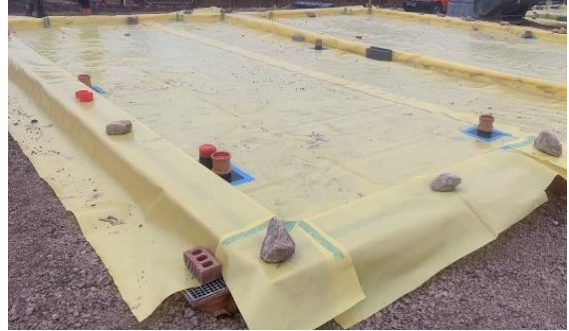
**Plot - 237**

**General Condition of Membrane-Good Condition**

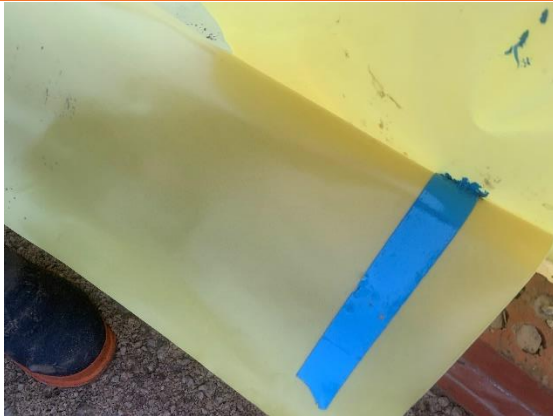
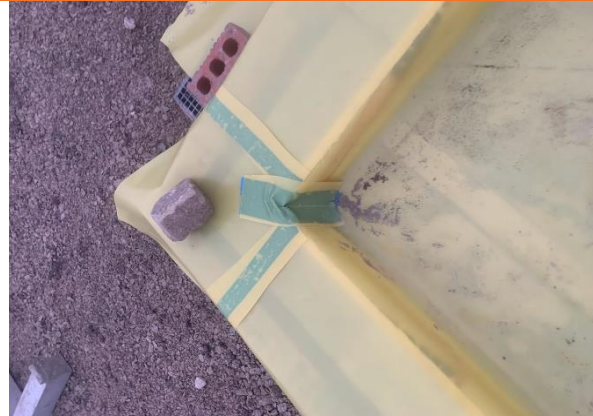
**Verification of Joints and Seals- Overlapped and sealed correctly**

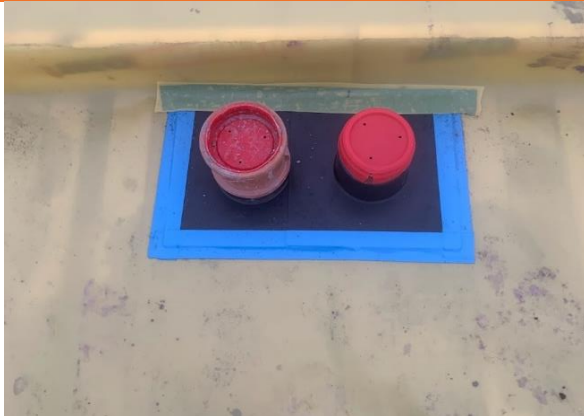
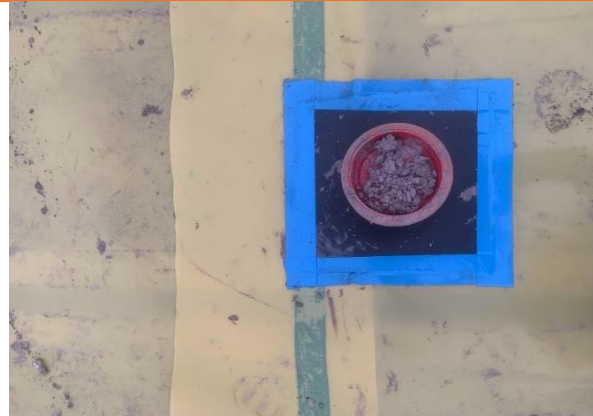
**Verification of Service Penetrations-Good Condition**

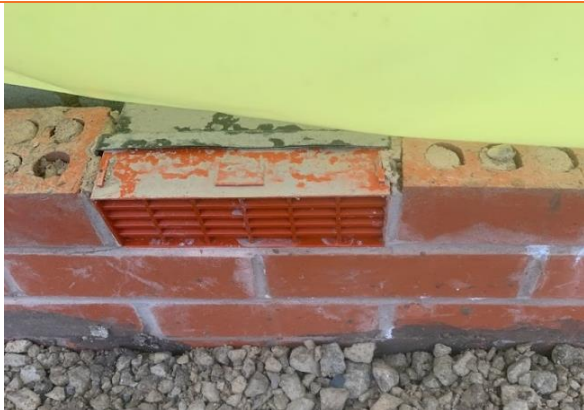
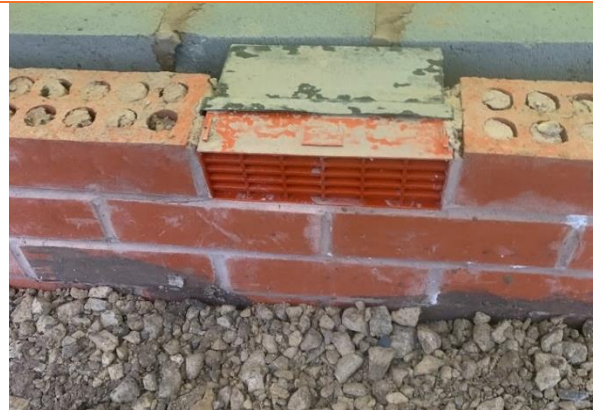
**Verification of Ventilation-Good Condition**

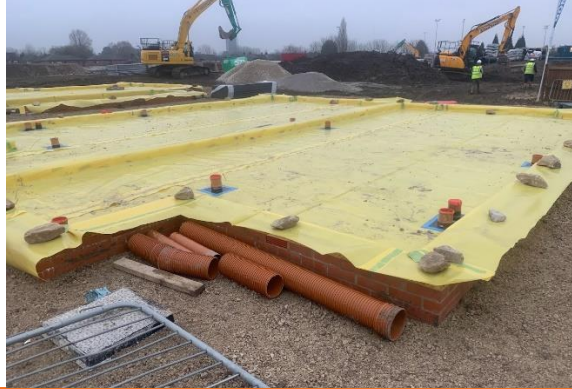
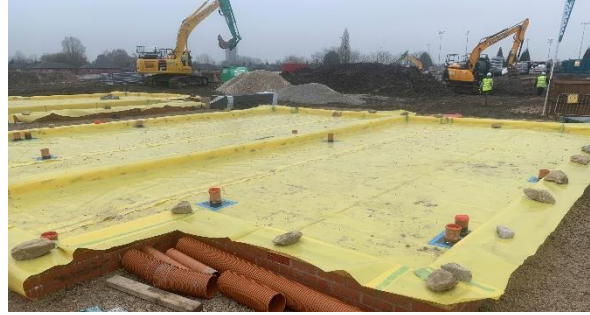
**Plot - 238**

**General Condition of Membrane-Good Condition**

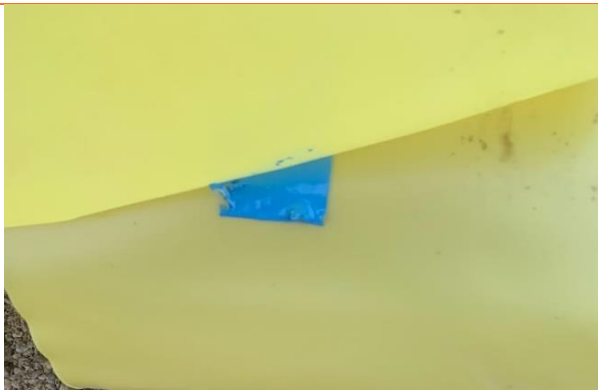
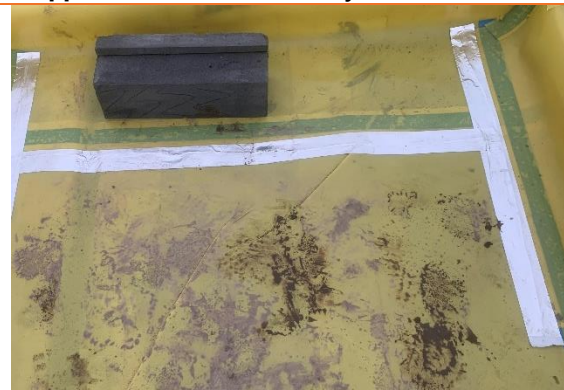
**Verification of Joints and Seals- Overlapped and sealed correctly**

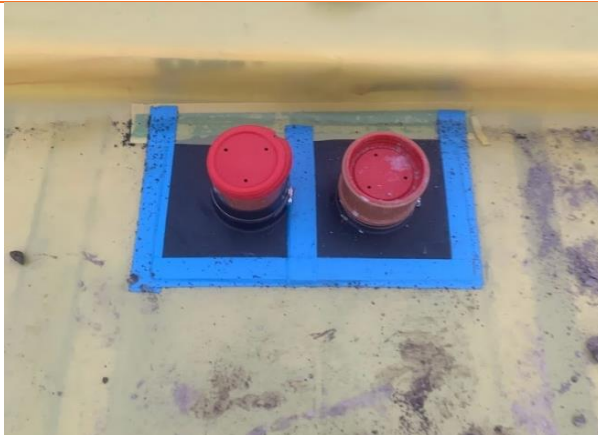
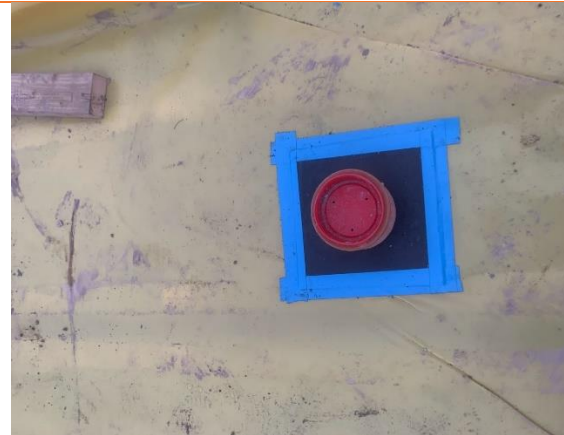
**Verification of Service Penetrations-Good Condition**

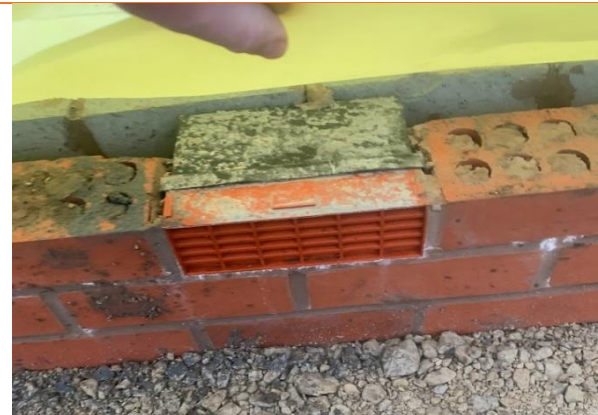
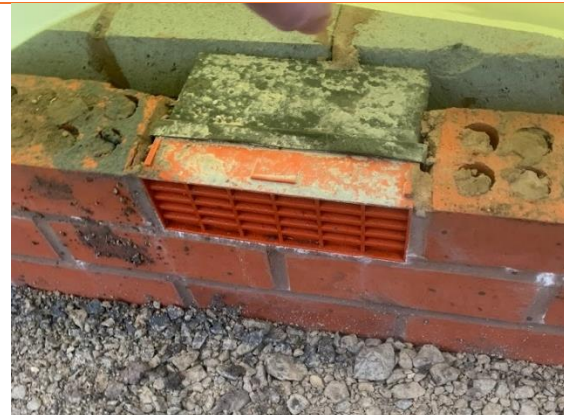
**Verification of Ventilation-Good Condition**

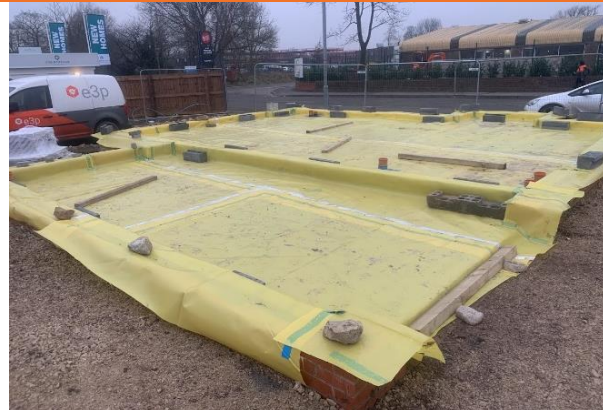
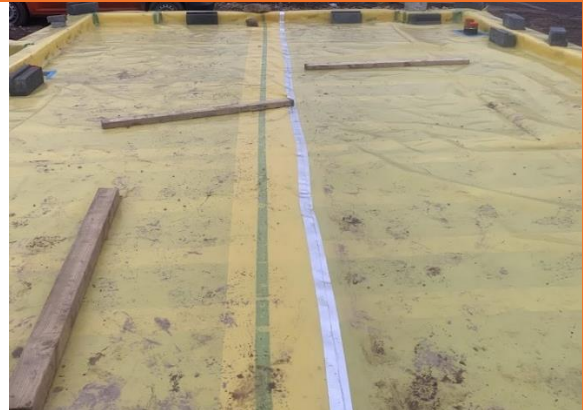
**Plot - 239**

**General Condition of Membrane-Good Condition**

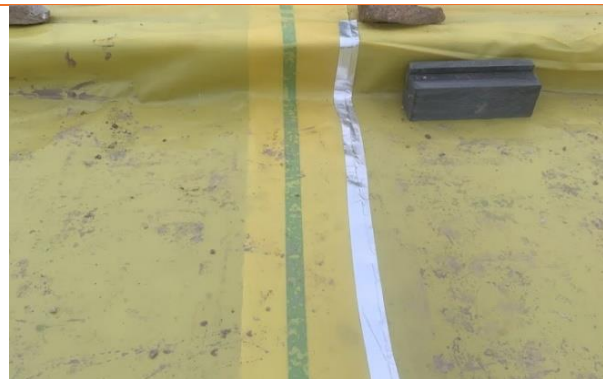
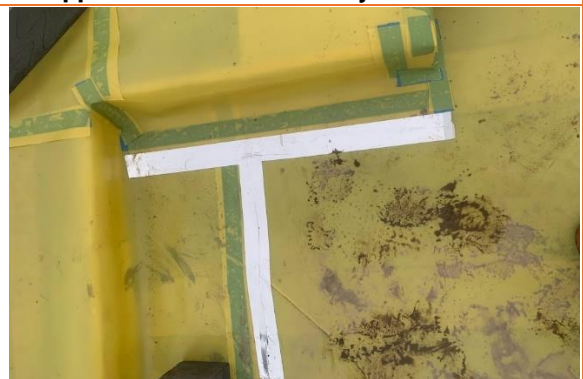
**Verification of Joints and Seals- Overlapped and sealed correctly**

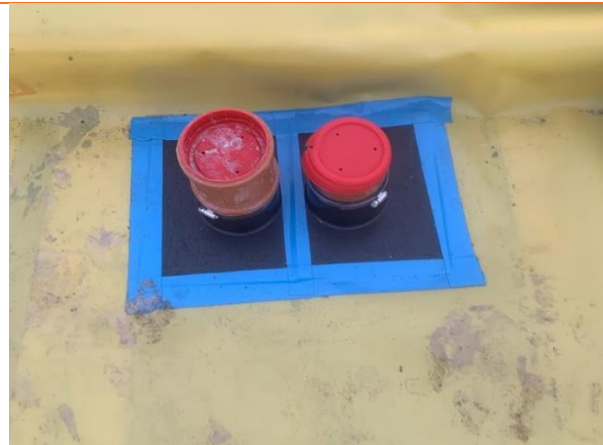
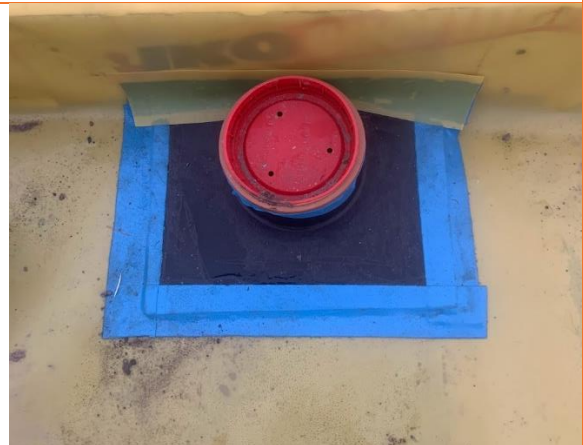
**Verification of Service Penetrations-Good Condition**

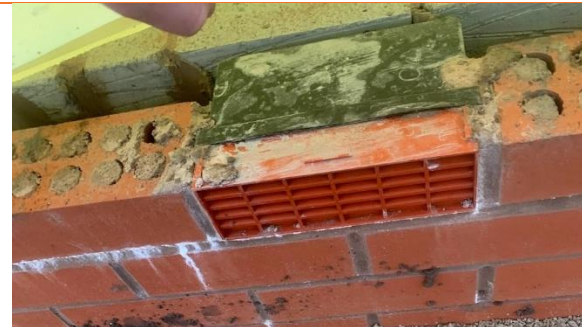
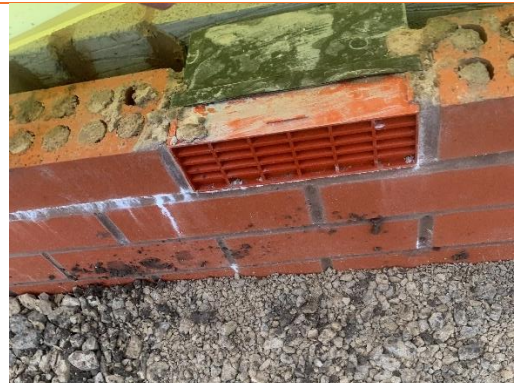
**Verification of Ventilation-Good Condition**
