**PHASE I DESK STUDY & SITE  
INVESTIGATION REPORT**

**PALATINE ROAD**

**DIDSBURY**

**Report Ref: A6550/25/SI**

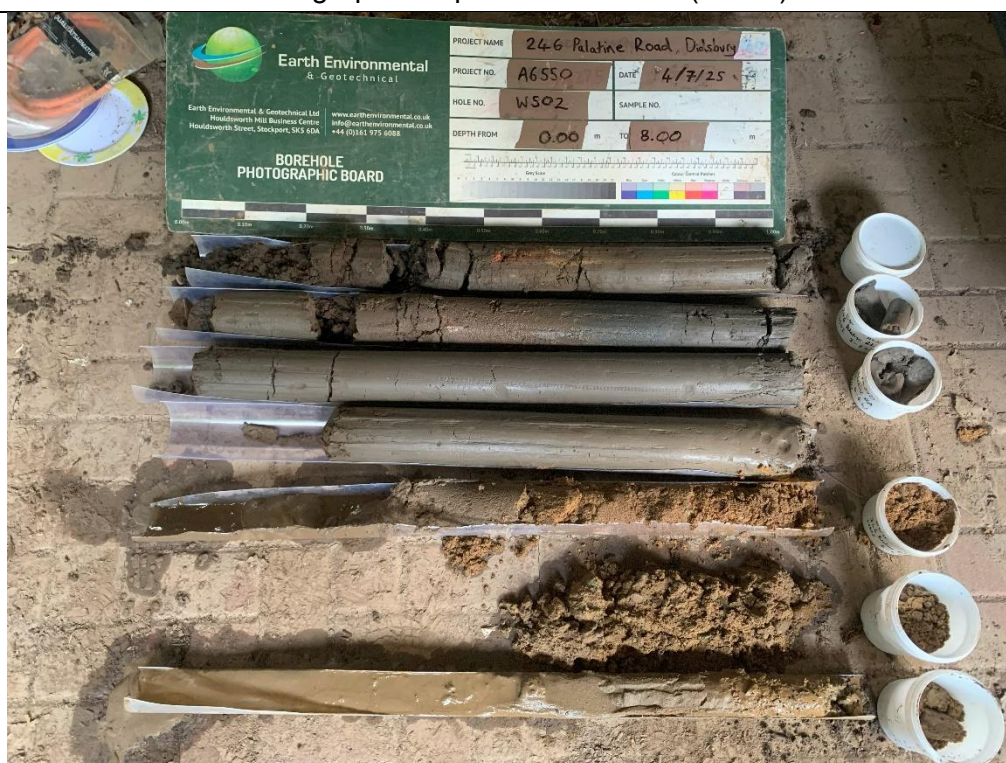
Photograph of representative soils (WS02)

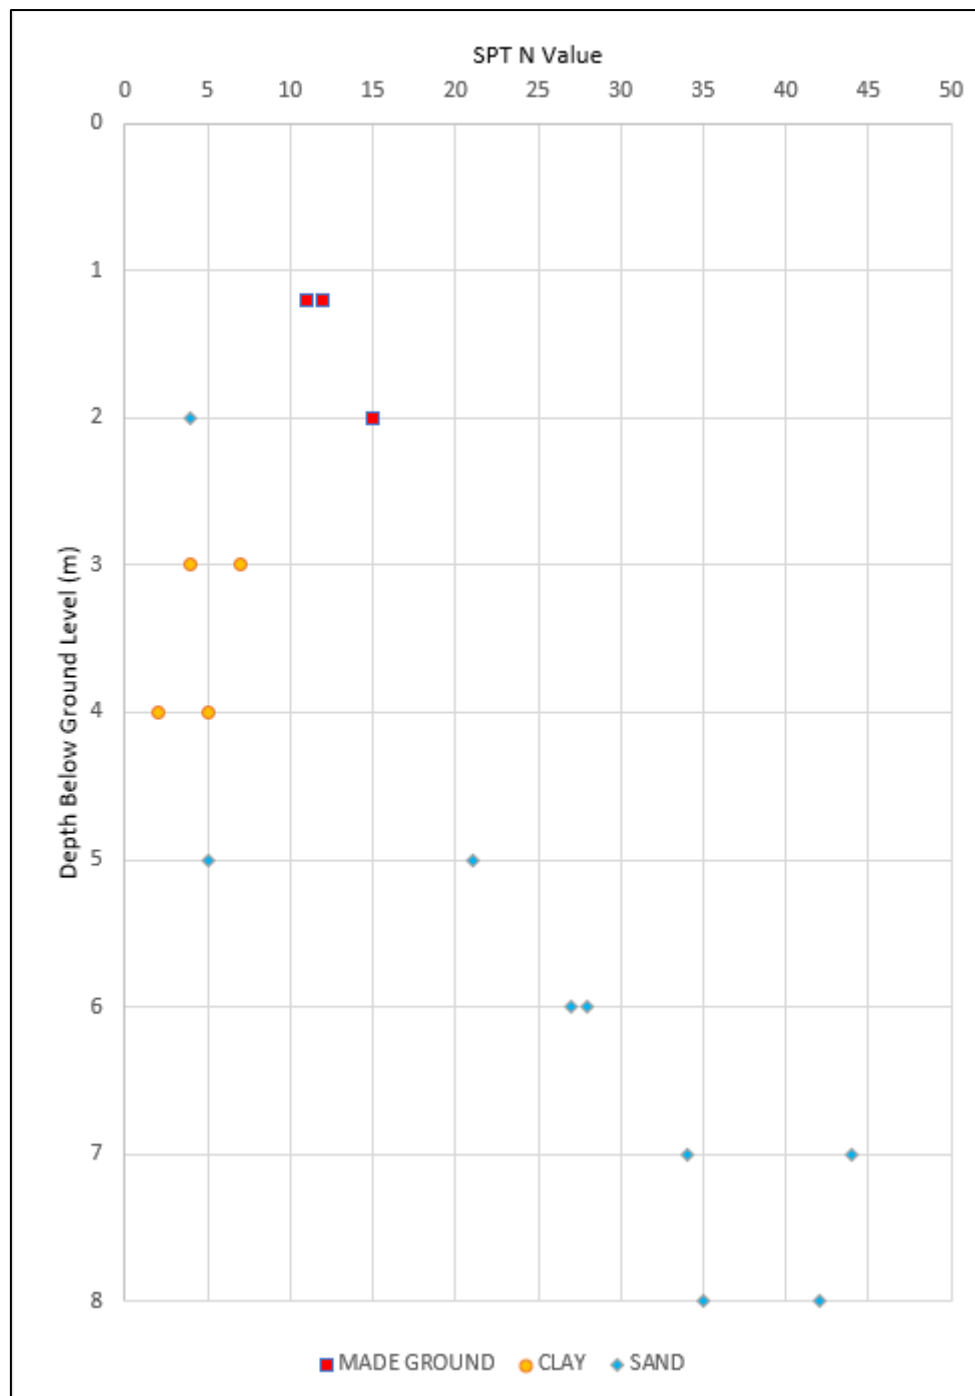
Figure 12: SPT N v Depth Plot

**SPT tests** carried out in the granular material resulted in **SPT N values** between 4 and 44, as shown on the SPT v Depth Plot in Figure 12 (overleaf). This result suggests the granular material is loose to dense.

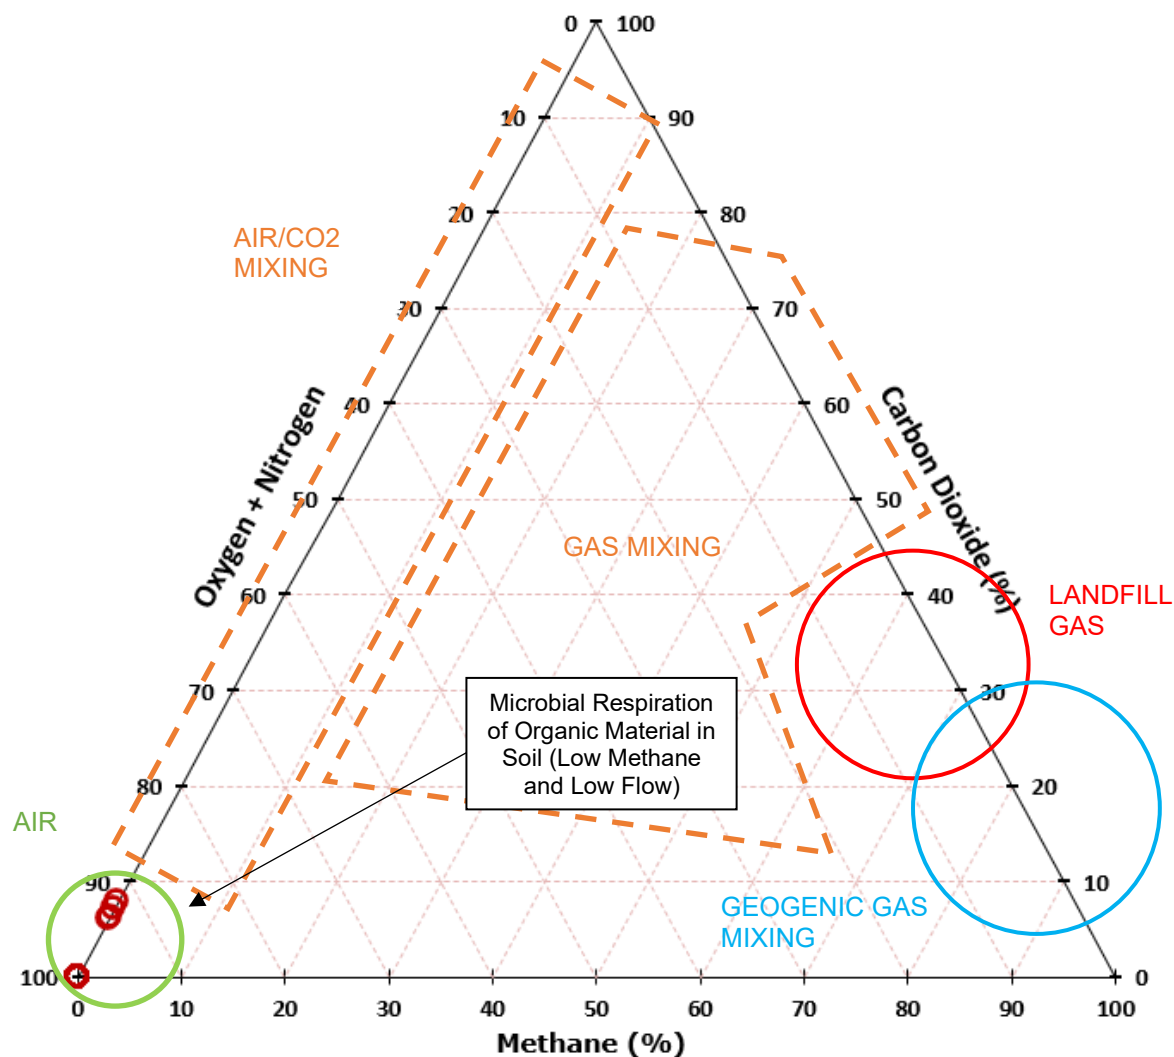
Figure 14: Gas Ratio Ternary Plot

Figure 14 shows the ground gas monitoring results from this site investigation plotted with the gas composition from different sources, adapted from Teasdale et al. 2015. The results show that the gas composition within the monitoring wells at the site is unlikely to be landfill gas.

The results generally correspond to air on the gas ratios ternary plot.

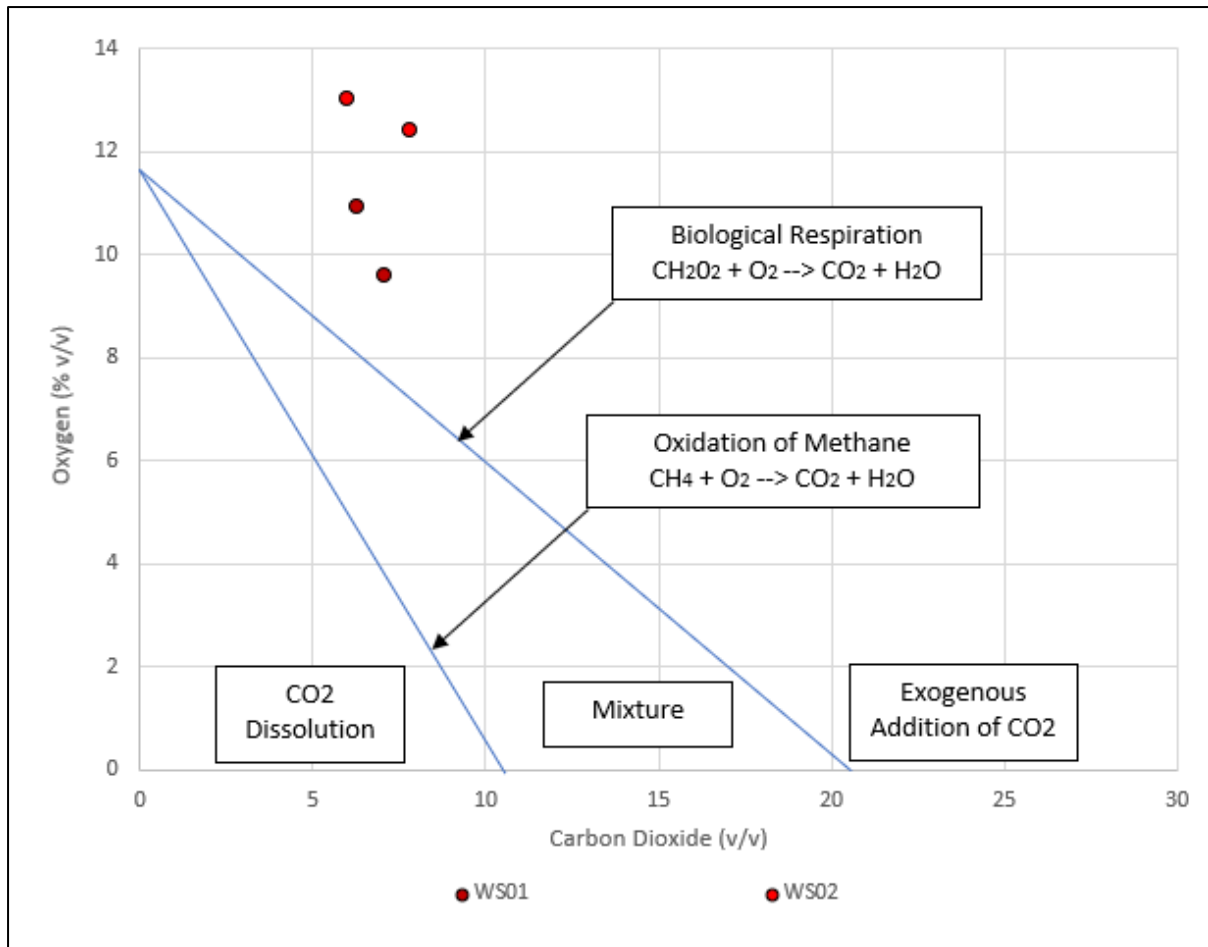
**Figure 15: Carbon Dioxide: Oxygen Ratio Plot**

Figure 15 shows that the points that plot to the left of the biological respiration and oxidation of methane lines are caused by dissolution of gas from the ground (or pore) water and from the reaction of rainwater with soil. The points to the right of the biological respiration line are caused by biological respiration (i.e., oxidation of organic material in the soil).

All of the data plots to the right side of the biological respiration line. This indicates that the source of carbon dioxide is likely to be from the oxidation of organic material in the soil.

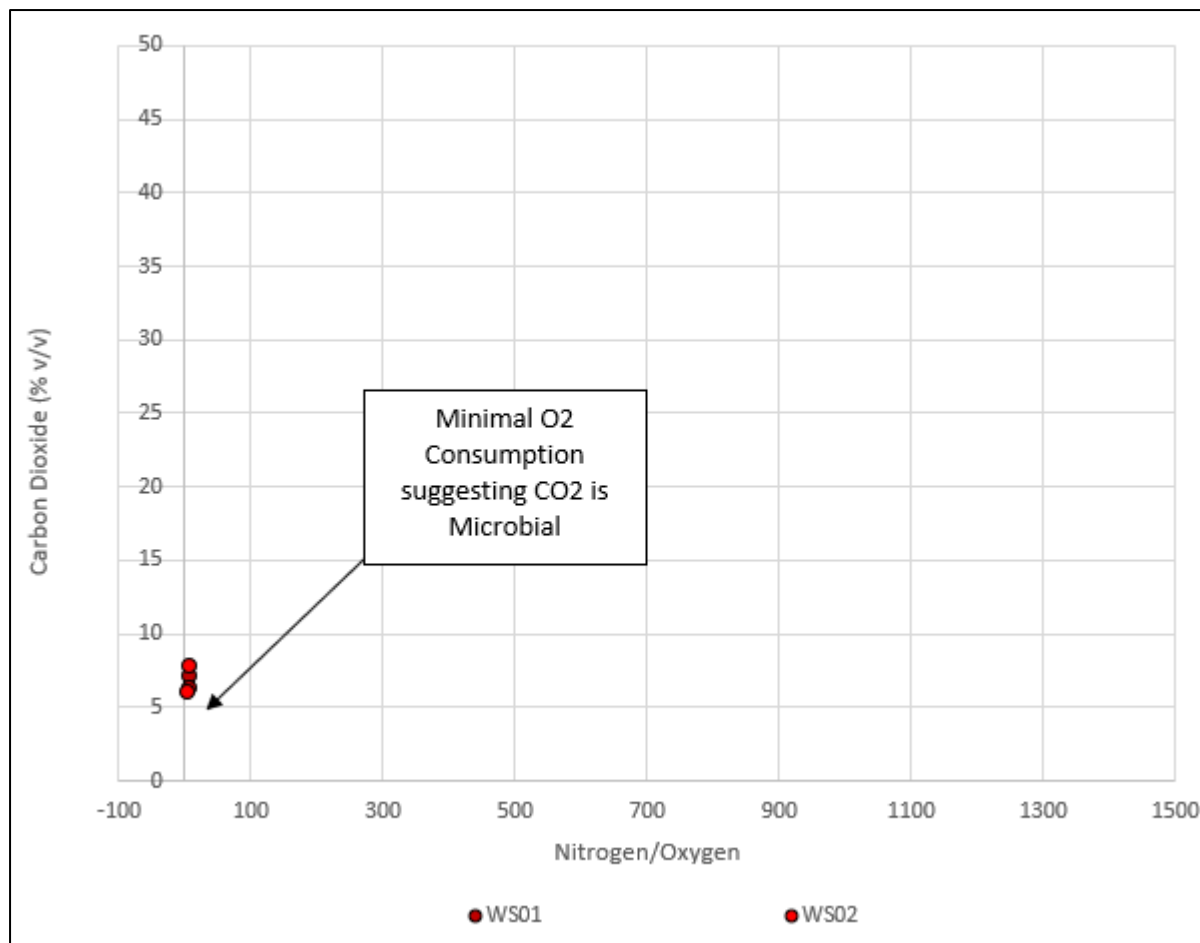
**Figure 16: Nitrogen/Oxygen: Carbon Dioxide Ratio Plot**

Figure 16 presents an assessment of the nitrogen/oxygen and carbon dioxide ratios. The figure shows all the monitoring results plotted on the left side of the graph, which represents minimal oxygen consumption. There is no data plotting towards the right side of this figure, which would suggest methane oxidation.

The above results and assessment suggest the site can be given a Characteristic Situation 1, i.e., 'very low risk', in accordance with Table 17.
