# Natural Finishes Limited

## Lime plastering report 28/11/2022

## Grosvenor Building MMU

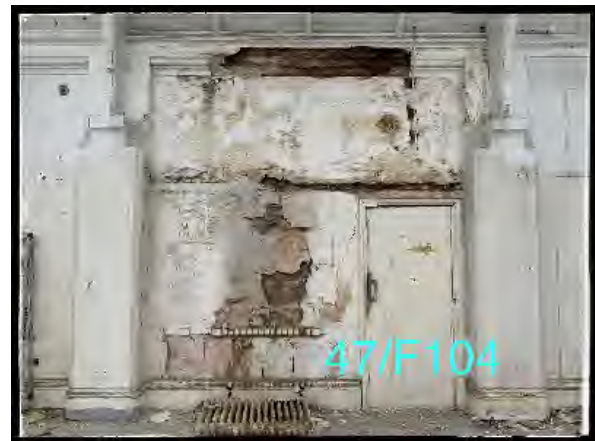
Hydroscopic salts and bossed plaster are a result of moisture movement through the stone and brick walls of the building, manifesting itself as efflorescence (white powdery deposits on the surface of stone or plaster). It is particularly evident at higher levels and concentrations in rooms F110, F104, G14,G02,G15,G20,30/GD \_GF-038C, G.Corridor, Corridor F1.1& F1.2 due to water ingress. (Ref-appendix for additional images)

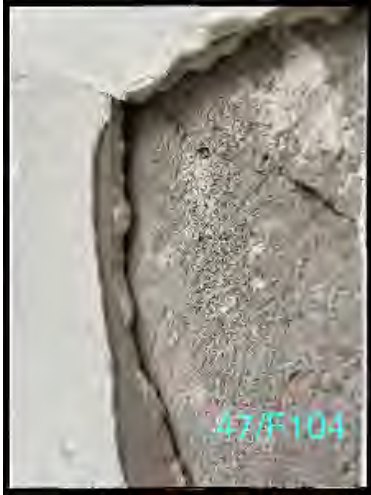
Mould growth and flaking paint is evident in some areas, this is likely due to condensation and/or water ingress. Some lime plaster has been replaced with gypsum plaster in a number of locations within the building, most notably in F110. Visual inspection and experience would indicate that the base coats are a mixture of cementitious mortars, premixed gypsum backing and finishing plaster. Often moisture in the walls is forced up the wall and efflorescence becomes visible at the boundary between the old and new plaster, in places there is evidence to demonstrate this point.

Replastered areas containing any cement, gypsum or waterproofing materials should be removed and replastered in a traditional lime based plaster. Gypsum plasters are not vapour permeable and can create a damaging build-up of water within the structure.
