Our ref: 25-6599  
Your ref:

**Regarding the Structural Inspection of:**

Boundary Retaining Wall along Palatine Road  
West Didsbury

**Date of report:** 23<sup>rd</sup> October 2025

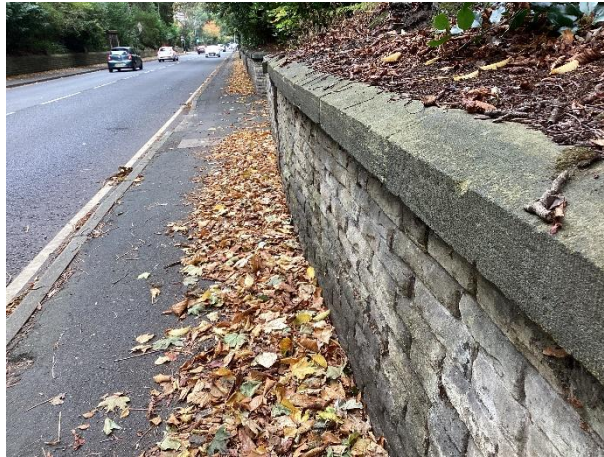
As stated earlier, the boundary wall acts as a retaining wall. It is not clear how much of the height of the retained ground is original to the time of construction and how much is built up over the years with decaying vegetation.

*Note retained ground levels*

The wall appears to be around 360mm thick, although precise checks could not be made because of the ground covering the coping. As such, in engineering terms it is not strong enough to act as a retaining wall. Nevertheless, it has withstood an estimated 120 years of use without major defects. The bulk of the wall is acceptably vertical in relation to its thickness.

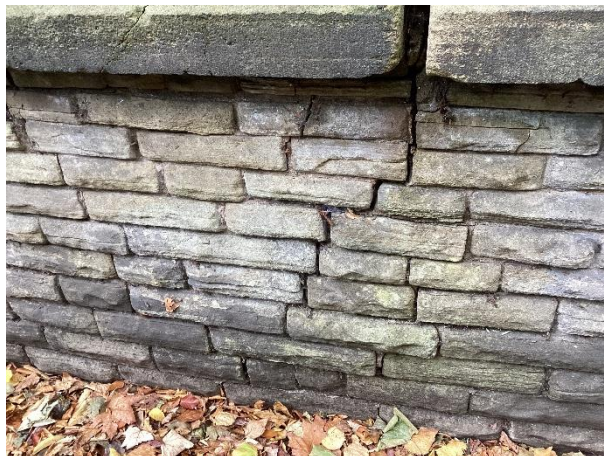
To the right of the pedestrian access to the flats there is a section of localised bulging wall with open joints in the stonework. The bulging primarily affects the lower sections of the wall rather than becoming a full height lean. 1 metre from the back of this section of wall there is a chestnut tree which is leaning towards the public highway.

*Damage adjacent to chestnut tree*

Further to the right adjacent to the chestnut tree it is considered that the degree of bulging is sufficient to warrant localised rebuilding over a narrow section. The chestnut is leaning over towards the highway and so we would question suitability for retention. We are not arboriculturists, but the amount of lean must

significantly impair the lateral stability of the tree with the risk of collapse onto the public highway. Thus, an Arboriculturist report may well suggest its removal.

We do consider that localised reconstruction is recommended in the areas in front of the Lime and Chestnut trees where the wall should be taken down, the foundations grubbed up and replaced with mass concrete strip footings off which a new wall consisting of dense concrete block faced with the existing stonework and capped with the existing copings.

As discussed above, it is recommended that consideration is given to the removal of these two trees for stability reasons. This is something to check with an Arborist.

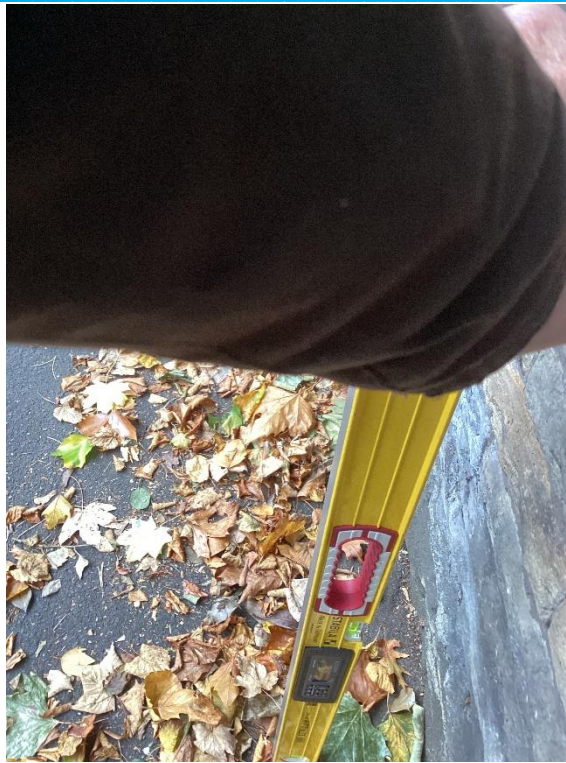
The section of the wall to the left of the entrance has a total lean of approximately 140mm. This is a little surprising as there is relatively less vegetation in this vicinity consisting of what is thought to be rhododendron.

*Lean to the left of the entrance*

The general area of lean in the areas to the left of the pedestrian entrance is again considered to be within acceptable limits. The condition of the wall will require periodic checks to ensure there is no significant deterioration.

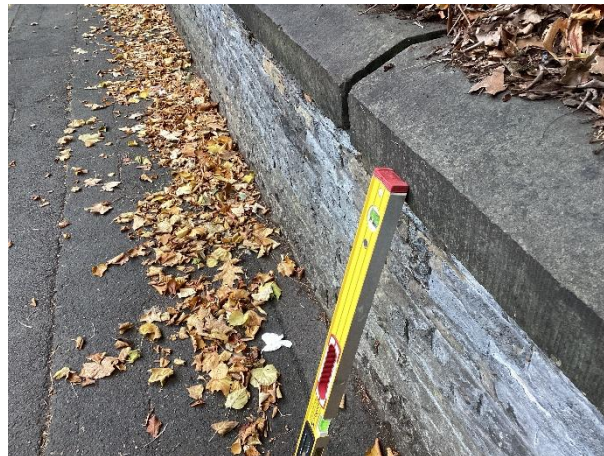
The second main point of lean is adjacent to a plane tree which is 1.2 metres to the rear of the wall. There is a gradual lean on the wall of around 100 mm at this point.

*Lean adjacent to the plane tree*

The next point of concern is adjacent to the plane tree where the wall leans by around 100mm. The amount of lean here is borderline acceptable with the risk that the lean will continue to develop and possibly lead to collapse at some point in the future. An arborist might be able to give some indication as to how much the tree might grow in diameter and at what rate to thus allow a better assessment of the risk to the wall. Again, a root barrier is considered inappropriate for similar reasons as discussed above in that it will involve cutting stabilising roots and in any case will not relieve the lateral pressure from the growth of the tree.

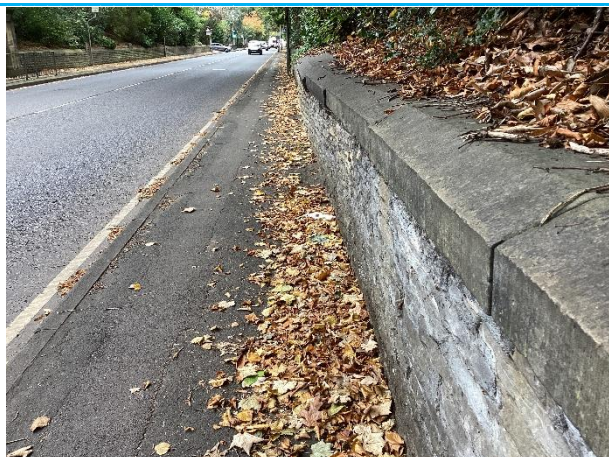
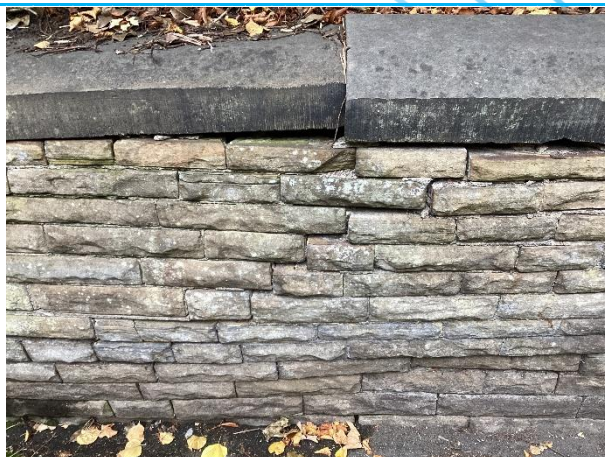
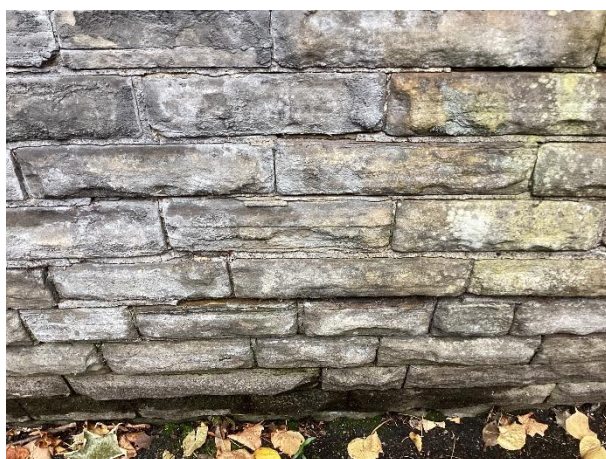
A little further to the left of this there is a localised area of severe bulging to the wall. The bulge is approximately 250 mm at this point. Coping stones have displaced and the movement of the wall has caused opening of the horizontal and vertical stone bedding joints. There is a Lime tree approximately 700 mm behind this section of wall in line with the area of bulging.

*Severe lean adjacent to the lime*

There is evidently more severe bulging adjacent to the lime tree as described above. This tree is so close to the rear of the wall that its growth is evidently overloading the structure causing it to bulge. The degree of bulge is such that consideration should be given to dismantling the wall and rebuilding, possibly on a new deeper foundation. At present the depth of the foundation is unclear.

A matter for an arborist to consider is the stability of the tree itself. The close proximity of the tree to the wall must limit root growth on that side of the tree. Hence, there must be concern that under a strong easterly wind the tree will have insufficient anchorage through its roots system to resist the wind forces. The tree has therefore the possible potential to collapse. Note that installation of a root barrier will further weaken the root system on that side of the tree. It is also possible that reconstruction of the wall will also involve the cutting of some of the roots, further destabilising the tree.

To protect the rebuilt wall from continued growth of the tree it is considered appropriate to ask for removal of the tree. Mention has been made of utilising a root barrier to protect the back of the wall, but this is not considered practical. Given the narrow gap between the face of the tree trunk and the rear of the wall it is doubtful that a barrier can be successfully installed. Even if it were, continued growth of the tree behind the barrier would still tend to push the barrier and therefore the wall laterally. Thus, nothing would be achieved.
