**PHASE I GEOENVIRONMENTAL DESK STUDY**

**BOAT LANE**

**NORTHENDEN**

**Report Ref: A6986/25/FDS/V2**

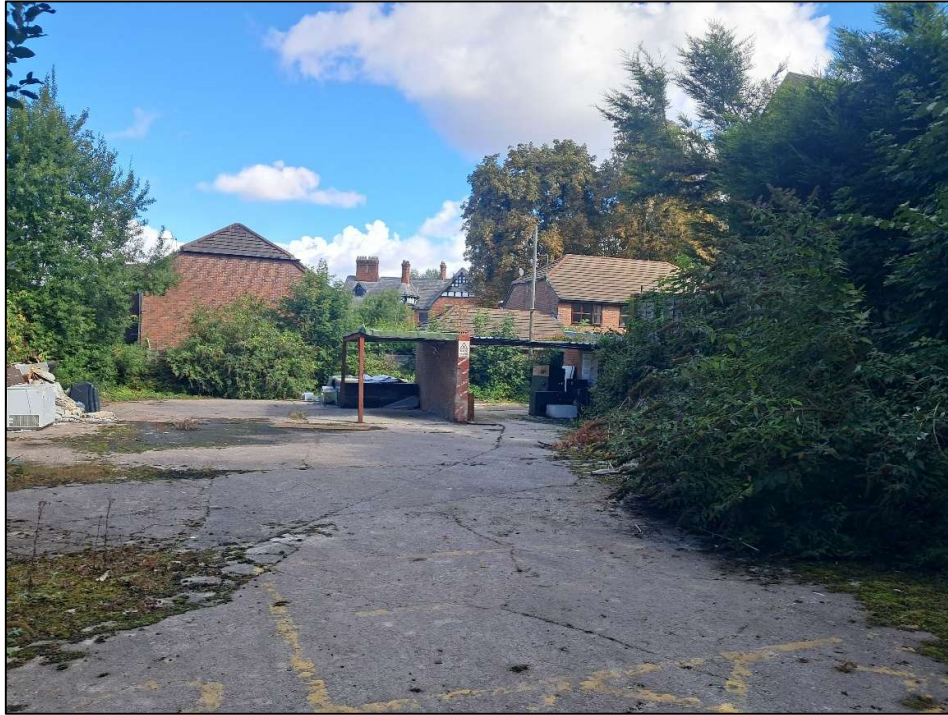
**Figure 3: Site Photograph**

- 2.3 The site is occupied by a disused breakers yard, entirely covered with hardstanding. There is a single-storey small toilet block in the central west of the site, adjacent to a portable metal-framed office block. The northeast of the site features two single-storey brick-built garages with metal-covered and metal-roofed areas. There are overgrown shrubs in the northwest, central, and southeastern boundaries of the site.

- 2.4 Access to the site is gained via the gate from Boat Lane, in the southwest corner of the site.
- 2.5 The site is bounded by brick walls on the north and south, a concrete wall to the west, and fencing to the east.

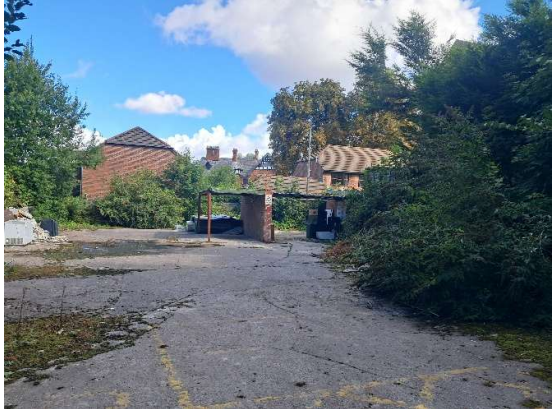
| <p><b>Plate 1 View facing north showing site</b></p> | <p><b>Plate 2 View facing west showing site entrance</b></p> |

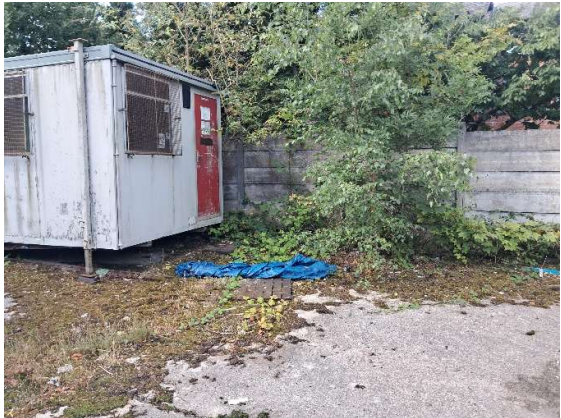
| <p><b>Plate 3 View facing west showing portable office</b></p> | <p><b>Plate 4 View facing south showing boundary wall</b></p> |

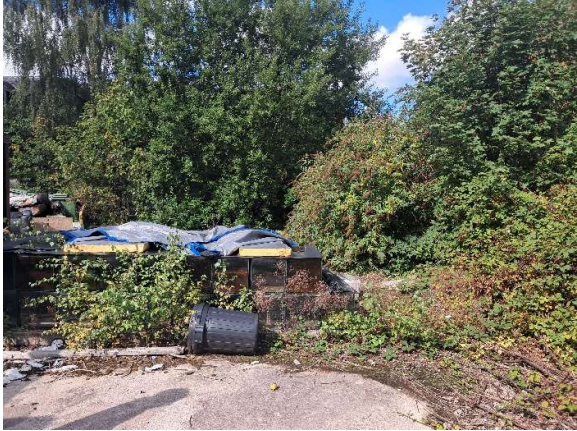
| <p style="text-align: center;"><b>Plate 5 View facing west showing vegetation and stockpile of fish tanks</b></p> | <p style="text-align: center;"><b>Plate 6 View facing east inside garages</b></p> |

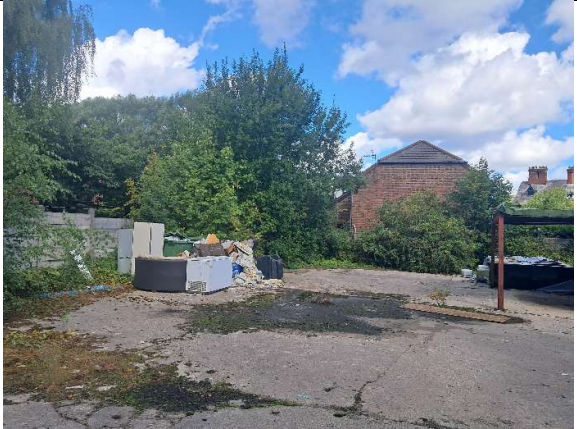
| <p style="text-align: center;"><b>Plate 7 View facing north showing covered area and domestic waste stockpile</b></p> | <p style="text-align: center;"><b>Plate 8 View facing south showing the site.</b></p> |
