**GAS MEMBRANE VALIDATION**

| <b>Site Name:</b> Belle Vue | <b>Project Number:</b> 12-123 |

**Plot - 168**

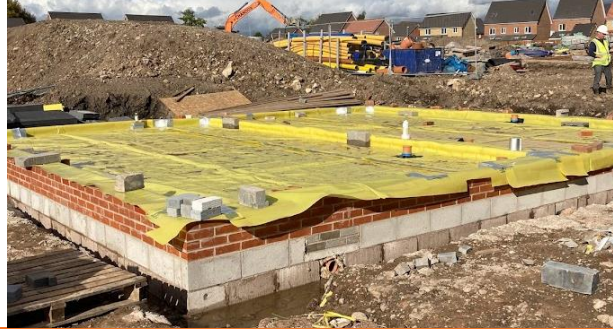
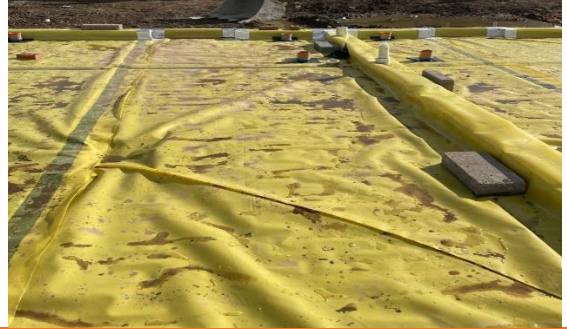
**General Condition of Membrane-Good Condition**

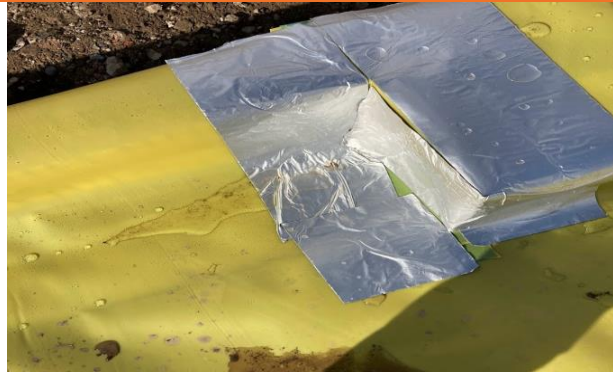
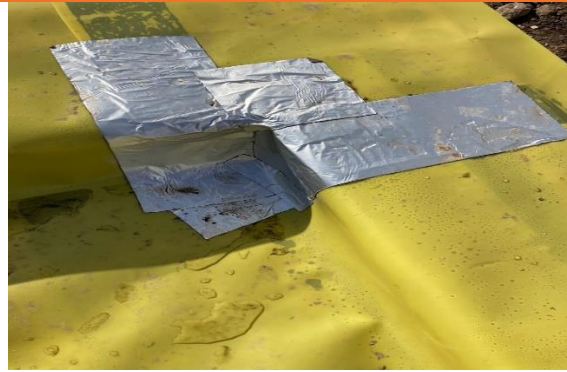
**Verification of Joints and Seals-Good Condition**

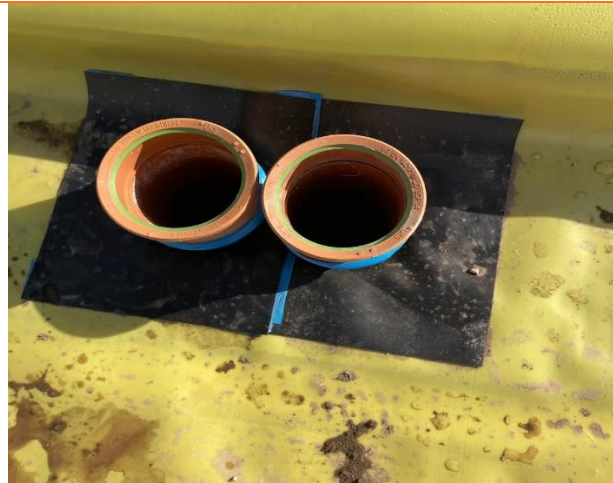
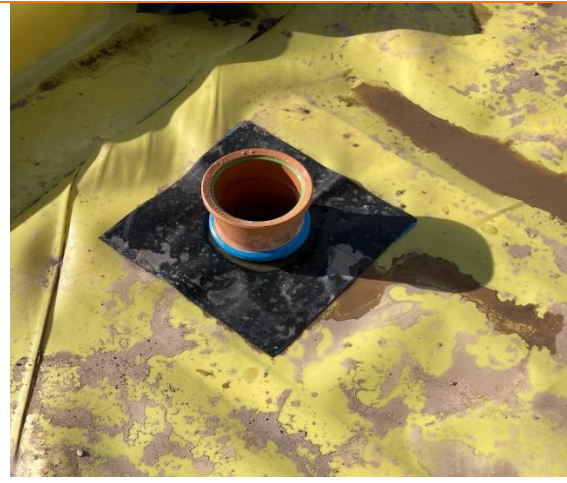
**Verification of Service Penetrations-Good Condition**

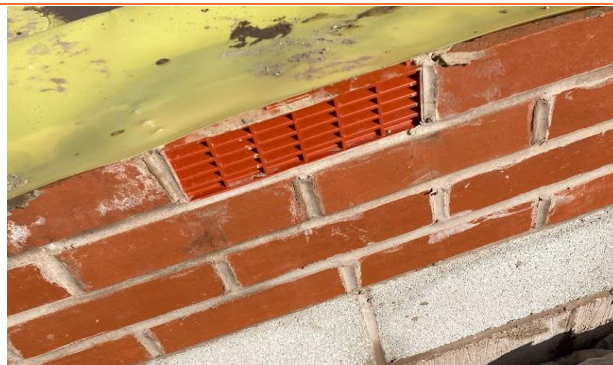
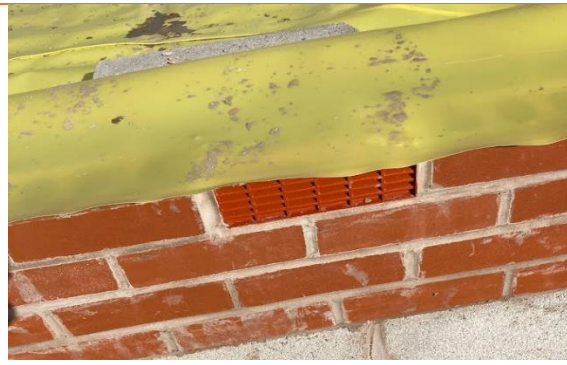
**Verification of Ventilation-Good Condition**
