# Grosvenor West- Front Stone Elevation observations and recommended interventions

## Appraisal Report & Design proposals

**Curtins Ref: 073425-CUR-ZZ-ZZ-RP-S-000090**

Site Address: Grosvenor West, 153 Oxford Rd, Manchester M15 6AD

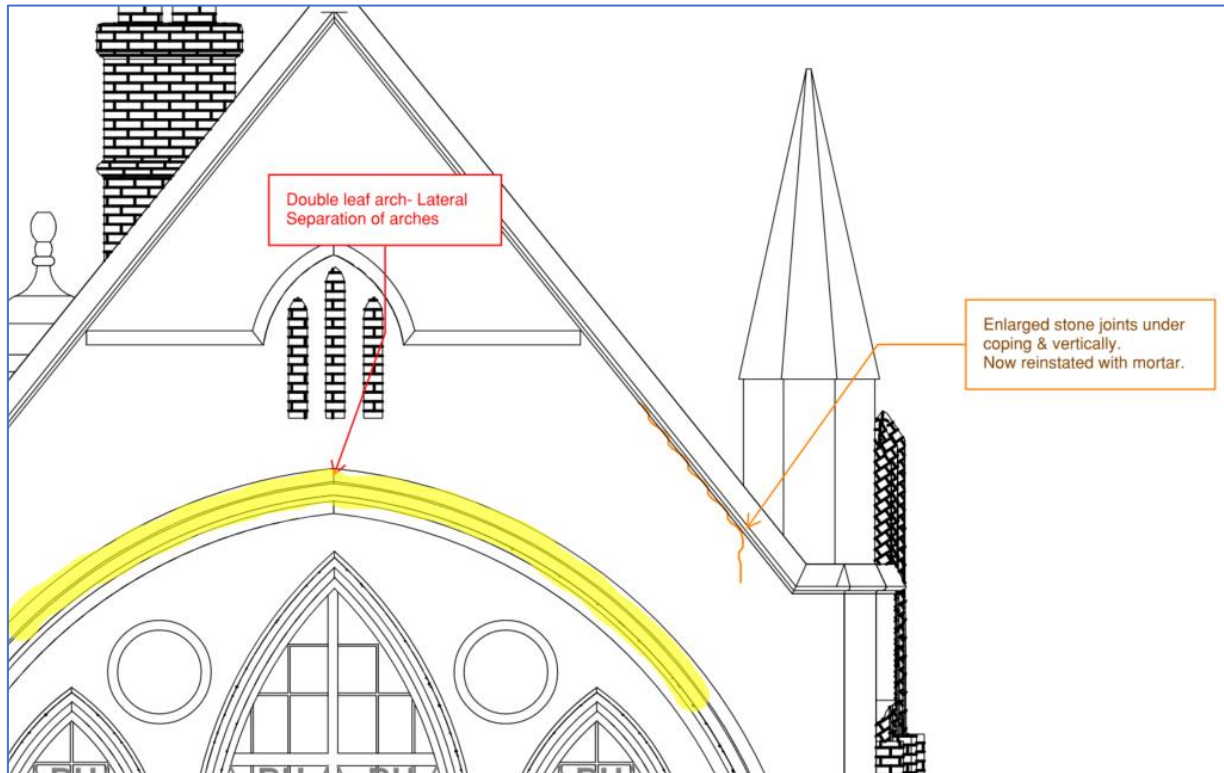
The findings can be separated into three adjacent issues observed on site, that which may be related to the same underlying cause or coincidental.

Figure 2-1 Western gable end. Cracking below turret Orange. Arch separation yellow.

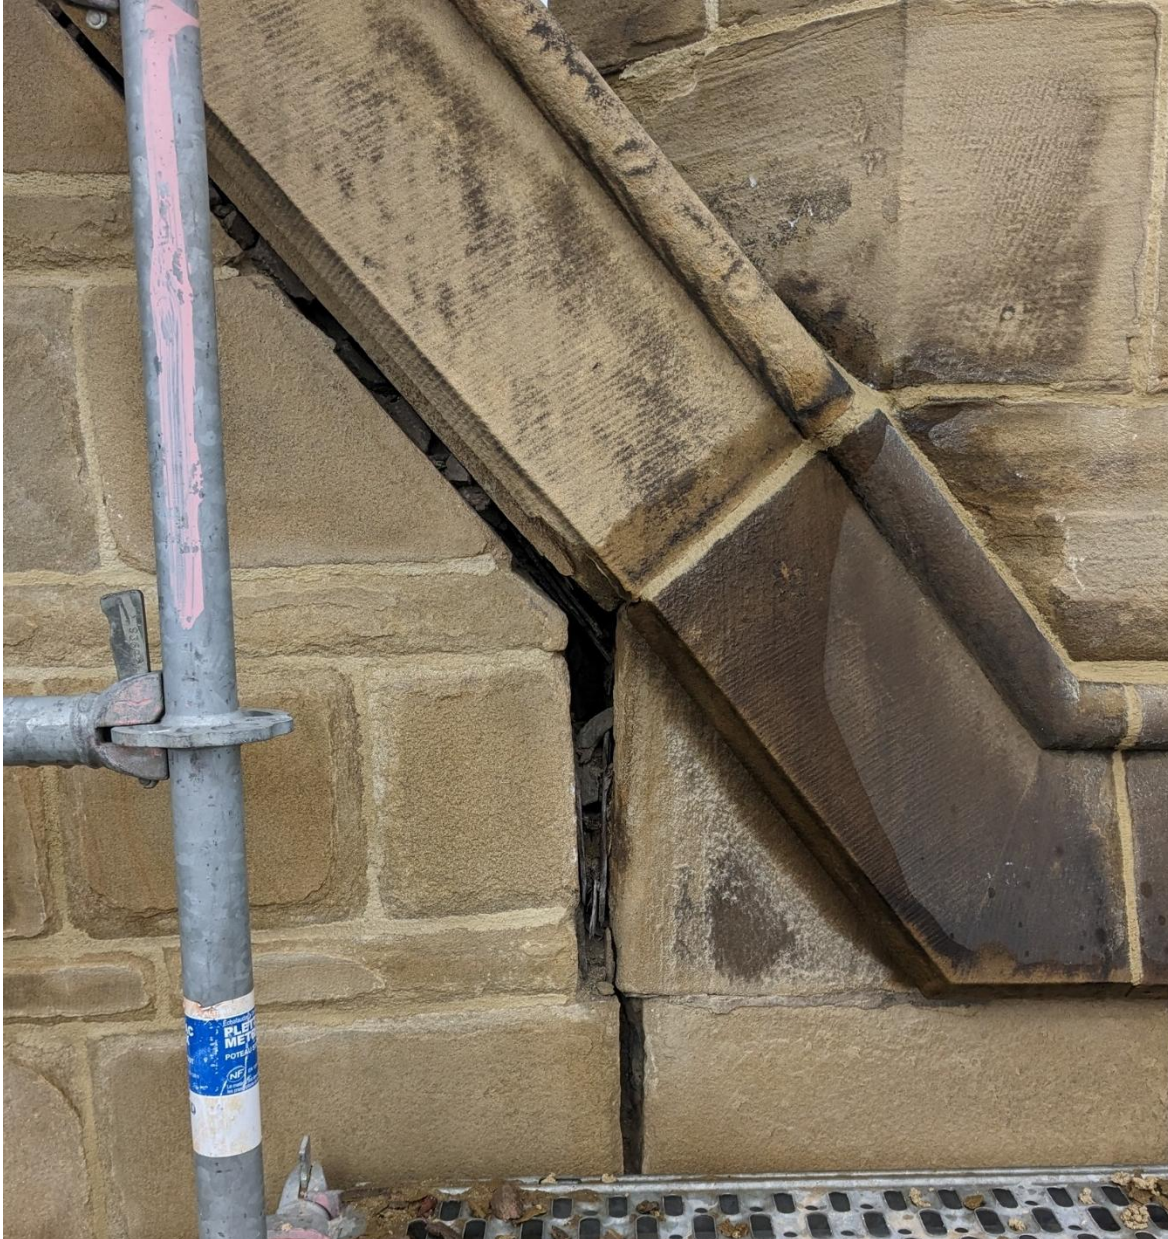
Major mortar joint gaps were observed at the right-hand end of the Western arched gable where it meets an ornate corner turret. However it can be deduced from preceding photographs (Google Streetview showing mortar present months before Curtins photographs) that these joints in the stone were raked out in preparation for mortar replacement, rather than reflecting the size of movement cracking. 2025 images show these joints have been reinstated with mortar. Yet this mortar damage instigating raking out has inevitably been caused by a degree of differential stone movement that may still be of concern today. Being coping level it's highly likely that rainwater ingress has exacerbated or even solely caused this mortar degradation and repointing in 2024 will have resolved this ingress.

This location observed is where the arch is at its shallowest depth and may be caused by a combination of arch spread and downward sliding of the coping stones on the gable end, which are inclined at the very steep slope of slate roof of over 1:1 (52 degrees). Thermal expansion of the exposed gable may also have contributed to the movement and the exposed location at near the coping may be expedited weathering of the cracked mortar.

Figure 2-2 2023 Inspection on scaffolding showing raked-out mortar joints

It is proposed to install metallic ties downwards from the gable coping through or nearly through the crack zone to further connect the respective sides following the repointing (already carried out).

Furthermore it is proposed to tie down the coping stones above to ensure that they do not slide down the roof gables.

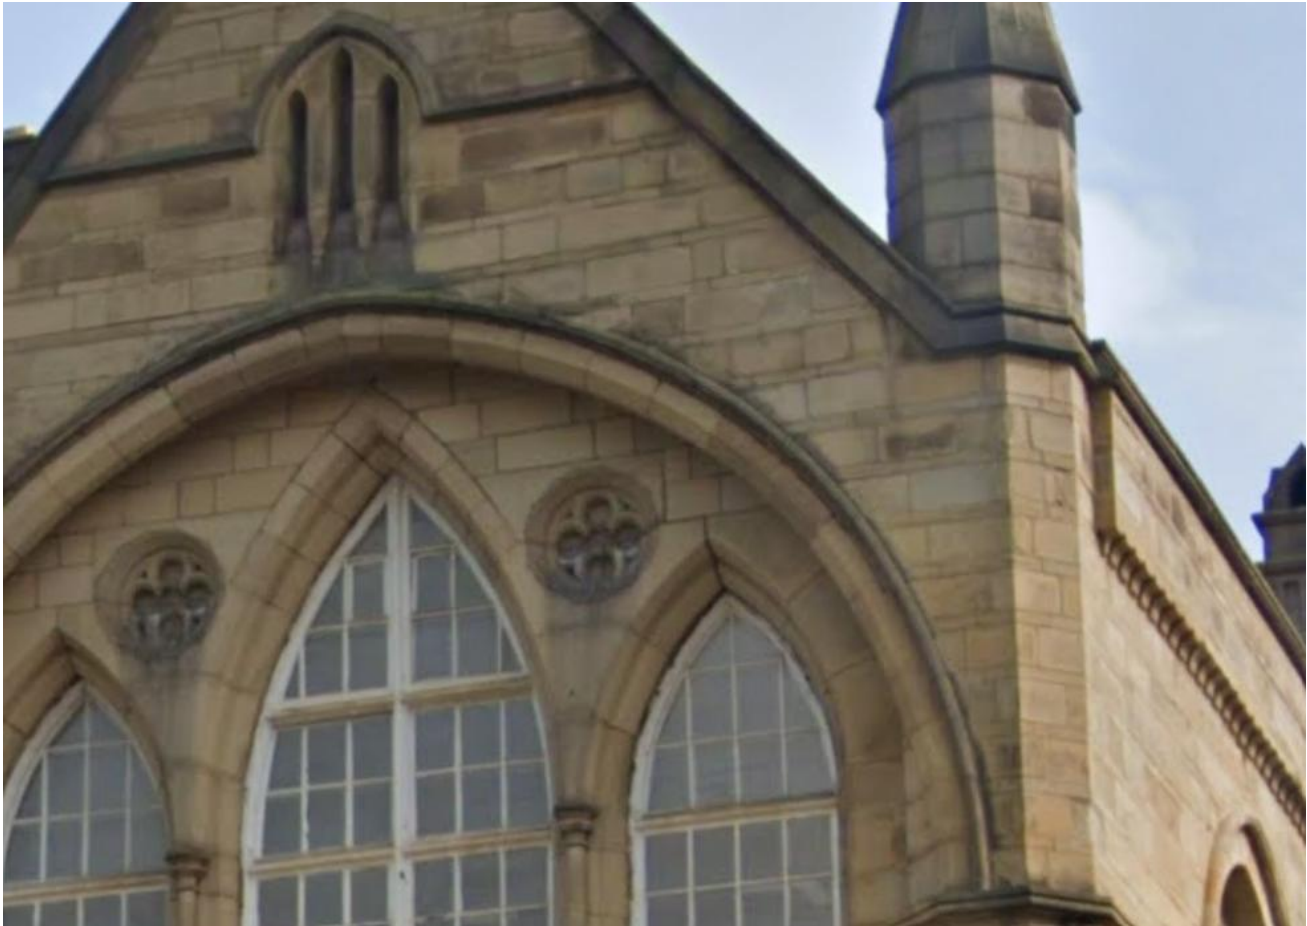
**Figure 2-3 Pre Grosvenor restoration works (2021 Google Streetview). This shows mortar in place (too low resolution for observing cracking).**

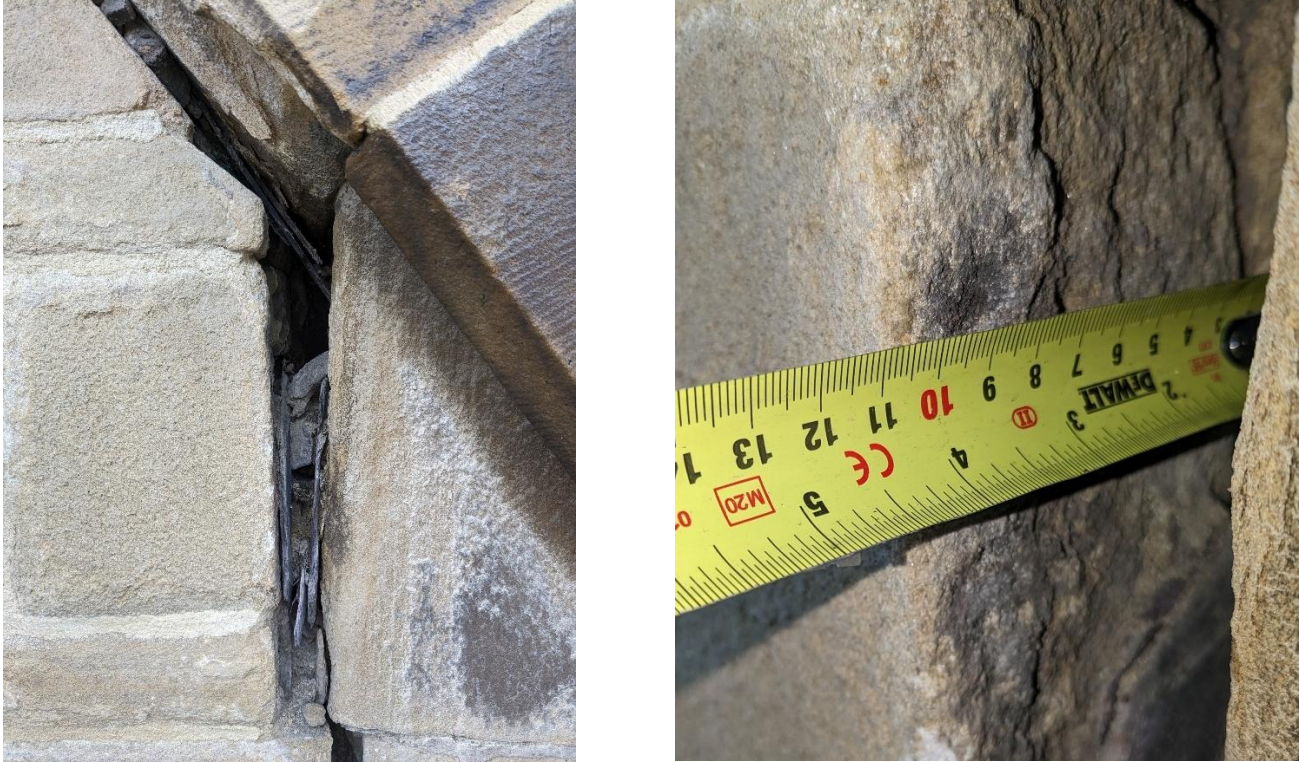
**Figure 2-4 Left: Closeup showing slate in joints following raking out of mortar. May imply this has been repointed multiple times. Right: Front stonework 100mm thk only.**

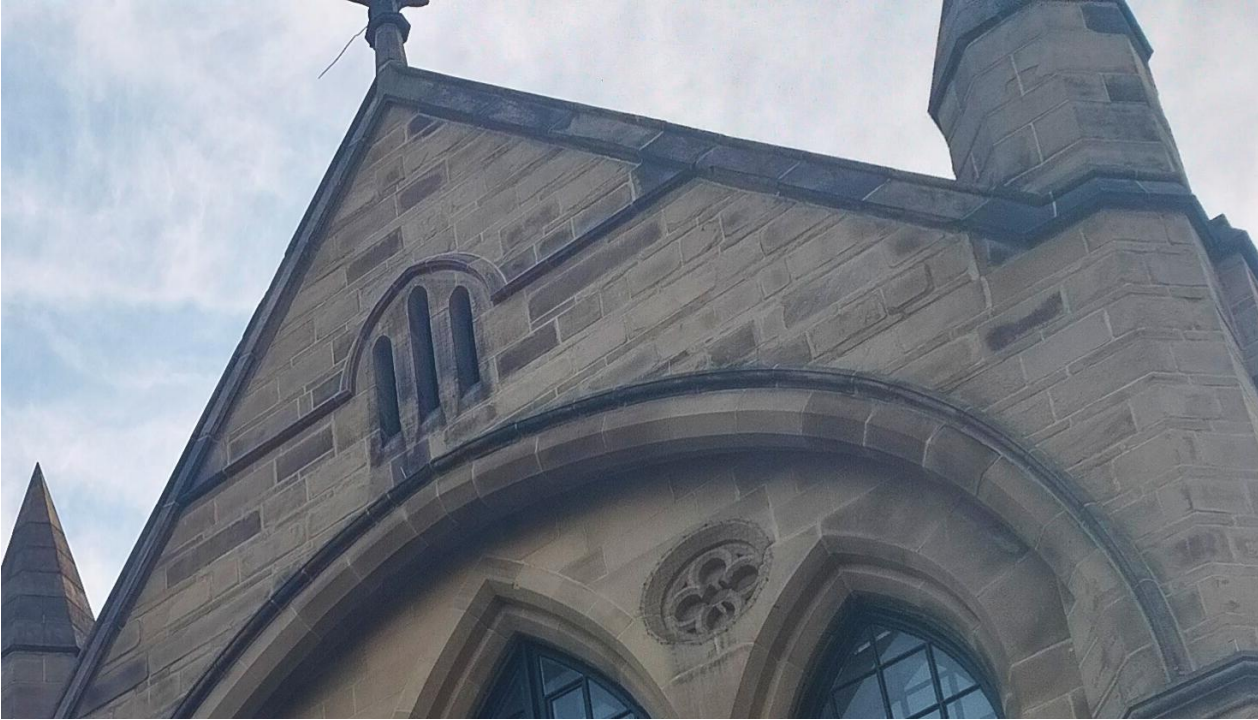
**Figure 2-5 2025 from ground level. Shows joints have been mortared up to reinstate intended load paths & weather tightness.**

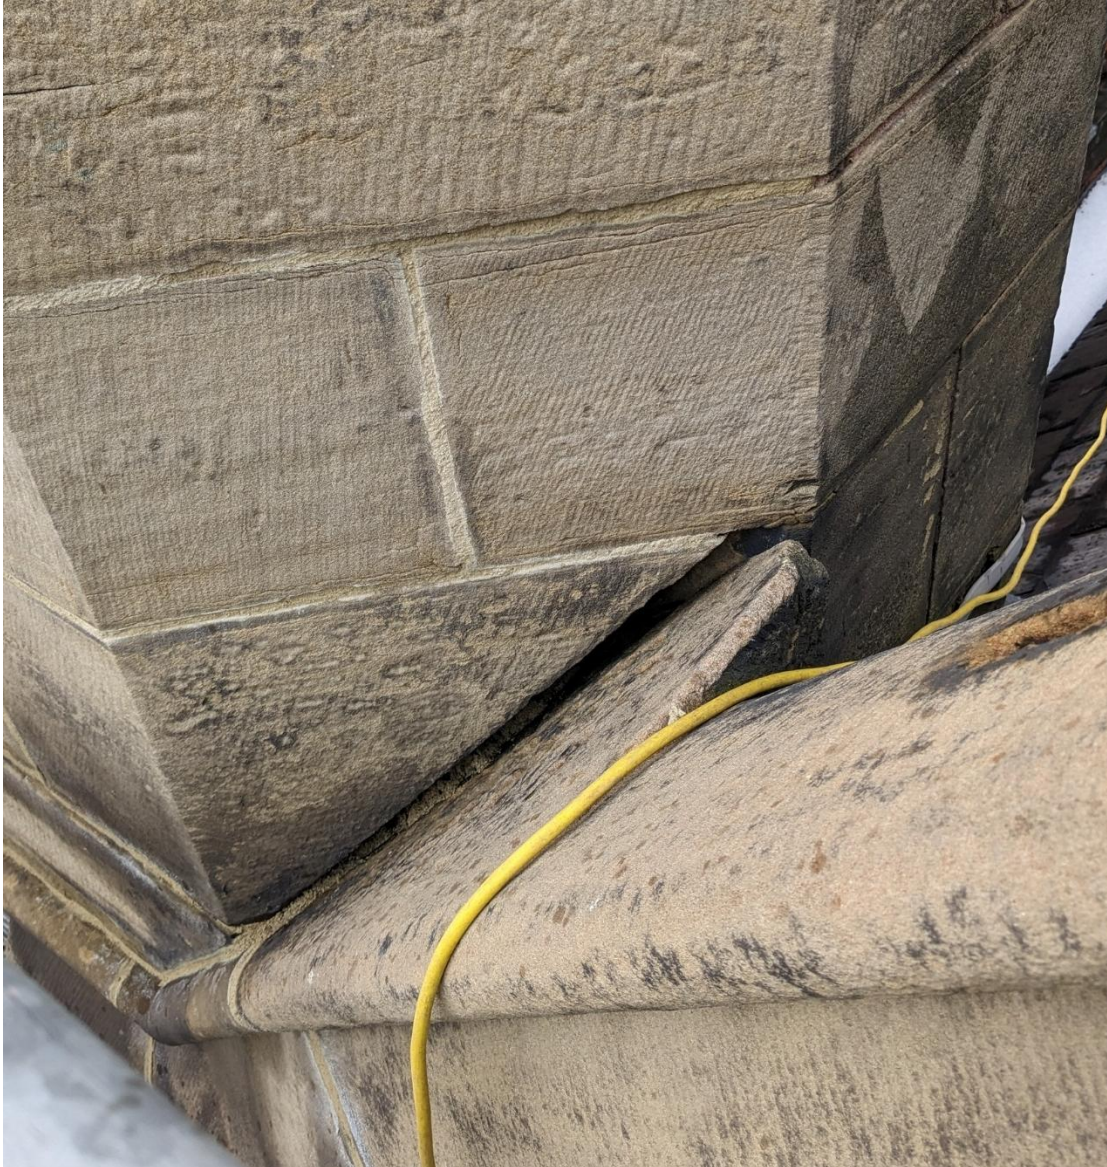
Figure 2-6 2023 photograph- View from the opposite side of the turret showing washed or raked-out mortar. Thought to be fully reinstated in 2024 to prevent water ingress.

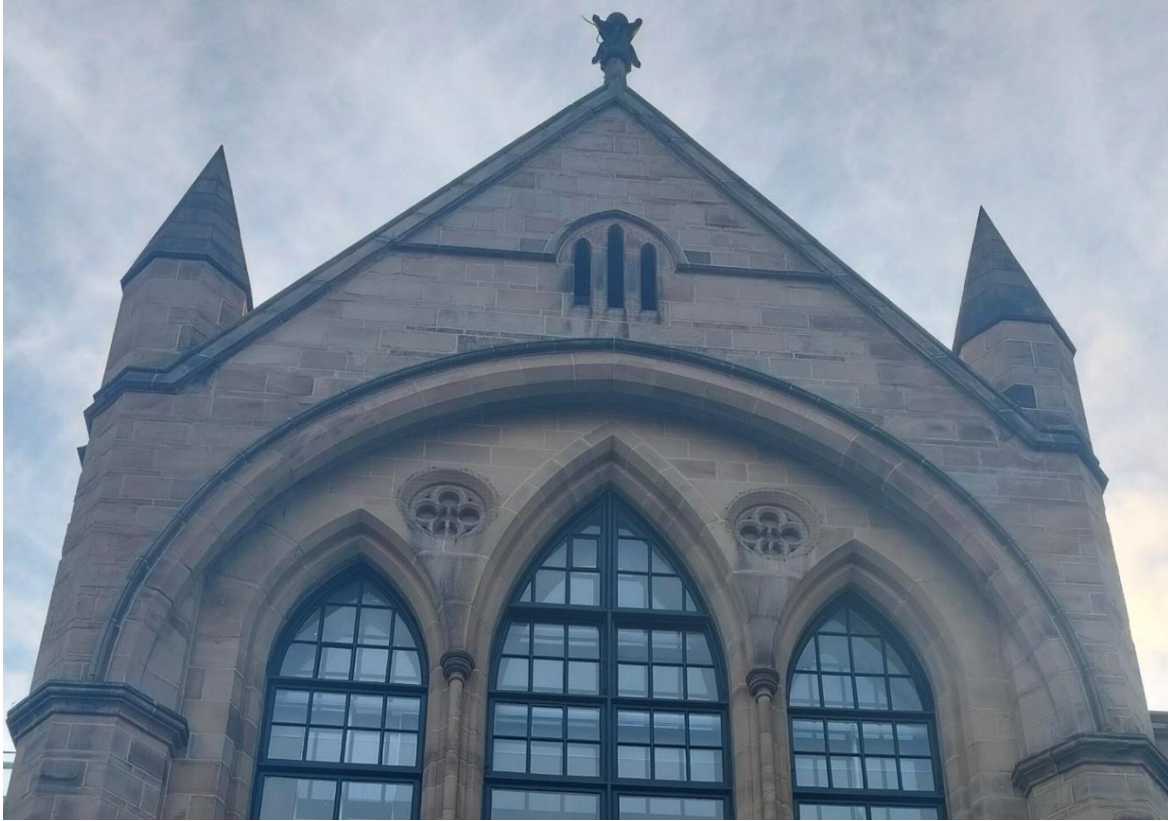
**Figure 2-7 Arched Gables to the Grosvenor stone elevation (Eastern Gable- No similar issues evident)**

On the Eastern gable the same construction is evident, but this arch separation is not apparent. However, it is proposed to remediate both gables in the same fashion to mitigate risks of this lack of tying affecting the eastern gable in time.

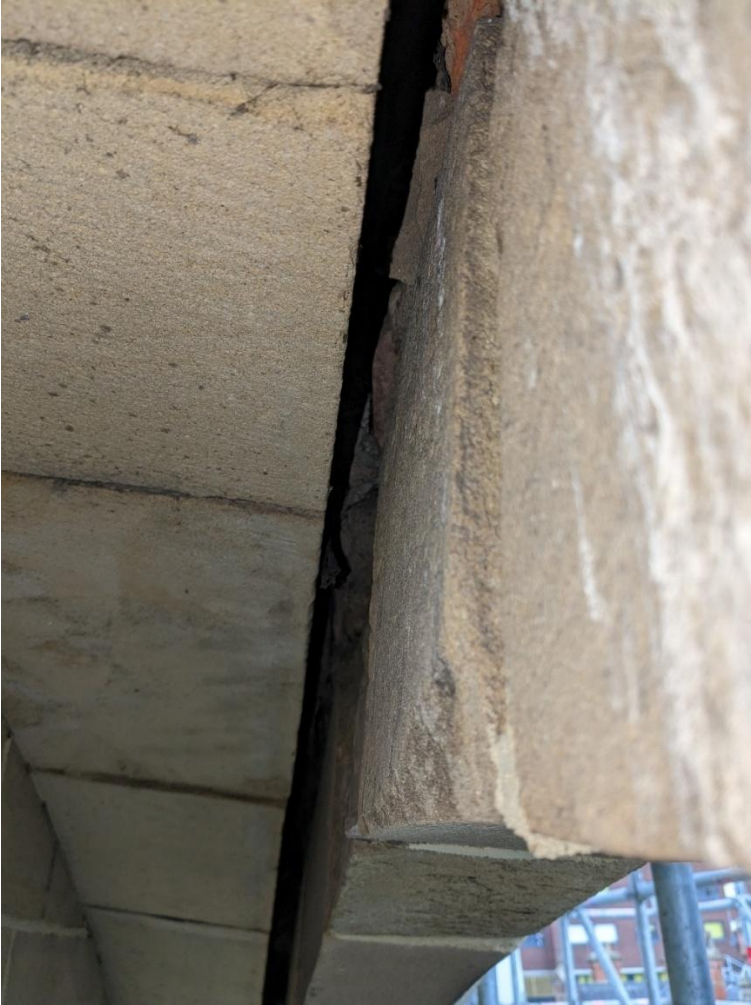
To the Western arched gable, this has resulted in some differential lateral movement which has widened the original vertical mortar joint between them (little mortar is present implying it has dropped out). The joint between varies up to around 40mm, which is assumed to be roughly double the original joint size. This implies there has been some lateral separation of the arches suggesting the outer arched gable has moved outwards, away from the main structure.

**Figure 2-8 Underside of Western arched gable- Enlarged vertical joint between inner & outer arches**

It is proposed to install specialist metallic reinforcement designed for masonry / stone retrofit tying. These are only to provide a tension 'cavity tie' between the arches, not transfer vertical loading. This enables the ties to be a minimal cross section, minimising the drilled holes in stonework to sensitively repair. Quality Finishing to these ties in the stone façade is required to be both visually unobtrusive and to minimise environmental degradation to the stone or the metallic ties. To achieve this depends on the particular proprietary system employed. This generally involves recessing the ties below the surface and covering over with a matching stone/ mortar (if in the mortar joint). Recommendations from the Helifix Cemtie product proposed are:

It is proposed to individually tie every stone forming the outer arches to continuously tie the gable at the arch level back to the inner gable wall/ arch. There may be issues around drilling at the appropriate angle to meet the two archways at differing levels; however the existing bevelled corner will assist in drilling. An expert installer of masonry retrofit tying should be appointed in conjunction with trial installations to ensure the methodology is successful and sensitive.

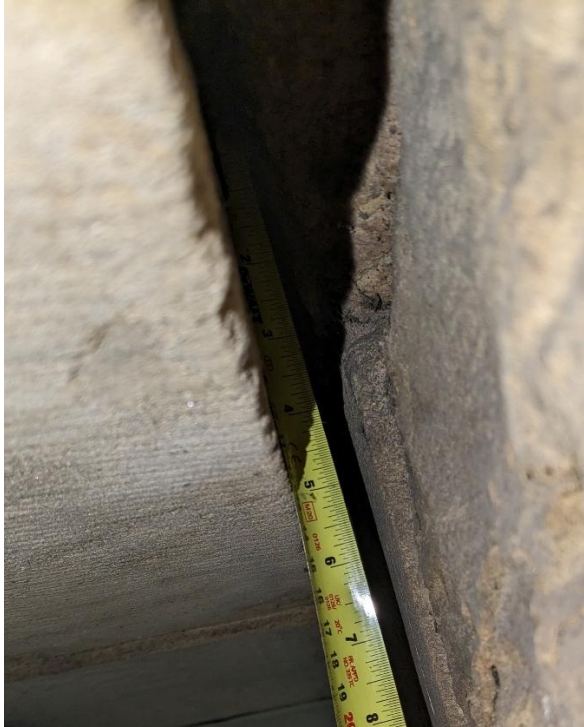
**Left:** Inner Arch circa 140mm Depth stone.  
offset below inner).

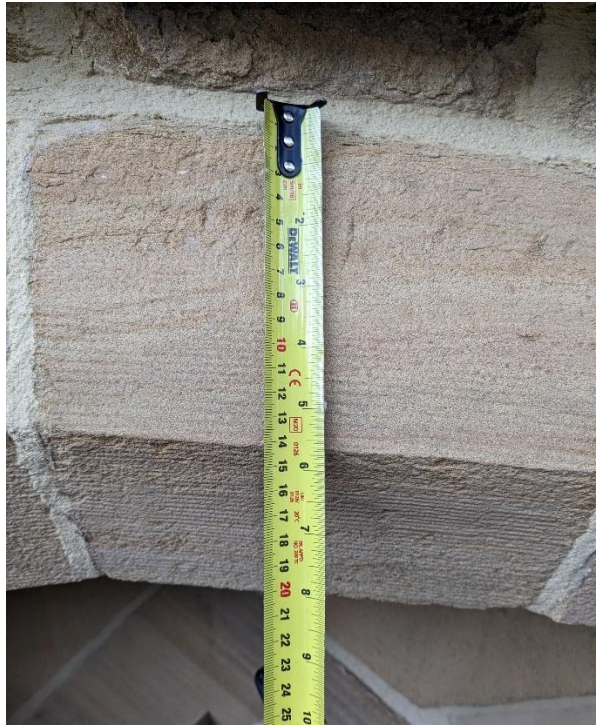
**Right:** Outer Arch circa 200mm Depth Stone (Underside  
offset below inner).

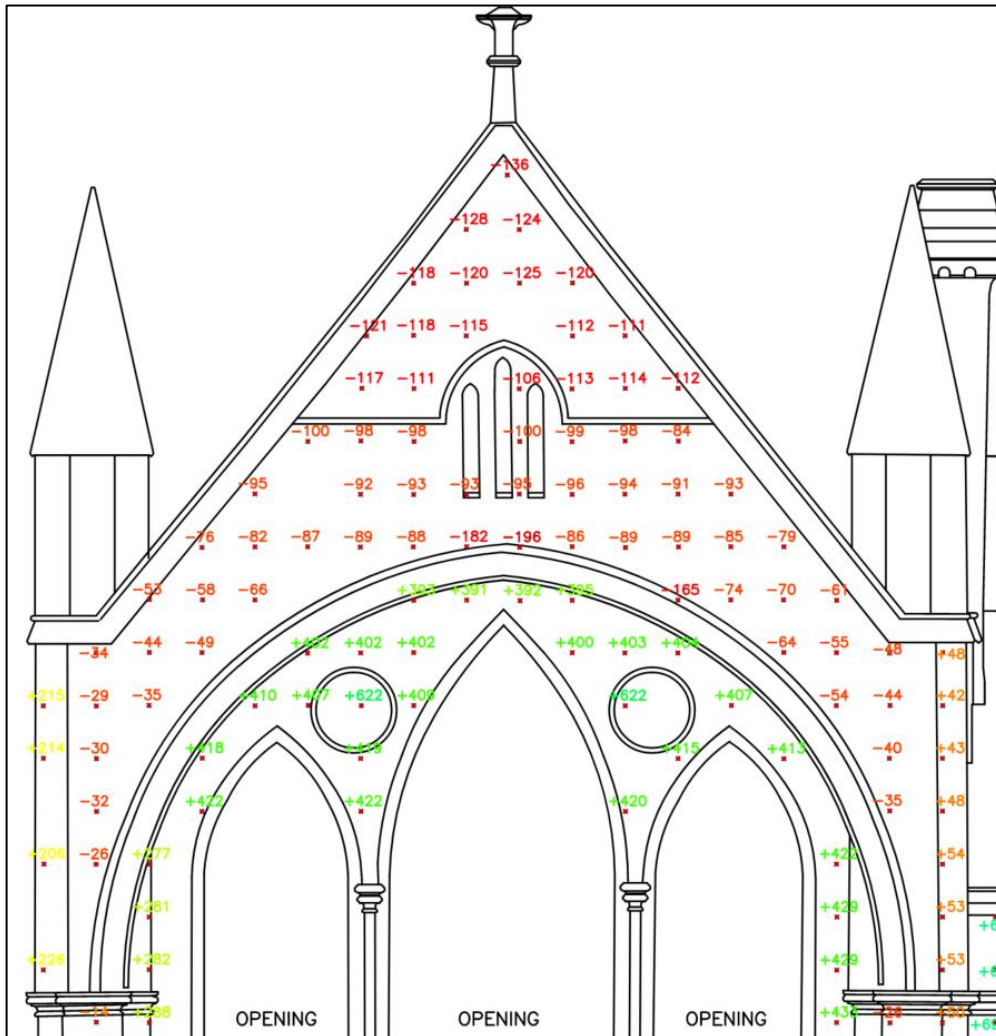
Figure 2-10 Eastern Gable (Left hand). Gable is not showing leaf spread but inclination (towards footway) of 1:50 is very steep.

Therefore given the severity of the wall lean and modest interventions proposed, it is recommended to increase the lateral tying to the timber roof by enhancing the tension tying capabilities of the existing timber members that lie in the leaning gable zone from the arch up to the ridge:

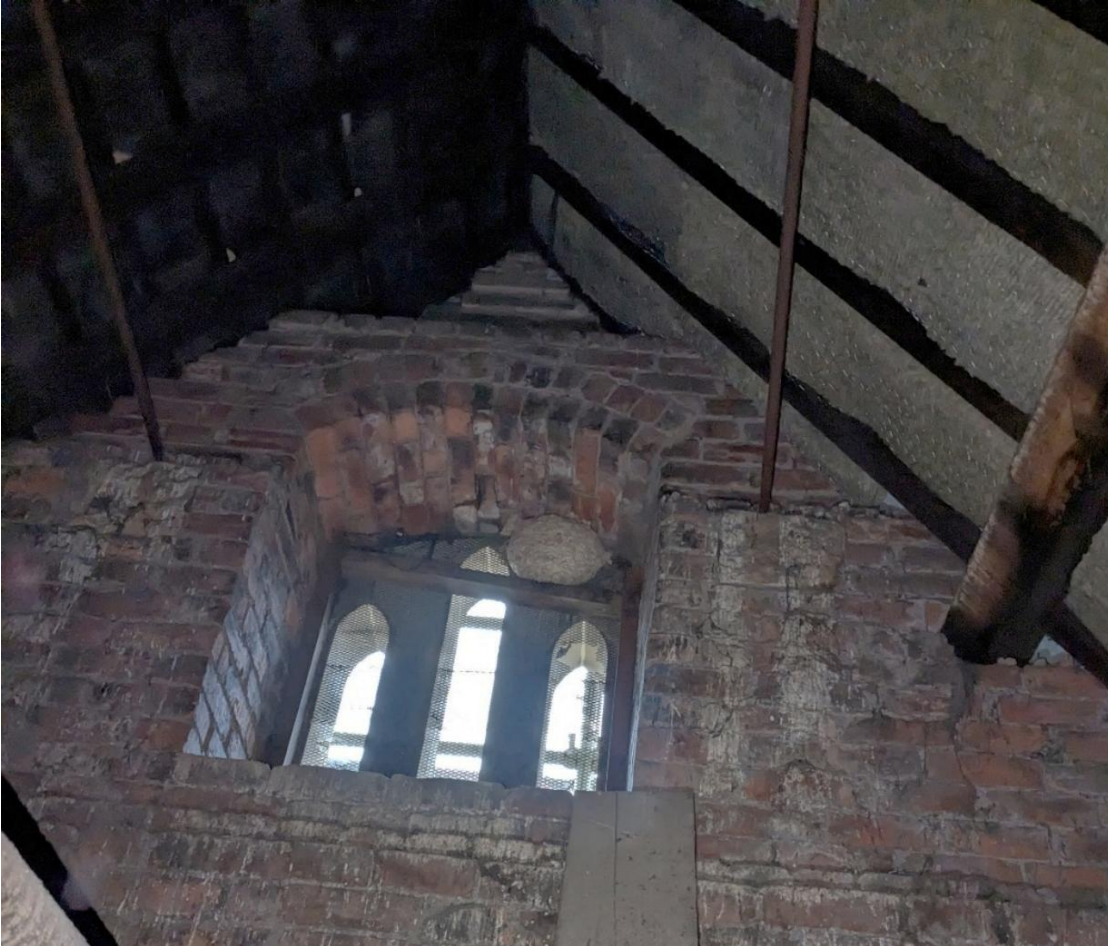
Figure 2-11 Inside attic void (Eastern Gable) showing roof purlins bearing into gable wall & additional tension ties.  
Inclination not measured nor noticed on original visit.

- Roof Purlins which bear into the wall at approximately the same level as the tension rods and the window.
- Attic level ceiling joists, which bear into the inner leaf of the end gable at a level above the stained glass windows.

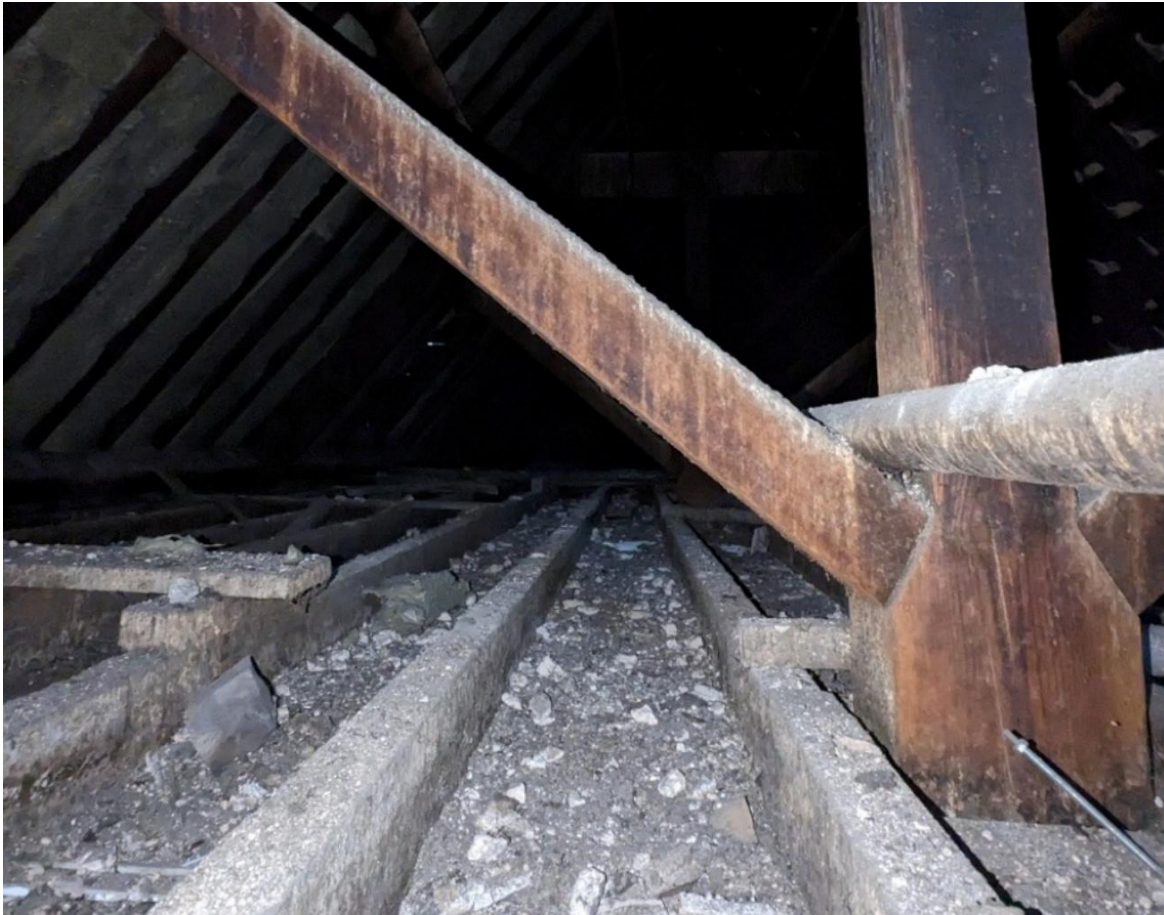
Figure 2-12 Inside Roof void space (Eastern gable) showing ceiling joists spanning between gable & King post trusses

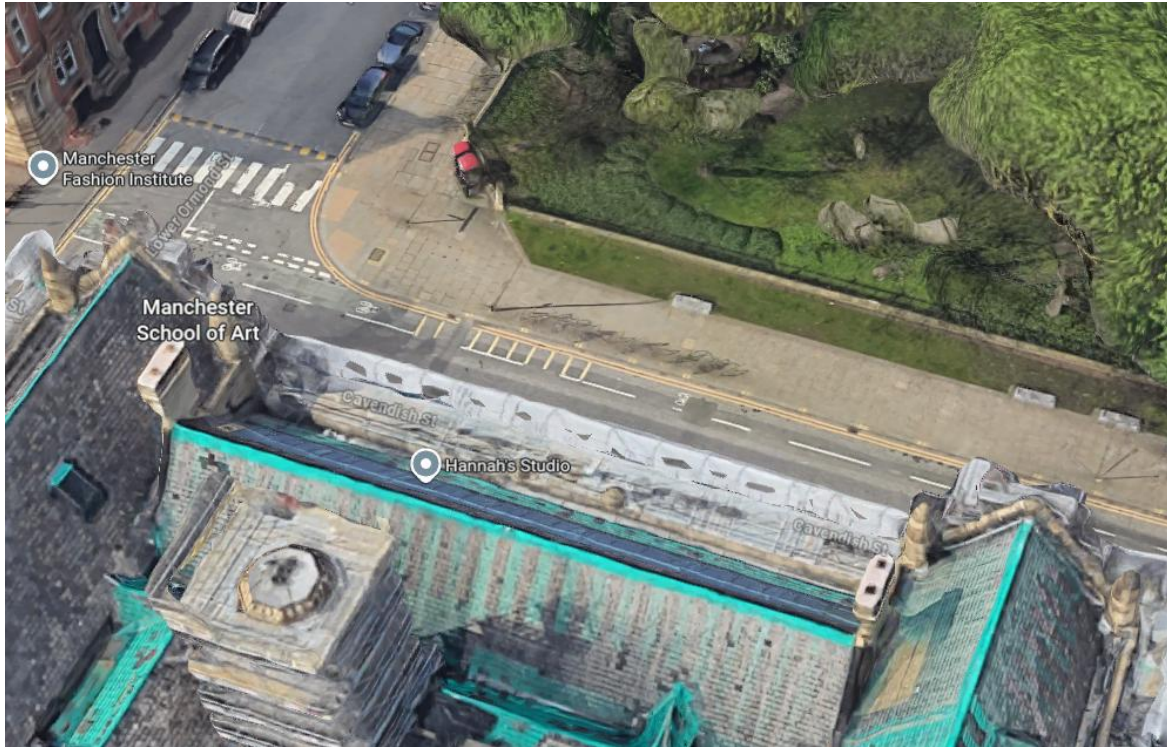
Figure 2-13 Satellite showing rear of gable elevations. Western gable (left in view) with arch separation. Eastern right (right in view) without evident separation but still 1:50 lean.

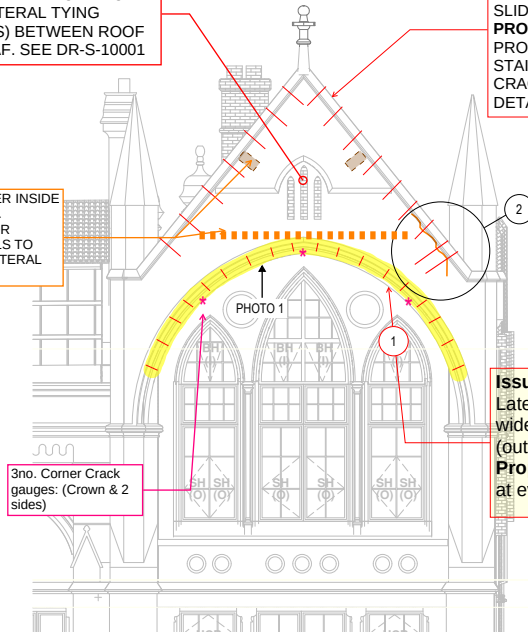
Western Gable (Right hand end)  
Scale: NTS

**ISSUE:** GABLE WALL STONE COPING IS LAID FLAT ON STEEP ROOF PITCH (OVER 45 DEG) WITHOUT KEYING IN NOR MECHANICAL TIES: AT CONTINUAL RISK OF LONG TERM SLIDING DOWNWARDS.  
**PROPOSALS:** NOTIONAL HOLDING-DOWN FASTENERS PROPOSED (EVERY COPING STONE)- PROPRIETARY STAINLESS TIES RESIN FIXED: SIMILAR METHODOLOGY TO CRACK STITCHING **DETAIL 2** (SMALLER SCALE)- SPECIALIST DETAILS.

**Issue:** Locally enlarged stone joints under coping & vertically indicates previous movement cracking. (Has been reinstated with mortar).  
**Proposals:** Local crack stitching to mitigate risk of crack growth. See **Detail 2**

**Issue:** Double leaf arches not connected- Lateral separation of Western arch is part of wider steep gable wall lean to both gables (outwards)-  
**Proposals:** Laterally Tie arch leaves together at every outer stone. See **Detail 1**

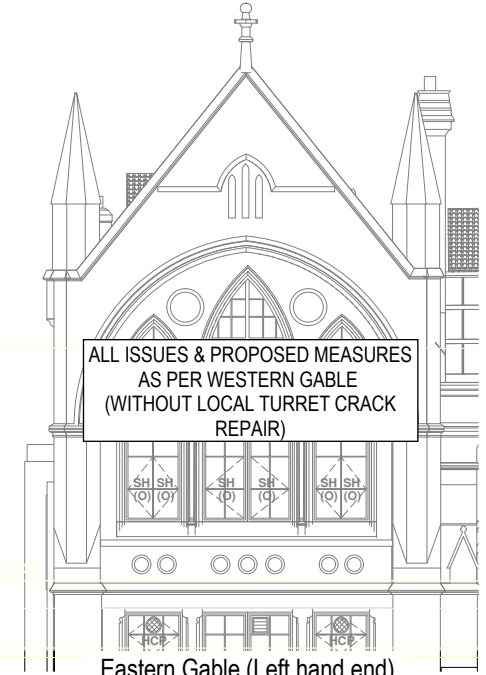
Eastern Gable (Left hand end)  
Scale: NTS

ALL ISSUES & PROPOSED MEASURES  
AS PER WESTERN GABLE  
(WITHOUT LOCAL TURRET CRACK  
REPAIR)
