### Watercourse Pre-Determination Response

Further to receiving the response from the LLFA in relation to the planning application 144899/FO/2026 we would confirm that the culvert was surveyed using CCTV.

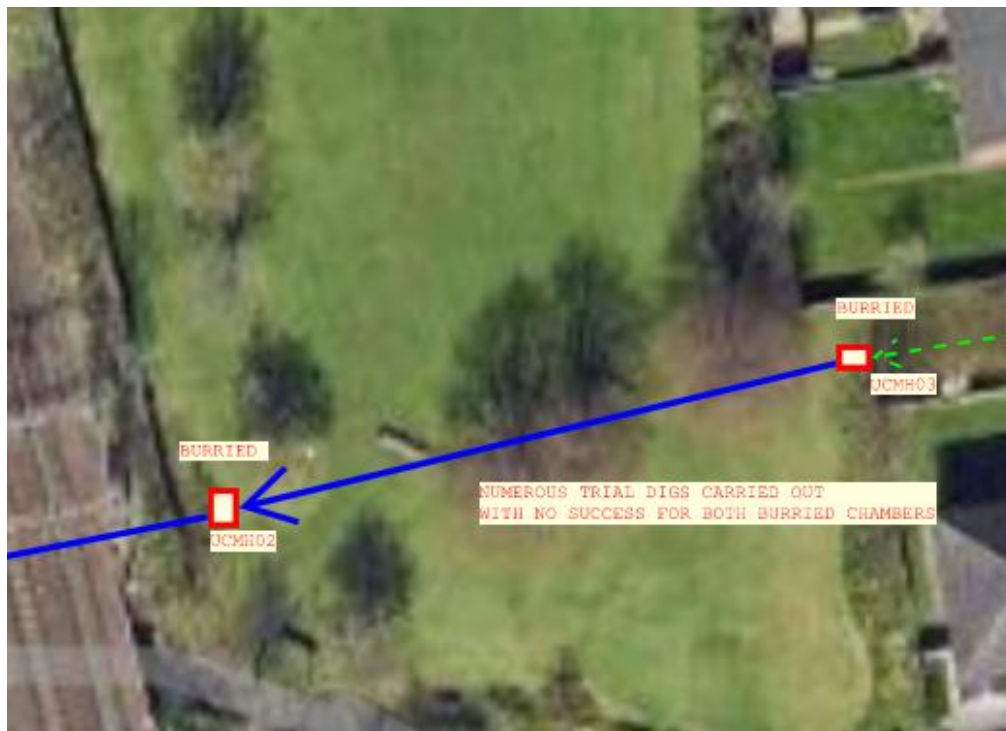
The survey of the culvert was carried out from UCMH02 upstream, as per below extract.

MH covers UCMH02 and UCMH03 could not be located on site.

A sond trace was used to locate the line of the culvert but due to the nature of the overlying material the received signal at ground level could not be confirmed. The signal to ground was being interfered with by material within the overlying soils.

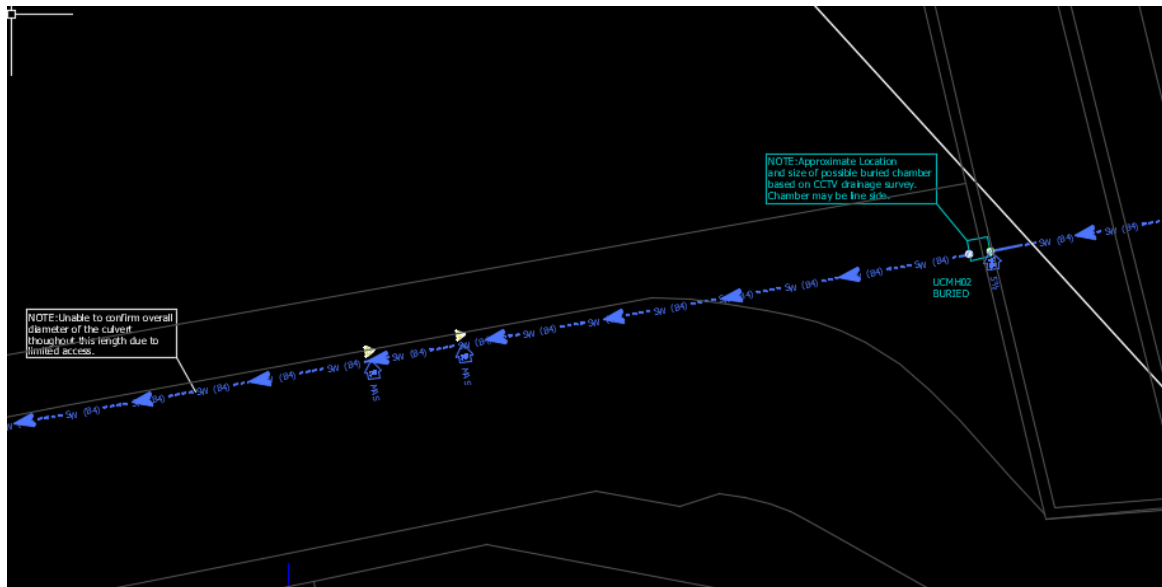
The line of the culvert surveyed to the west of the railway was able to be located using a sond trace and is indicated as below extract.
