**Technical Submittal Proposal**  
**Project: Peeler Yard**  
**Heritage Conservation and Repair Work and initial scoping.**

**Scope: External façade, chimney, cast iron columns, and associated brickwork repairs**

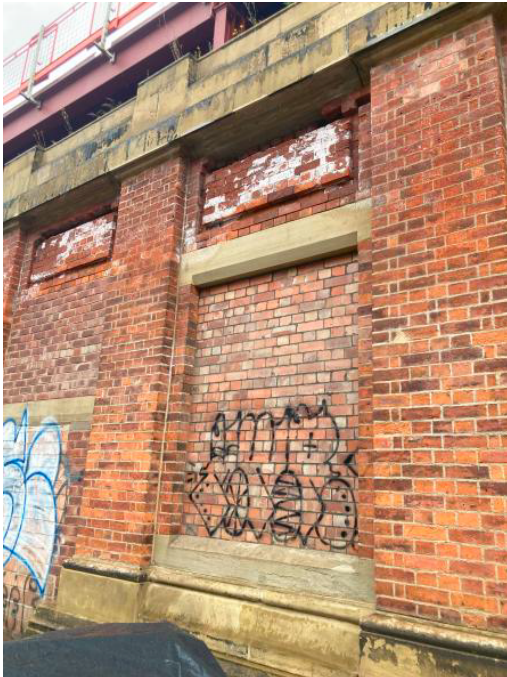
Planned location of new window
