**Project Name:** 60342 Equans alexandra park housing office 011225

**Project Date:** 01/12/2025

**Company:** Equans Services Limited  
**Department:** Neon Q10 Quorum Business Park  
**Street:** Benton Lane  
**Town or City:** Newcastle Upon Tyne  
**Post Code:** NE12 8BU

**Company:** Clearway Drainage Systems Limited  
**Street:** Unit A2 Leigh Trading Estate  
**Town or City:** Leigh  
**Post Code:** WN7 3EQ  
**Phone:** 01942 606761

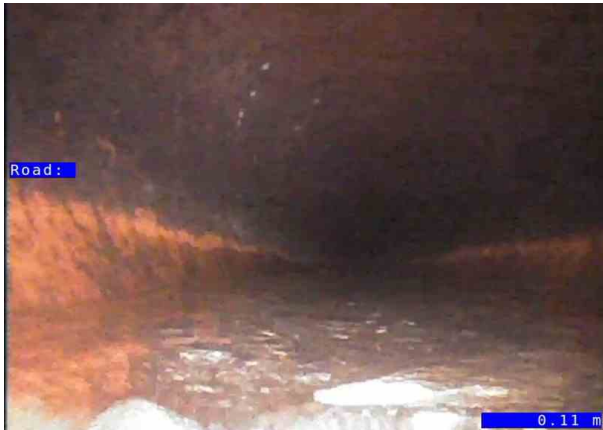
| Scale: | 1:50 | Position [m] | Code | Observation | MPEG | Photo | Grade |
|---|---|---|---|---|---|---|---|
| | 0.10 | S01 | DE | Debris, other, start: Along the bottom of the pipe | 00:00:24 | MH1X_05<br>8da639-c3<br>3a-40be-b | |

MH1X\_058da639-c33a-40be-b1e9-1de6a032ca9d\_20251202\_105143\_363.jpg, 00:00:24, 0.10 m  
Debris, other, start, Along the bottom of the pipe

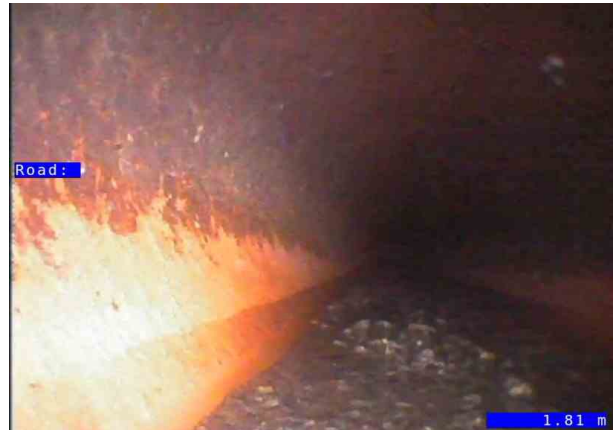
MH1X\_cb103d0c-5897-421a-9b4a-da42e4a442c3\_20251202\_105156\_201.jpg, 00:00:24, 0.10 m  
Debris, other, start, Along the bottom of the pipe

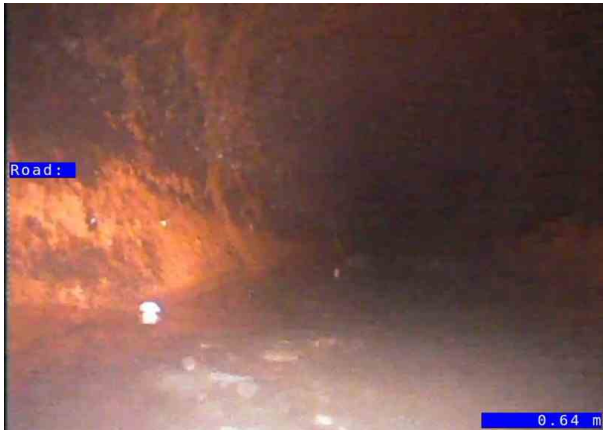
| Scale: | 1:50 | Position [m] | Code | Observation | MPEG | Photo | Grade |
|---|---|---|---|---|---|---|---|
| | | 0.65 | S01 | DE | Debris, other, start: Along bottom of pipe | 00:00:18 | MH1X_82<br>0c11f4-37f<br>e-4bd5-b4 |

MH1X\_820c11f4-37fe-4bd5-b413-ada0139f7de8\_20251202\_1  
05344\_487.jpg, 00:00:18, 0.65 m  
Debris, other, start, Along bottom of pipe

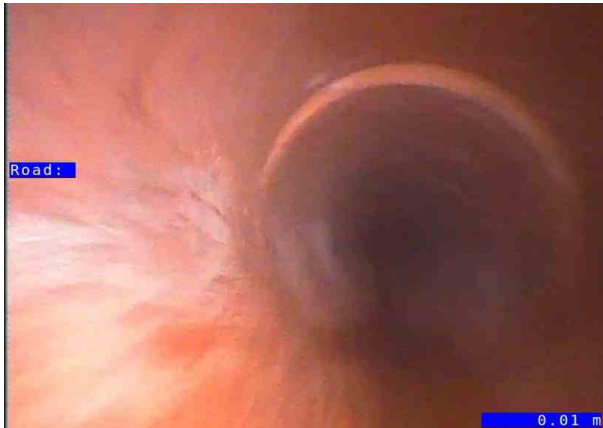
L1X\_185a980d-b20a-4bd4-af2c-254c7c94452f\_20251202\_105606\_373.jpg, 00:00:14, 0.01 m

| Scale: | 1:223 | Position [m] | Code | Observation | MPEG | Photo | Grade |
|---|---|---|---|---|---|---|---|
| | | 0.01 | JDM | Joint displaced, medium (between 1.0 and 1.5 times the pipe wall thickness): 10o'clock to 3 o'clock | 00:00:14 | U_S L1X_185a 980d-b20a | 1 |

Joint displaced, medium (between 1.0 and 1.5 times the pipe wall thickness), 10o'clock to 3 o'clock

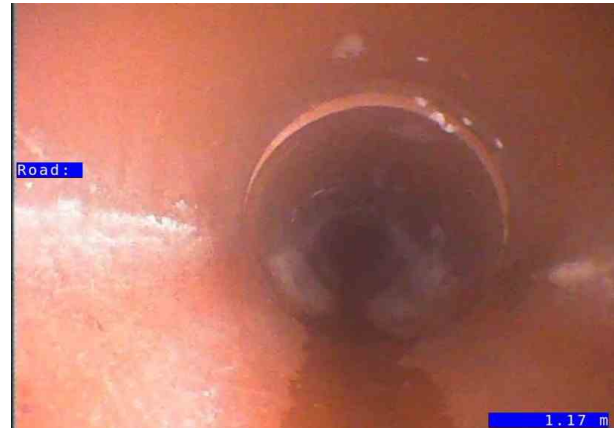
L1X\_900fcfe-abf8-49c5-9116-f906c4de2e37\_20251202\_105645\_397.jpg, 00:00:27, 1.21 m

| Scale: | 1:223 | Position [m] | Code | Observation | MPEG | Photo | Grade |
|---|---|---|---|---|---|---|---|
| | | 1.21 | JDM | Joint displaced, medium (between 1.0 and 1.5 times the pipe wall thickness): 10o'clock to 3o'clock | 00:00:27 | U_S L1X_900fc ffe-abf8-49 | 1 |

Joint displaced, medium (between 1.0 and 1.5 times the pipe wall thickness), 10o'clock to 3o'clock

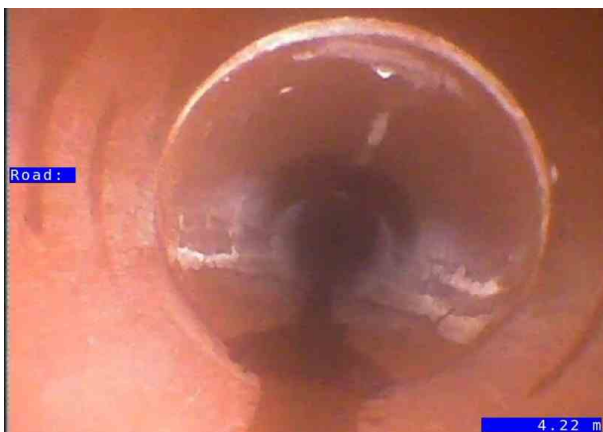
L1X\_1ad78f39-1de3-4997-b334-985baf69add2\_20251202\_105801\_827.jpg, 00:01:01, 4.22 m

| Scale: | 1:223 | Position [m] | Code | Observation | MPEG | Photo | Grade |
|---|---|---|---|---|---|---|---|
| | | 4.22 | JDM | Joint displaced, medium (between 1.0 and 1.5 times the pipe wall thickness): 10o'clock to 4o'clock | 00:01:01 | U_S L1X_1ad7 8f39-1de3- | 1 |

Joint displaced, medium (between 1.0 and 1.5 times the pipe wall thickness), 10o'clock to 4o'clock

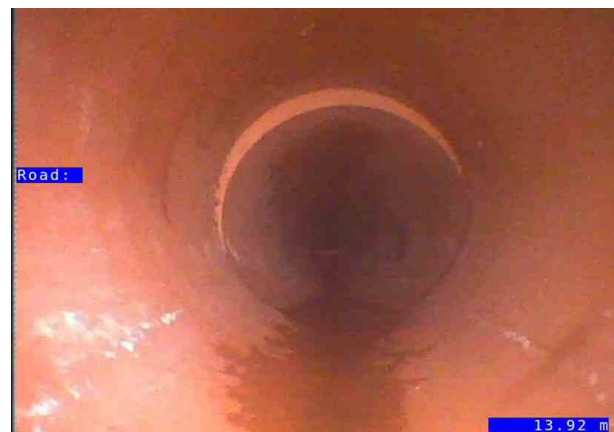
L1X\_ac02eb41-bd6b-44aa-88fd-bb1653865245\_20251202\_110957\_748.jpg, 00:02:43, 13.92 m

| Scale: | 1:223 | Position [m] | Code | Observation | MPEG | Photo | Grade |
|---|---|---|---|---|---|---|---|
| | | 13.92 | JDM | Joint displaced, medium (between 1.0 and 1.5 times the pipe wall thickness): 9o'clock to 2o'clock | 00:02:43 | U_S L1X_ac02 eb41-bd6b | 1 |

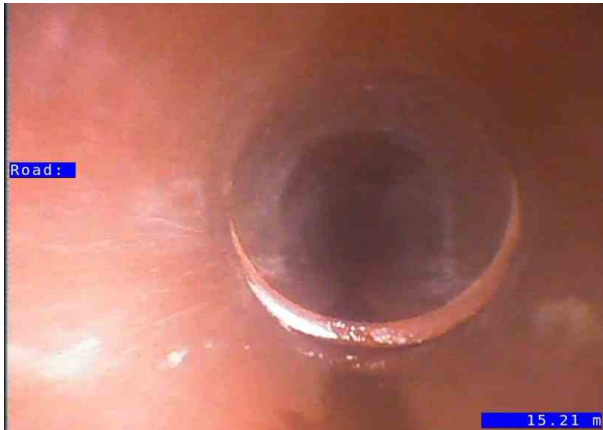
L1X\_1a5b7026-f9b7-44b3-b275-cfe619b4c0b2\_20251202\_111028\_469.jpg, 00:03:01, 15.21 m

| Scale: | 1:223 | Position [m] | Code | Observation | MPEG | Photo | Grade |
|---|---|---|---|---|---|---|---|
| | | 15.21 | JDM | Joint displaced, medium (between 1.0 and 1.5 times the pipe wall thickness): 3o'clock to 8o'clock | 00:03:01 | U_S L1X_1a5b 7026-f9b7- | 1 |

Joint displaced, medium (between 1.0 and 1.5 times the pipe wall thickness), 3o'clock to 8o'clock

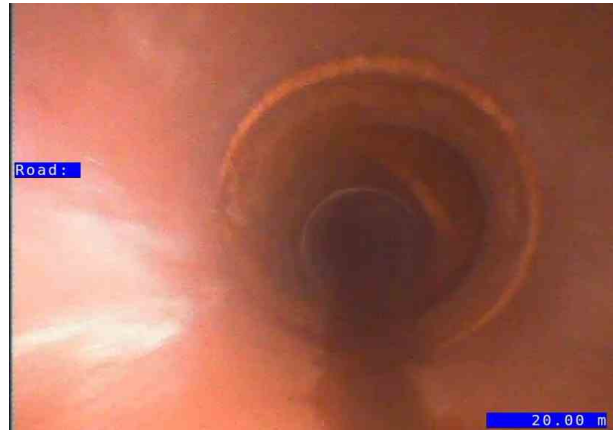
L1X\_1a59211a-aed8-426f-8a6b-ac7cab2cdd70\_20251202\_111106\_812.jpg, 00:04:24, 20.00 m

| Scale: | 1:223 | Position [m] | Code | Observation | MPEG | Photo | Grade |
|---|---|---|---|---|---|---|---|
| | | 20.00 | JDM | Joint displaced, medium (between 1.0 and 1.5 times the pipe wall thickness): 9o'clock to 5o'clock | 00:04:24 | U_S L1X_1a59 211a-aed8 | 1 |

Joint displaced, medium (between 1.0 and 1.5 times the pipe wall thickness), 9o'clock to 5o'clock

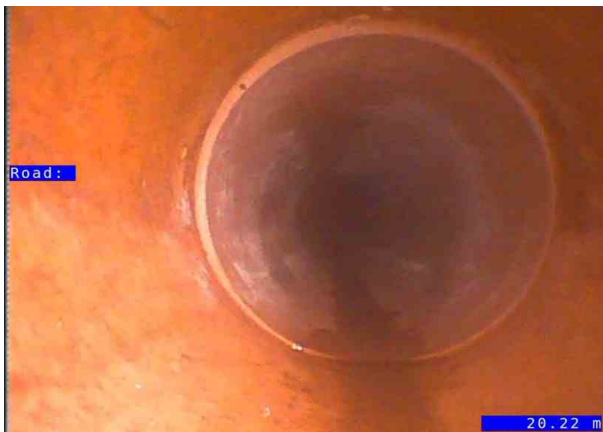
L1X\_6539f839-2af0-4d90-903e-562ab2740197\_20251202\_111144\_918.jpg, 00:04:29, 20.22 m

| Scale: | 1:223 | Position [m] | Code | Observation | MPEG | Photo | Grade |
|---|---|---|---|---|---|---|---|
| | | 20.22 | JDM | Joint displaced, medium (between 1.0 and 1.5 times the pipe wall thickness): 8o'clock to 1o'clock | 00:04:29 | U_S L1X_6539f 839-2af0-4 | 1 |

Joint displaced, medium (between 1.0 and 1.5 times the pipe wall thickness), 8o'clock to 1o'clock

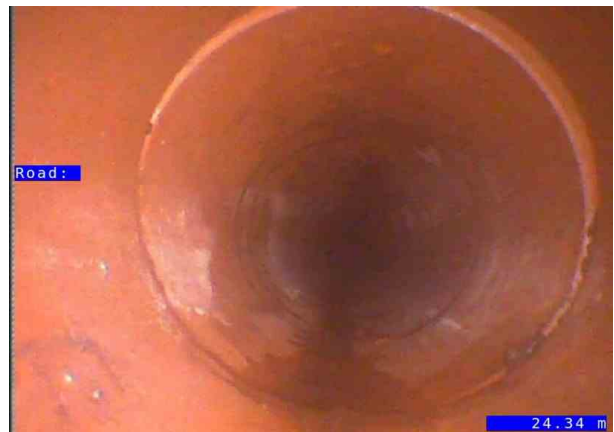
L1X\_62ef5796-fed9-440d-89c7-1486ce4d3852\_20251202\_111210\_283.jpg, 00:05:16, 24.35 m

| Scale: | 1:223 | Position [m] | Code | Observation | MPEG | Photo | Grade |
|---|---|---|---|---|---|---|---|
| | | 24.35 | JDM | Joint displaced, medium (between 1.0 and 1.5 times the pipe wall thickness): 11o'clock to 3o'clock | 00:05:16 | U_S L1X_62ef5 796-fed9-4 | 1 |

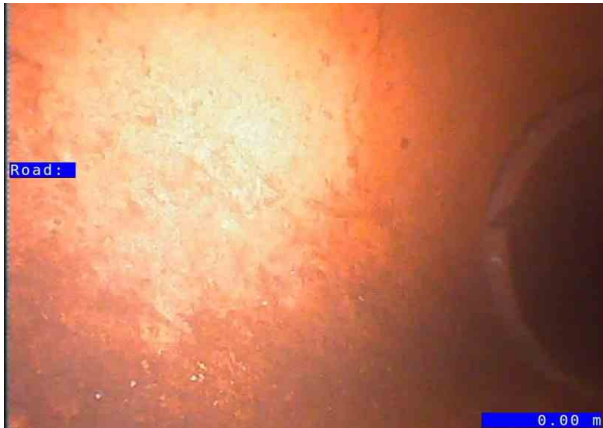
L2X\_5591add-9507-4a39-b0dd-ea5071f5684f\_20251202\_112105\_479.jpg, 00:00:09, 0.01 m  
Joint displaced, medium (between 1.0 and 1.5 times the pipe wall thickness), 12 o'clock to 12 o'clock

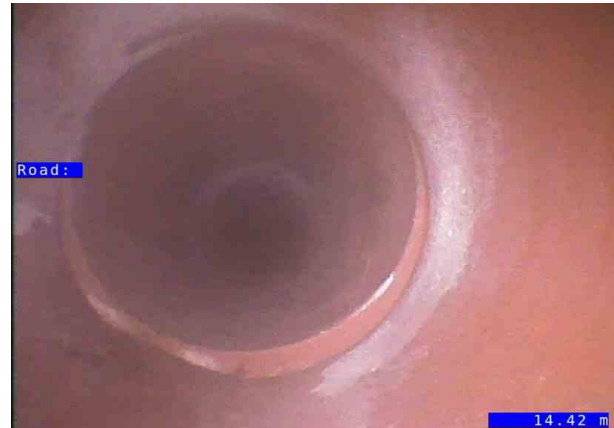
L2X\_32a28e5f-1132-4a24-84e6-579a690acda5\_20251202\_112337\_317.jpg, 00:01:52, 14.42 m  
Joint displaced, medium (between 1.0 and 1.5 times the pipe wall thickness), 3 o'clock to 9 o'clock

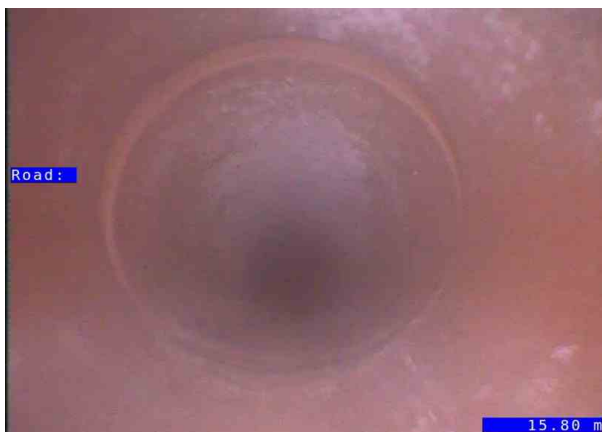
L2X\_4f31c3a5-ae38-4c2a-a94d-4b54eaf4b7cc\_20251202\_112430\_173.jpg, 00:02:03, 15.80 m  
Joint displaced, medium (between 1.0 and 1.5 times the pipe wall thickness), 8 o'clock to 2 o'clock

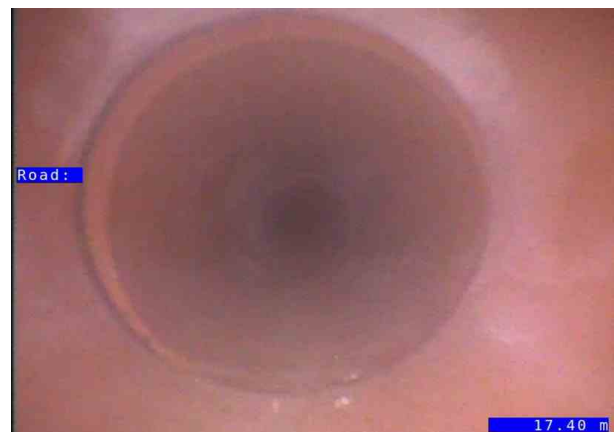
L2X\_e70af9f8-0e39-4ae4-8797-9795091f6584\_20251202\_112458\_731.jpg, 00:02:18, 17.40 m  
Joint displaced, medium (between 1.0 and 1.5 times the pipe wall thickness), 7 o'clock to 2 o'clock

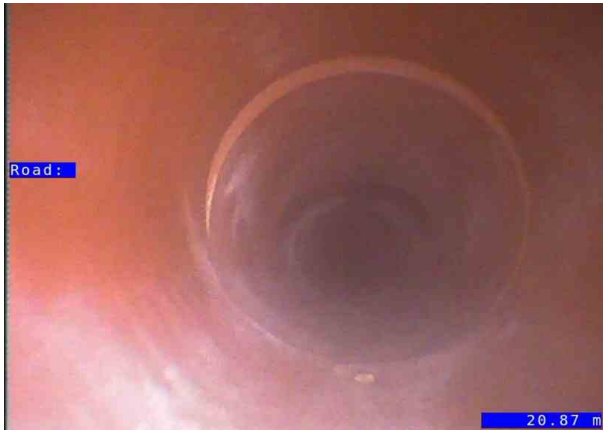
L2X\_6217cadd-cb9a-4392-b23f-86bce4c8741d\_20251202\_112528\_043.jpg, 00:02:44, 20.87 m  
Joint displaced, medium (between 1.0 and 1.5 times the pipe wall thickness), 9 o'clock to 2 o'clock

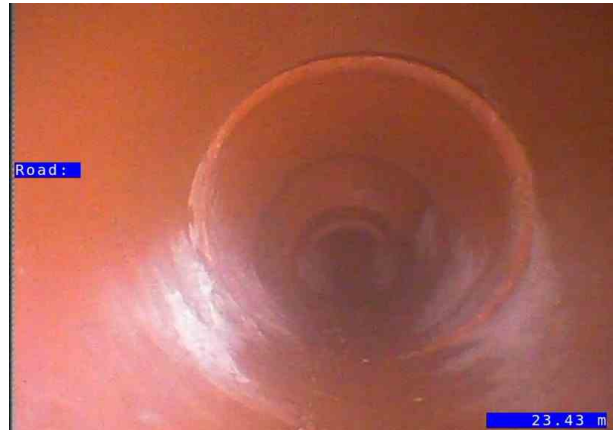
L2X\_bbc57da1-e6b6-4a01-a7d8-016d5efe7e10\_20251202\_112556\_754.jpg, 00:03:03, 23.45 m  
Joint displaced, medium (between 1.0 and 1.5 times the pipe wall thickness), 9 o'clock to 5 o'clock

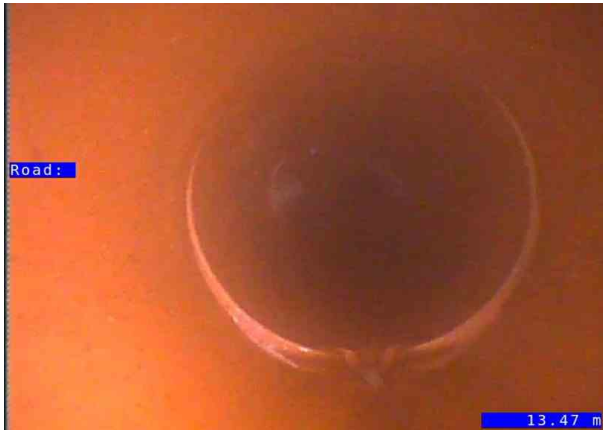
L2X\_da868ab9-626c-4fd3-9c97-dedc9a0f00ad\_20251202\_15  
2842\_019.jpg, 00:04:43, 13.50 m

Joint displaced, medium (between 1.0 and 1.5 times the pipe  
wall thickness), 3o'clock to 9o'clock - holding water

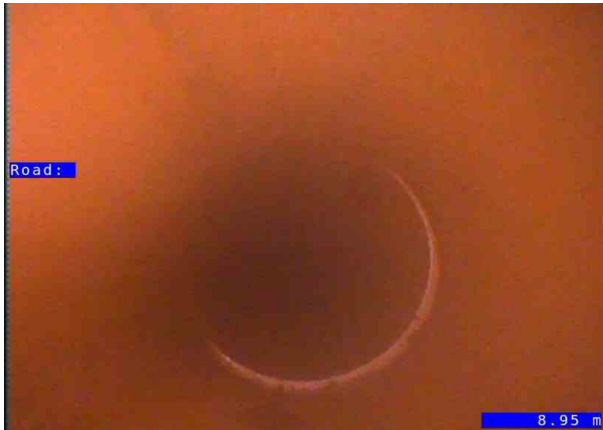
L1X\_42ed431c-066b-46db-bea2-ec67fe663b58\_20251203\_093441\_209.jpg, 00:00:31, 9.00 m

Joint displaced, medium (between 1.0 and 1.5 times the pipe wall thickness), 20 o'clock to 70 o'clock

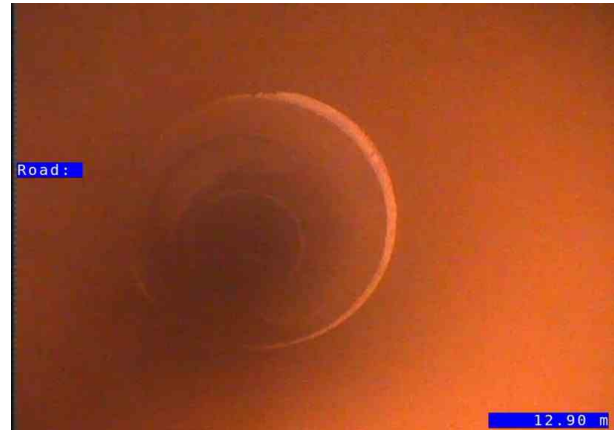
L1X\_b9322f9b-0427-46ba-9fd3-8f7b818f6670\_20251203\_100916\_835.jpg, 00:00:51, 12.90 m

Joint displaced, medium (between 1.0 and 1.5 times the pipe wall thickness), 120 o'clock to 50 o'clock

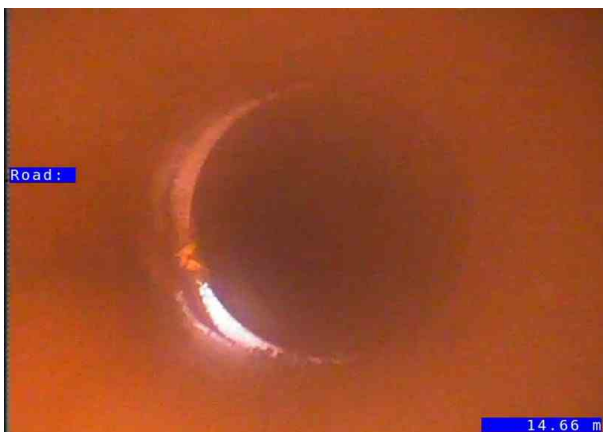
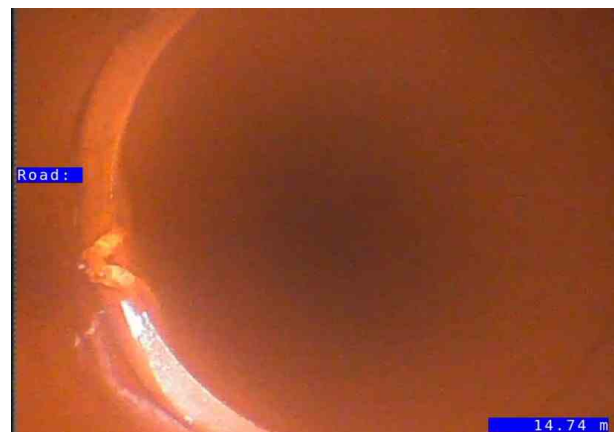
Joint displaced, medium (between 1.0 and 1.5 times the pipe wall thickness), 60 o'clock to 120 o'clock

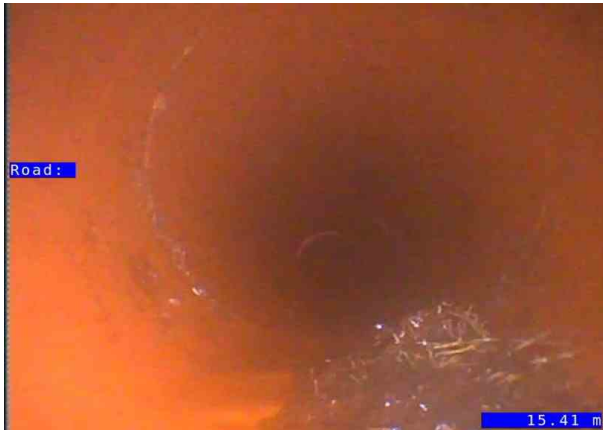
L1X\_b02ff920-bd43-486e-b3ea-0725554709fa\_20251203\_101406\_321.jpg, 00:03:20, 15.41 m  
Roots, mass

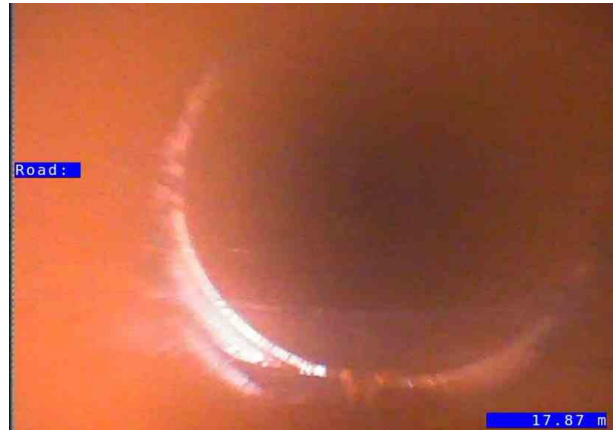
L1X\_721125ff-d591-4ad2-95dd-fe3bc46f417e\_20251203\_101449\_985.jpg, 00:03:45, 17.87 m  
Joint displaced, medium (between 1.0 and 1.5 times the pipe wall thickness), 30'clock to 90'clock

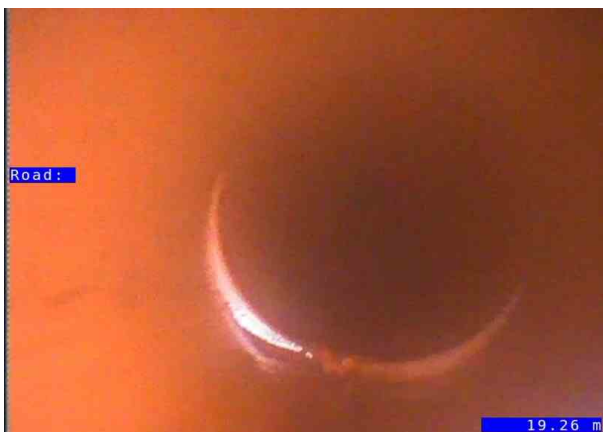
L1X\_d308e799-d1b7-4d62-94e4-5b8f10945b7e\_20251203\_101506\_401.jpg, 00:03:51, 19.26 m  
Joint displaced, medium (between 1.0 and 1.5 times the pipe wall thickness), 30'clock to 90'clock

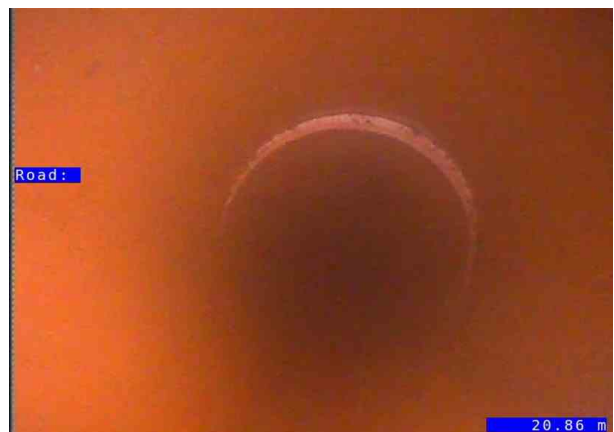
L1X\_f99854c1-b0e6-47cd-af4f-85c6c2cadd68\_20251203\_101730\_713.jpg, 00:03:58, 20.90 m  
Joint displaced, medium (between 1.0 and 1.5 times the pipe wall thickness), 100'clock to 30'clock

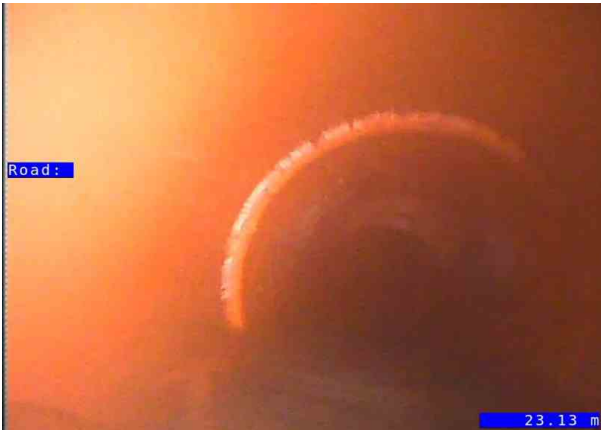
L1X\_b175e77a-fc63-4956-aef1-a945c9f5aa35\_20251203\_101  
822\_833.jpg, 00:04:11, 23.13 m

Joint displaced, medium (between 1.0 and 1.5 times the pipe wall thickness), Unable to see bottom of pipe due to water level

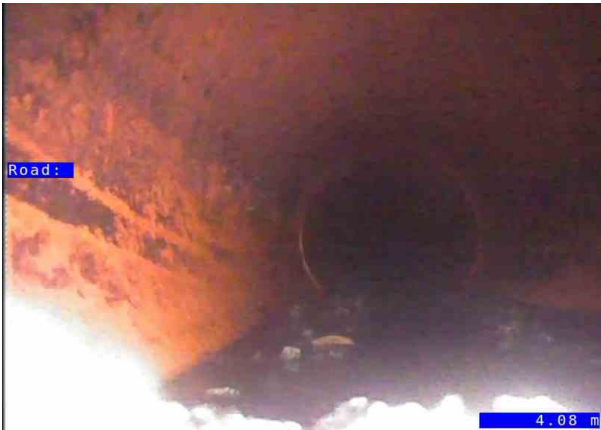
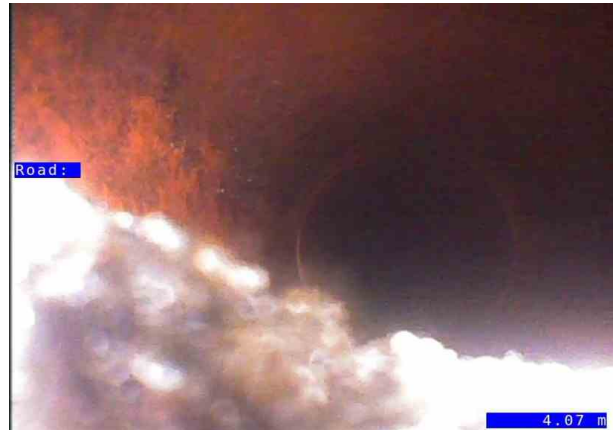
MH1X\_f6c90ccc-3df0-47e2-bb8e-0a9a94b9dba2\_20251203\_102836\_816.jpg, 00:00:39, 4.08 m  
Debris, other, start, Debris under water

MH1X\_9e8a9542-dfea-42e4-922d-90372e53fa8c\_20251203\_102839\_998.jpg, 00:00:39, 4.08 m  
Debris, other, start, Debris under water

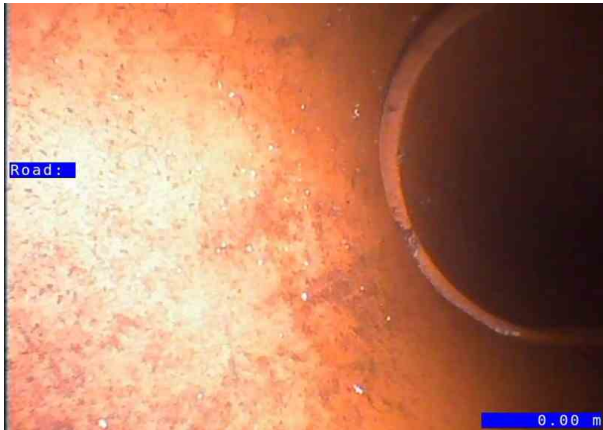
L1X\_91cd0ffd-4aeb-4ee4-8e12-1b3fc78f620e\_20251203\_103355\_573.jpg, 00:00:11, 0.00 m  
Joint displaced, medium (between 1.0 and 1.5 times the pipe wall thickness), 12o'clock to 12o'clock

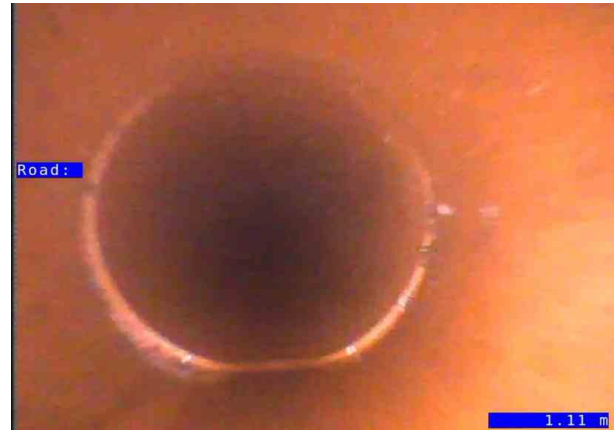
L1X\_49b09f59-0a70-4085-be3e-0f0e73be2d4a\_20251203\_103502\_780.jpg, 00:00:22, 1.11 m  
Joint displaced, medium (between 1.0 and 1.5 times the pipe wall thickness), 12o'clock to 12o'clock - holding small amount of water

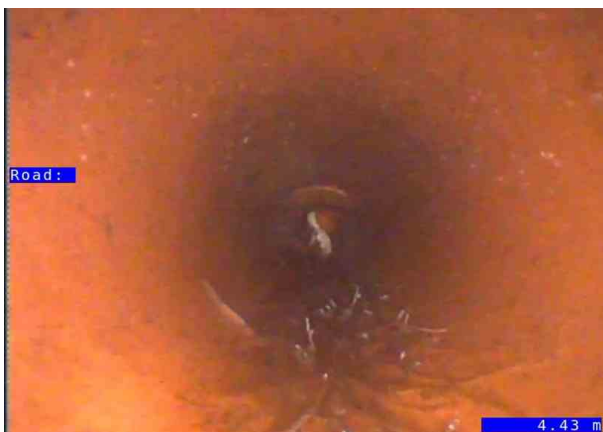
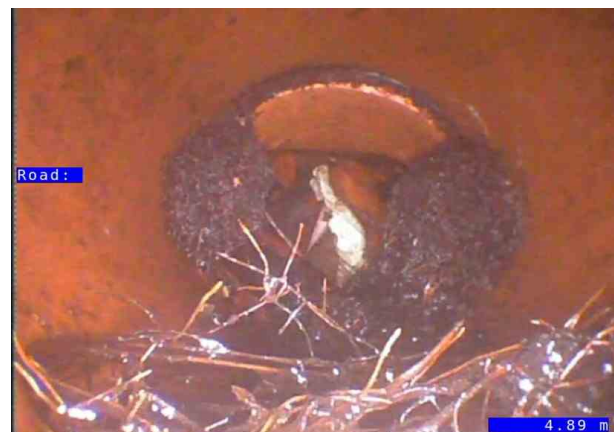
L1X\_90ed05bc-6bb5-47f5-abf9-fc47c3883b14\_20251203\_103532\_154.jpg, 00:00:35, 4.40 m  
Roots, fine, start

L1X\_44dce950-c832-45b2-8a14-0ba280d066b9\_20251203\_103539\_298.jpg, 00:00:35, 4.40 m  
Roots, fine, start

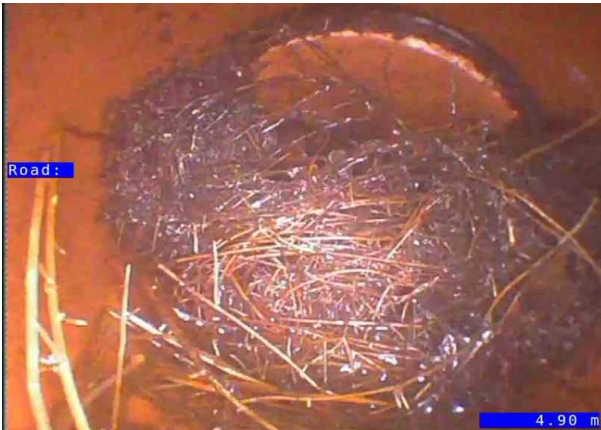
L1X\_e758e4d2-2c7b-48f3-9d0f-3f911f3826b9\_20251203\_103  
620\_377.jpg, 00:01:52, 4.90 m  
Survey abandoned, Line blocked with roots

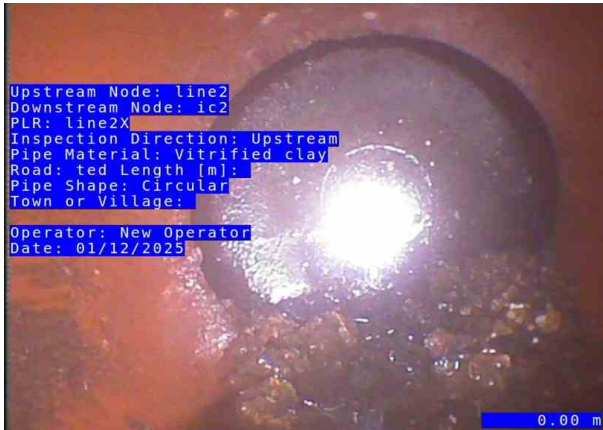
L2X\_985e198a-f455-4863-aa5c-804e329f2f49\_20251203\_103  
736\_583.jpg, 00:00:01, 0.00 m  
Debris, other, Stones

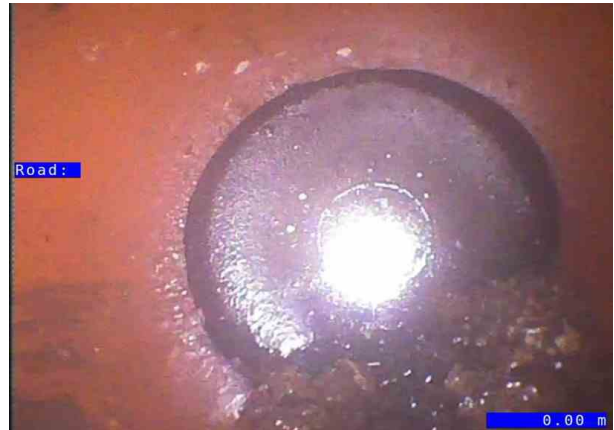
L2X\_c8be1bea-a494-48c5-9e11-209e96547c49\_20251203\_1  
03807\_670.jpg, 00:00:16, 0.10 m  
Survey abandoned, Capped off

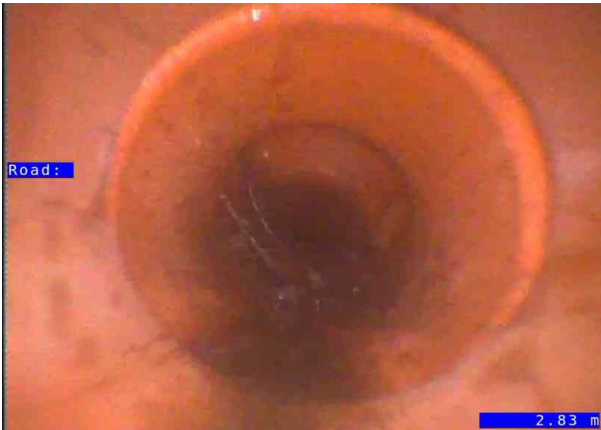
IC3X\_82ed8295-6d23-4c8a-8ef7-c8390ac38535\_20251203\_1  
03941\_949.jpg, 00:00:48, 2.85 m

Joint displaced, medium (between 1.0 and 1.5 times the pipe  
wall thickness), 9o'clock to 4o'clock

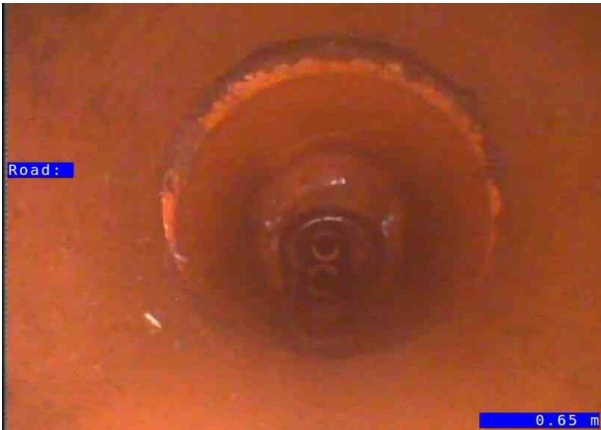
IC4X\_30f85ff1-7a89-44c2-b977-0775a0d9eb05\_20251203\_10  
4135\_427.jpg, 00:00:13, 0.70 m

Joint displaced, medium (between 1.0 and 1.5 times the pipe  
wall thickness), 9o'clock to 3o'clock

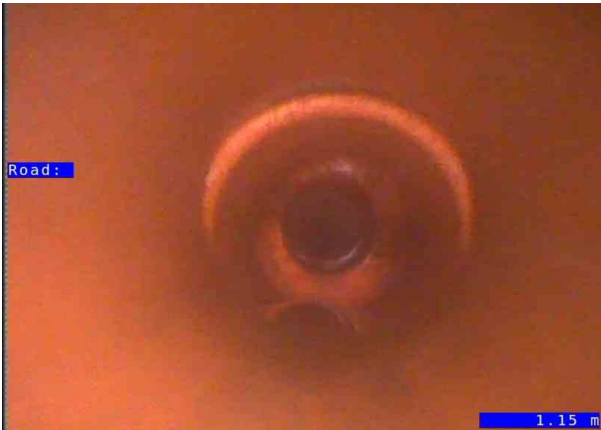
IC5X\_01aa612c-d973-4c11-ab89-89b7a1abc1d0\_20251203\_104330\_905.jpg, 00:00:17, 1.15 m

Joint displaced, medium (between 1.0 and 1.5 times the pipe wall thickness), 9o'clock to 3o'clock

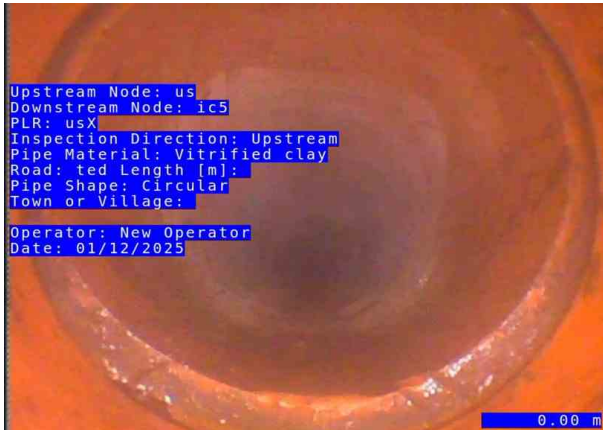
U\_SX\_d2b81afc-145b-409c-b27d-2755f2851e11\_20251203\_104420\_930.jpg, 00:00:01, 0.00 m  
Joint displaced, large (over 1.5 times the pipe wall thickness), 12 o'clock to 12 o'clock

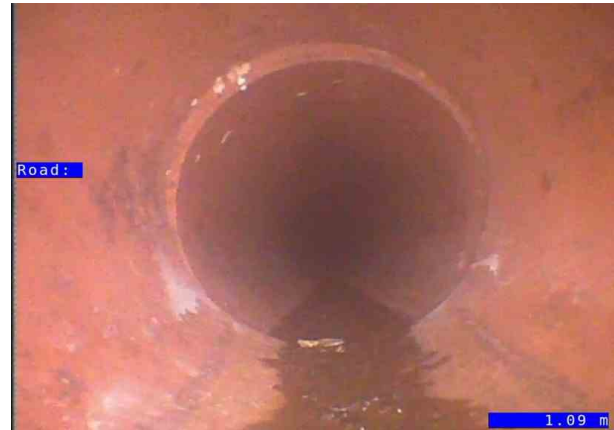
U\_SX\_1315d83b-f9db-4ddf-9afc-24fe433f1d7b\_20251203\_104456\_834.jpg, 00:00:17, 1.09 m  
Joint displaced, medium (between 1.0 and 1.5 times the pipe wall thickness), 9 o'clock to 2 o'clock

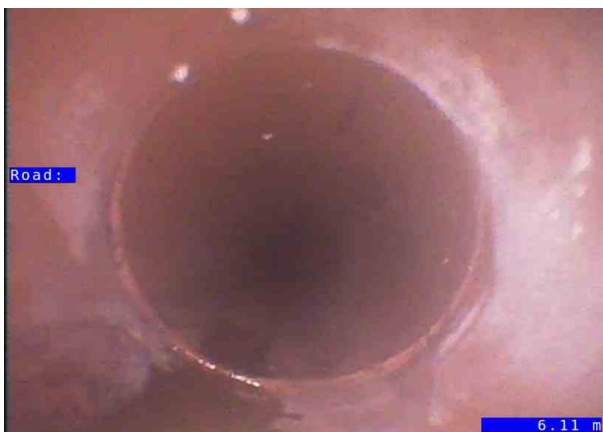
U\_SX\_9ef3008b-2c02-4a29-81b4-5271e2ca8f5d\_20251203\_104541\_449.jpg, 00:00:38, 6.11 m  
Joint displaced, medium (between 1.0 and 1.5 times the pipe wall thickness), 4 o'clock to 9 o'clock

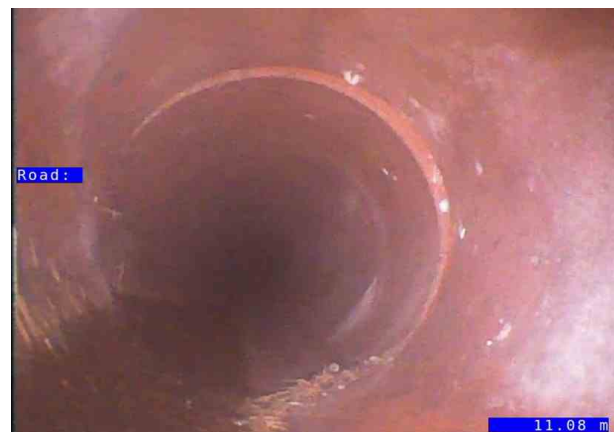
U\_SX\_536b1336-2e10-4062-bdfd-c81599bc85a0\_20251203\_104624\_873.jpg, 00:00:58, 11.08 m  
Roots, mass

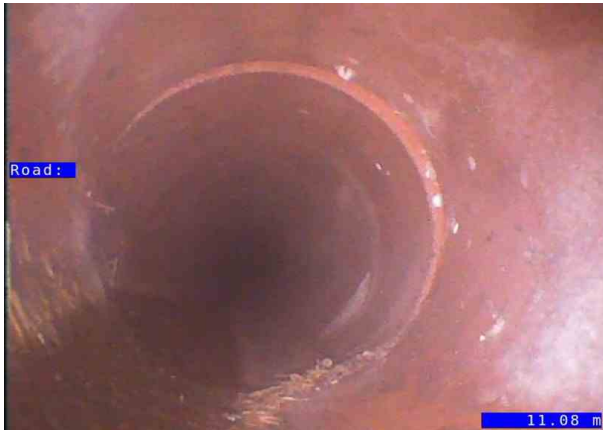
U\_SX\_ee523dcc-4451-43ba-9b95-2b1b84c7e0c2\_20251203\_104645\_232.jpg, 00:00:58, 11.10 m  
Joint displaced, medium (between 1.0 and 1.5 times the pipe wall thickness), 9 o'clock to 1 o'clock

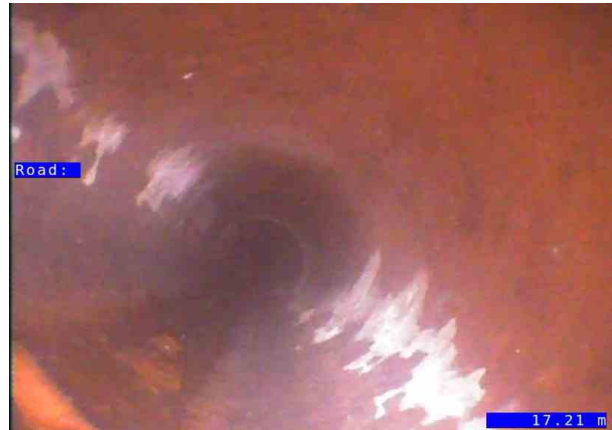
U\_SX\_e23aac85-f3d1-46a8-9421-e4ee960dc4db\_20251203\_104740\_961.jpg, 00:01:29, 17.21 m  
Debris, other, start, Stones / Debris

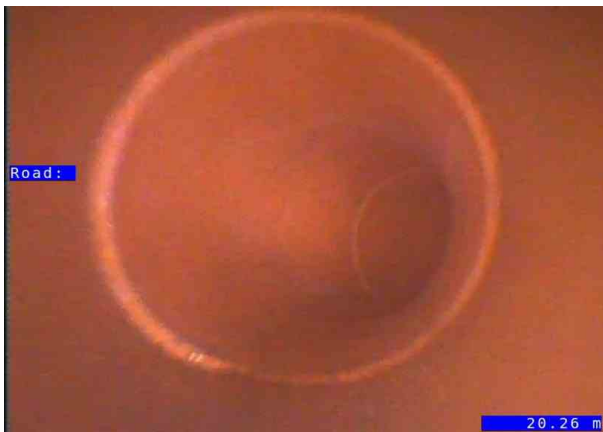
U\_SX\_9328f0eb-69a5-490c-afde-69c3e01f9e95\_20251203\_104849\_191.jpg, 00:01:49, 20.26 m  
Joint displaced, medium (between 1.0 and 1.5 times the pipe wall thickness), 12 o'clock to 12 o'clock

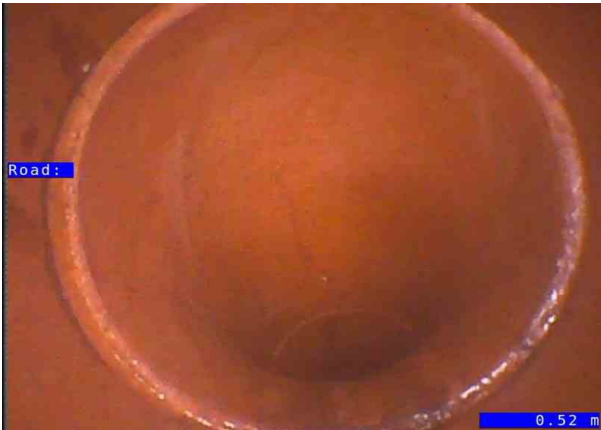
SVP5X\_452a1ebd-3a23-437b-bb96-91026f0dcb45\_20251203\_105505\_037.jpg, 00:00:10, 0.52 m

Joint displaced, medium (between 1.0 and 1.5 times the pipe wall thickness), 12o'clock to 12o'clock

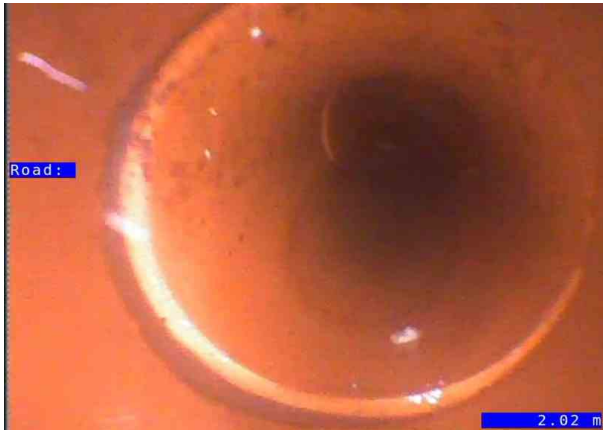
SVP4X\_66a6968e-d7a4-4fe5-8506-9ba4780cf1a8\_20251203\_134551\_244.jpg, 00:00:20, 2.02 m  
Joint displaced, medium (between 1.0 and 1.5 times the pipe wall thickness), 4 o'clock to 12 o'clock

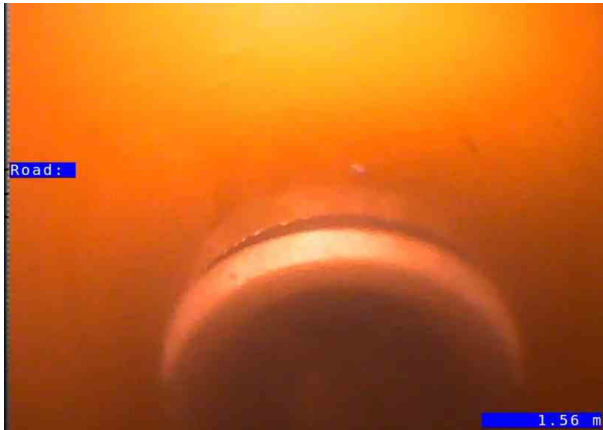
SVP3X\_9a0b19a9-f58c-4638-9b3e-c137b5c45634\_20251203\_134912\_322.jpg, 00:00:23, 1.56 m  
Joint displaced, large (over 1.5 times the pipe wall tickness), 9o'clock to 3o'clock

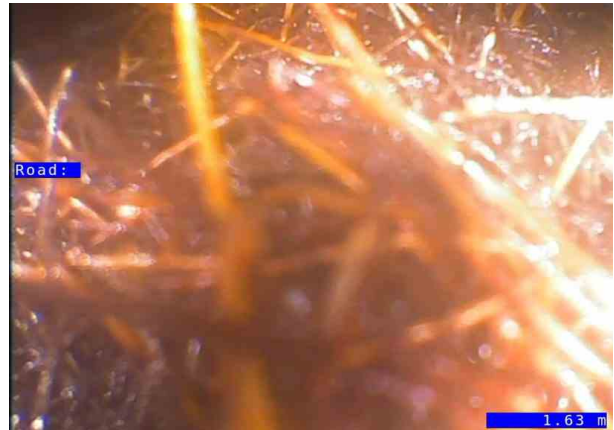
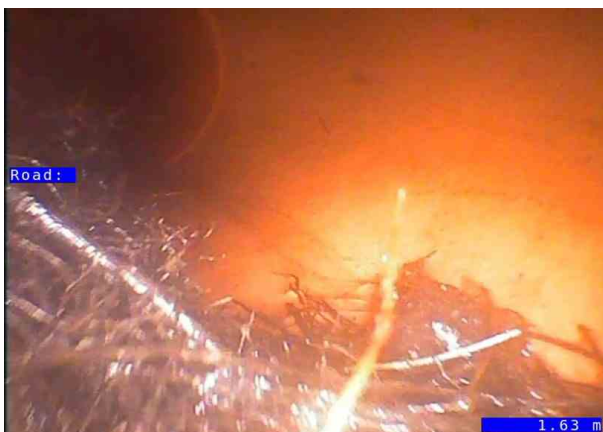
SVP3X\_059e008b-1e4f-41e2-8482-a12eb390e000\_20251203\_135010\_539.jpg, 00:00:29, 1.63 m  
Roots, mass

SVP3X\_2227dab0-1200-43ac-9585-9b920f58c9b1\_20251203\_135043\_002.jpg, 00:00:29, 1.63 m  
Roots, mass

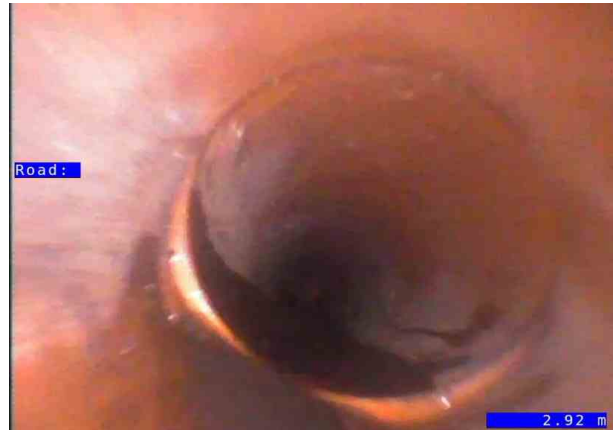
RGY2X\_d6becfc0-1a68-459f-9370-b2ec6bb59780\_20251203\_153349\_746.jpg, 00:00:15, 2.92 m

Joint displaced, medium (between 1.0 and 1.5 times the pipe wall thickness), 3o'clock to 9o'clock - holding water

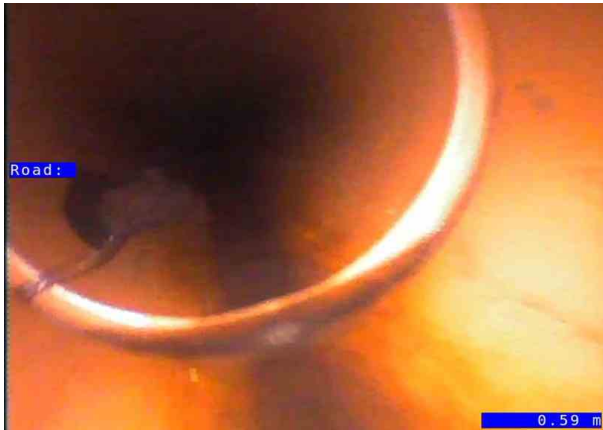
RGY3X\_fa14638b-8e7b-4073-b8aa-469931047013\_20251203\_153922\_867.jpg, 00:00:07, 0.60 m  
Joint displaced, medium (between 1.0 and 1.5 times the pipe wall thickness), 12o'clock to 12o'clock

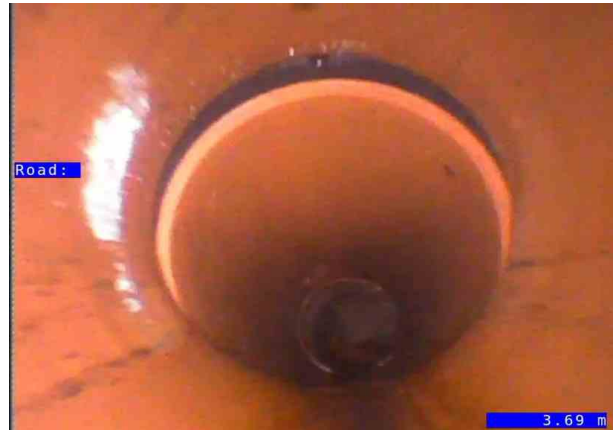
RGY3X\_b3cc2459-c923-4239-9af6-311d4437dfce\_20251203\_154005\_866.jpg, 00:00:18, 3.70 m  
Joint displaced, medium (between 1.0 and 1.5 times the pipe wall thickness), 8o'clock to 3o'clock

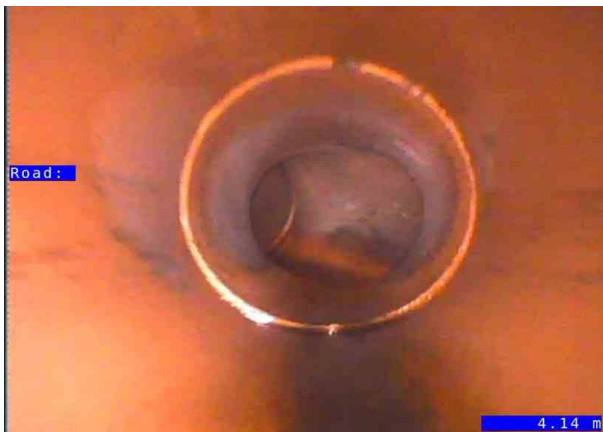
RGY3X\_446cb528-bb39-4c6f-bd47-20cc33bca0bf\_20251203\_154050\_634.jpg, 00:00:19, 4.15 m  
Joint displaced, medium (between 1.0 and 1.5 times the pipe wall thickness), 12o'clock to 12o'clock

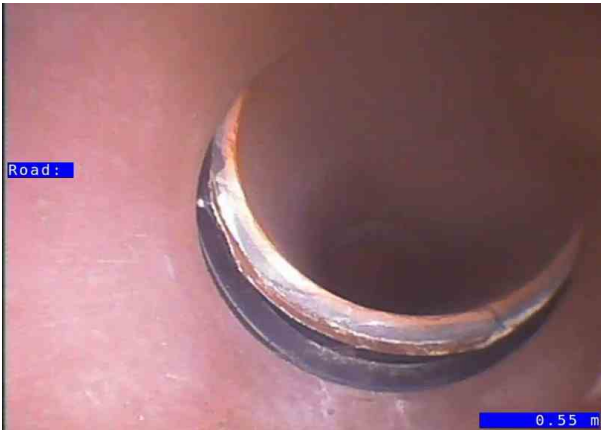
L1X\_d6080f05-9855-4189-83b4-fd962dc0b6a8\_20251203\_15  
4617\_625.jpg, 00:00:09, 0.55 m

Joint displaced, large (over 1.5 times the pipe wall tickness),  
3o'clock to 9o'clock

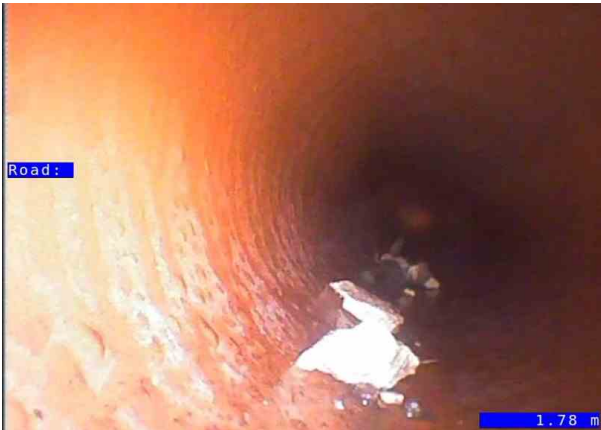
L2X\_864d693f-5394-49b7-8795-e8f0b3c6c3bd\_20251203\_15  
5459\_486.jpg, 00:00:37, 1.78 m  
Debris, other, start, Stones / Debris
