Application for Listed Building Consent –  
Supporting Statement

6-14a Oxford Road,  
Manchester M1 5QA

Prepared by: Delwyn Jones BSc (Hons) MRICS  
Rheith Limited  
Date: 05 February 2026  
Reference: 128507-101

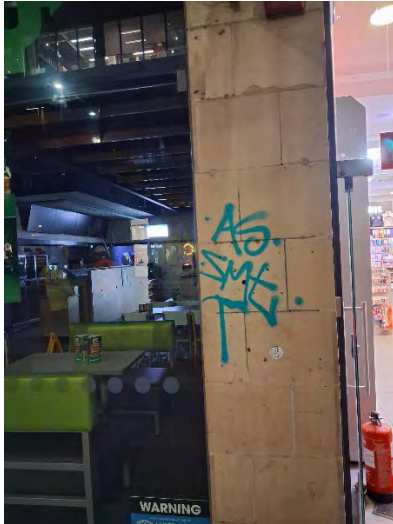
Instances of spray or pen applied graffiti marking to the mid and lower sections of terracotta pilasters at street level is an intermittent but reoccurring issue.

The issue is currently part managed through a call off contract with a specialist contractor. However, work undertaken on a 'responsive' basis cannot always achieve an optimal outcome in terms of removal of the marking and/or reinstatement of the surface barrier coating which is relied upon to mitigate against the penetration of paint/marker in the event of subsequent instances of graffiti in the same location.

The adopted strategy is one of reviewing levels of removal of marking/shadowing on the face of the terracotta and of reinstating barrier coating protection under more controlled conditions as part of the programme of cyclical maintenance activity.

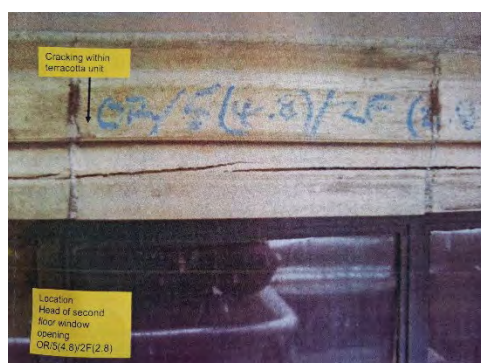
Interventions involving the breakout of original terracotta units followed by reinstatement adopting matching, new, terracotta units arise where cracking and displacement of the terracotta has occurred in consequence of the expansive corrosion of the embedded steel frame.

The adopted strategy is one of localised intervention with terracotta features reinstated in matching terracotta following treatment of the embedded steelwork, in addition to addressing potential sources of water entry which could account for localised corrosion of the embedded steelwork.

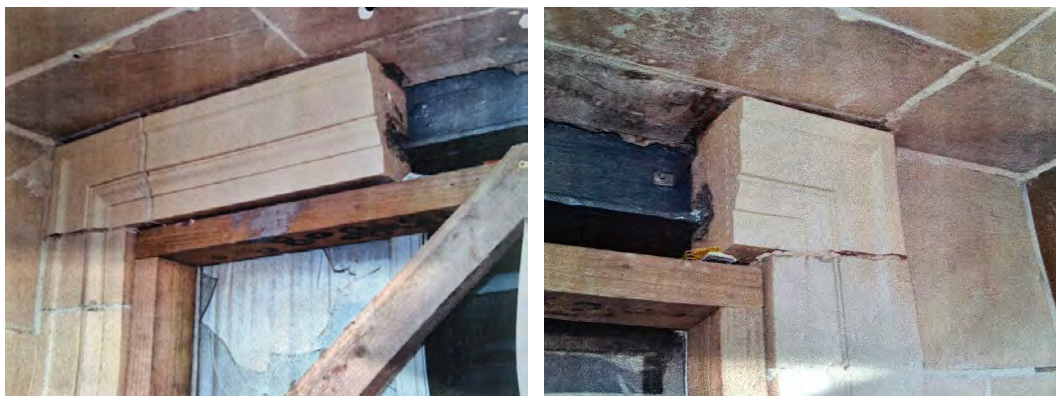
The following record photographs show the application of this approach to the repair of a defective window head detail of the nature shown above in this Section 4.3.

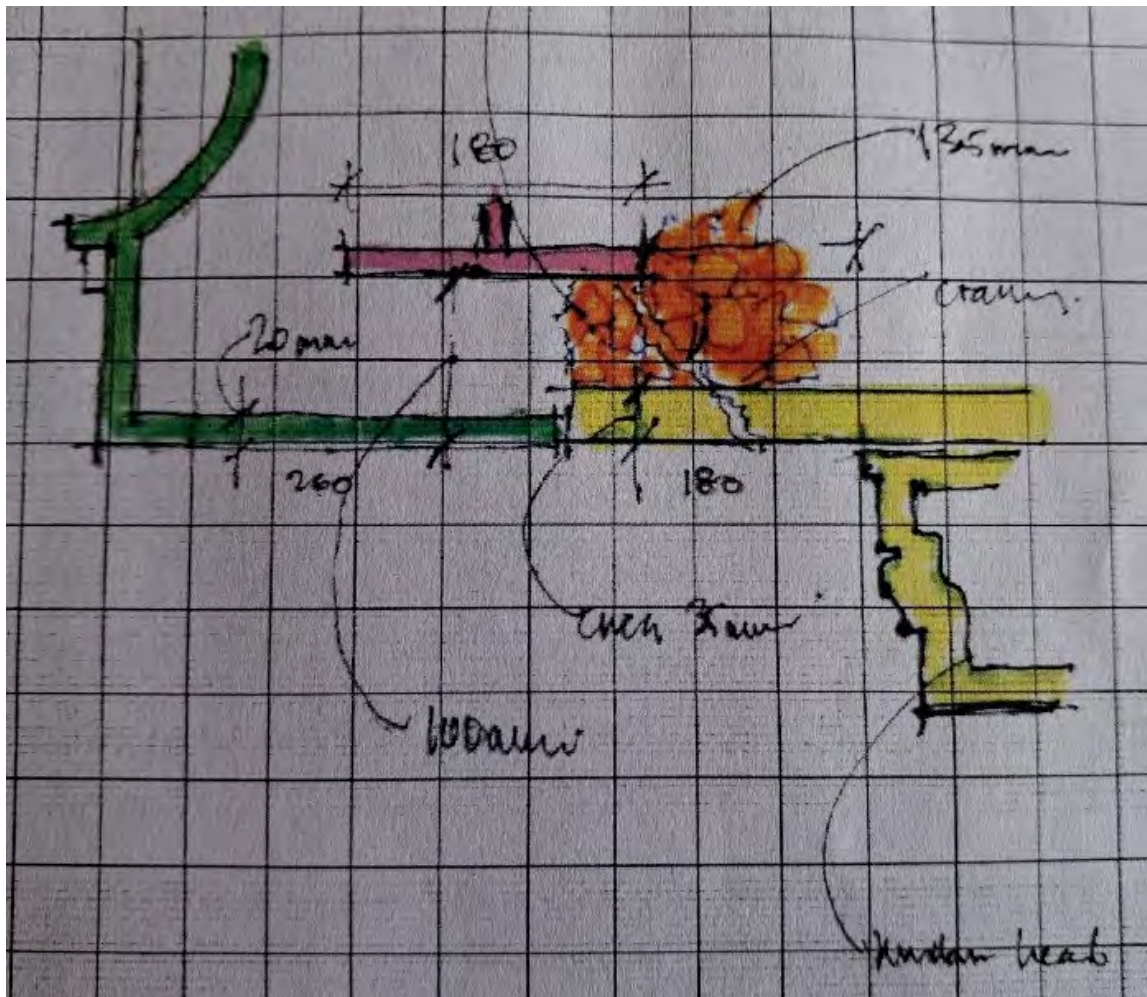
Records were taken of details of construction and condition at the location of the spall prior to making safe and temporary boarding over. A copy of a sketch cross section detail with graphic representation of the factors at play in the development of the defect is shown below. The mode of failure is exaggerated for the purpose of illustration.

In factual terms the key finding was that terracotta replacement undertaken circa 2000 had been partial and that the construction of the rearmost 200mm or so of the underside of the cornice (viewed from pavement level) to this section of the Oxford Road frontage of the building remained original, that is steelwork remained encased with the original 1930's concrete infill, with a terracotta 'shell' completing the soffit detail. It could be seen that concrete which originally would have encased the remainder of steelwork support to the cornice had been removed (presumably as part of the circa 2000 interventions) and a paint coating subsequently applied to the then newly exposed steelwork, likely with the objective of reinstating corrosion protection.

The mode of failure resulting in the initiation of a spall in the remaining terracotta to the soffit of the cornice was identified as corrosion of the supporting steelwork beyond the boundary of the interventions undertaken circa 2000 with the associated expansive outward pressure resulting in cracking and displacement of the surrounding concrete encasement and, in turn, attached terracotta.

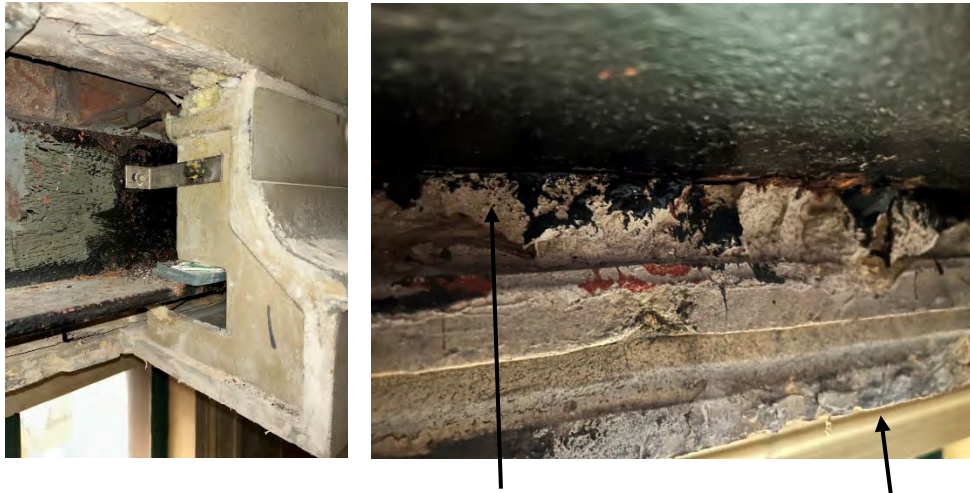
The mixed findings of the February 2025 intrusive investigations in respect of the cornice detail to the Chester Street elevation of the building were considered insufficient to provide a high level of confidence surrounding detailed design development for necessary remedial works. A further set of intrusive investigations, this time in respect of a section of the Oxford Road section of the cornice, were organised for the Summer of 2025. The purpose of those future investigations would be to gather additional data on condition, establish the extent to which construction details were consistent (and conversely departed from a particular pattern) and gain greater insight as to critical dimensions within which a solution for reinstatement would need to be developed.

Underside of structural steelwork

Soffit of cornice

- removal of remaining defective concrete and terracotta encasement to the underside of the cornice (at the rear of the cornice soffit)
- passivation of accessible sections of steelwork immediately behind the cornice feature (and not exposed on completion of the intervention) against corrosion

- treatment of exposed sections of steelwork against corrosion
- replacement of fixings dating from circa 2000 corroded or potentially vulnerable to bi-metallic corrosion with robust measures introduced to protect against bi-metallic corrosion

- the introduction of supplemental steelwork to reduce reliance on the effectiveness of any new fixings to corroded sections of original 1930's steelwork

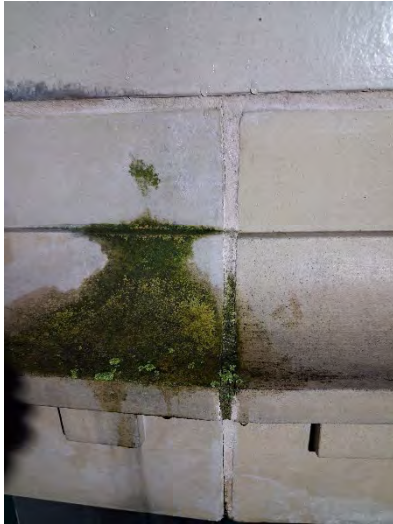
Joint treatment on the installation of replica GRC units circa 2000 was by means of the use of flexible sealant. The anticipated service life of such flexible sealant joints installed in 'ideal conditions' would rarely be in excess of 15 years. 'Ideal conditions' in this context takes in such factors as joint width relative to joint depth, the use of backing cord and the like. The limited thickness of the GRC mouldings presents a challenge in satisfying 'ideal conditions' and widespread failure of sealant joints between 'shell' of GRC mouldings installed circa 2000 were noted as having developed by 2011-2012. Traditional mortar has subsequently been adopted for repointing operations with greater success but, there is a compromise in that traditional mortar is unable to accommodate thermal and other movement within the GRC units. This can result in hairline movement cracking at joint locations.

In order to reduce the susceptibility of 'skyward facing' joints between adjacent GRC units to the penetration of water or moisture the requirement identified is one of a change in detailing to eliminate potential paths for the tracking of water into the construction cavity formed by the GRC mouldings, thereby bringing about a less humid environment surrounding encased steelwork.

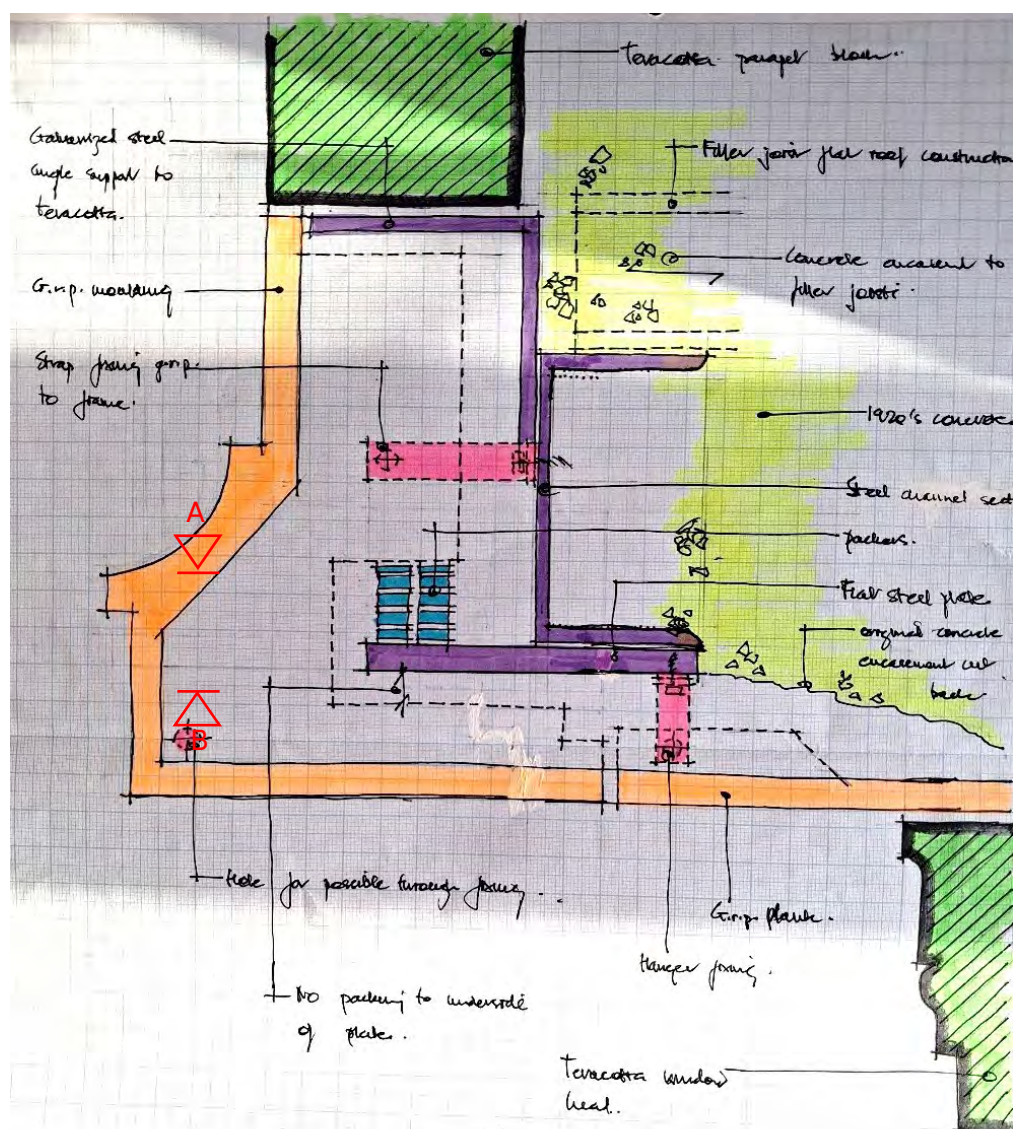
G-114A, OXFORD ROAD, MANCHESTER  
 INTENSIVE INVESTIGATIONS - PRINCIPAL CORNICES [CHURCH ST. LOCATIONS]  
 02.02.2025. UPDATES FOLLOWING FURTHER INVESTIGATIONS 08.02.2025  
 APPROX. HALF SCALE.

A cross section sketch of the make up of the existing cornice at this level (based on the findings of forward planning investigations) appears below. For the location in question it should be noted that the original terracotta to the rear of the underside of the cornice had been removed (one assumes as part of the interventions undertaken circa 2000) and detailing encountered in this specific location has seen the terracotta soffit filling reinstated adopting GRC units.

The key design constraint on the development of a solution for reinstatement in this location is the available dimension between the underside of the structural steelwork and the level of the underside of the cornice. This cryptical dimension is recorded at circa 85mm-100mm in locations where verified through intrusive investigation, but allowing for construction tolerances quite possible reduces to 70mm or less.

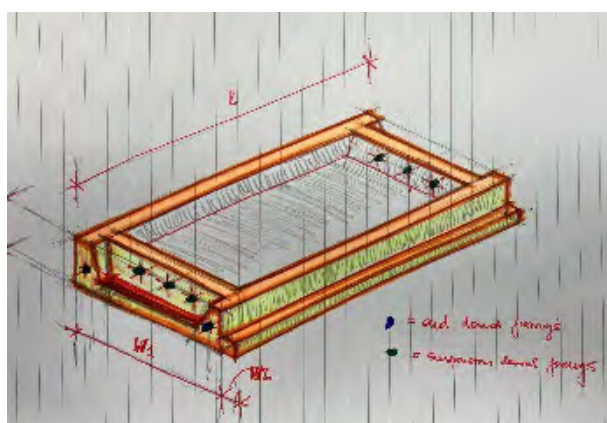
The preferred option explored was one of the adoption of bespoke terracotta 'soffit planks' suspended from the original steelwork. Discussions were held with Darwen Terracotta (a terracotta manufacturer with a history of past involvement with the building) to identify and develop (on paper) options utilising terracotta planks. A sketch detail of a possible solution appears below:

Unfortunately the studies identified that there was a high probability that the adoption of a solution based on the adoption of terracotta planks would not be feasible. The realisation was:

- that the thickness of terracotta tiles (with ribs to accommodate fixings) could not be reduce to a point which would accommodation a 70mm constraint on the total depth of the fixing/suspension system and tile thickness
- that a consequence of minimisation of the thickness/dimensions of terracotta units would be that it would not be feasible to undertake any further on site cutting/adjustments to accommodate departures in tolerances beyond those identified in sample locations already subject to forward planning checks.

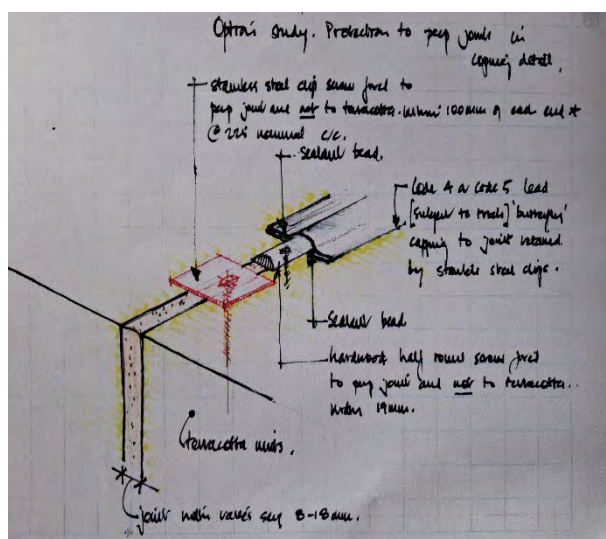
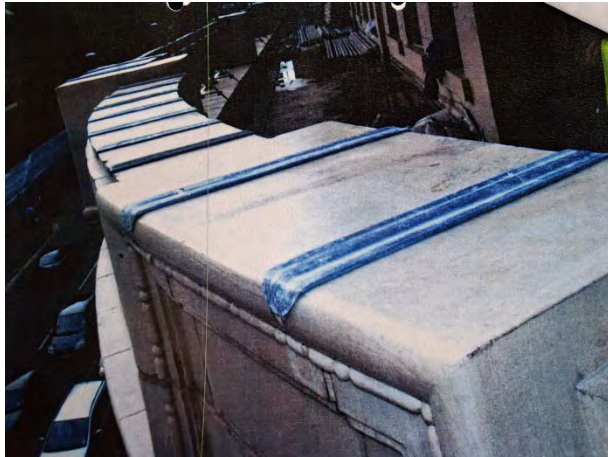
Below is a sketch of the design selection developed for the treatment of 'skyward' facing joints within the parapet capping together with a photo of the parapet, post installation.

The optimum solutions in this instance is identified as the adoption of raised profile lead 'tongues' at individual joint locations between GRC mouldings.

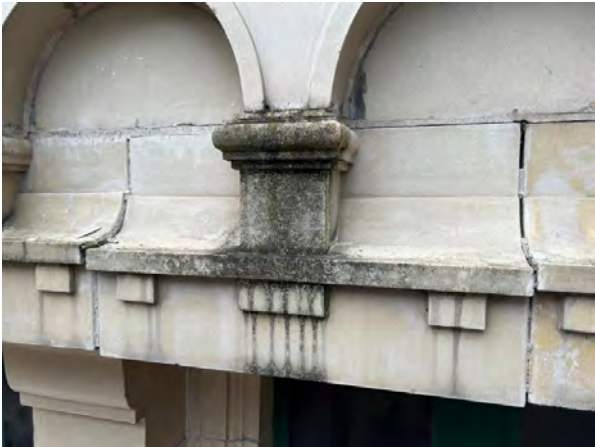
| Ref | Photo | Description |
|---|---|---|
| 1. | | <p>View of lower section of cornice.</p> <p>Form is a GRC moulding.</p> <p>Charles Street elevation between Grid Lines B and C.</p> |

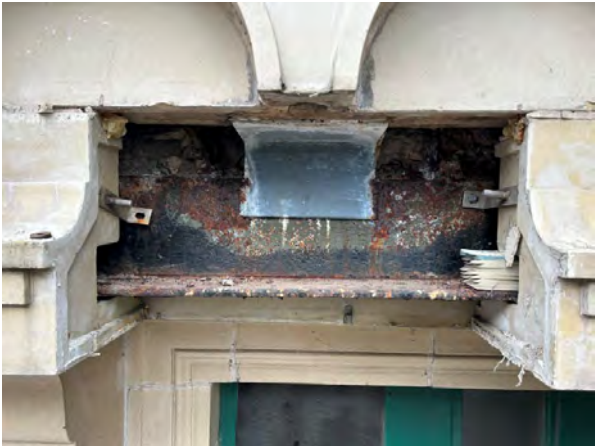
| Ref | Photo | Description |
|---|---|---|
| 2. | | <p>View of lower section of cornice following removal of GRC moulding.</p> <p>Note support bracket to terracotta units above GRC.</p> <p>Charles Street elevation between Grid Lines B and C.</p> |

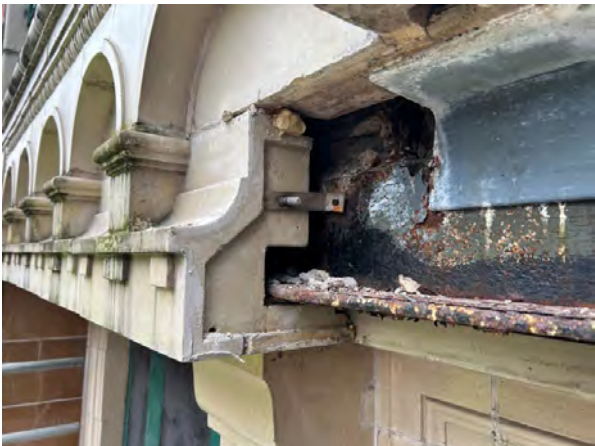
| Ref | Photo | Description |
|---|---|---|
| 3. | | <p>View of lower section of cornice following removal of GRC moulding.</p> <p>Note strap fixings to GRC moulding understood to date from circa 2000.</p> <p>Charles Street elevation between Grid Lines B and C.</p> |

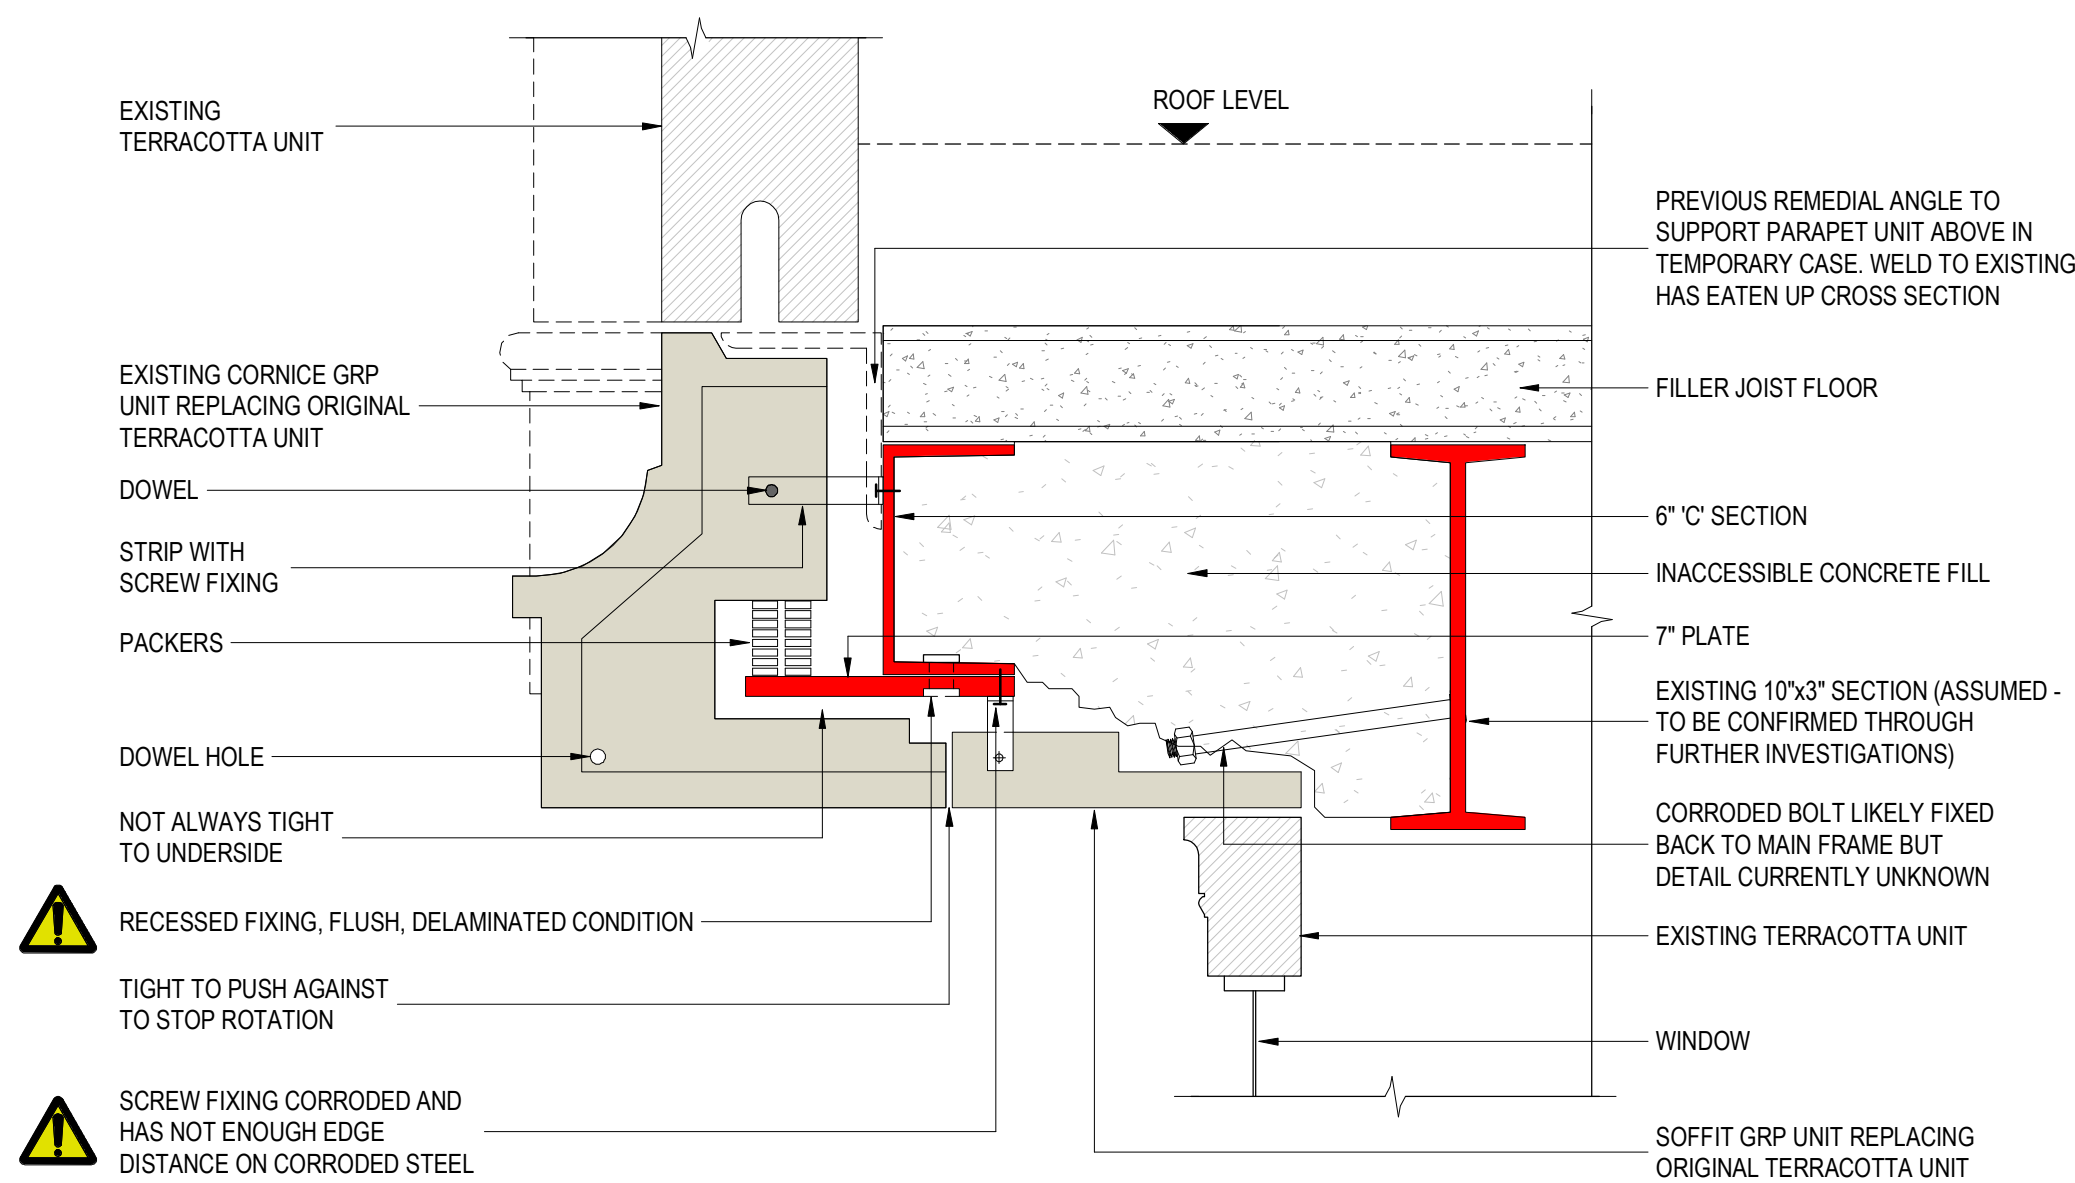
**DETAIL 1**  
**EXISTING CONDITION**  
SCALE: 1 : 5

REMOVE GALVANISED STEEL BRACKETS BY CUTTING INTO THE BRACKET AND NOT INTO THE CHANNEL SECTION. ANY REMAINING PIECES OF SECTION SHOULD THEN BE GROUND FROM THE SURFACE - NOTE THAT THIS NEEDS TO BE DONE VERY CAREFULLY TO AVOID FURTHER DAMAGE AS THE EXISTING WELD HAS CONSUMED SOME OF THE EXISTING CHANNEL CROSS SECTION

REMOVE CORNICE UNITS AND ASSOCIATED FIXINGS AND PACKERS

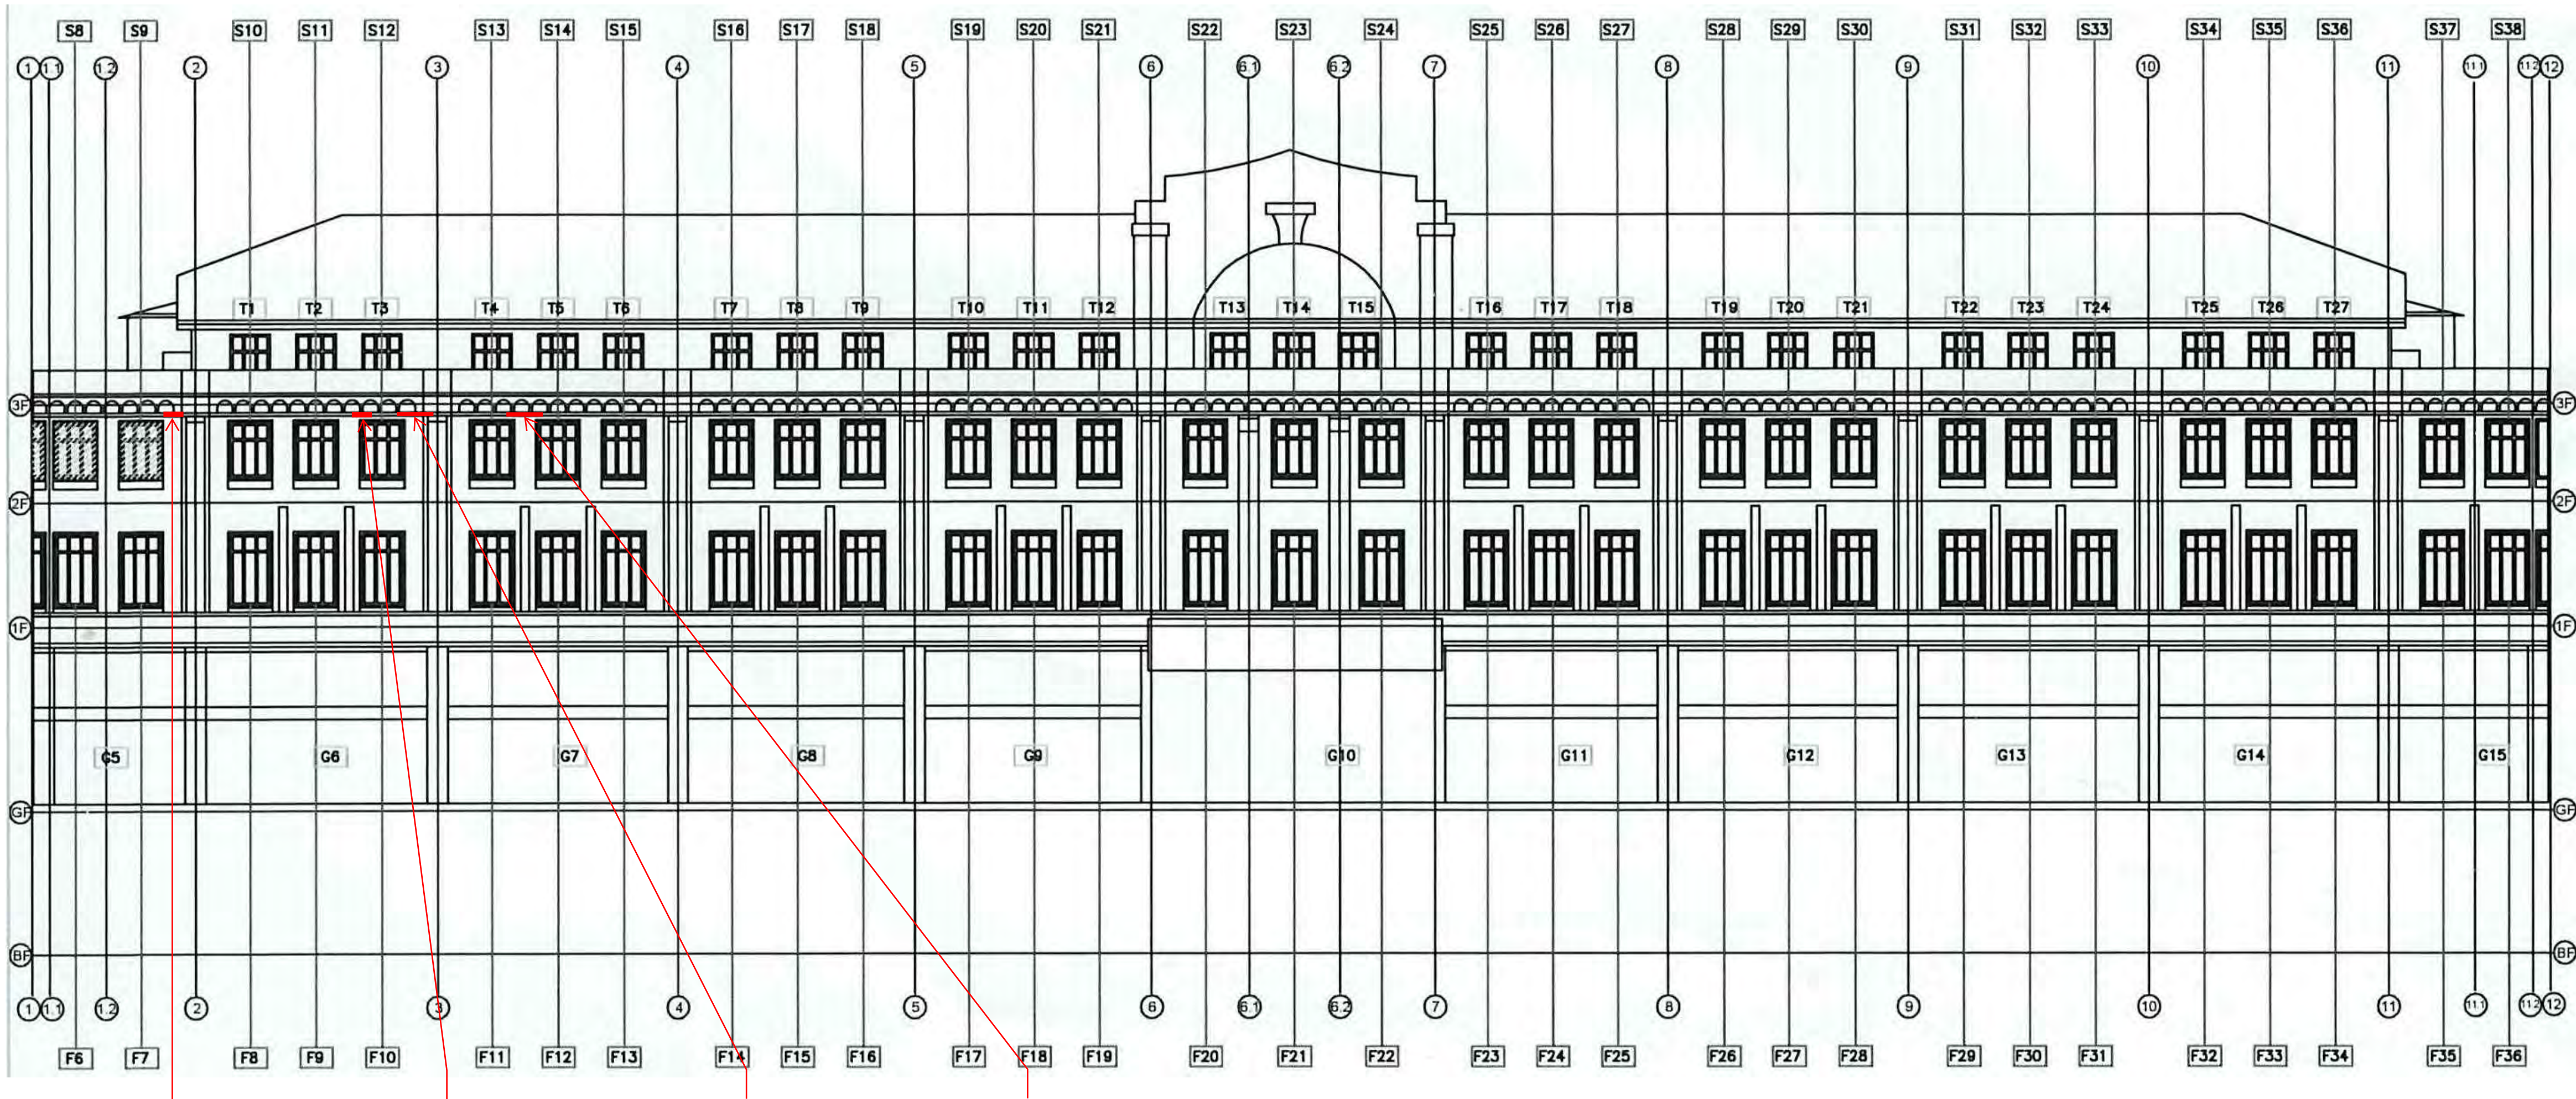
OR / 2 / 3F  
CURVED ELEVATION.  
INVESTIGATE CORNICE BEAM BEARING  
AND CONNECTION TO COLUMN FROM  
OUTSIDE FACE BY REMOVING THE  
UNITS ADJACENT TO CONNECTION.

OR / 3 (-2m) / 3F  
INVESTIGATE CONDITION OF  
STEEL AROUND THIS LOCATION  
AND CHECK FOR T RESTRAINT  
ANGLES TO ESTABLISH CENTERS

OR / 3 (2.5m) / 3F  
INVESTIGATE CONDITION OF  
STEEL AROUND THIS LOCATION  
AND CHECK FOR T RESTRAINT  
ANGLES TO ESTABLISH CENTERS

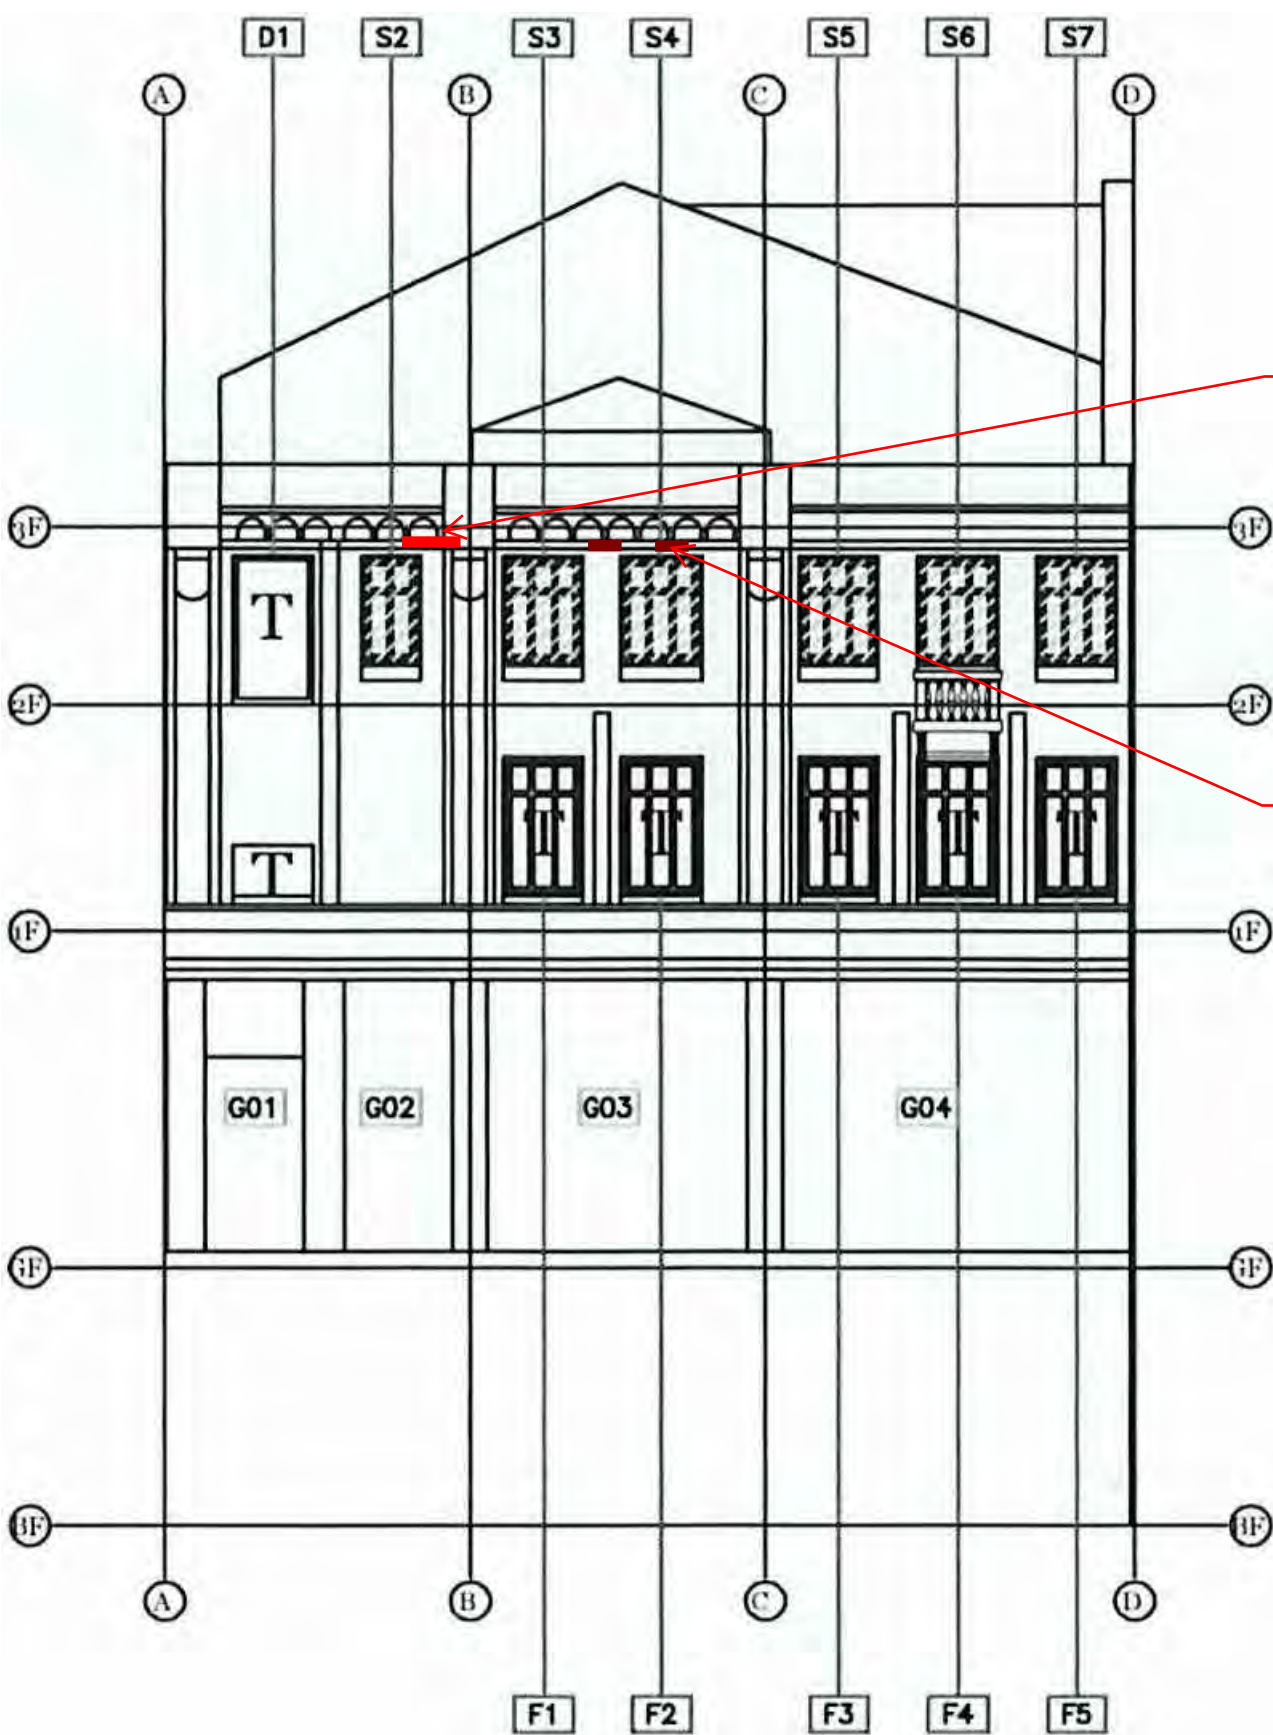
CS / B / 3F  
INVESTIGATE CORNICE BEAM BEARING  
AND CONNECTION TO COLUMN FROM  
OUTSIDE FACE BY REMOVING THE UNITS  
ADJACENT TO CONNECTION. ALSO  
CHECK CONDITION OF STEEL.  
AT THIS LOCATION UNCOVER THE  
RELATIONSHIP BETWEEN THE INTERNAL  
PRIMARY BEAMS AND THE OUTER  
CORNICE CHANNEL SECTION. THIS  
NEEDS TO INCLUDE SECTION SIZES,  
DIMENSIONS BETWEEN BEAMS AND  
ARRANGEMENT WITH ANY CONNECTIONS

INVESTIGATION UNDERTAKEN BEGINNING  
OF FEBRUARY 2025 AND RECORDED IN  
SURVEY RECORD DRAWING
