## IKO CONDITION SURVEY REPORT Brunswick Mill / 4 Jun 2025

| <b>Project Name</b> | Brunswick Mill |
| <b>Client Brief</b><br>Contractor looking to appraise existing roof coverings in order to determine a remedial specification for the areas identified | |

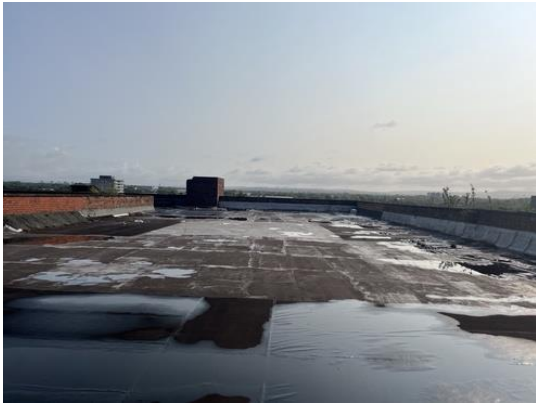
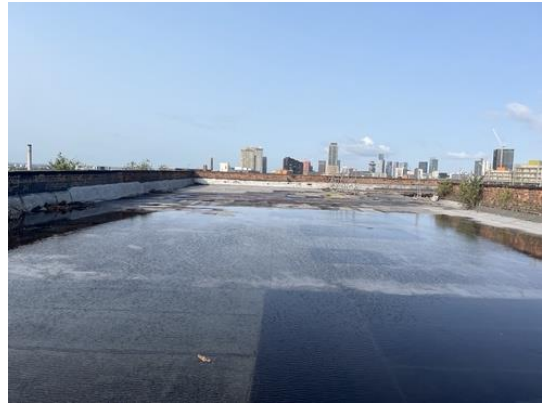
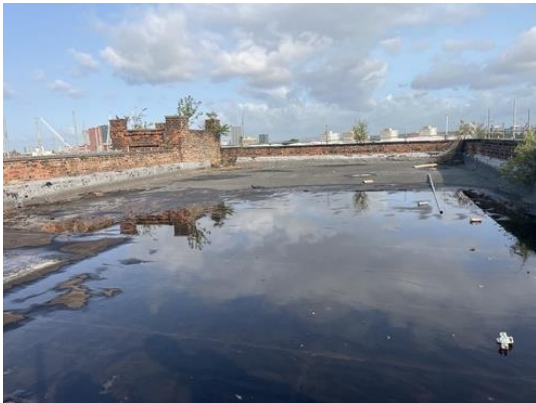
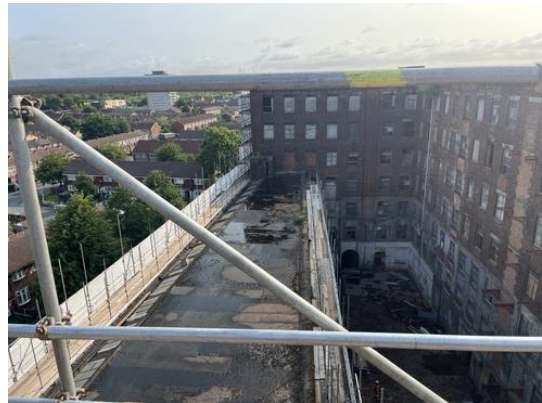
General overview images of the areas assessed during attendance, the existing waterproofing systems are a combination of the original asphalt waterproofing that is in excess of 35 years or more and a bitumen membrane, applied as remedial repairs to the asphalt substrate, the areas are at the end of their serviceable lifespan and any relevant guarantee period so should be considered for upgrade as part of the wider site refurbishment and redevelopment.

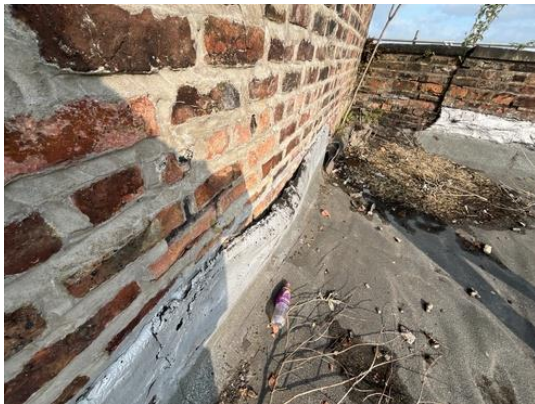
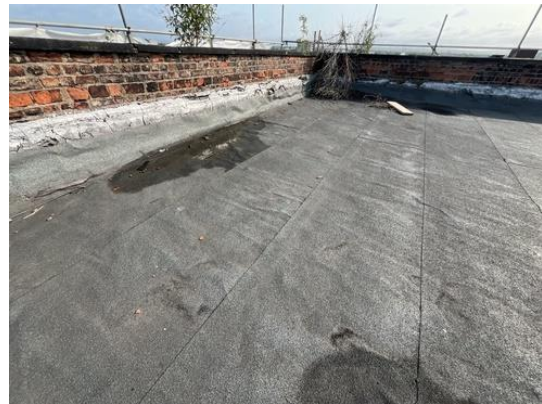
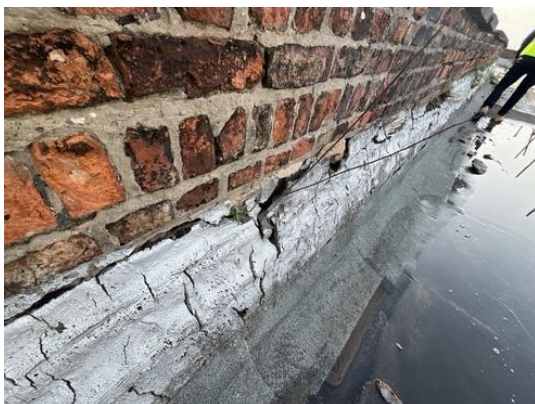
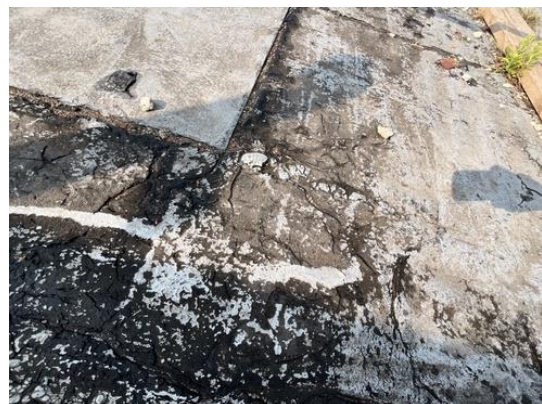
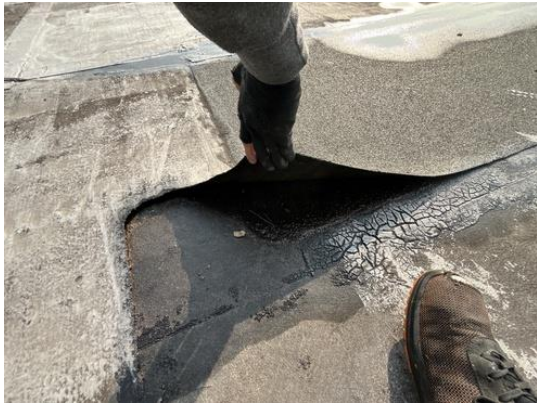
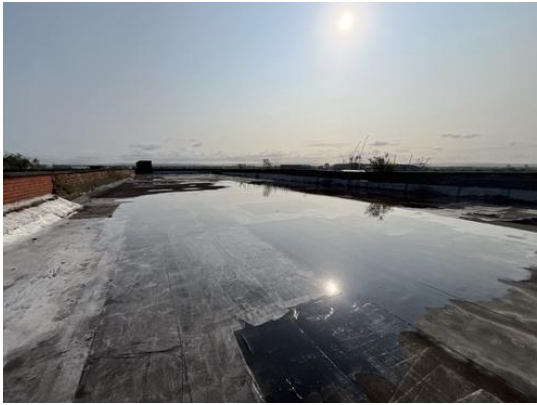
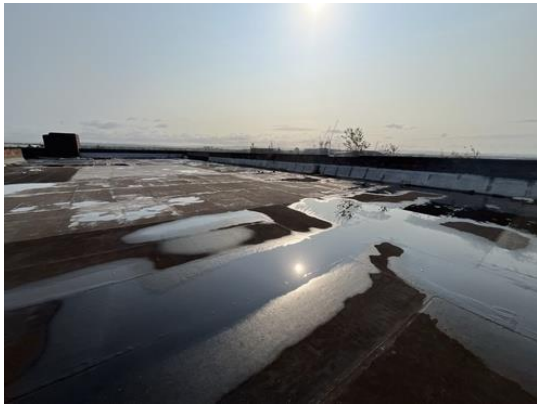
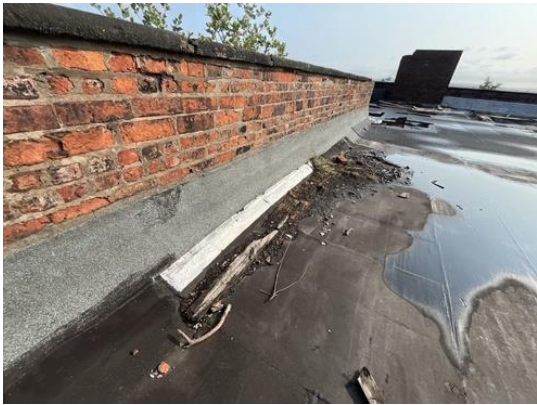
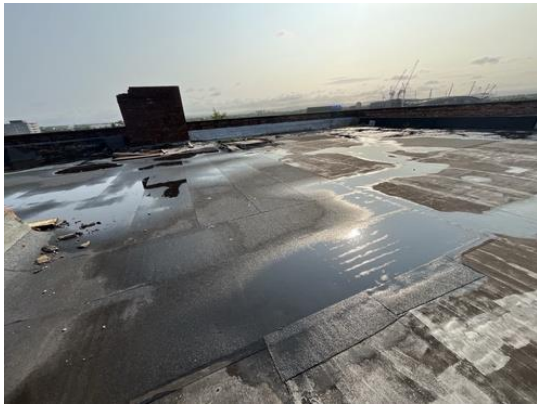
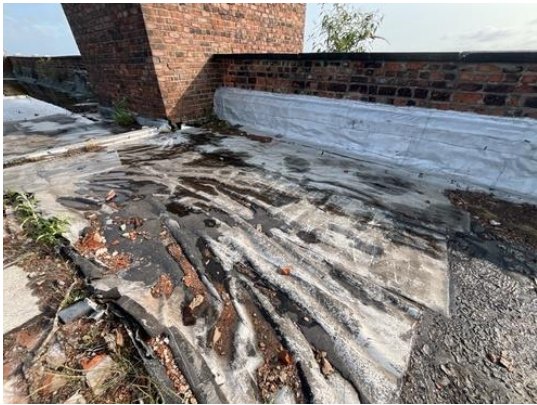
As highlighted the existing asphalt waterproofing and associated details is age deteriorated and failed so should be considered for upgrade.

- Delamination of asphalt waterproofing to perimeter upstands due to age and reduction of bond strength from the substrate, as such the leading edge is wide open allowing wind driven rainwater and draining surface rainwater to enter at the rear of the waterproofing.

- Creasing within the bitumen membrane applied as repairs, associated with poor quality preparation, lack of heat applied and or water penetration through side and head lap joints of the repairs that are able to penetrate cracks within the asphalt layer.

- Split, cracked and open sections of the original asphalt waterproofing, solar coatings have deteriorated through erosion under standing water or due to inability to re-apply, as such the asphalt layer has been subject to uneven expansion and contraction through weather cycles causing splits that can allow water penetration.

- Weak, partially open and open lap joints within bitumen felt repairs applied to the surface of the asphalt waterproofing due to age of the original system, the felt repairs have been installed to prevent water ingress through the asphalt, which do not appear to be a sufficient repair to prevent ingress.

- Creasing and blistering within the asphalt layer, can be associated with uneven expansion and contraction of the substrate, allowing delamination from the screed layer, over time these items are able to expand in warmer climates, rupturing the asphalt waterproofing allowing ingress.

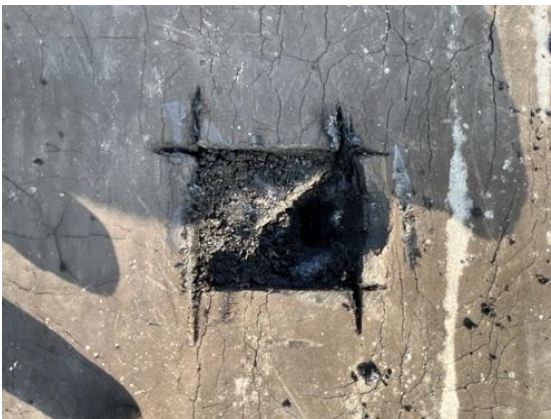
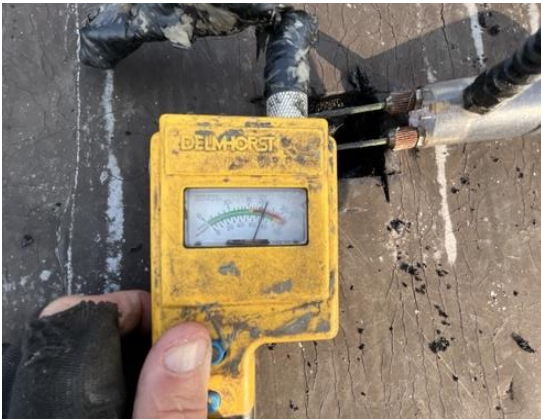
CORE SAMPLE 1

Concrete Deck/Screed Layer/20mm Asphalt/Solar Paint/Bitumen Felt Repairs

Client note, that wet reading was found between the applied bitumen felt repairs and the asphalt substrate therefore the existing area must be stripped back to the asphalt substrate to allow new system installation.

Wet

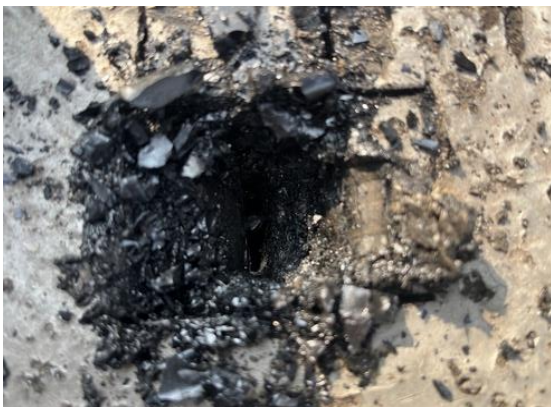
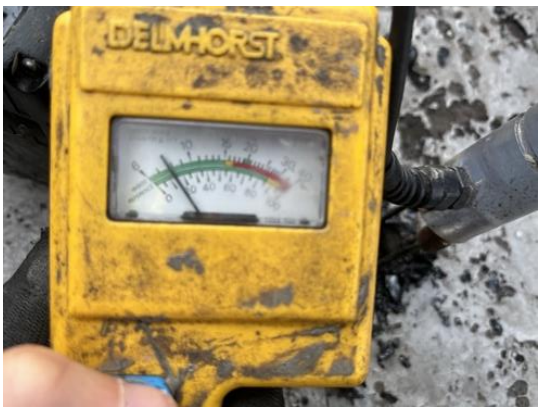
CORE SAMPLE 2

Concrete Deck/Screed Layer/20mm Asphalt/Solar Paint

Dry reading was attained during attendance, taken directly to and beneath the asphalt substrate just above the screed layer.

Dry

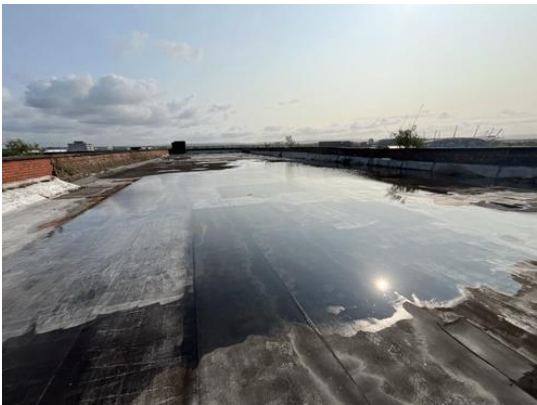
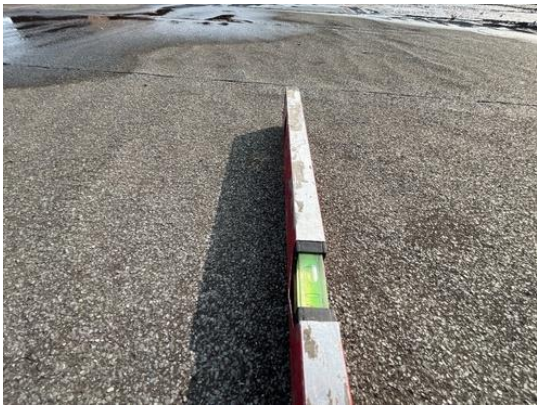
Falls generally through the area are poor, despite evidence of these being partially created within the screed layer beneath the asphalt, it is likely that deflections and hollows have formed, either through water ingress to the cementitious layer or alternatively as a result of the imposed dead loads from standing water, compressing the screed layer allowing wider build up of standing water.

At the time the roof is recovered, a tapered insulation layer is proposed in order to reinstate and improve falls through the area to minimise standing water in line with BS6229 requirements. However if falls cannot be improved, then standing water will be present on completion of the works but would not be deemed detrimental to system performance over the term of the guarantee offered.

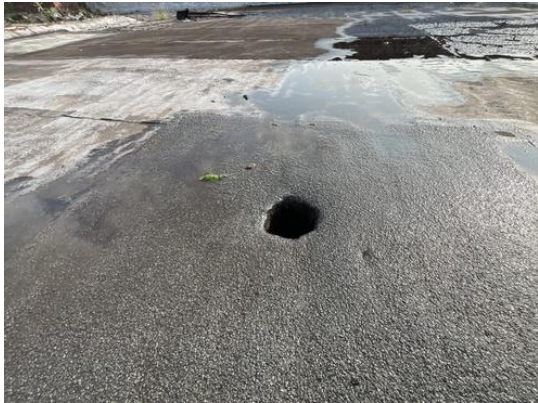
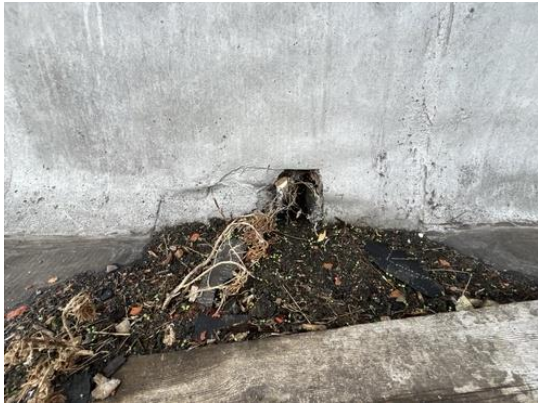
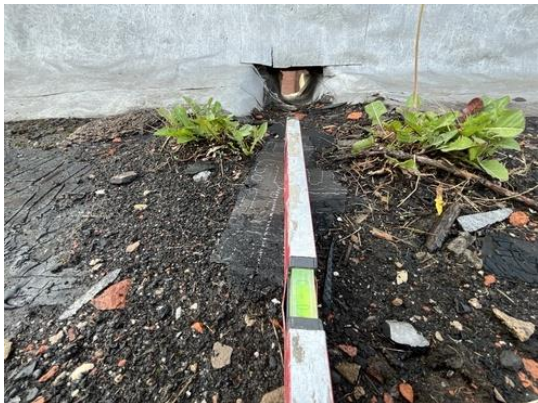
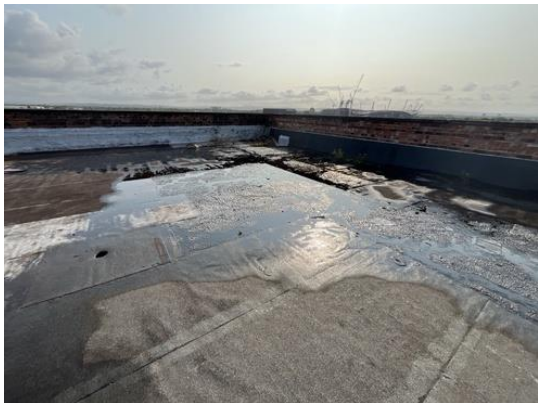
Both internal and external drainage locations are present to the roof sections at the mill site, these generally are restrictive due to build up of debris around the chute locations, with a water check evident due to build up of detail materials at the mouth of the internal outlet which is impeding rainwater run off.

At the time the roof is recovered, falls are proposed to be improved utilising tapered insulation layer however would suggest that all outlets be sumped, to allow more efficient drainage, with this change the existing chute positions may need to be modified in terms of their heights and or openings to account for the increased flow through the areas.

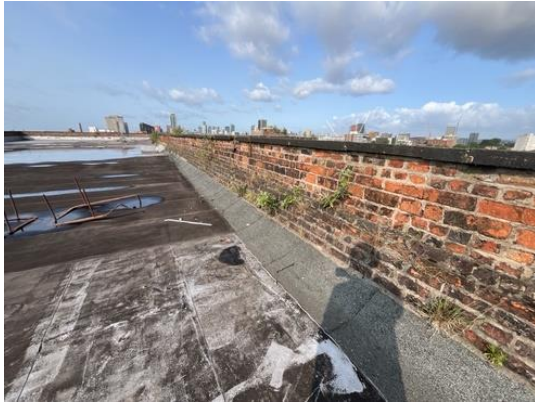
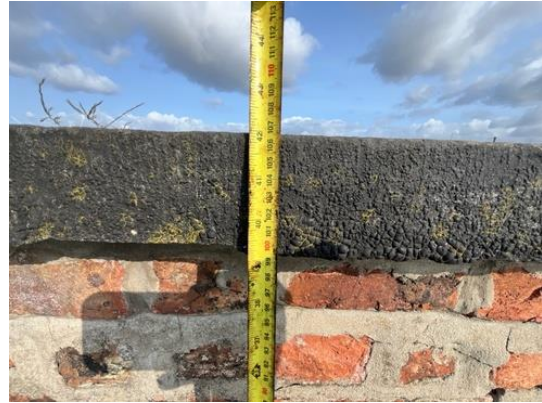
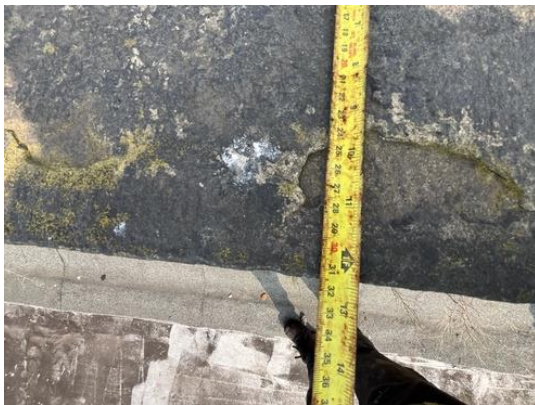
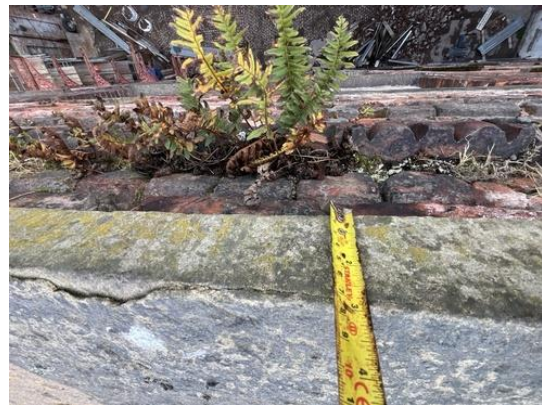
The existing parapets generally are in a very poor appearance, with evidence of spalled mortar joints to the butts and beneath the copings as the beddings that can allow water ingress to penetrate the building.

Due to heritage considerations, the proposal for the areas is that the existing copings be removed with the upstands boarded out to allow the installation of the new system, the membranes must encapsulate the cavity and at which point when the waterproofing is installed, the copings may be re-bedded on frost resistant mortar.

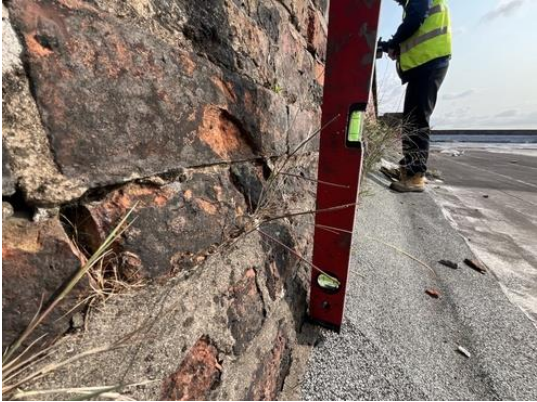
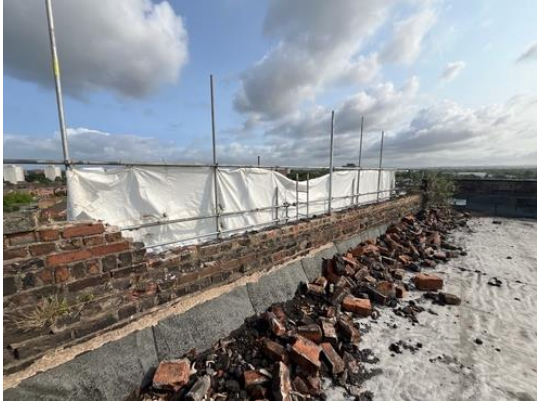
Client note, due the stepped course brickwork within the parapet upstands the areas may require sections of the parapet to be battened out with 25x50mm timber to allow an even substrate for the waterproofing to be applied.

Further guidance, is that any parapet subject to encapsulation above 250mm will require mechanical restraint of the side and head lap joints, sections of the parapets which have collapsed, or removed for survey purposes must be reinstated prior to waterproofing application.

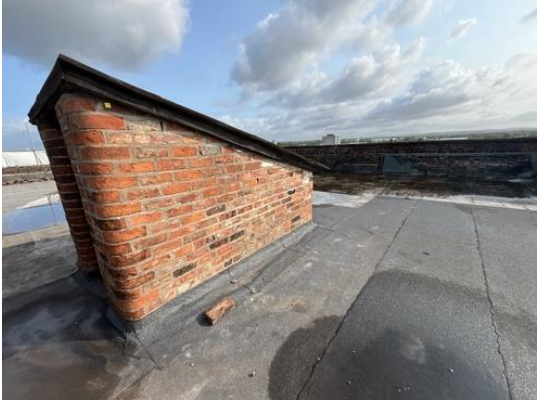
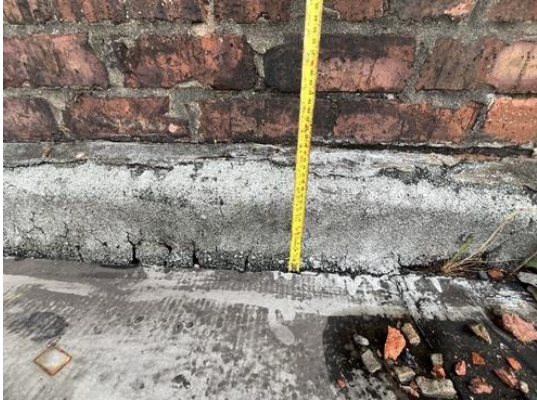
Solid brick abutment upstands are present to the rear and cheeks of the plant room and stair cores, these show delaminated asphalt waterproofing that will allow wind driven and draining rainwater to bypass the leading edge of the waterproofing to areas beneath the roof.

Due to change in height at roof level associated with tapered thermal upgrade, the upstands must be raised to show a finished height of 150mm or more from the new roof level, at which point a new 25mm depth chase must be cut and a lead free cover flashing installed to act as a counter flashing to the new waterproofing system.

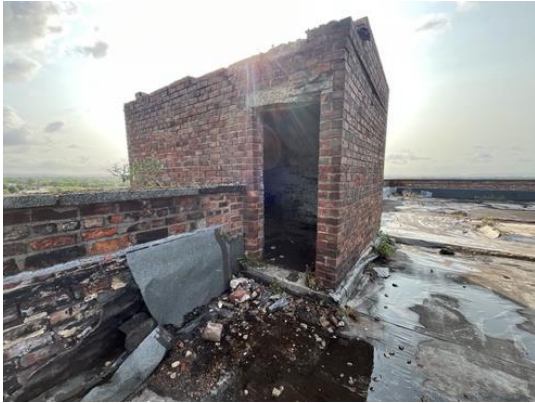
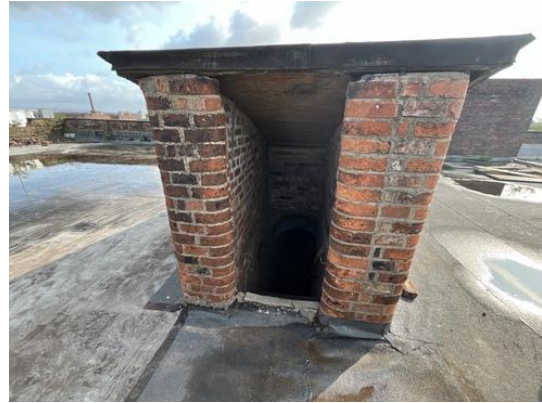
Access thresholds to the existing stair core and tank housing must be considered, due to tapered thermal upgrade proposed. Currently sill heights are level, or less than 150mm therefore at the time the roof is recovered either new sills will be required, or the existing to be raised to show a finished upstand height of 150mm or more from the new roof level.

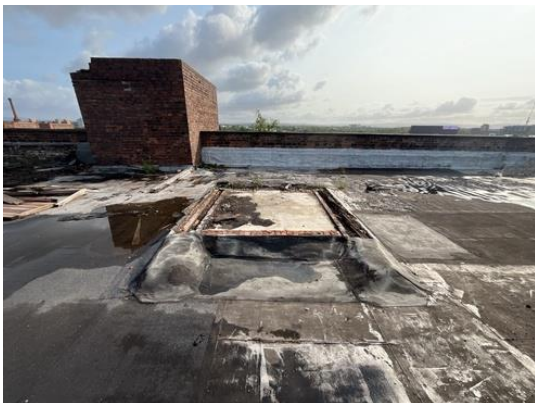
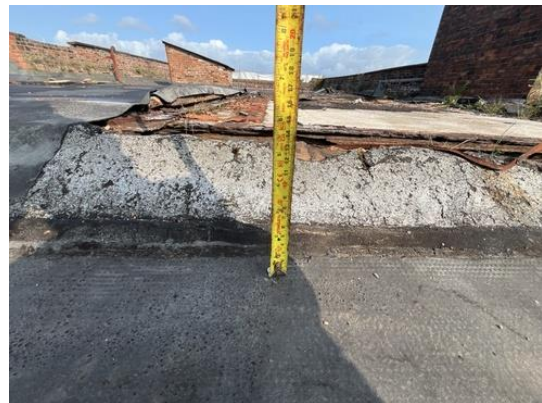
Two sections of concrete decking is present, suspected to be the remnants of tank houses or plant rooms which have been demolished that must be considered during planning and delivery of the roofing works.

Two options which are possible, are that the upstands lined with asphalt are cut away with the slab demolished back to asphalt or concrete deck level, with the area infilled and overlaid with the waterproofing system, to embed the item beneath the system.

The second, would be to create a ladder frame and kerb structure, around the area and line the top with timber as a substrate to carry the waterproofing up and over, to create a continuous detail around the item present through the existing waterproofing.

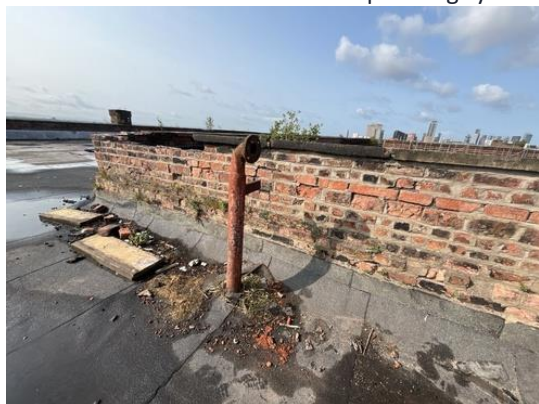
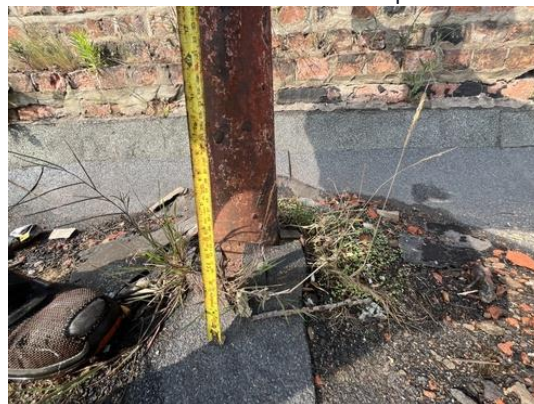
A single services pipe is present as a penetration through the waterproofing system, this appears to be redundant as the remainder of the pipework to carry the services has been dismantled and removed, the item may be cut and removed back to roof level so that the new system is able to encapsulate.

However if this item or opening is required, for cables or ventilation within the new system then the penetration must receive either a telescopic vent extension, or snorkel which contains bitumen flange that can be linked back into the waterproofing system to form a robust continuous detail at the penetration.
