**GAS MEMBRANE VALIDATION**

| Site Name: Belle Vue Stadium | Project Number: 12-123 |

**Plot – Apartment Block 2**

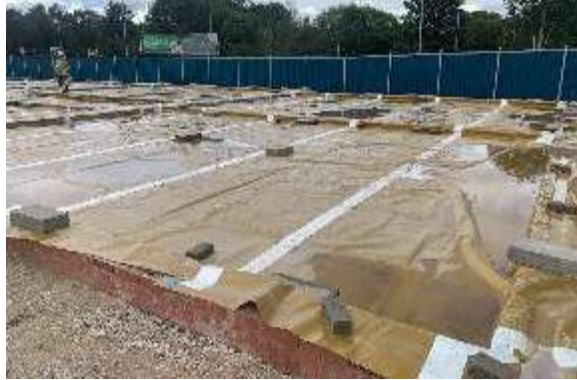
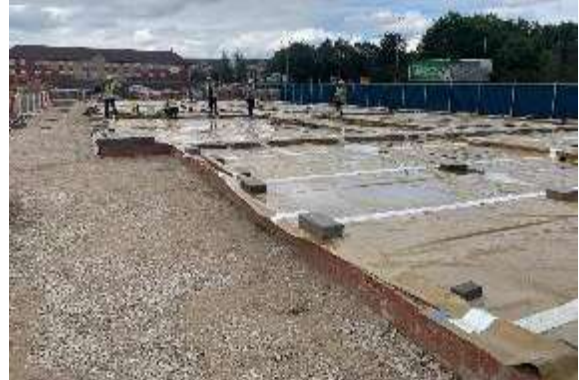
The membrane comprised a Visqueen Ultimate HC Blok (gold) resistant to radon, carbon dioxide and low levels of methane. E3P can confirm there were no holes or rips at the time of inspection. Upon being laid the membrane is to be covered with a Celotex (closed Cell) floor insulation material which is considered to provide a high degree of protection.

**General Condition of Membrane-Good Condition**

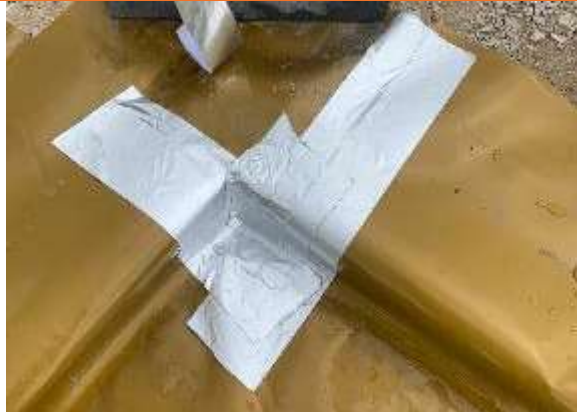
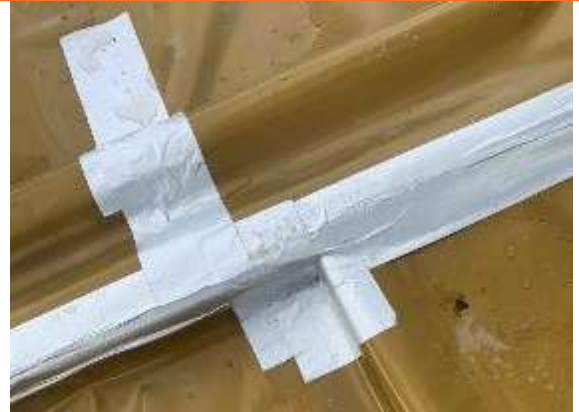
All external joints were inspected and E3P can confirm that the membrane was overlapped and double taped to external and internal gas resistant DPM. The membrane was taped to the gas resistant DPM using a double-sided jointing tape.

**Verification of Joints and Seals-Overlapped and sealed correctly**

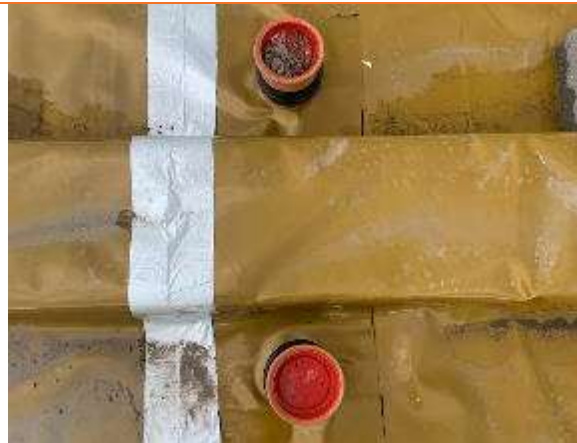
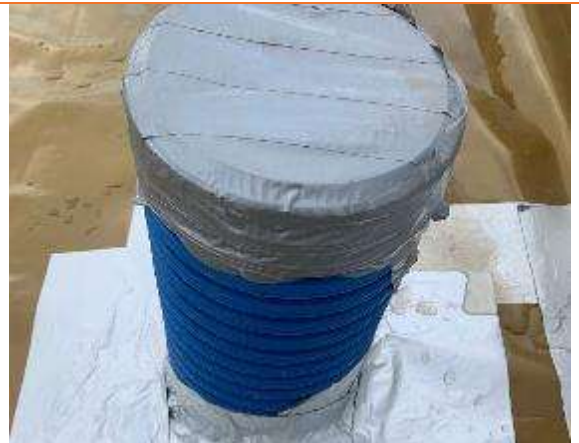
Each unit has a service duct located to the front and outer edge of the property. E3P inspected each one and can confirm that the top-hats have been adequately sealed against the membrane.

**Verification of Service Penetrations-Good Condition**

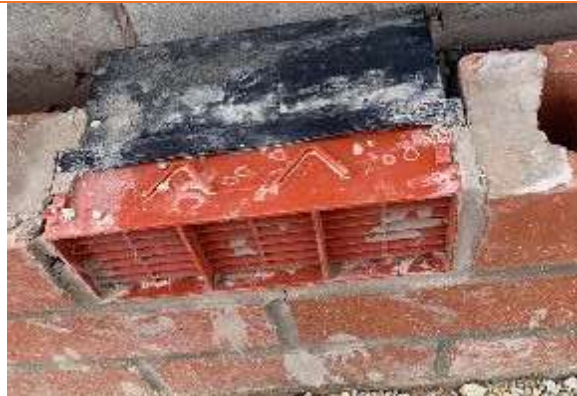
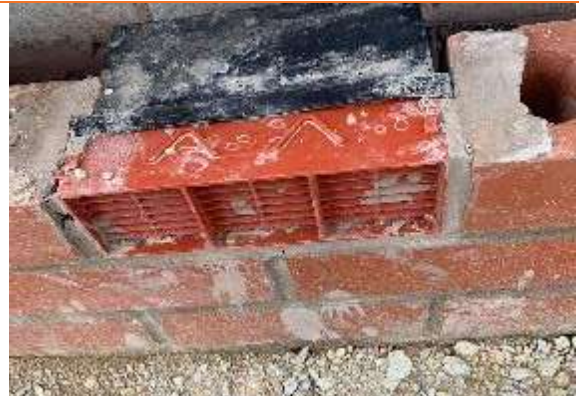
**Verification of Ventilation-Good Condition**
