### GAS MEMBRANE VALIDATION – BELLE VUE

**Project Name:** Belle Vue Stadium

**Project Number:** 12-123

**Plots:** 97-98

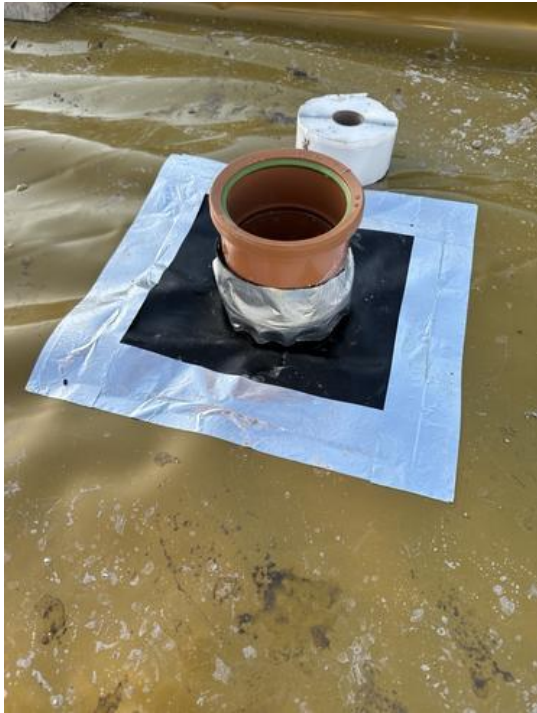
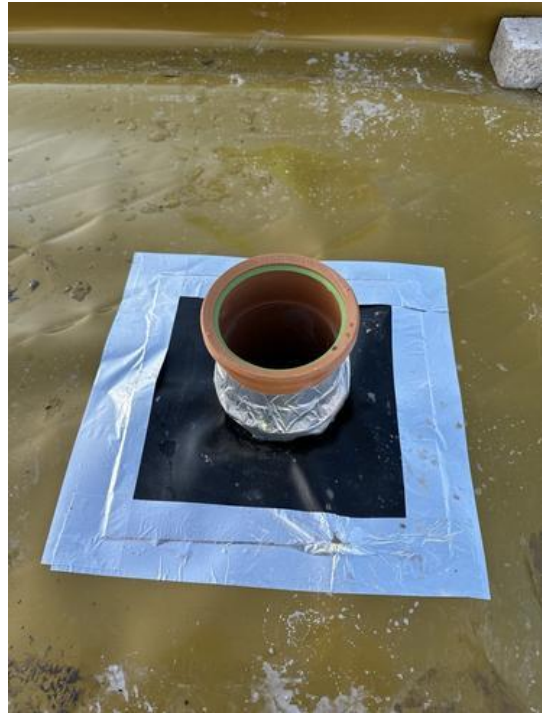
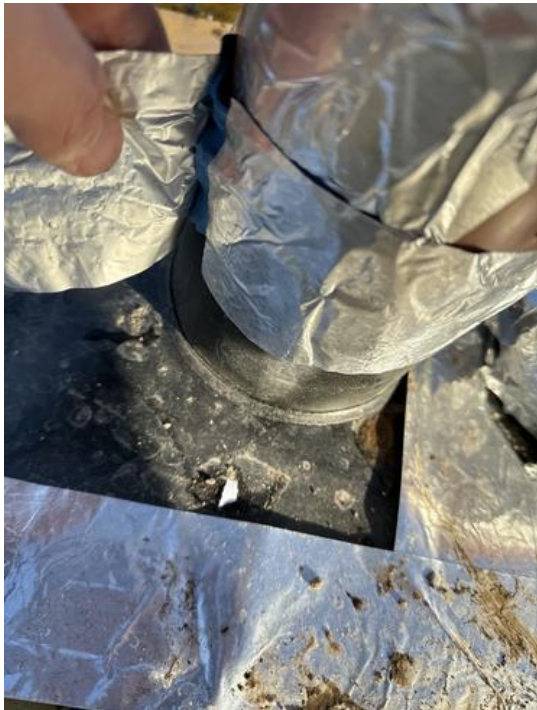
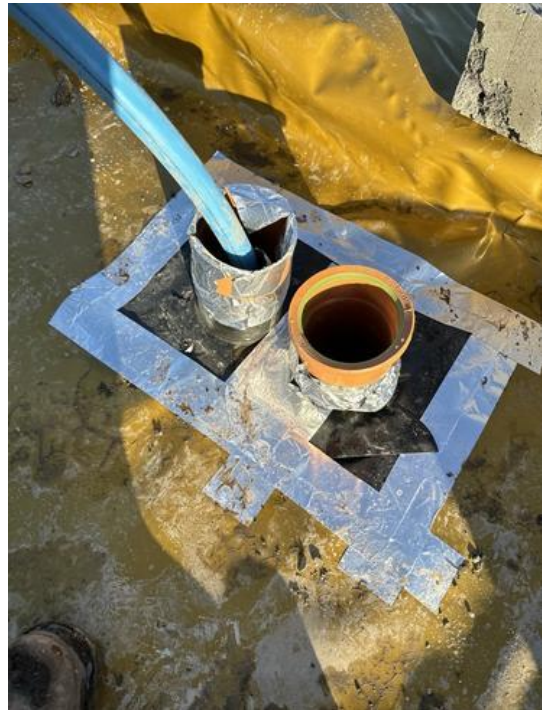
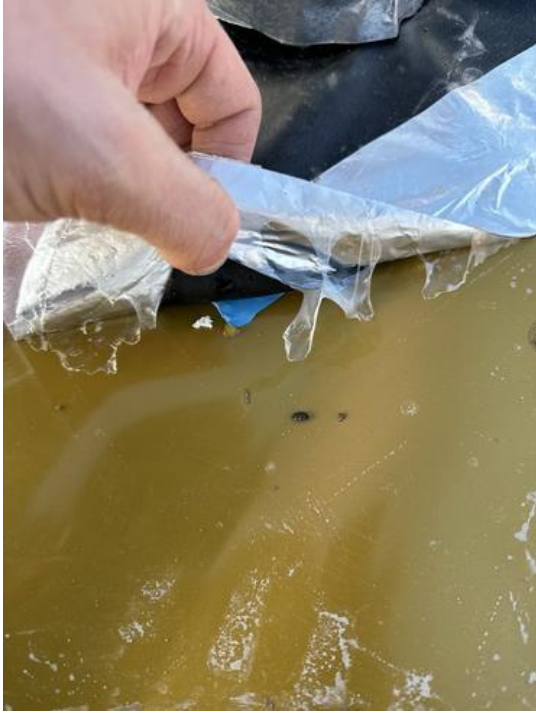
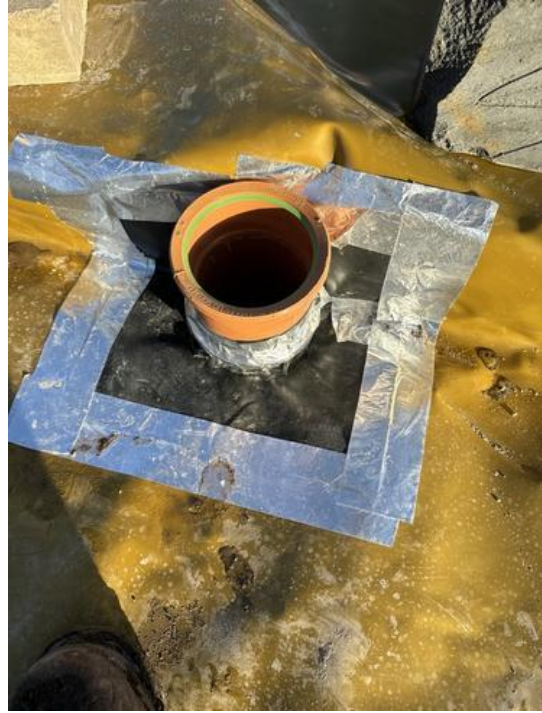
| Laps, welds, and joints seals: Joints lapped and sealed in accordance with manufacturer's requirements/ specification? Minimum overlap insured? Sections taped twice? Are welds complete? Appropriate joining/double-sided tape used, Folds running in line with joints? (no joints cutting across folds) | Pass |
| Service entries seals: Top hats seal arrangements fixed around service entries? Use of Jubilee clips? | Yes |

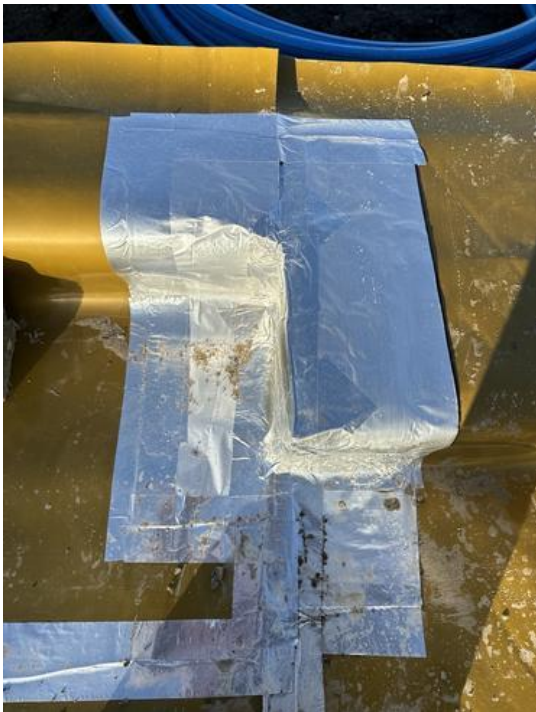
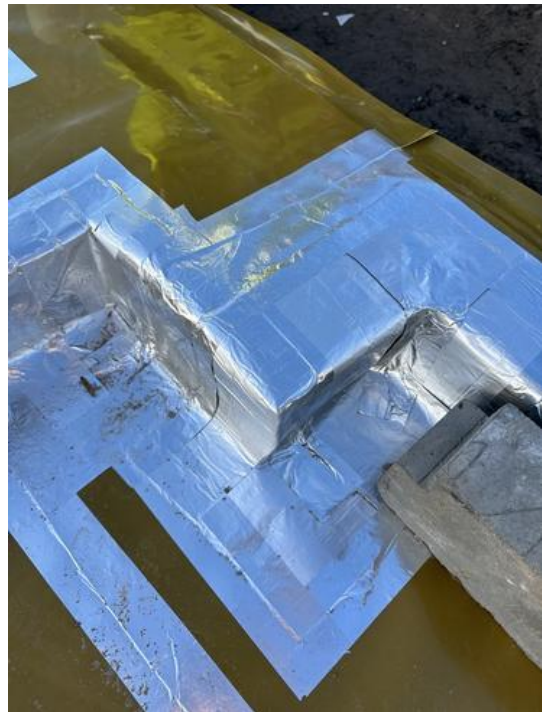
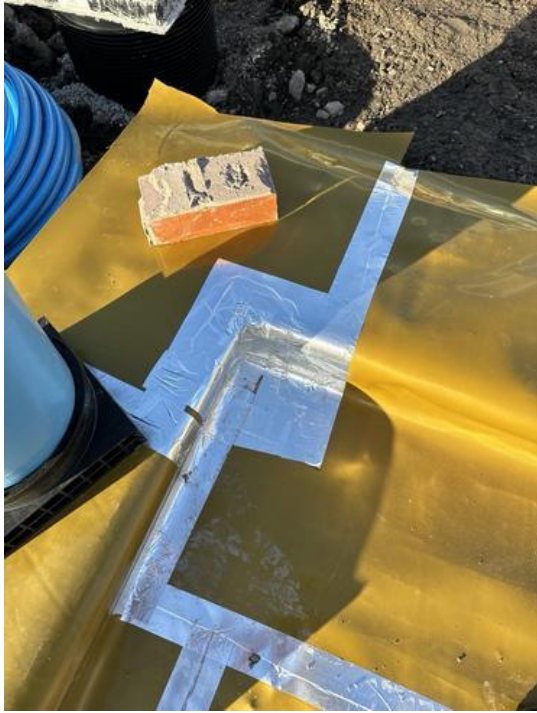
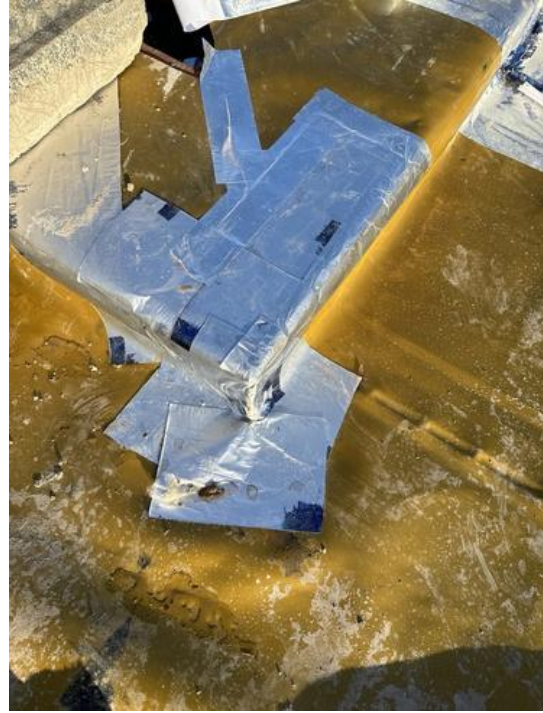
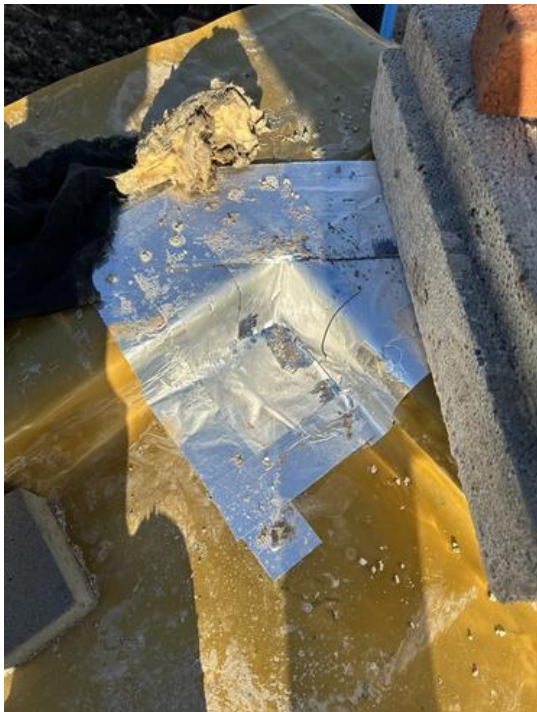
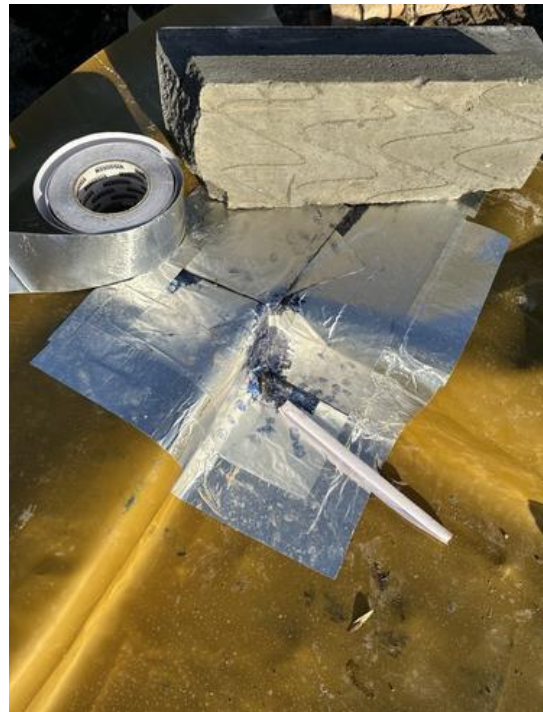
| Corners / Internal joints: Check all corners are correctly formed or contractor has used preformed corners. | Pass |

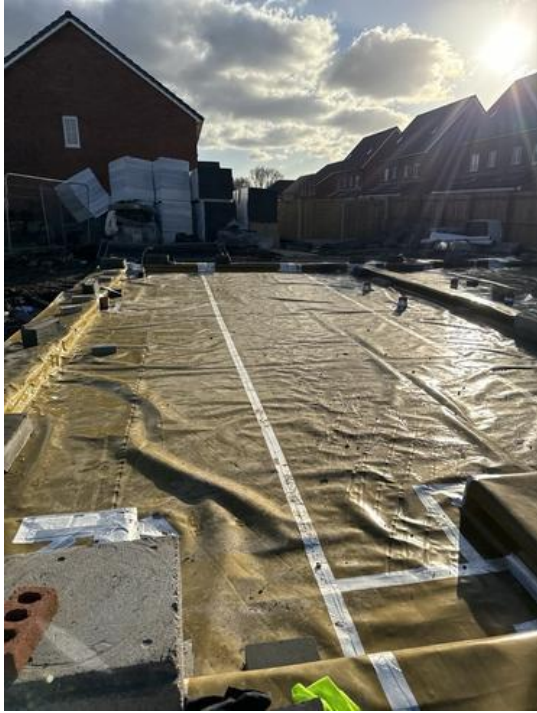
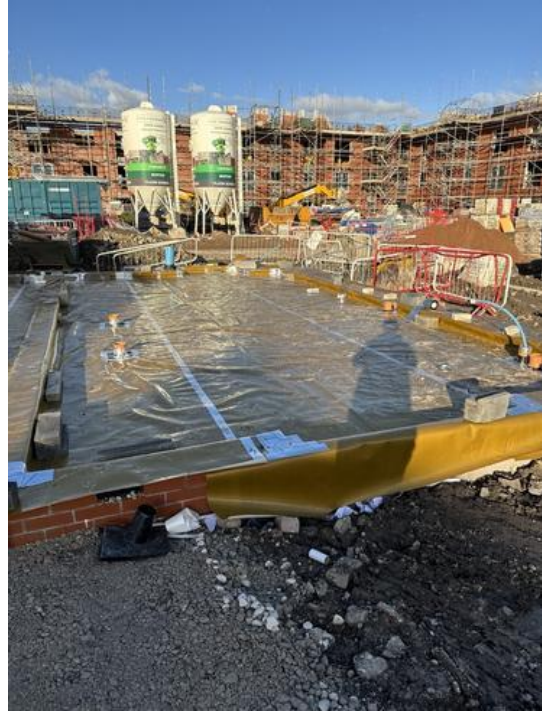
**Extent of Coverage: Is the membrane covering the entire plot? Does membrane span over outside walls?**

Yes

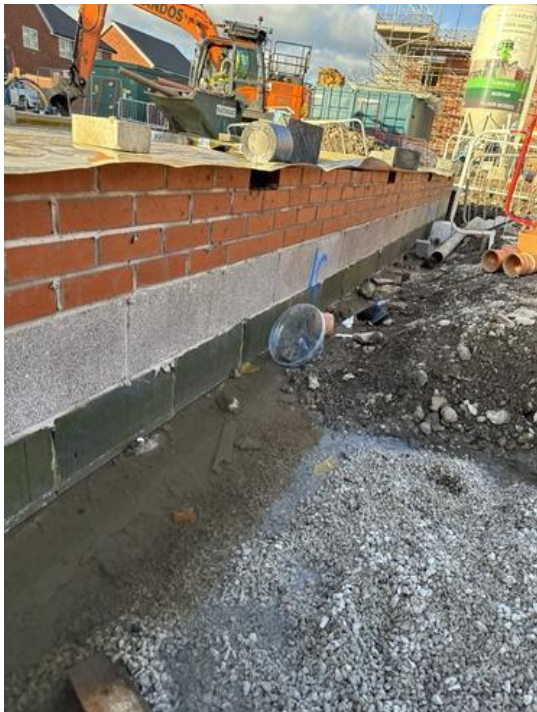
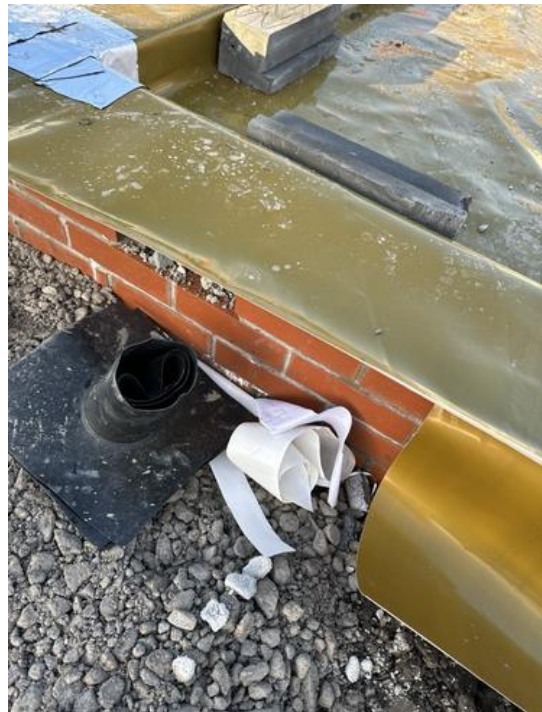
**External Wall Air bricks: Numbers, size. positions as design drawing? (Minimum of 3 walls)**

Pass

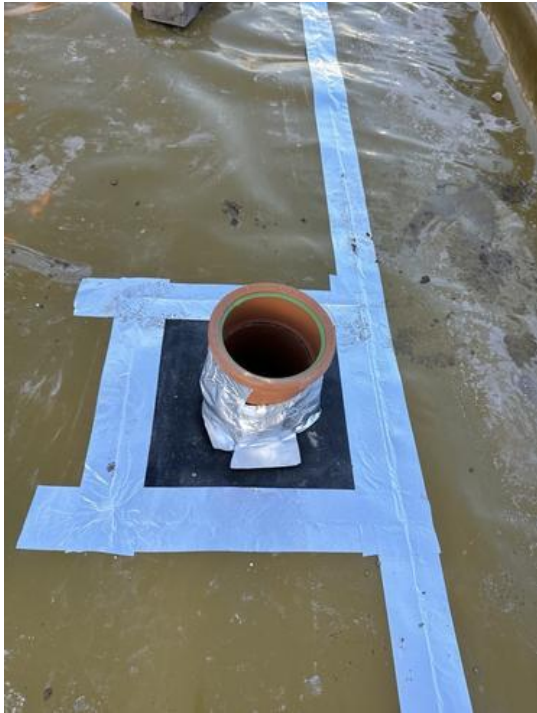
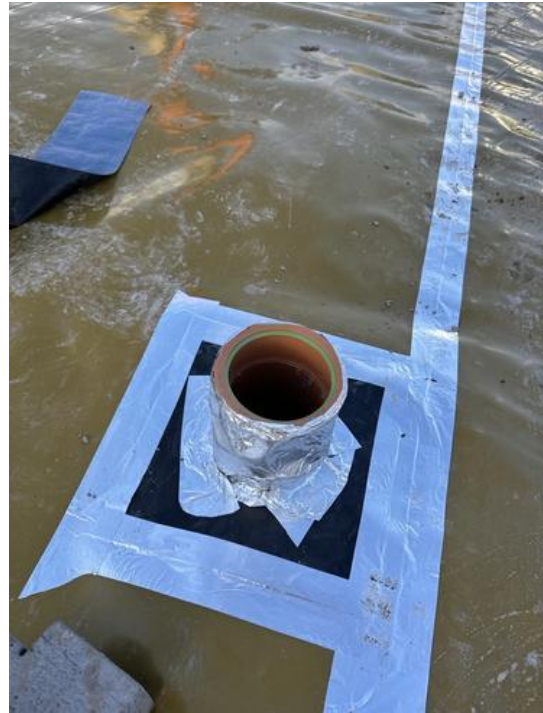
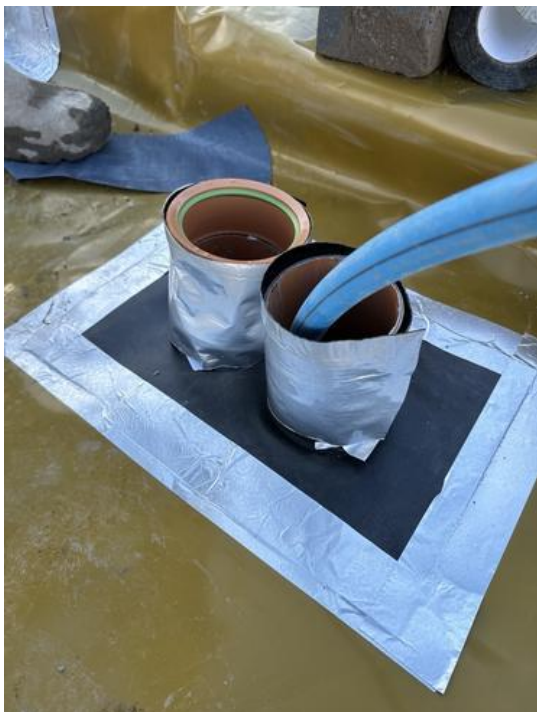
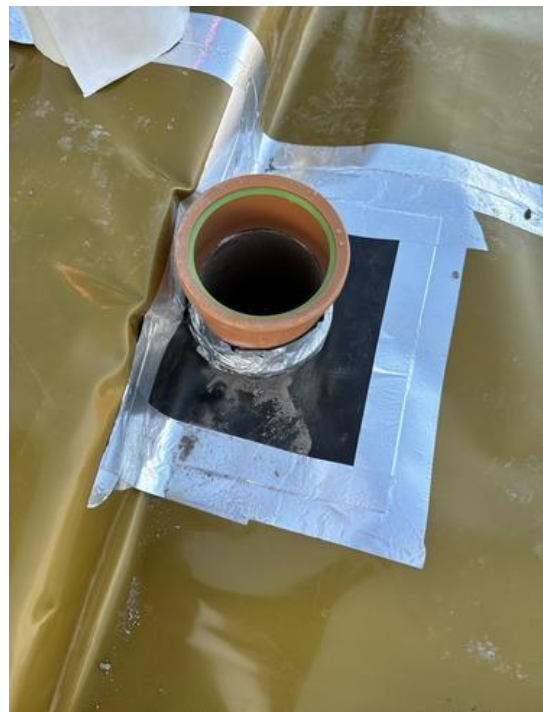
| Laps, welds, and joints seals: Joints lapped and sealed in accordance with manufacturer's requirements/ specification? Minimum overlap insured? Sections taped twice? Are welds complete? Appropriate joining/double-sided tape used, Folds running in line with joints? (no joints cutting across folds) | Pass |
| Service entries seals: Top hats seal arrangements fixed around service entries? Use of Jubilee clips? | Yes |

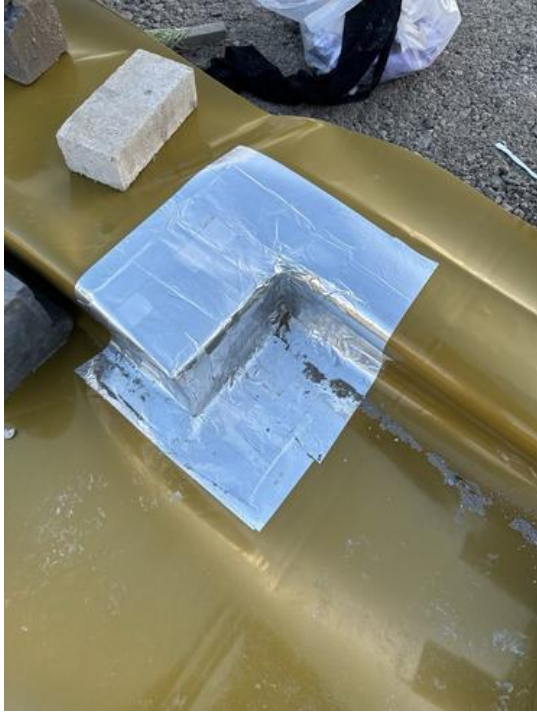
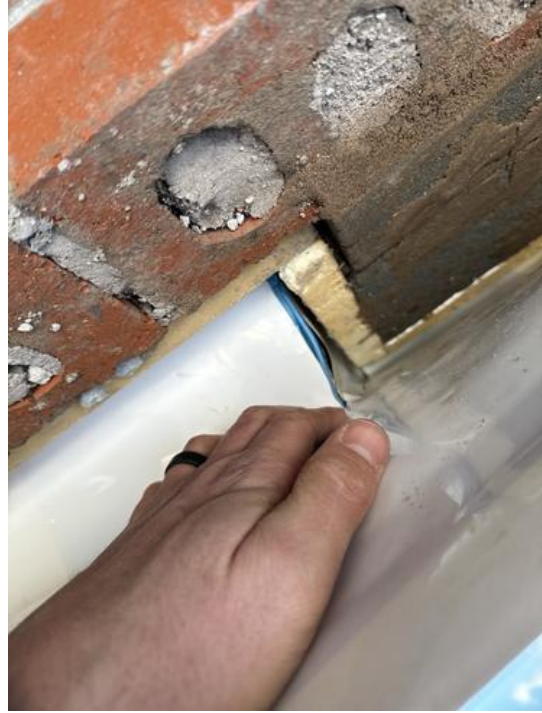
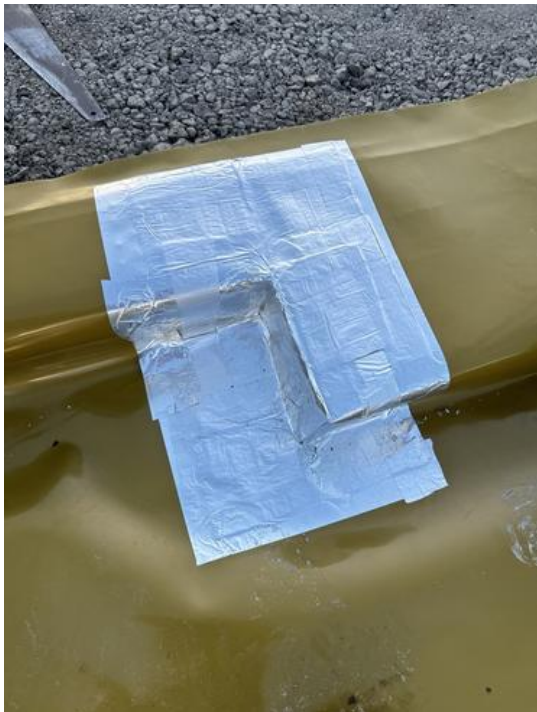
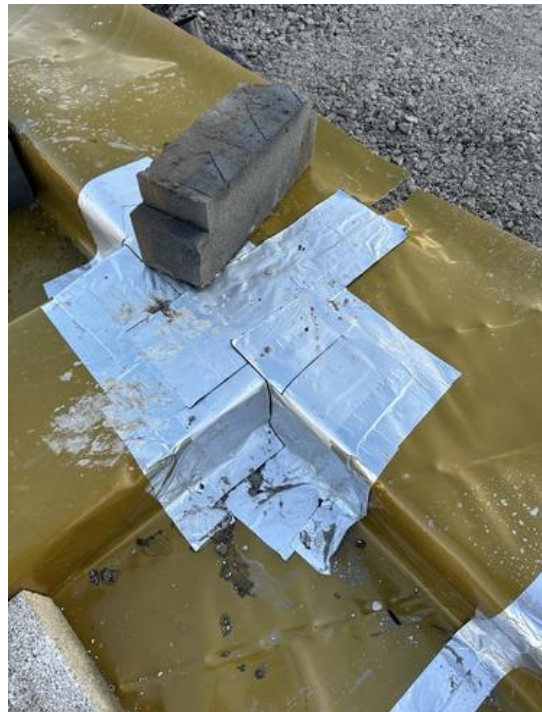
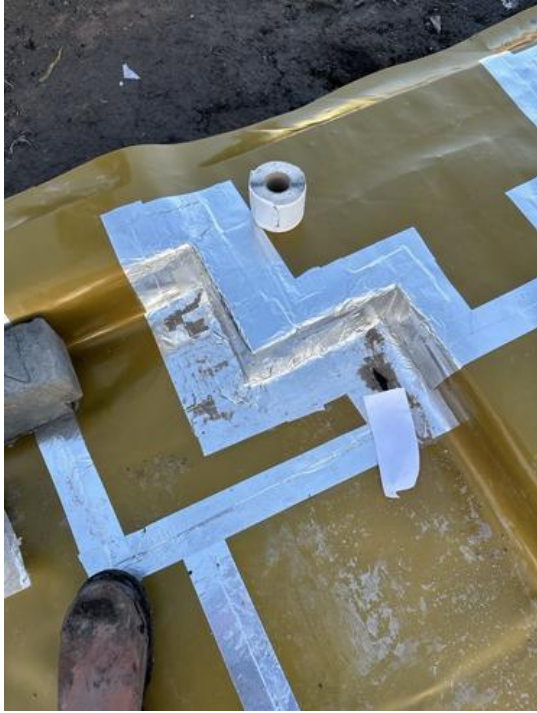
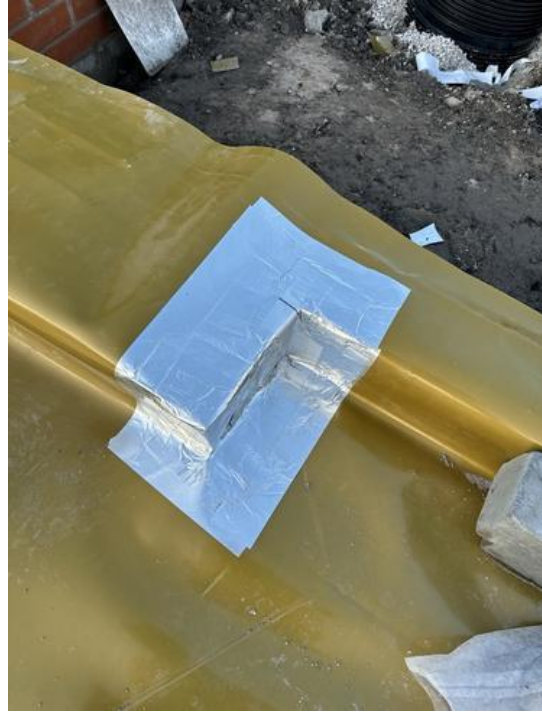
| Corners / Internal joints: Check all corners are correctly formed or contractor has used preformed corners. | Pass |

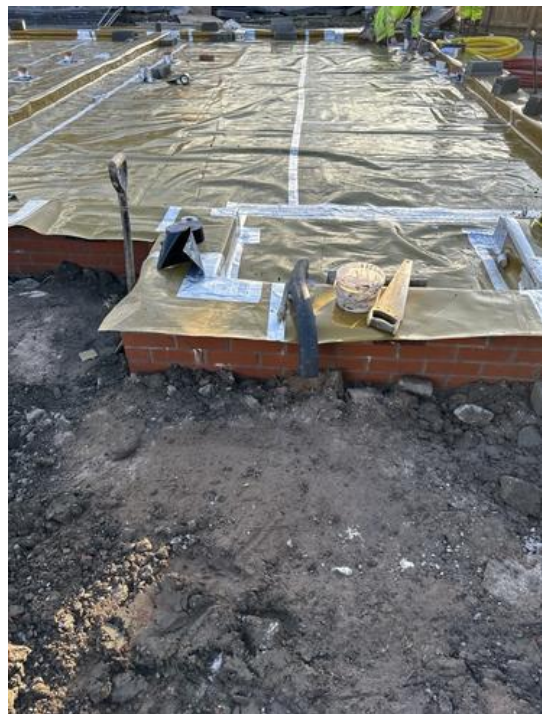
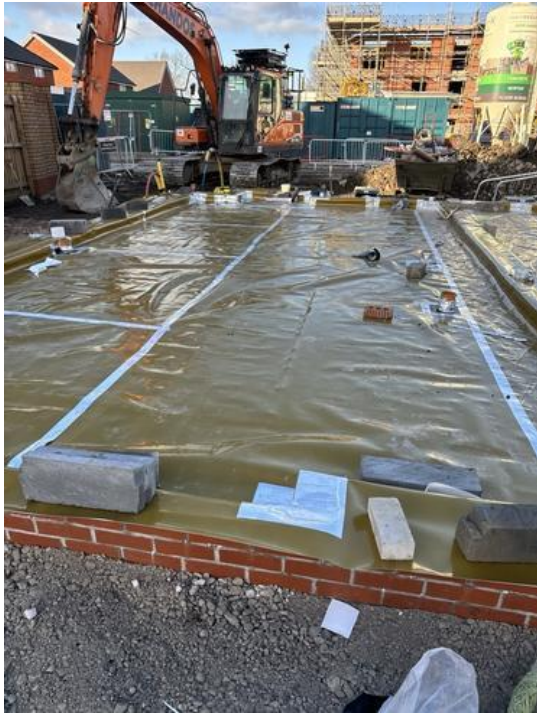
| Extent of Coverage: Is the membrane covering the entire plot? Does membrane span over outside walls? | Yes |

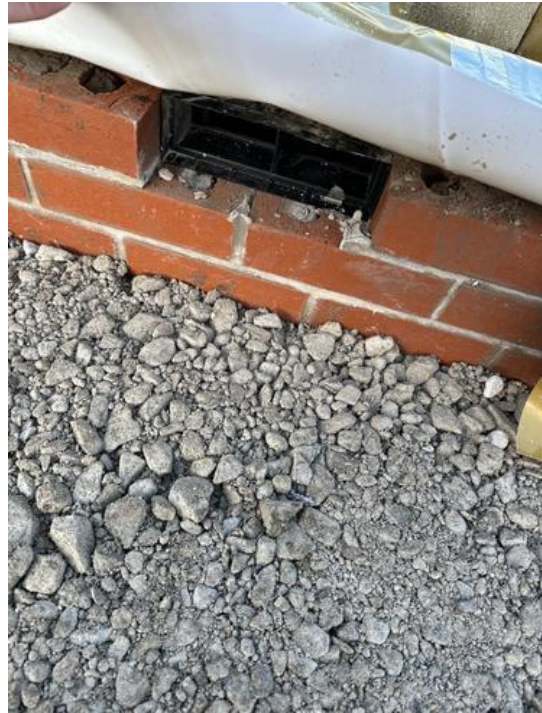
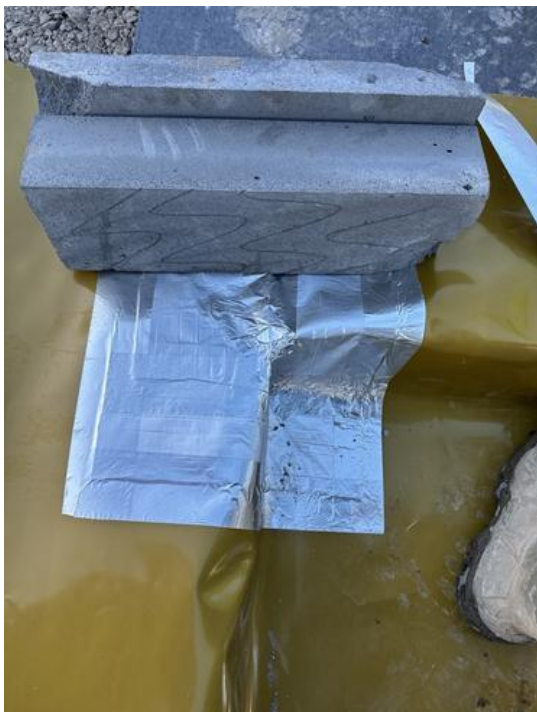
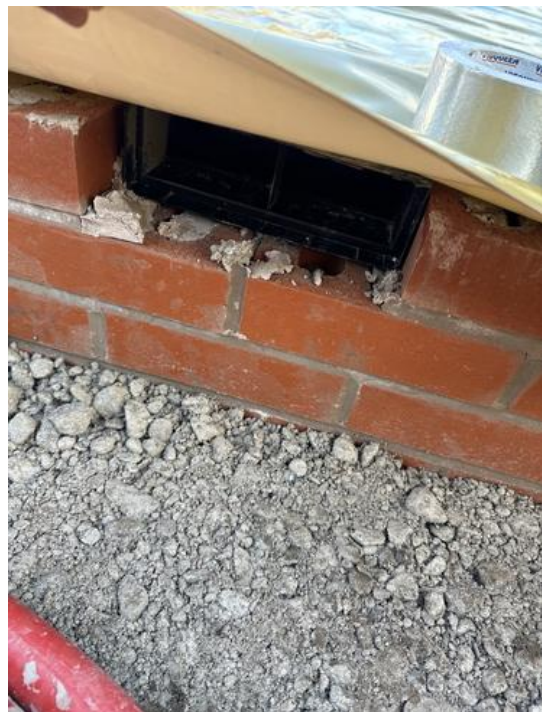
**External Wall Air bricks: Numbers, size. positions as design drawing? (Minimum of 3 walls)**

Pass
