**GAS MEMBRANE VALIDATION**

| Site Name: Belle Vue Stadium | Project Number: 12-123 |

**Plot – 110**

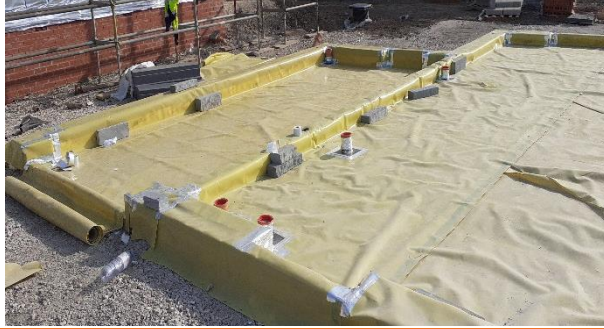
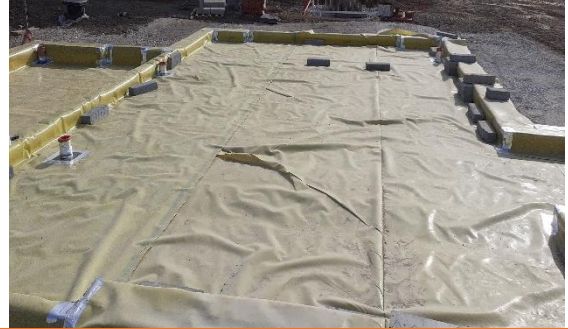
The membrane comprised a Visqueen gas membrane (yellow) resistant to radon, carbon dioxide and low levels of methane. E3P can confirm there were no holes or rips at the time of inspection. Upon being laid the membrane is to be covered with a Celotex (closed Cell) floor insulation material which is considered to provide a high degree of protection.

**General Condition of Membrane-Good Condition**

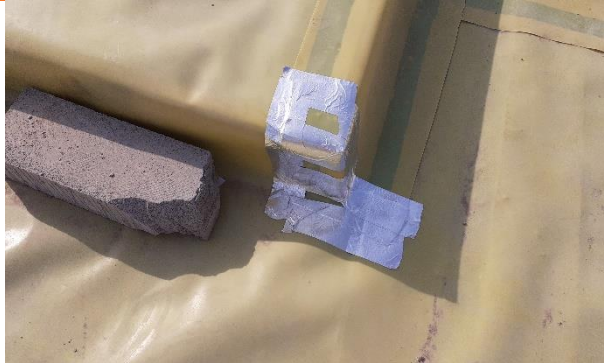
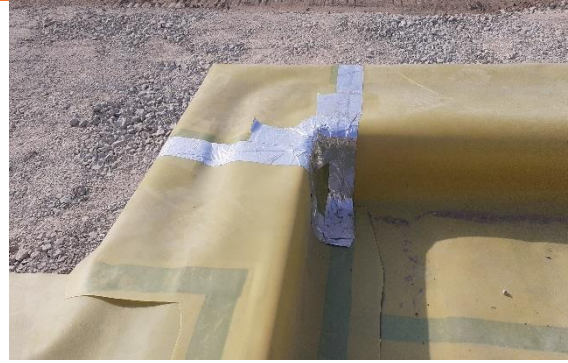
All external joints were inspected and E3P can confirm that the membrane was overlapped and double taped to external and internal gas resistant DPM. The membrane was taped to the gas resistant DPM using a double-sided jointing tape.

**Verification of Joints and Seals-Overlapped and sealed correctly**

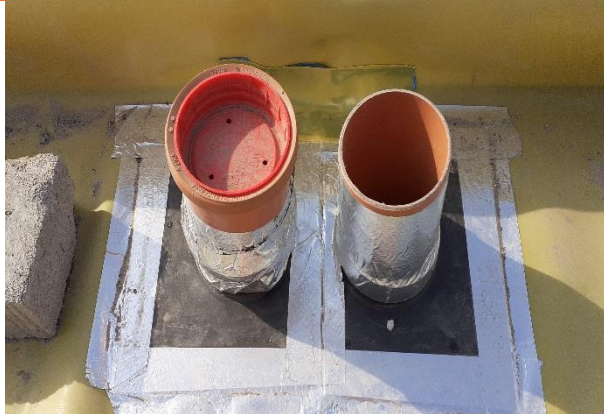
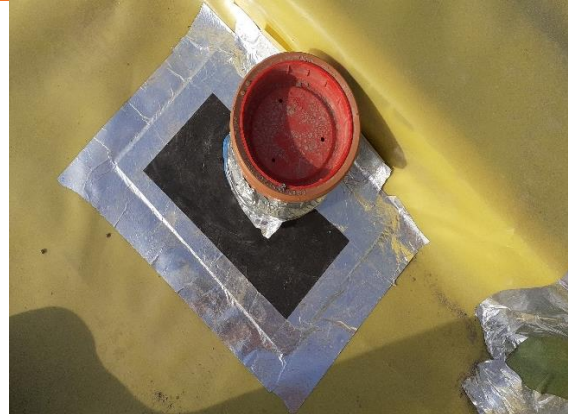
Each unit has a service duct located to the front and outer edge of the property. E3P inspected each one and can confirm that the top-hats have been adequately sealed against the membrane.

**Verification of Service Penetrations-Good Condition**

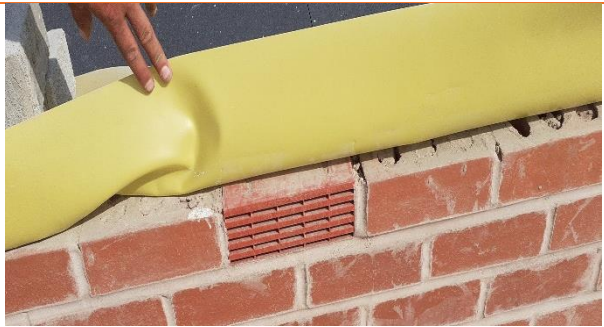
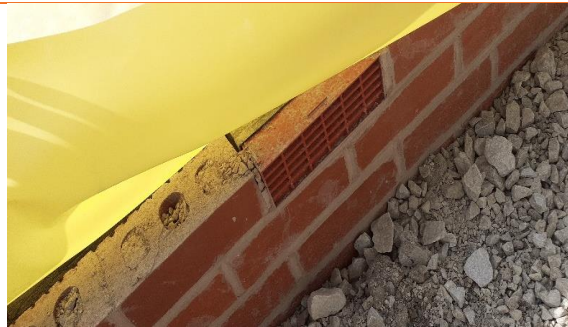
**Verification of Ventilation-Good Condition**
