### GAS MEMBRANE VALIDATION – BELLE VUE

**Project Name: Belle Bue Stadium****Project Number: 12-123****Client: Countryside Properties****Date: 04-09-2023****Project Manager; S. Ellis – FGS, CEnv****E3P Engineer: J. James****Gas Membrane Installers Chandos Civils****Ground Gas Risk Assessment: Amber 1****Plots: 234-235**

## GAS MEMBRANE VALIDATION

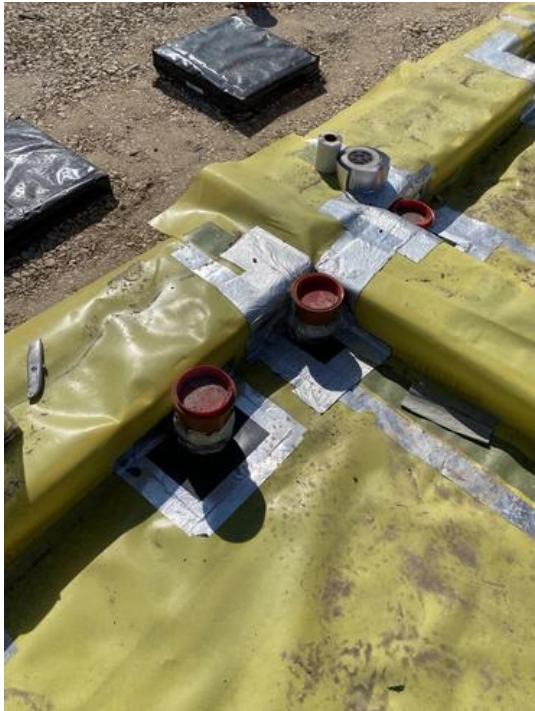
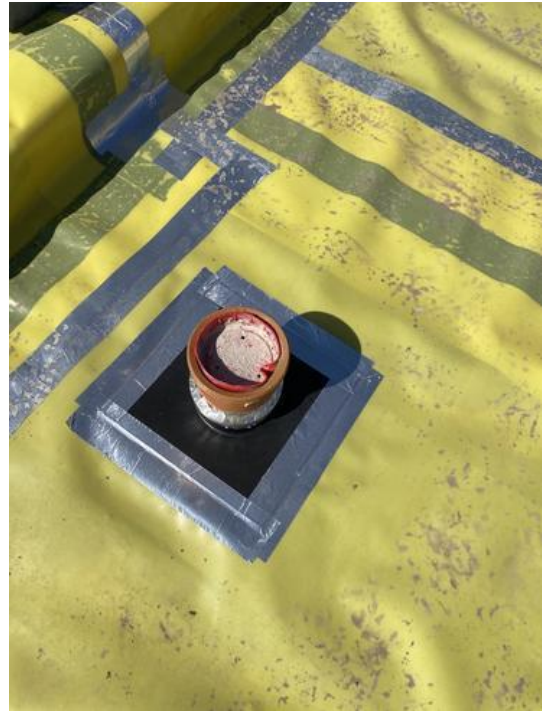
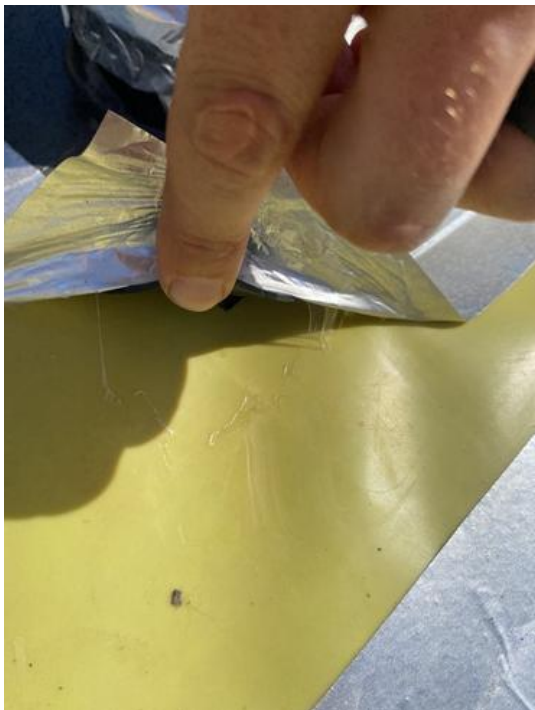
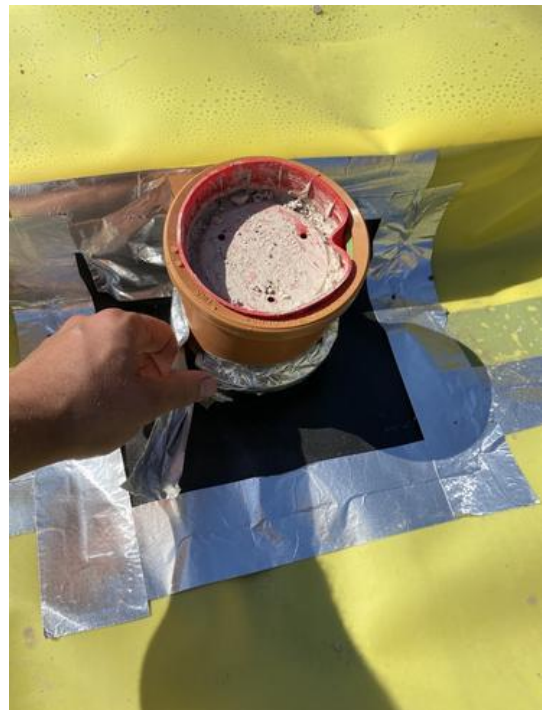
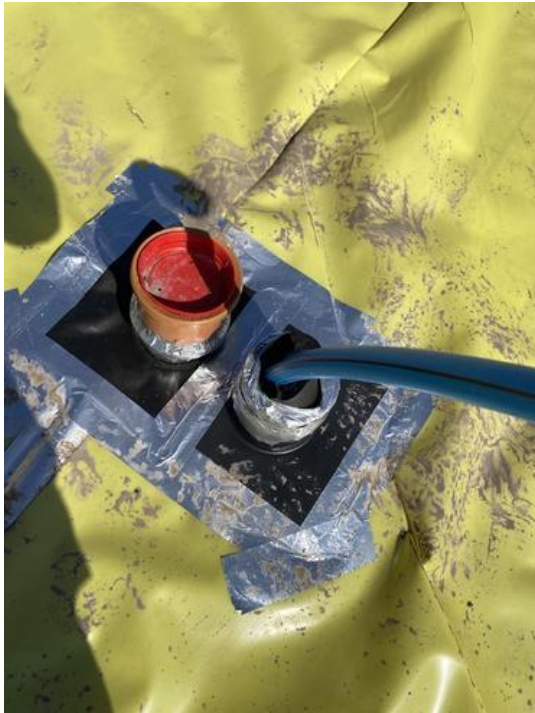
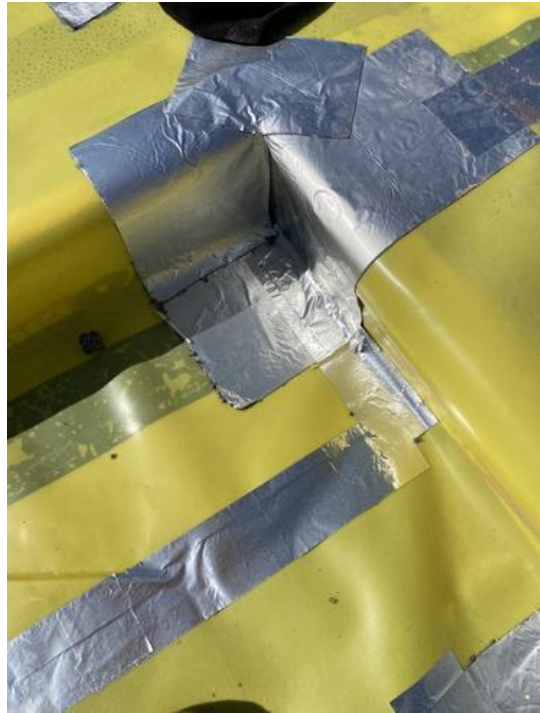
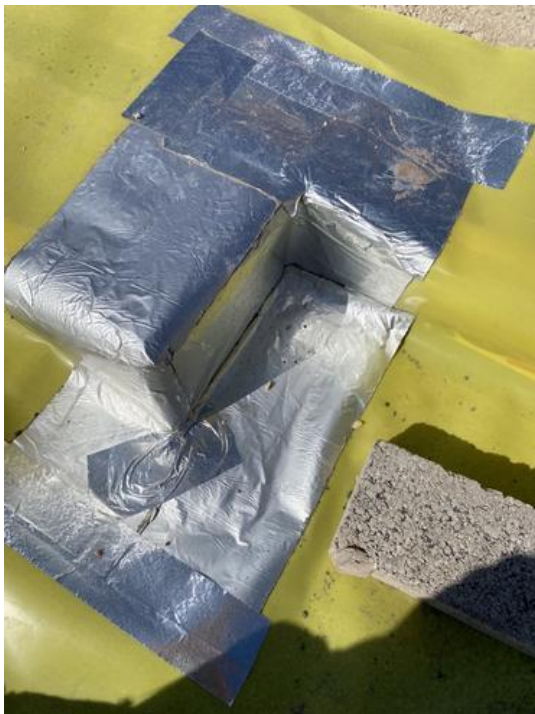
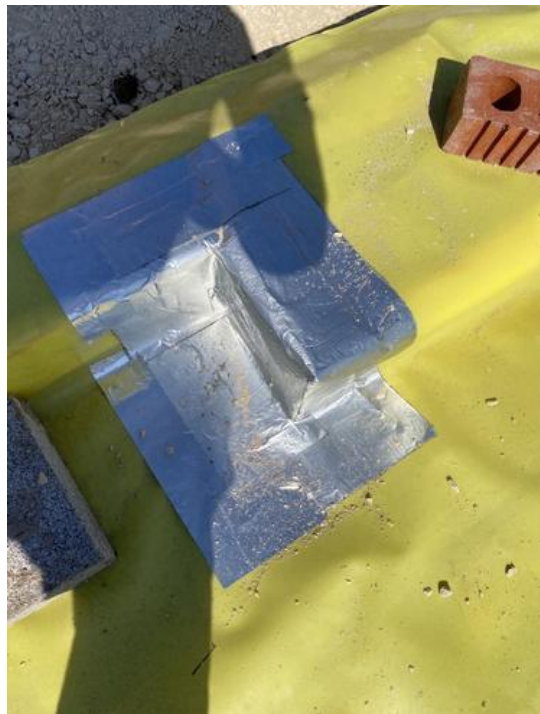
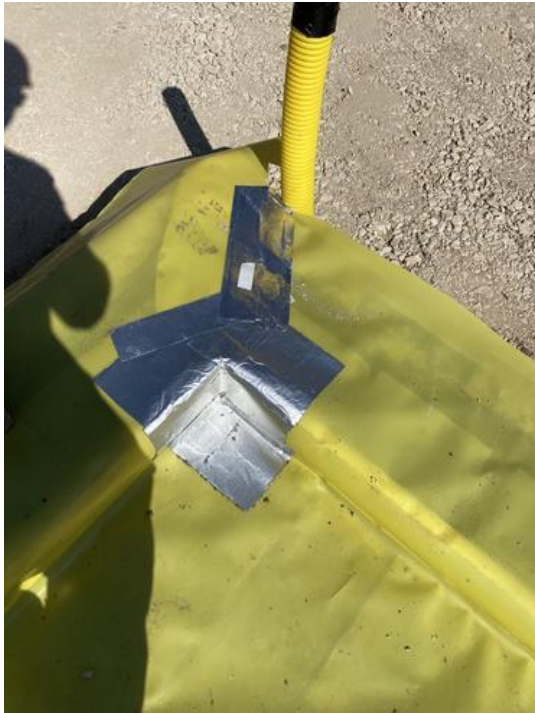
**Gas Membrane Condition: Open punctures, tears, rips, stretching, Presence of debris, Repairs, Signs of weakness such as raised or sunken indentations, Protection plan in place to restrict access to lain gas membrane? IF FAIL DESCRIPTION IN ACTIONS AND PHOTOS REQUIRED** Pass

**Laps, welds, and joints seals: Joints lapped and sealed in accordance with manufacturer's requirements/ specification? Minimum overlap insured? Sections taped twice? Are welds complete? Appropriate joining/double-sided tape used, Folds running in line with joints? (no joints cutting across folds)** Pass

**Service entries seals: Top hats seal arrangements fixed around service entries? Use of Jubilee clips?** Yes

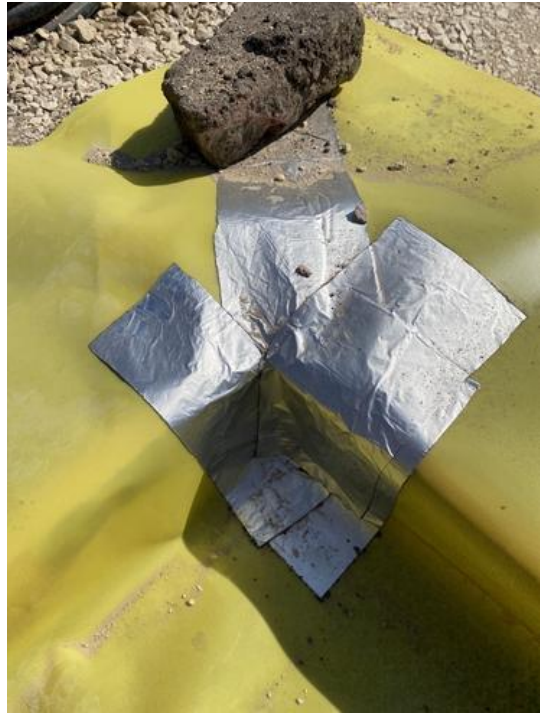
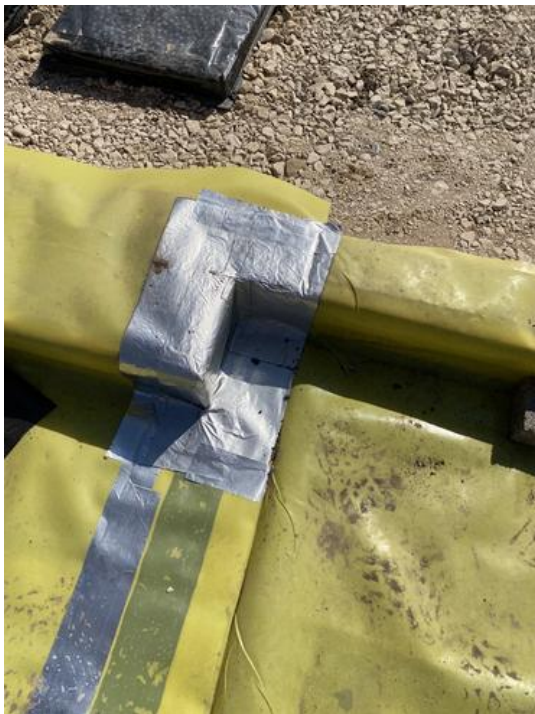
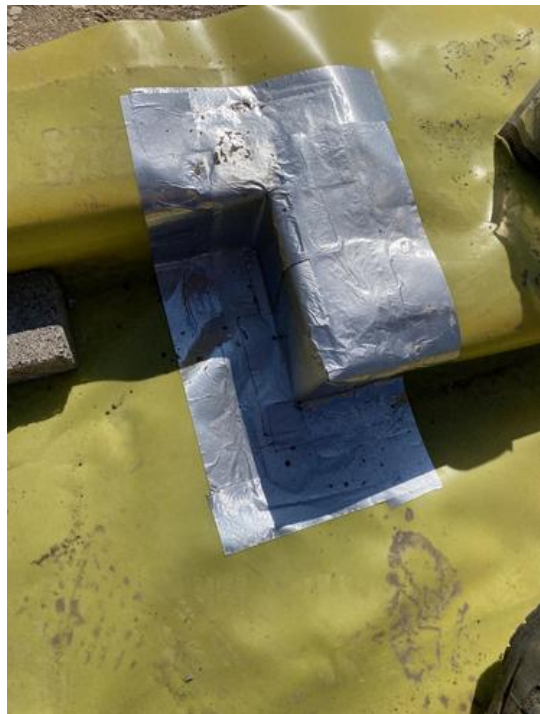
**Corners / Internal joints: Check all corners are correctly formed or contractor has used preformed corners.** Pass

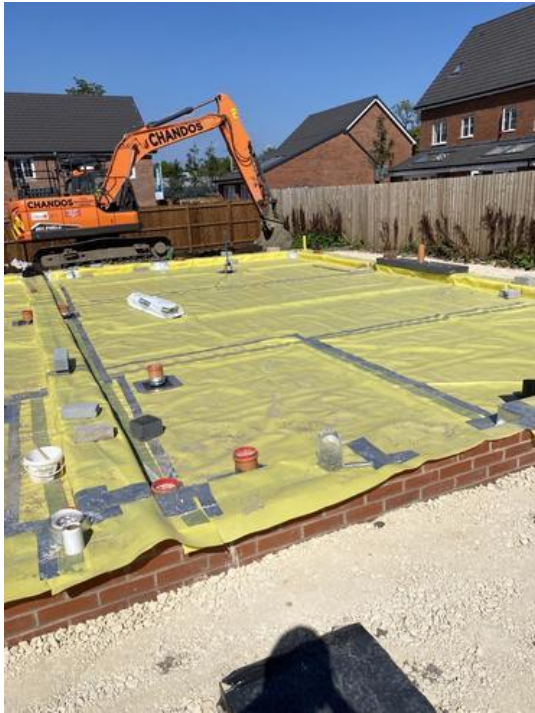
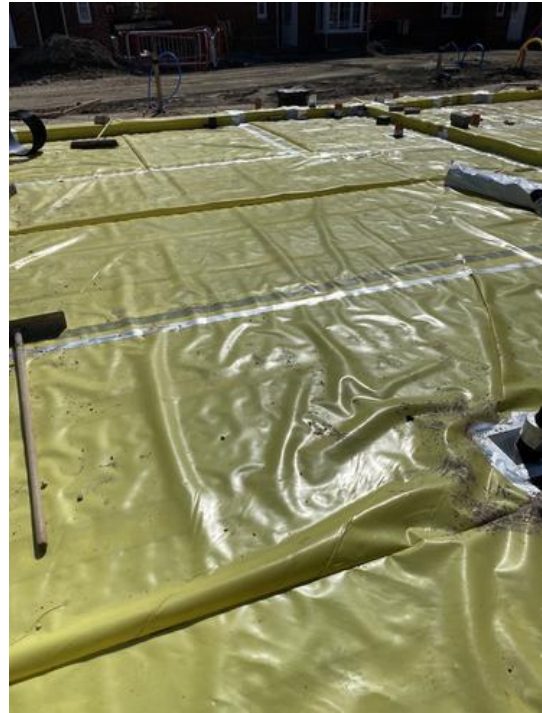
**Extent of Coverage: Is the membrane covering the entire plot? Does membrane span over outside walls?**

Yes

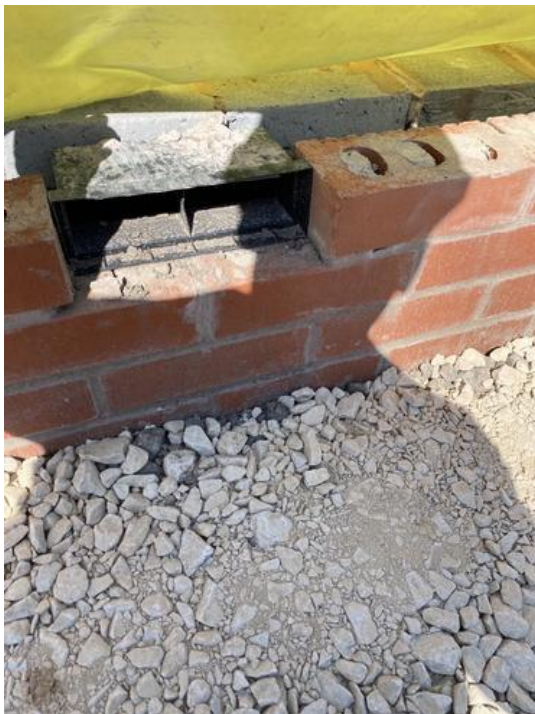
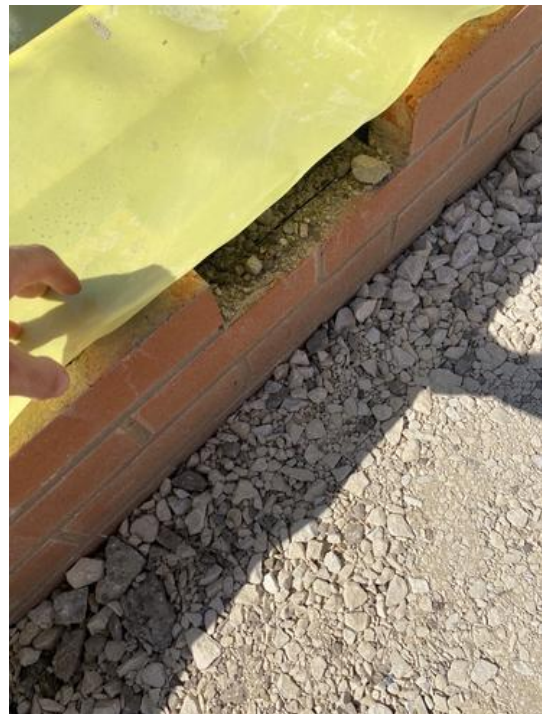
**External Wall Air bricks: Numbers, size. positions as design drawing? (Minimum of 3 walls)**

Pass

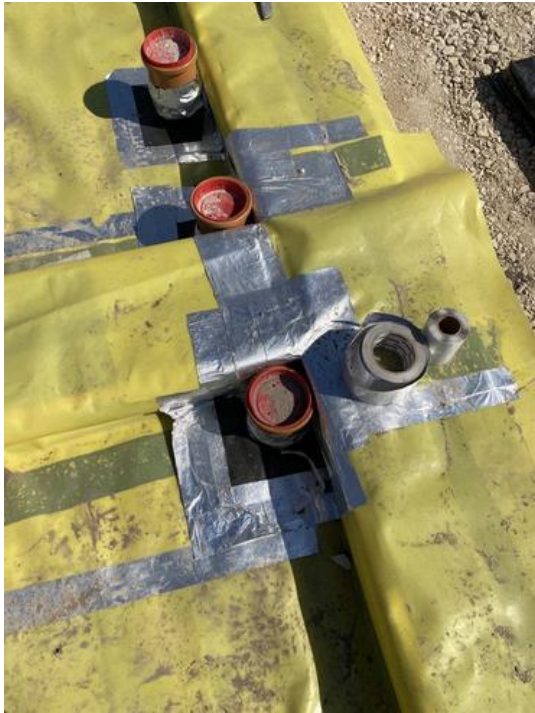
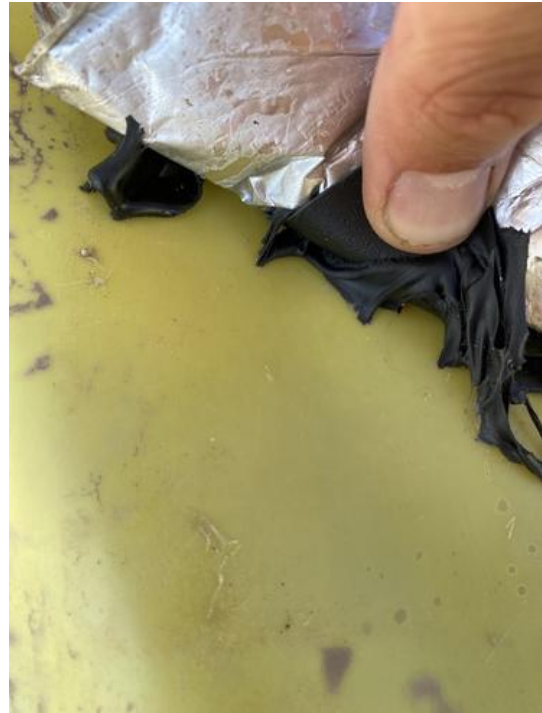
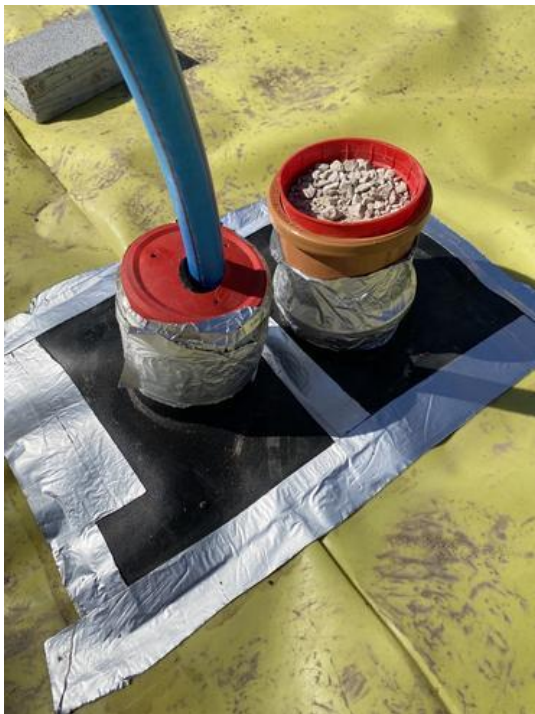
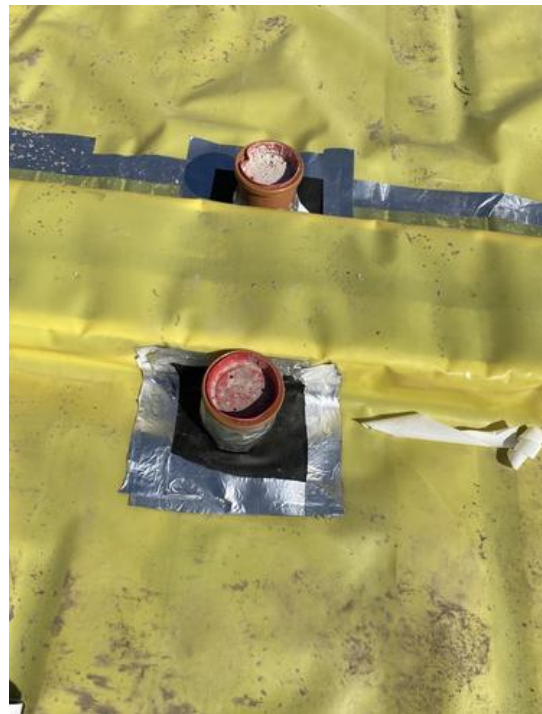
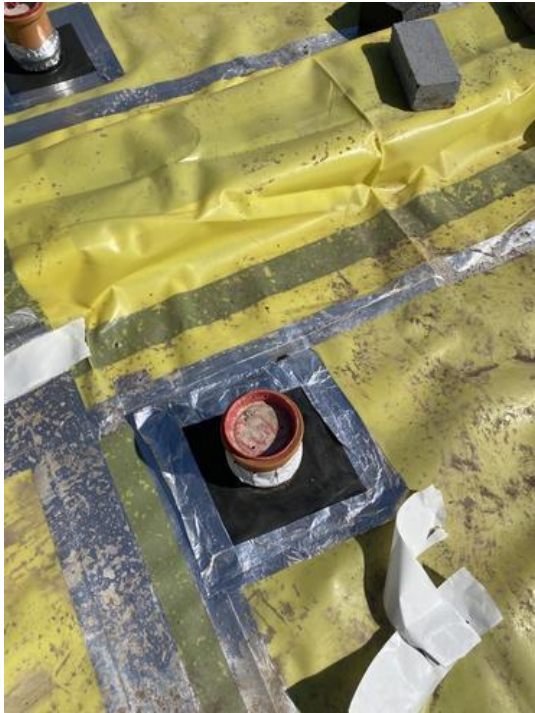
**Gas Membrane Condition: Open punctures, tears, rips, stretching, Presence of debris, Repairs, Signs of weakness such as raised or sunken indentations, Protection plan in place to restrict access to lain gas membrane? IF FAIL DESCRIPTION IN ACTIONS AND PHOTOS REQUIRED** Pass

**Laps, welds, and joints seals: Joints lapped and sealed in accordance with manufacturer's requirements/ specification? Minimum overlap insured? Sections taped twice? Are welds complete? Appropriate joining/double-sided tape used, Folds running in line with joints? (no joints cutting across folds)** Pass

**Service entries seals: Top hats seal arrangements fixed around service entries? Use of Jubilee clips?** Yes

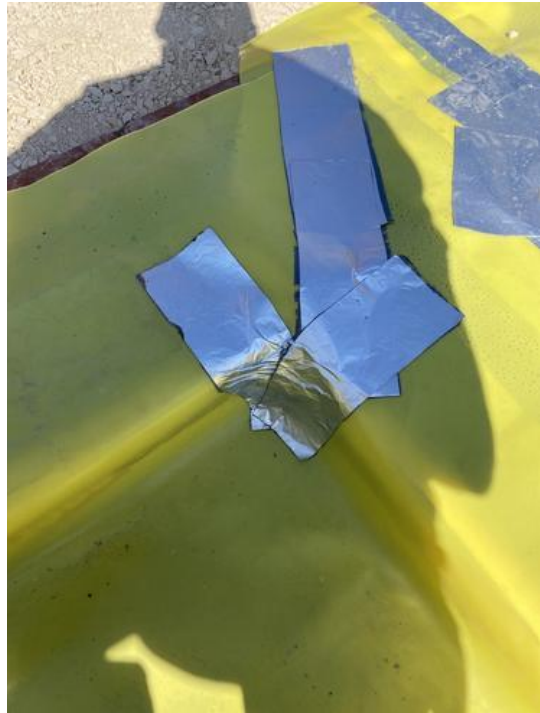
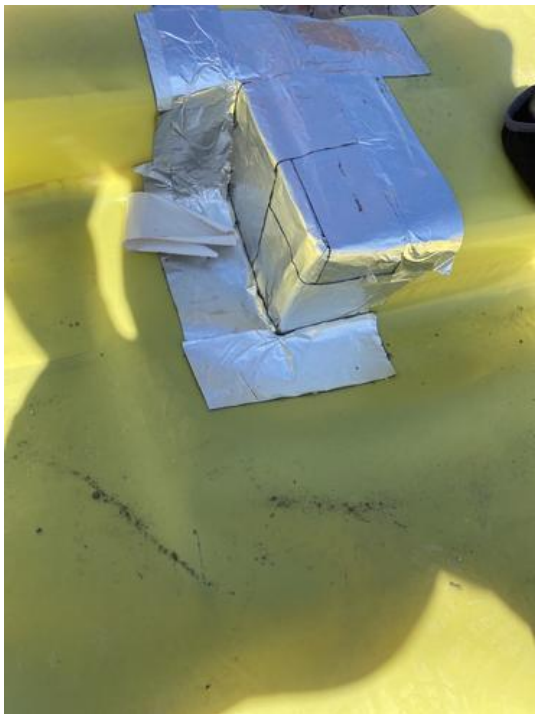
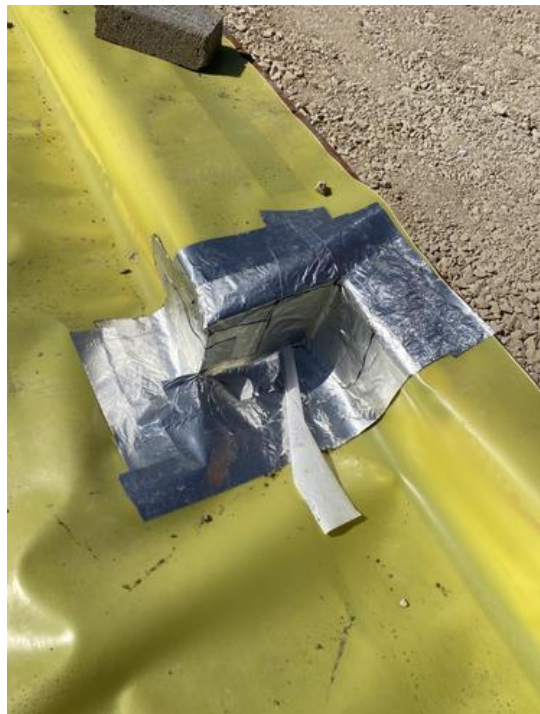
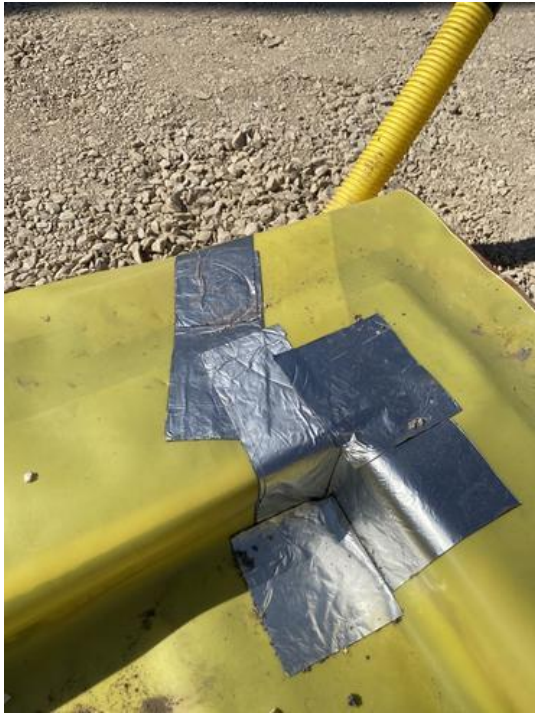
**Corners / Internal joints: Check all corners are correctly formed or contractor has used preformed corners.** Pass

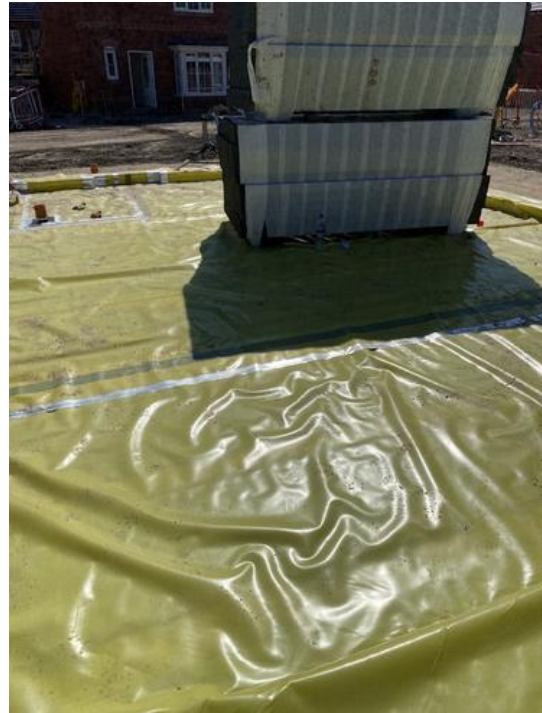
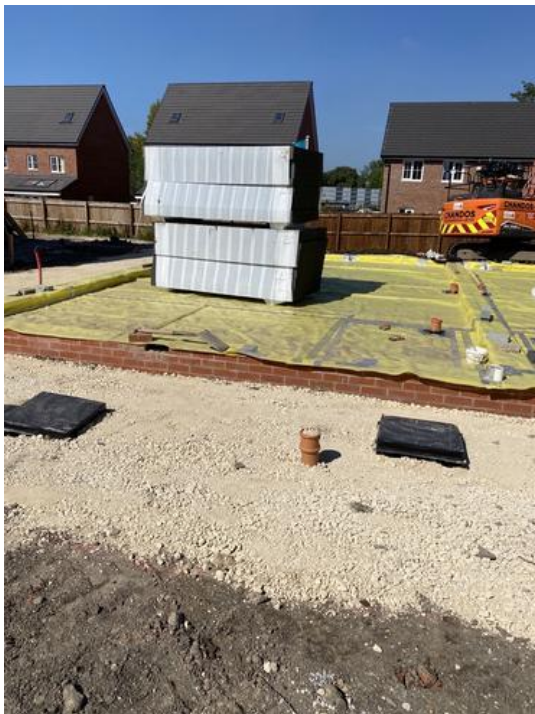
**Extent of Coverage: Is the membrane covering the entire plot? Does membrane span over outside walls?** Yes

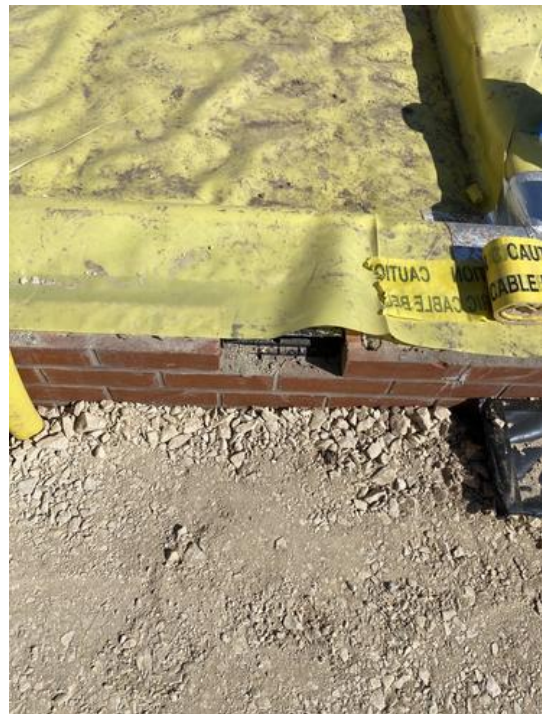
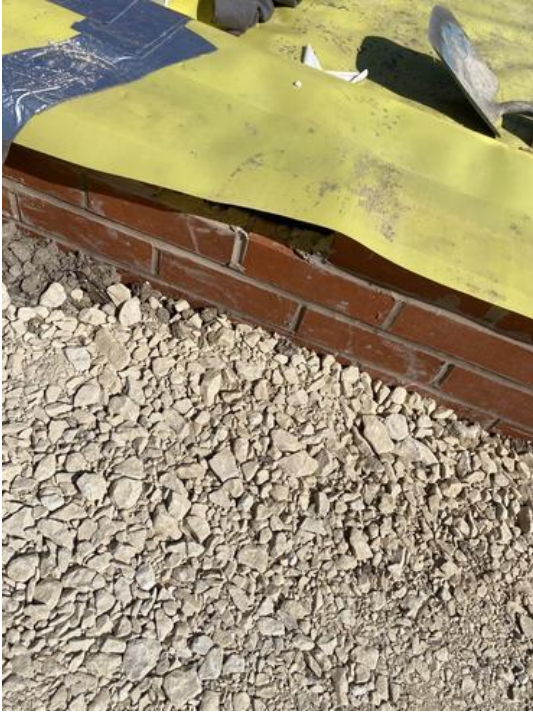
**External Wall Air bricks:** Numbers, size. positions as design drawing? (Minimum of 3 walls)

Pass
