**GAS MEMBRANE VALIDATION**

| Site Name: Belle Vue Stadium | Project Number: 12-123 |
| Company Name: Countryside | Date: 15-07-2022 |

**Plot – 141**

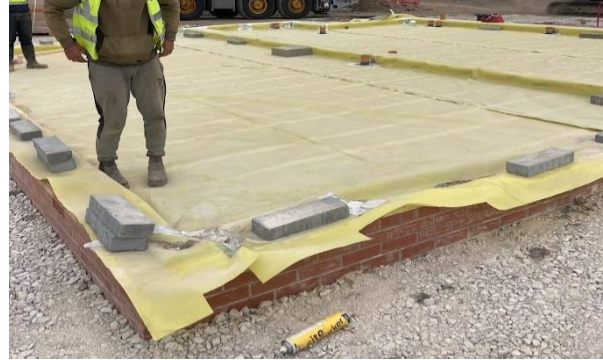
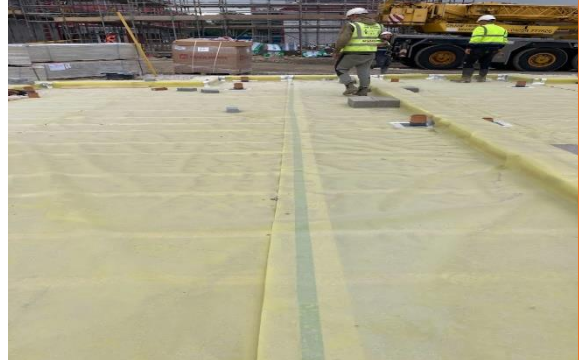
**General Condition of Membrane-Good Condition**

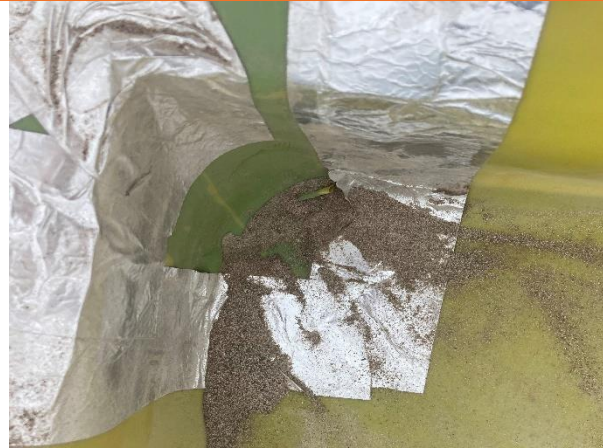
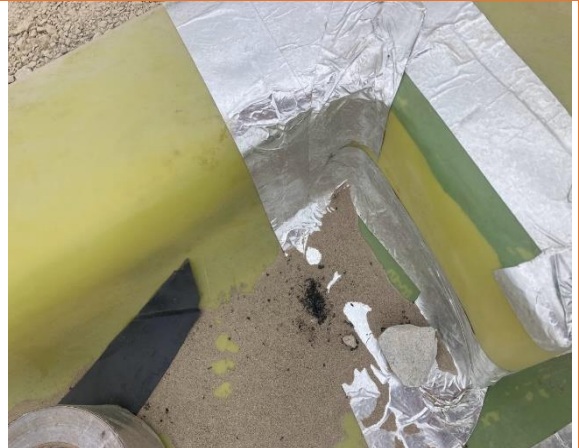
**Verification of Joints and Seals-Overlapped and sealed correctly**

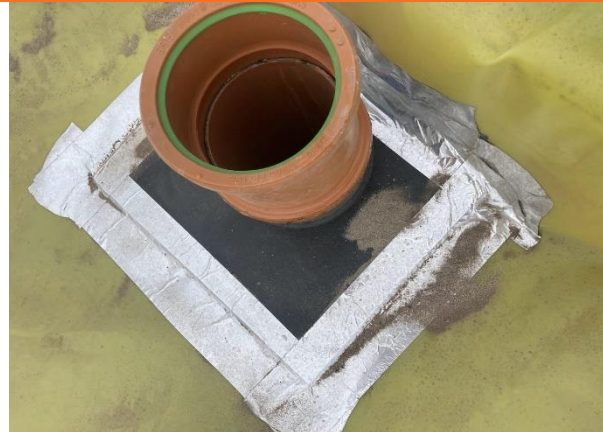
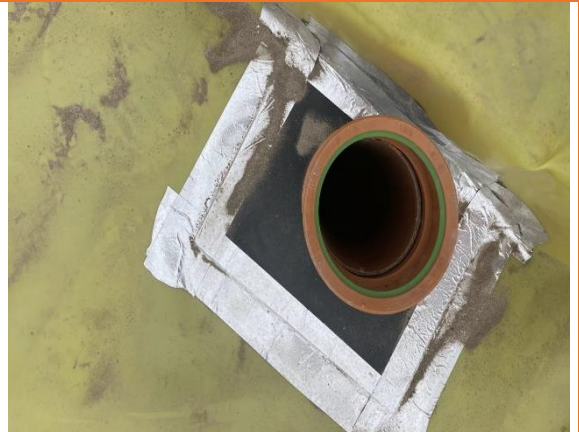
**Verification of Service Penetrations-Good Condition**

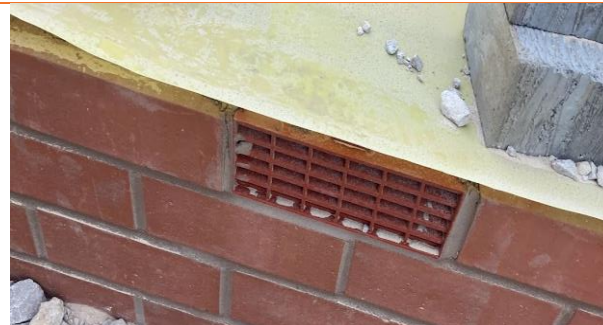
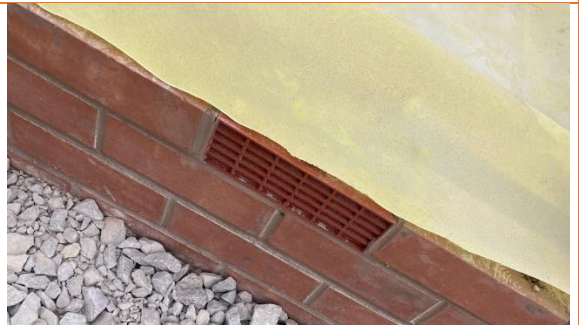
**Verification of Ventilation-Good Condition**

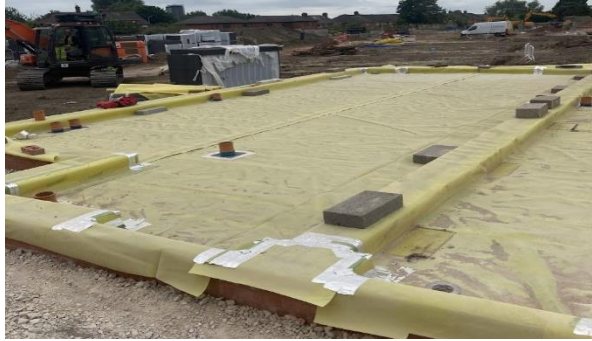
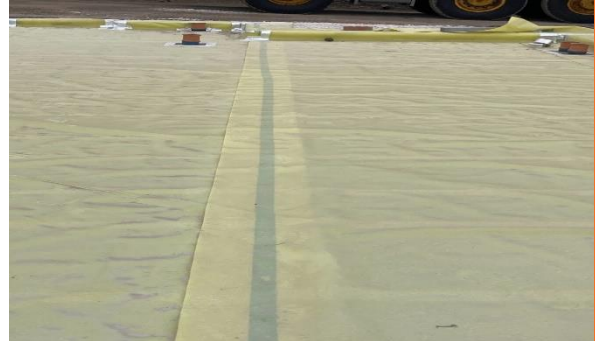
**Plot – 142**

**General Condition of Membrane-Good Condition**

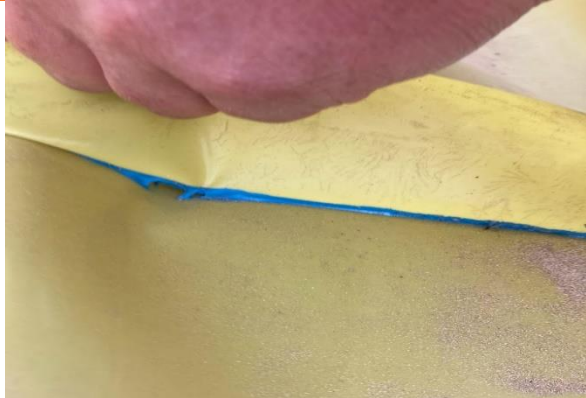
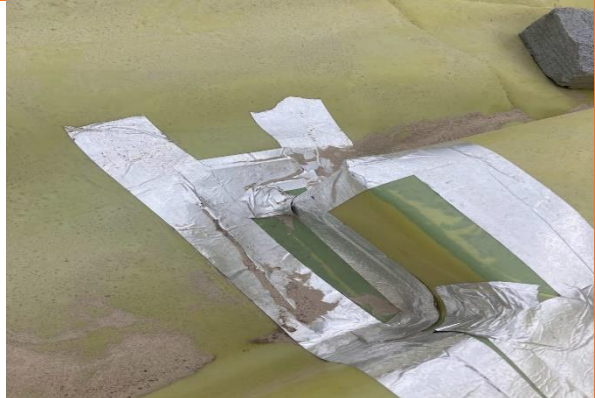
**Verification of Joints and Seals-Overlapped and sealed correctly**

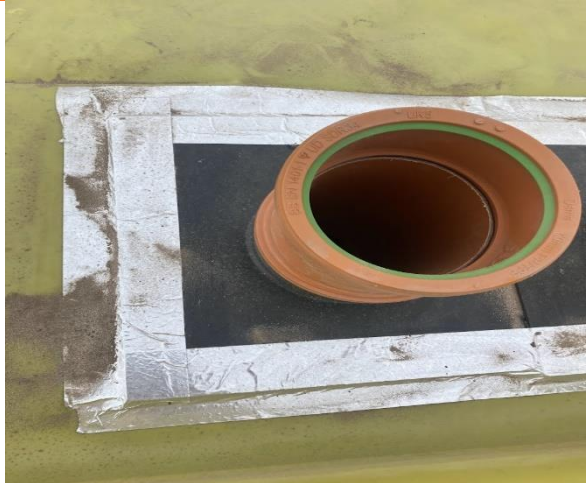
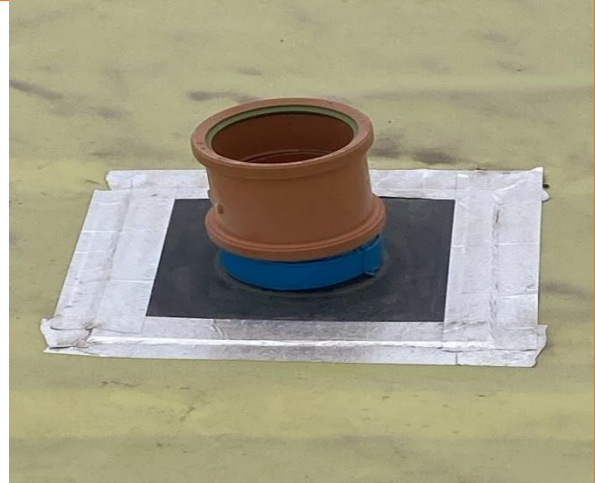
**Verification of Service Penetrations-Good Condition**

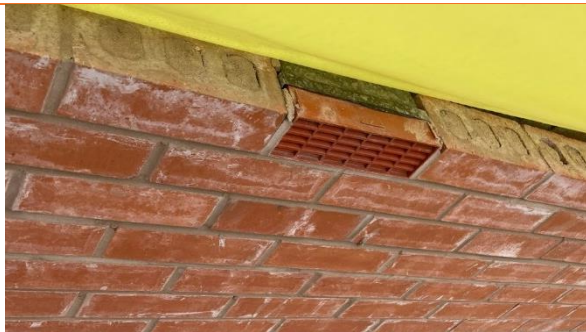
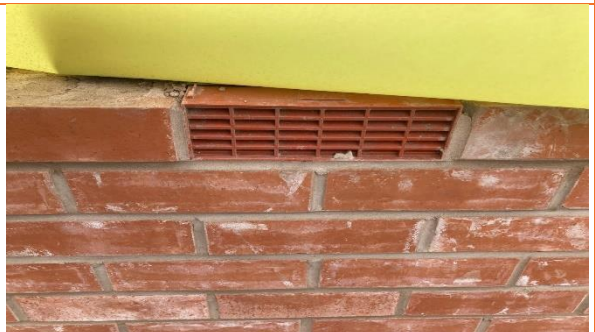
**Verification of Ventilation-Good Condition**
