### GAS MEMBRANE VALIDATION – BELLE VUE

| <b>Project Name: Belle Bue Stadium</b> |
| <b>Project Number: 12-123</b> |
| <b>Plots: 224</b> |

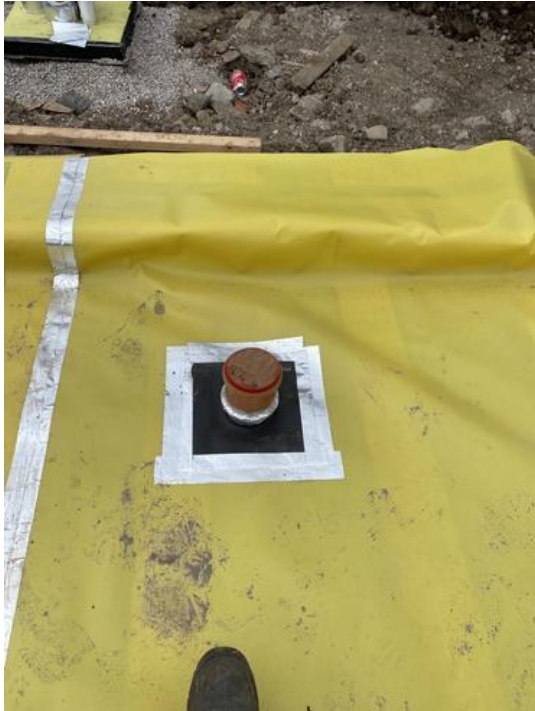
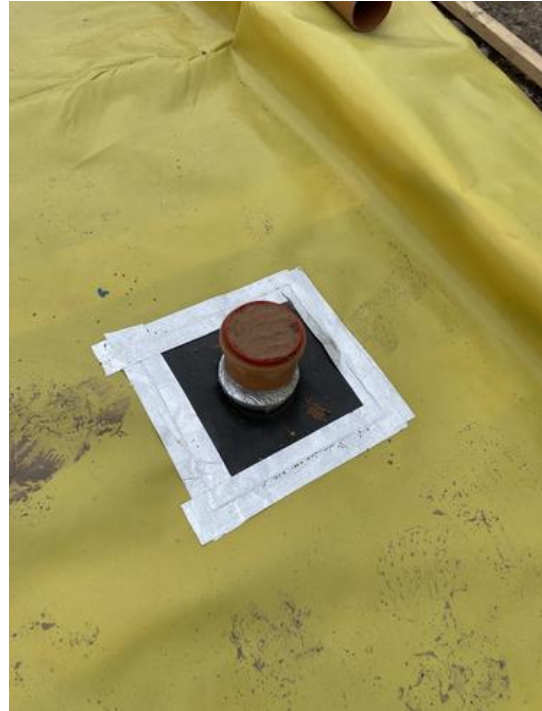
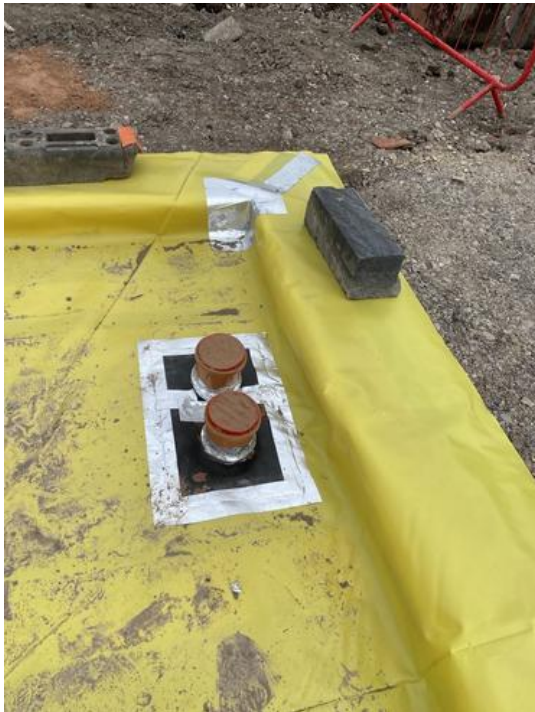
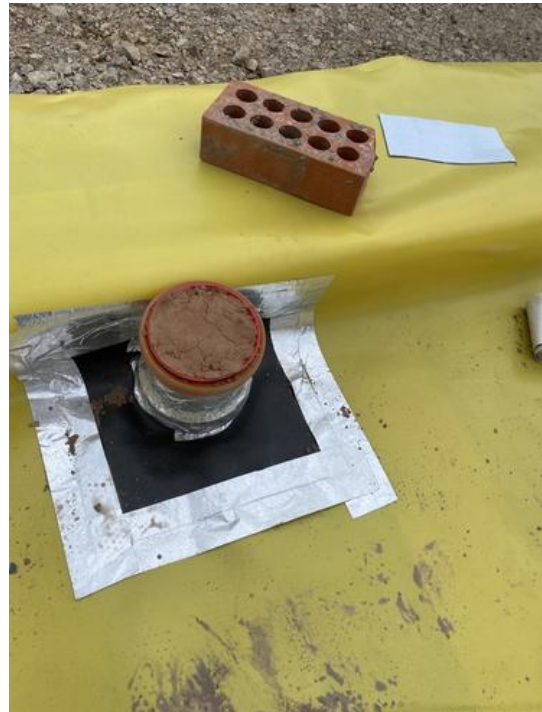
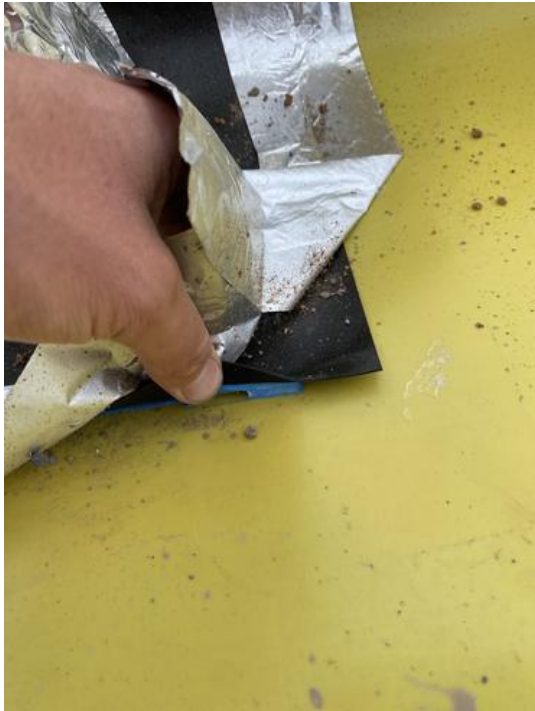
Service entries seals: Top hats seal arrangements fixed around service entries? Use of Jubilee clips?

Yes

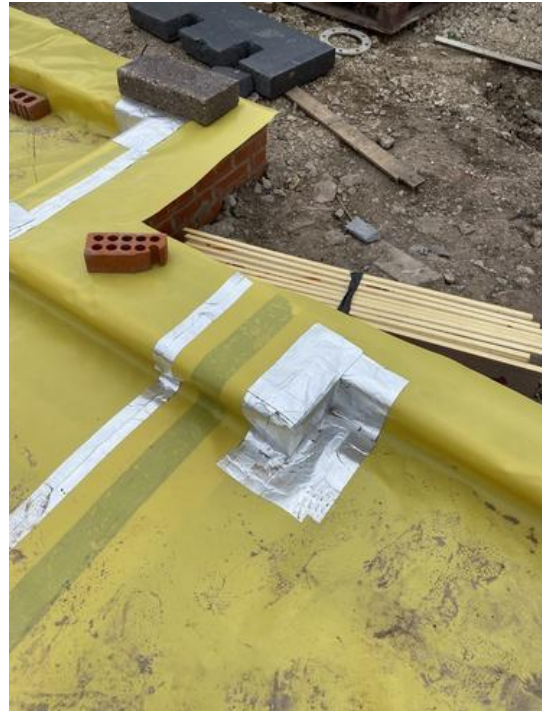
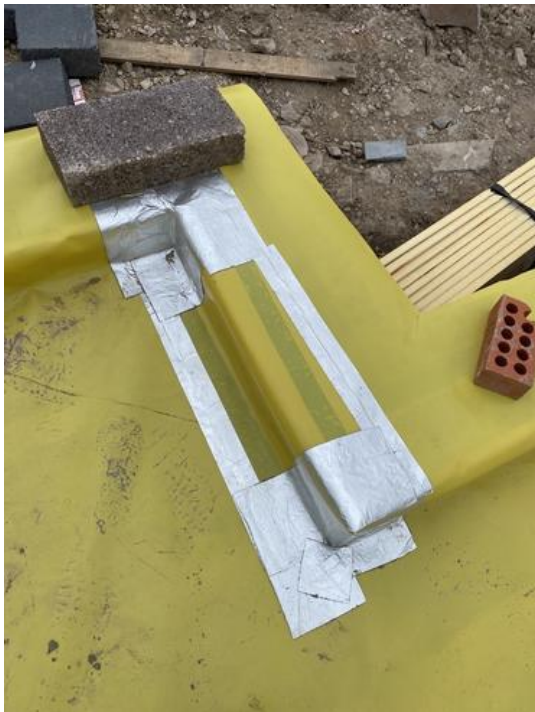
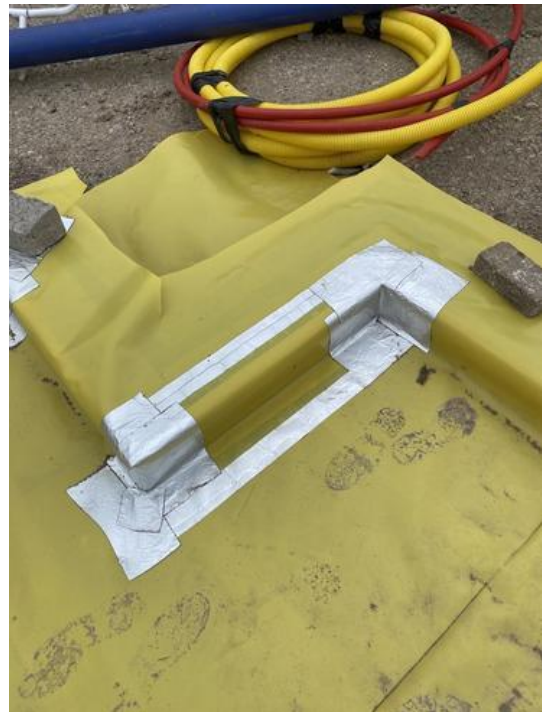
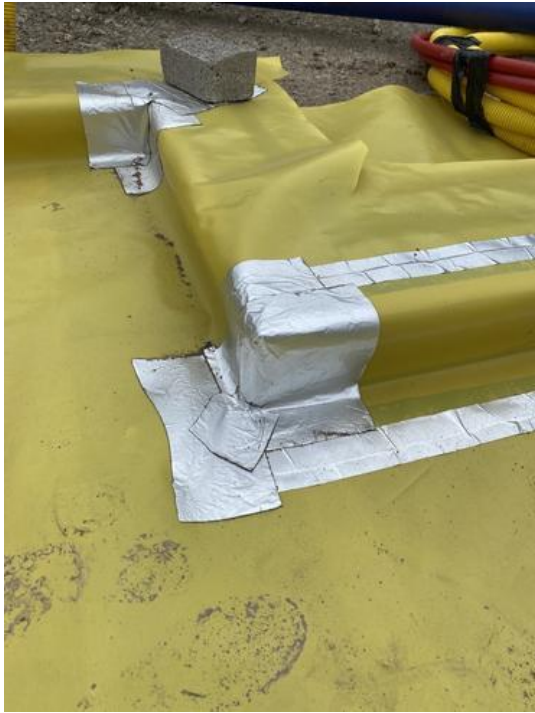
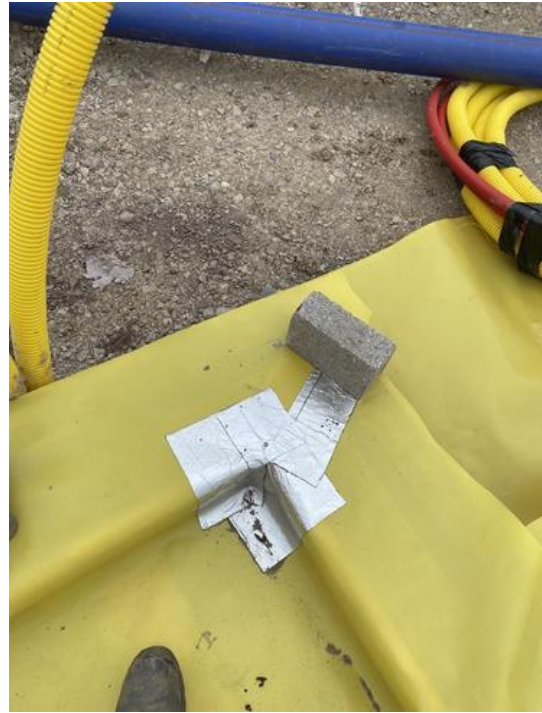
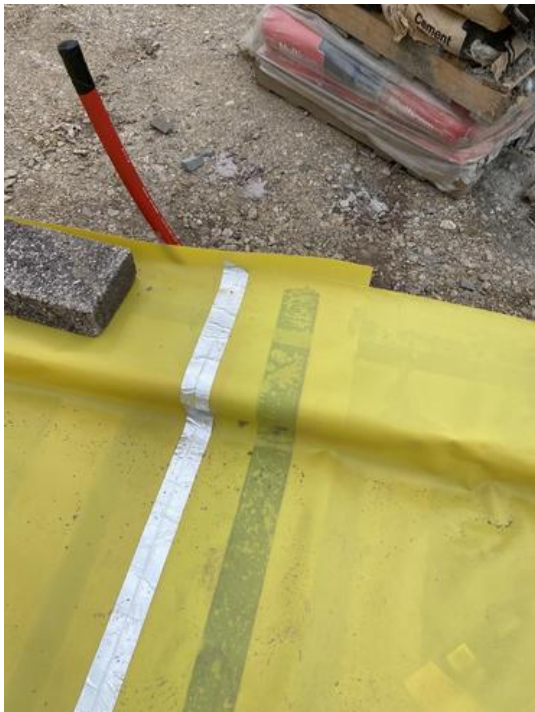
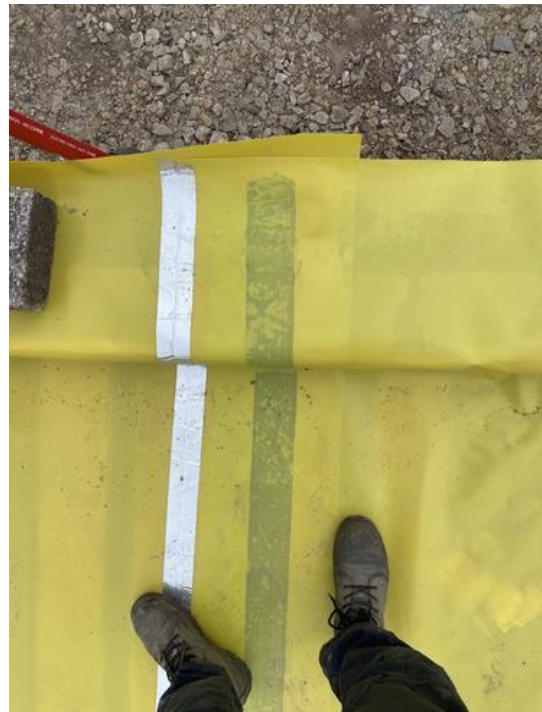
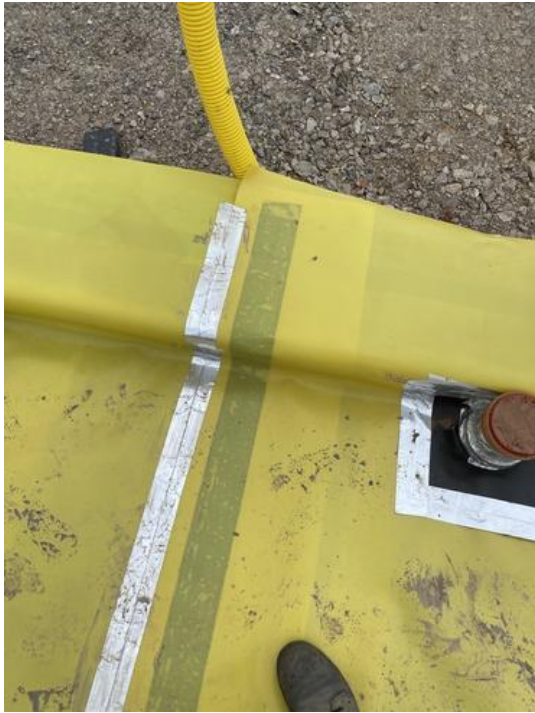
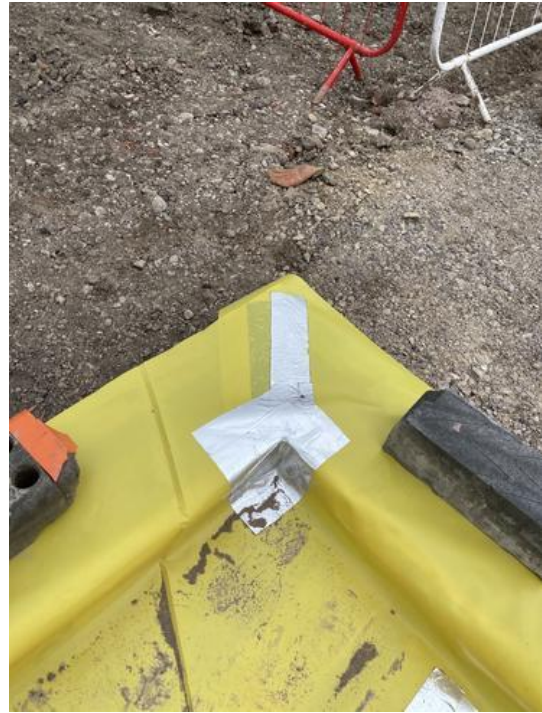
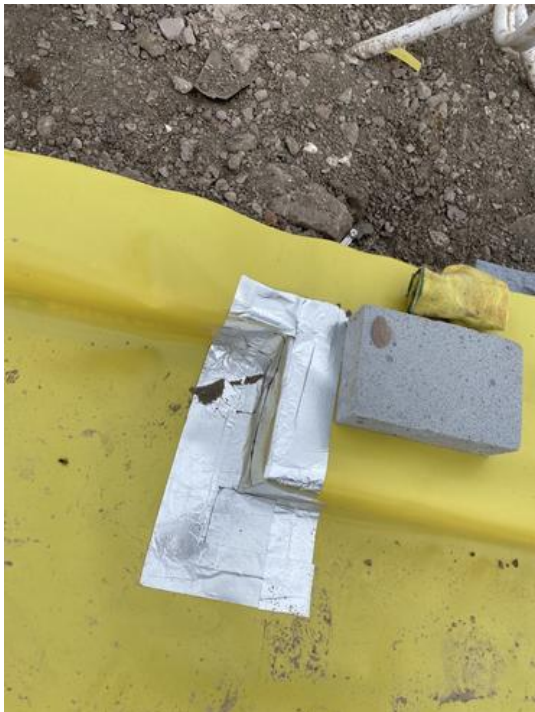
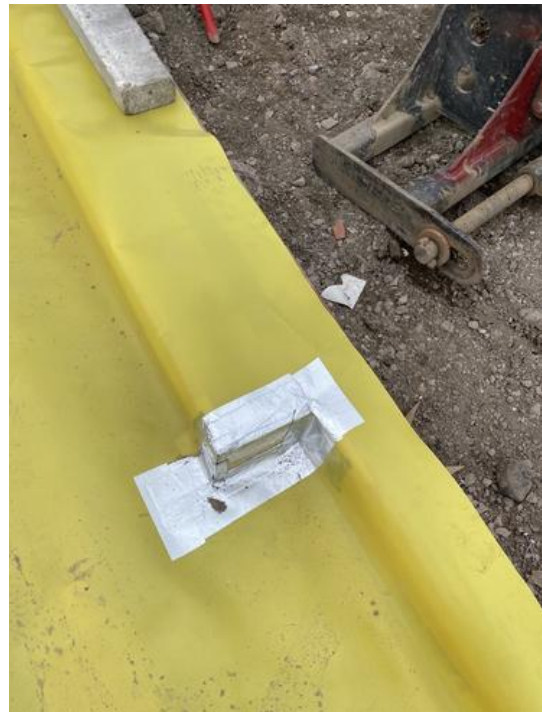
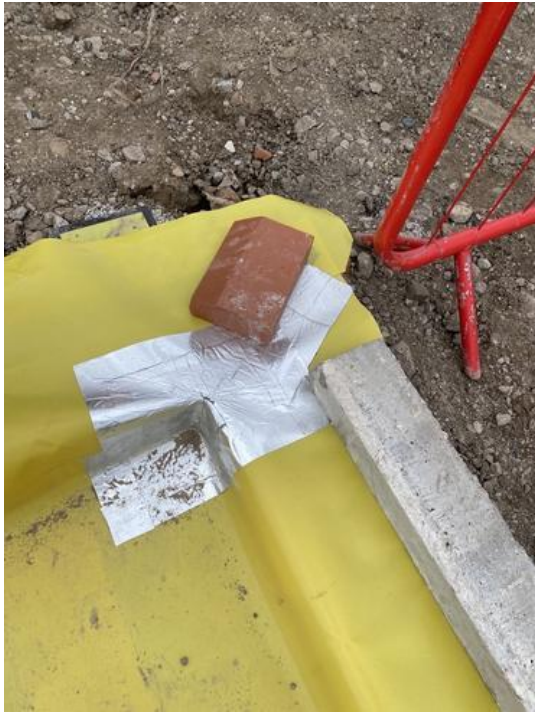
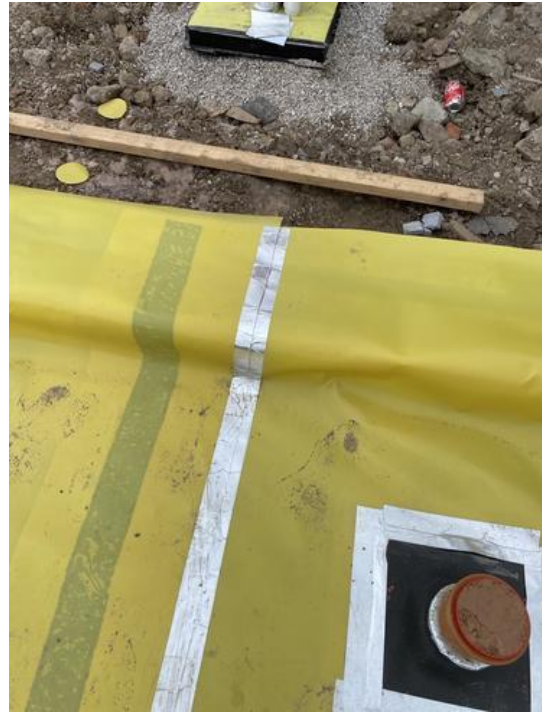
Corners / Internal joints: Check all corners are correctly formed or contractor has used preformed corners.

Pass

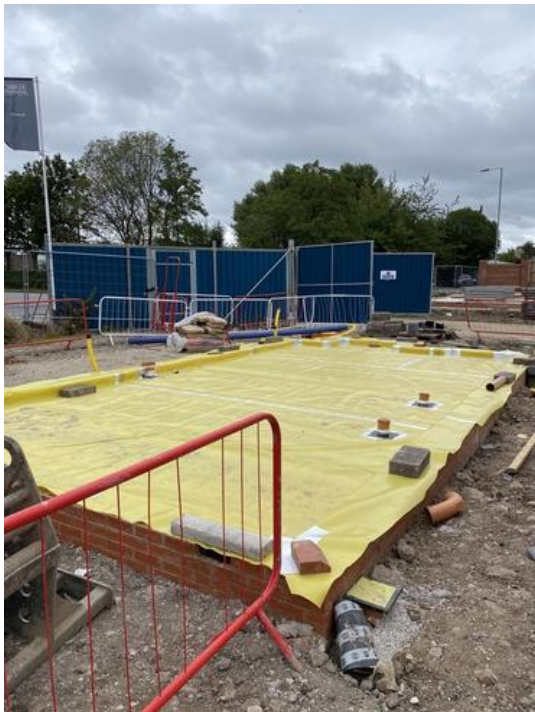
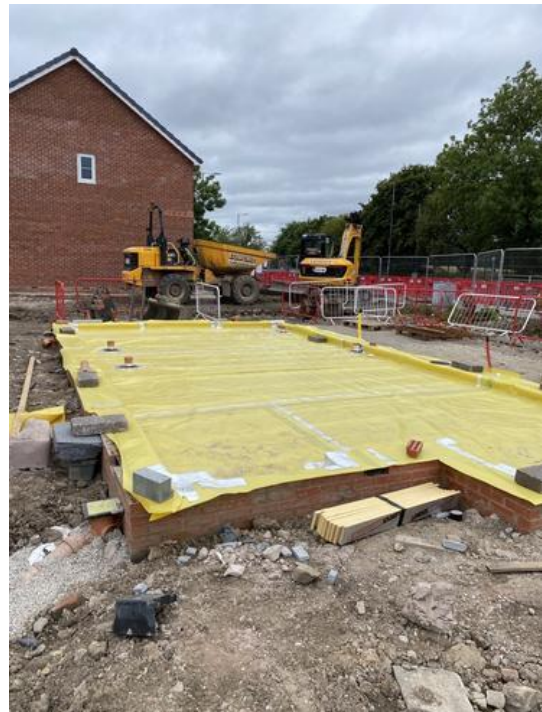
**Extent of Coverage: Is the membrane covering the entire plot? Does membrane span over outside walls?**

Yes

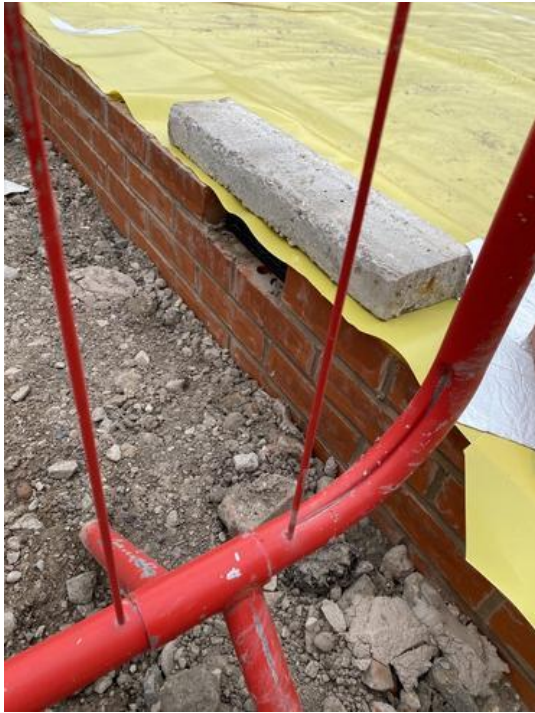
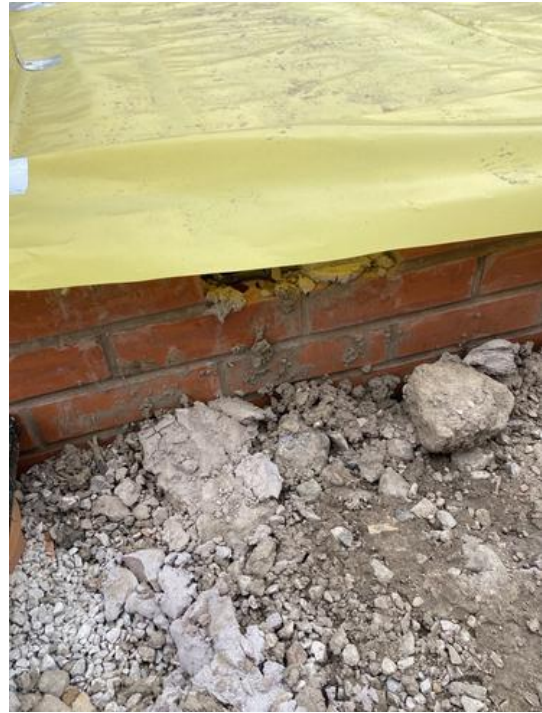
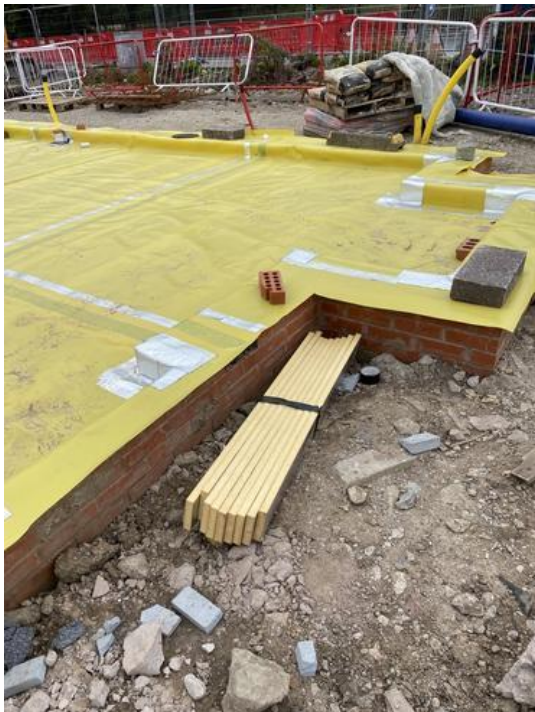
**External Wall Air bricks: Numbers, size. positions as design drawing? (Minimum of 3 walls)**

Pass

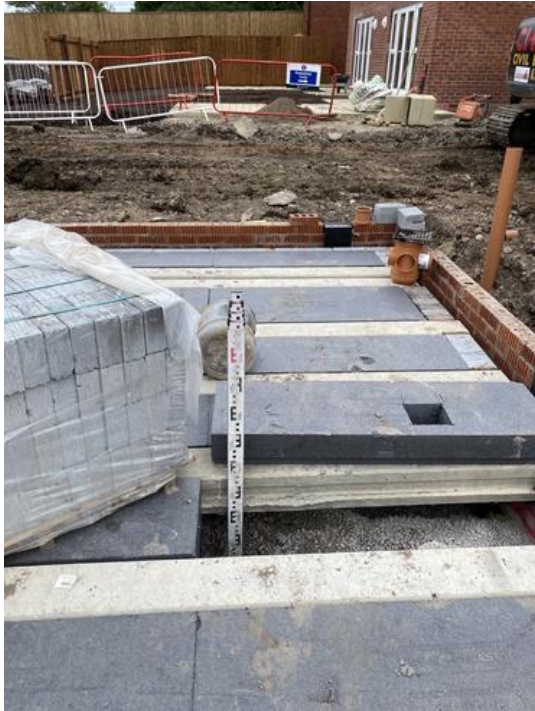
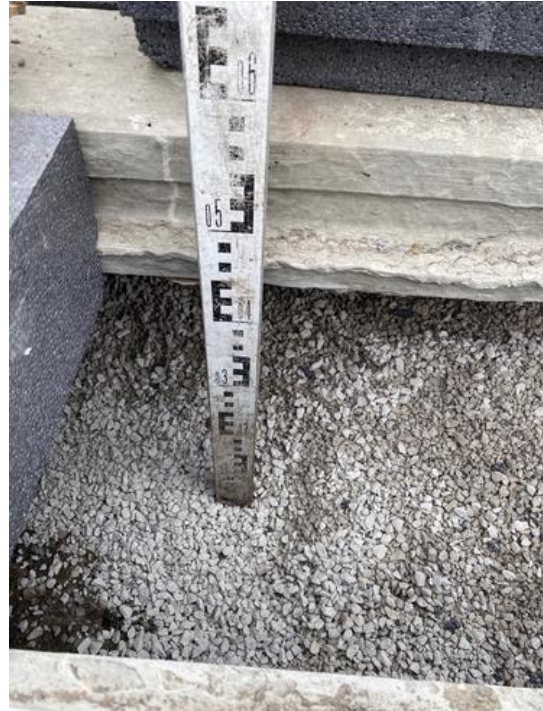
Plot Number223

Is the void clear?Yes

Depth of Void400
