### GAS MEMBRANE VALIDATION – BELLE VUE

| <b>Project Name: Belle Bue Stadium</b> |
| <b>Plots: 240-241</b> |

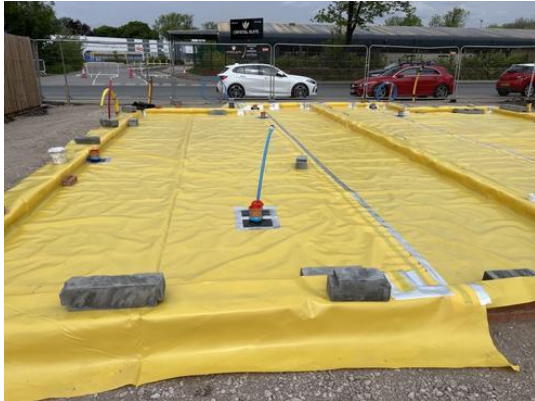
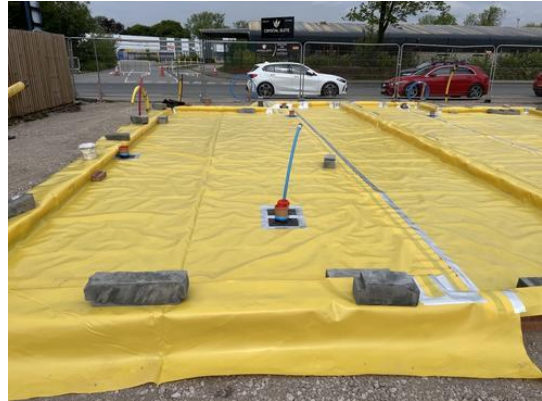
**Gas Membrane Condition:** Open punctures, tears, rips, stretching, Presence of debris, Repairs, Signs of weakness such as raised or sunken indentations, Protection plan in place to restrict access to lain gas membrane? IF FAIL DESCRIPTION IN ACTIONS AND PHOTOS REQUIRED

Pass

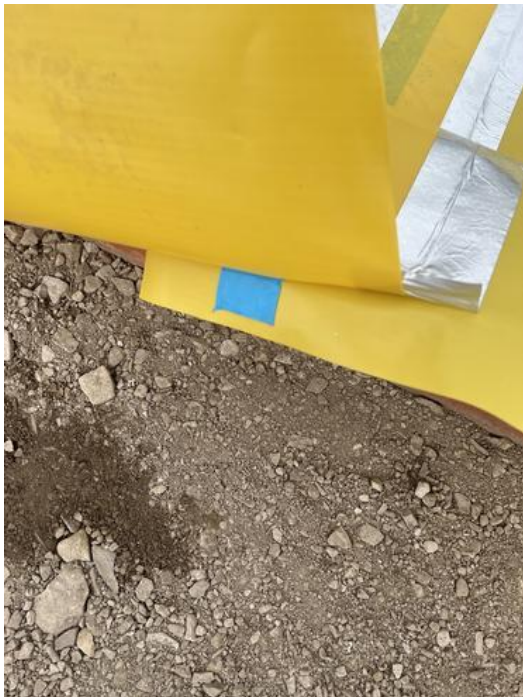
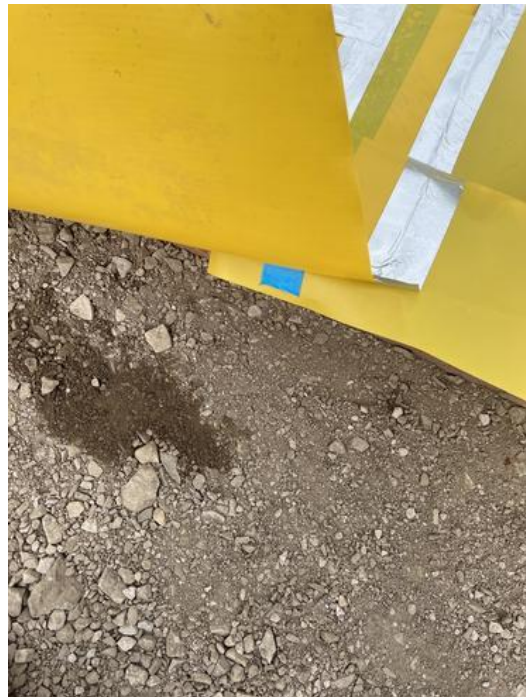
**Laps, welds, and joints seals:** Joints lapped and sealed in accordance with manufacturer's requirements/ specification? Minimum overlap insured? Sections taped twice? Are welds complete? Appropriate joining/double-sided tape used, Folds running in line with joints? (no joints cutting across folds)

Pass

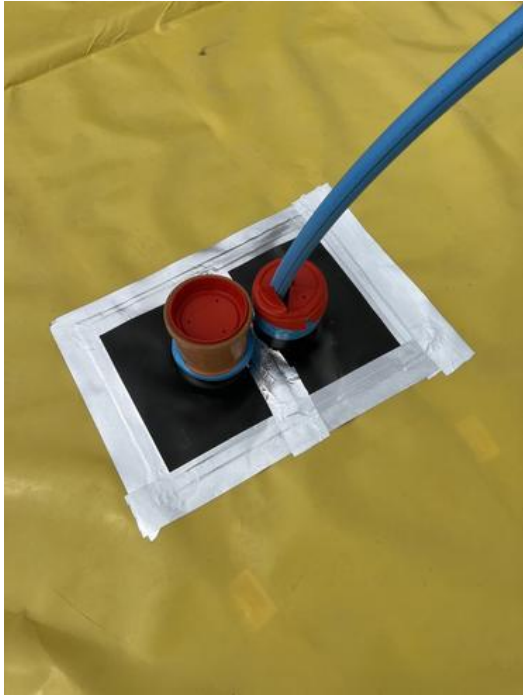
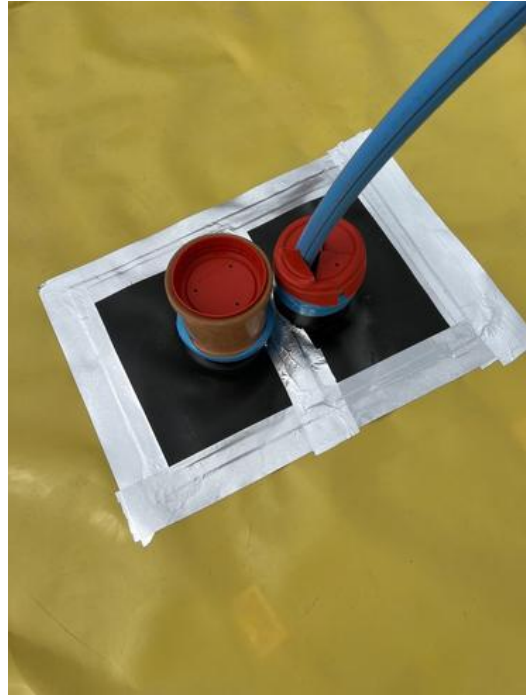
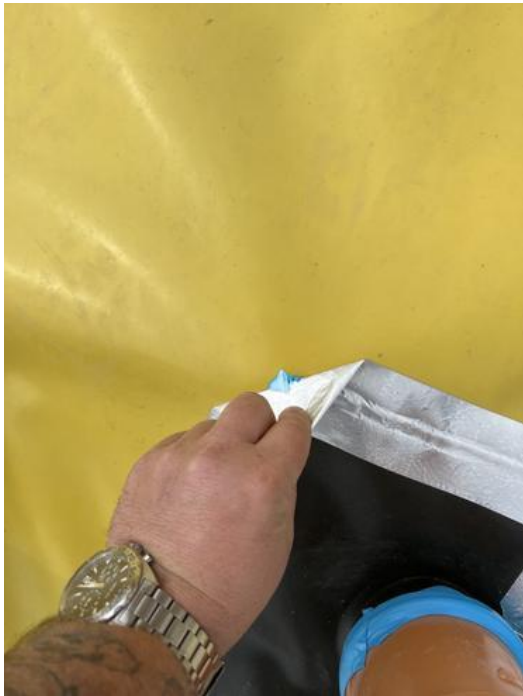
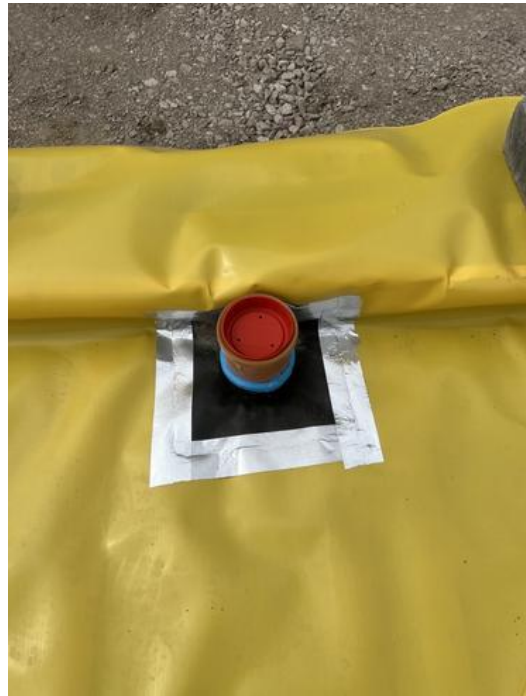
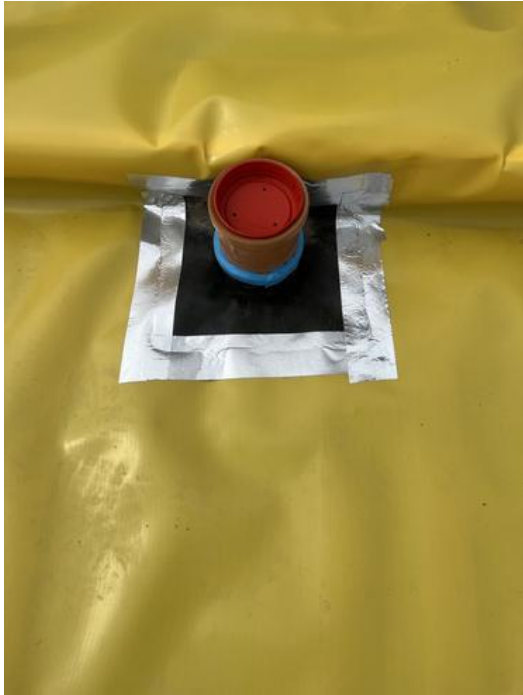
**Service entries seals:** Top hats seal arrangements fixed around service entries? Use of Jubilee clips?

Yes

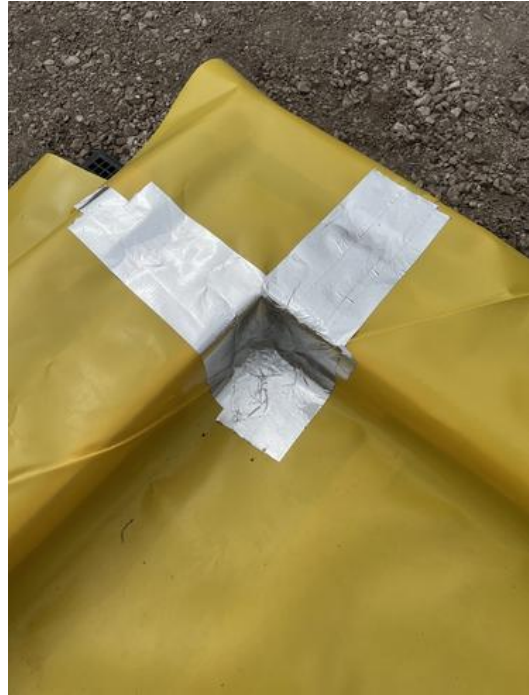
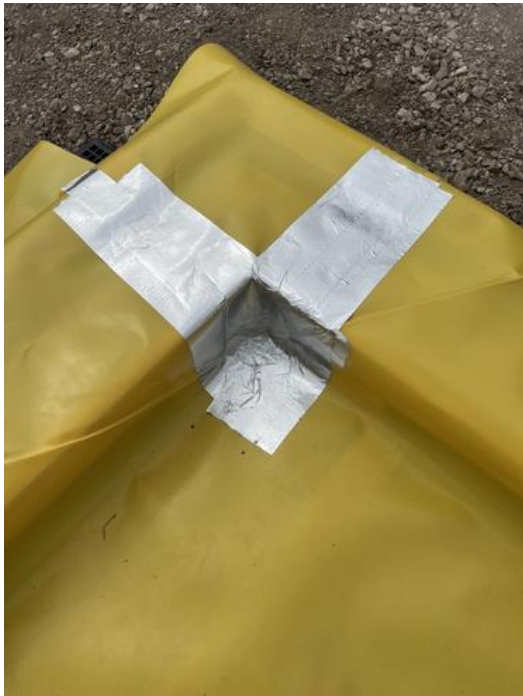
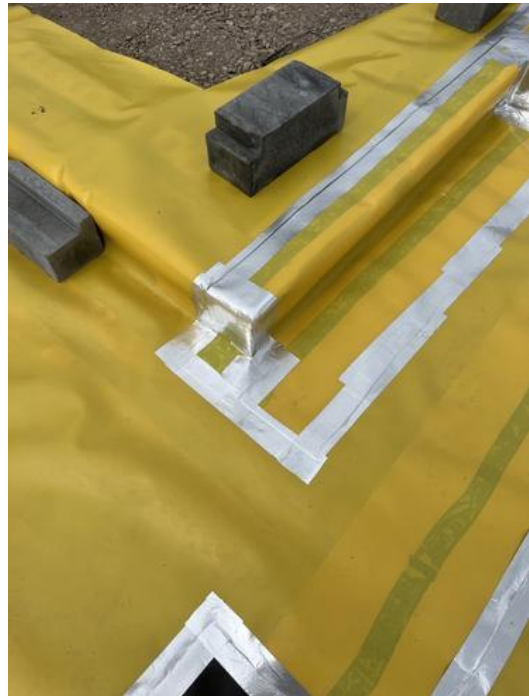
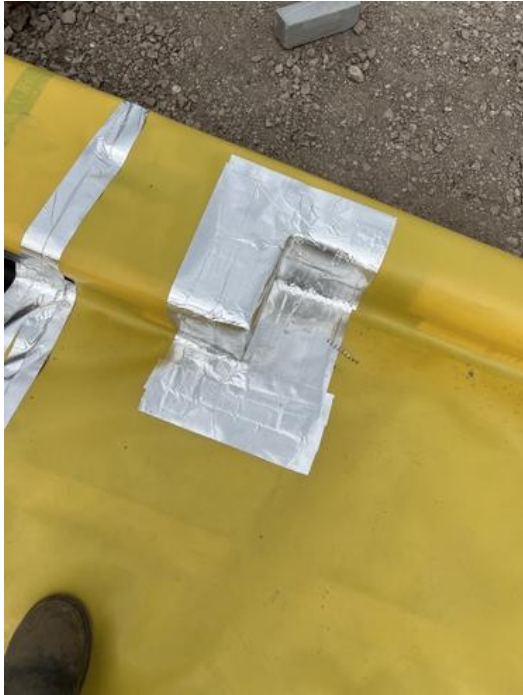
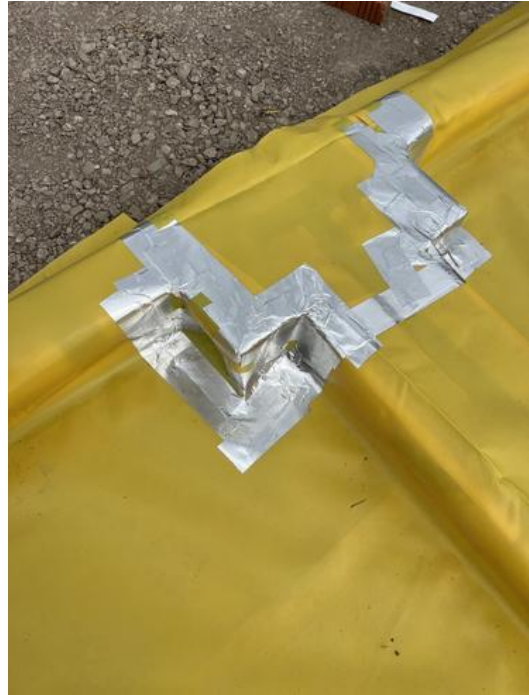
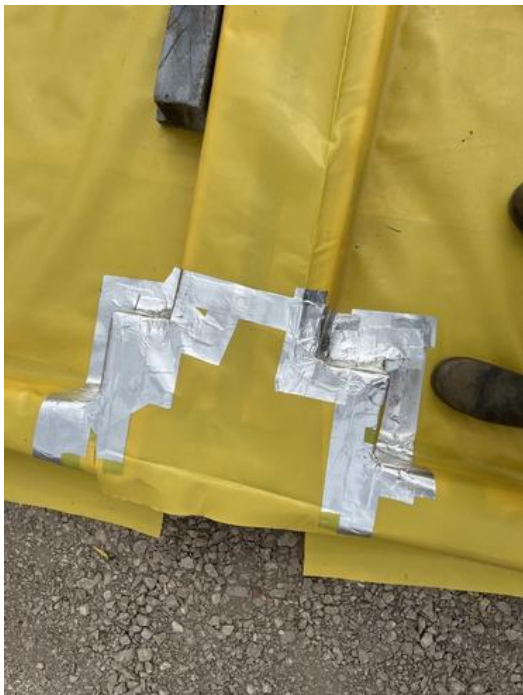
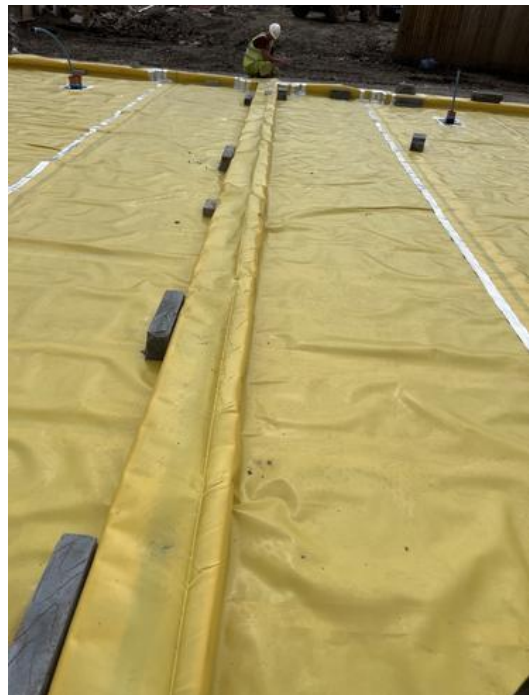
**Corners / Internal joints:** Check all corners are correctly formed or contractor has used preformed corners.

Pass

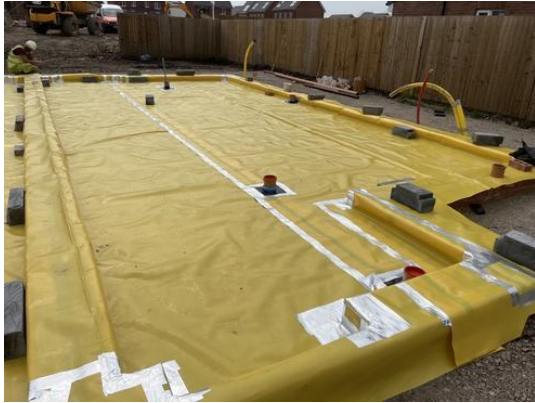
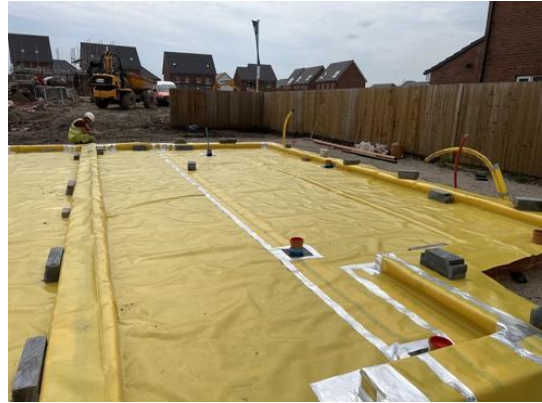
**Extent of Coverage:** Is the membrane covering the entire plot? Does membrane span over outside walls?

Yes

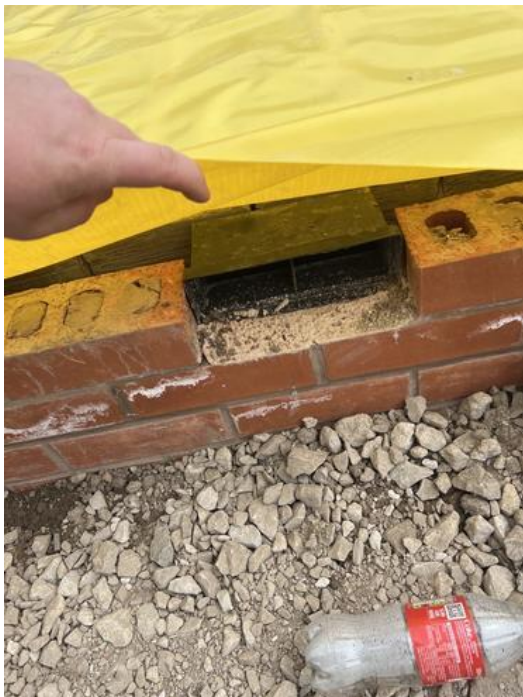
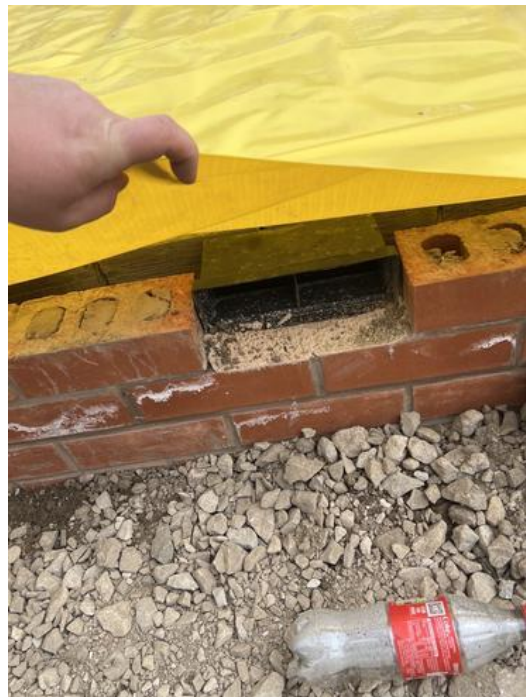
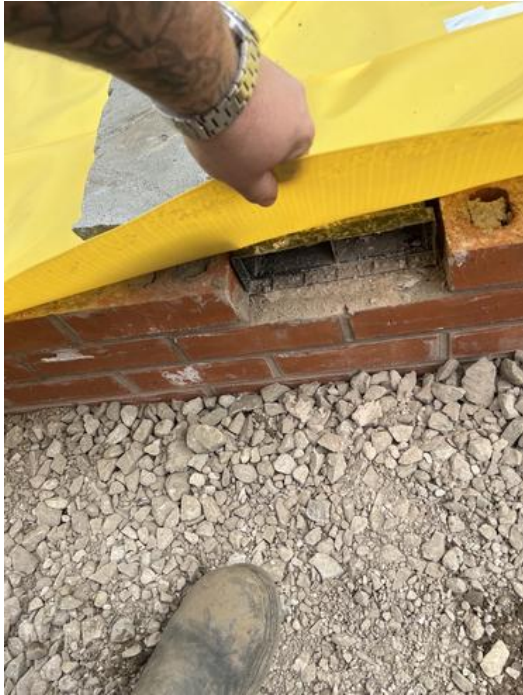
External Wall Air bricks: Numbers, size. positions as design drawing? (Minimum of 3 walls)

Pass

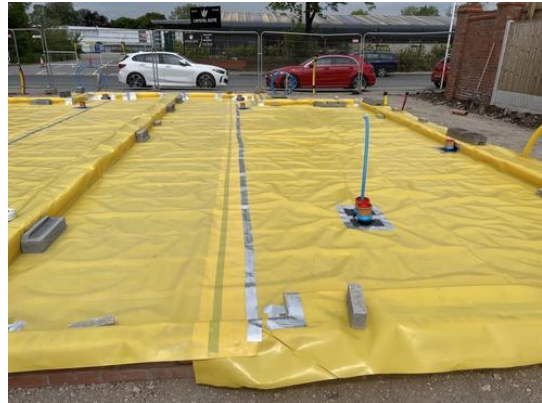
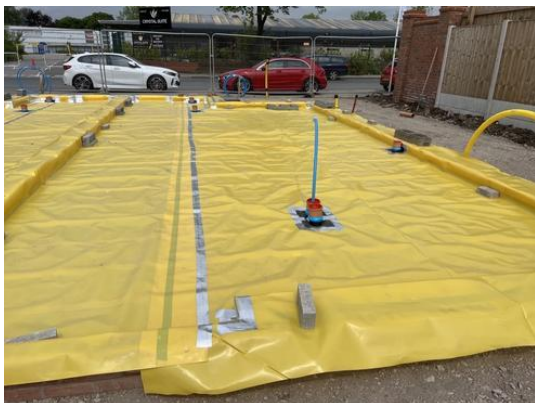
Gas Membrane Condition: Open punctures, tears, rips, stretching, Presence of debris, Repairs, Signs of weakness such as raised or sunken indentations, Protection plan in place to restrict access to lain gas membrane? IF FAIL DESCRIPTION IN ACTIONS AND PHOTOS REQUIRED

Pass

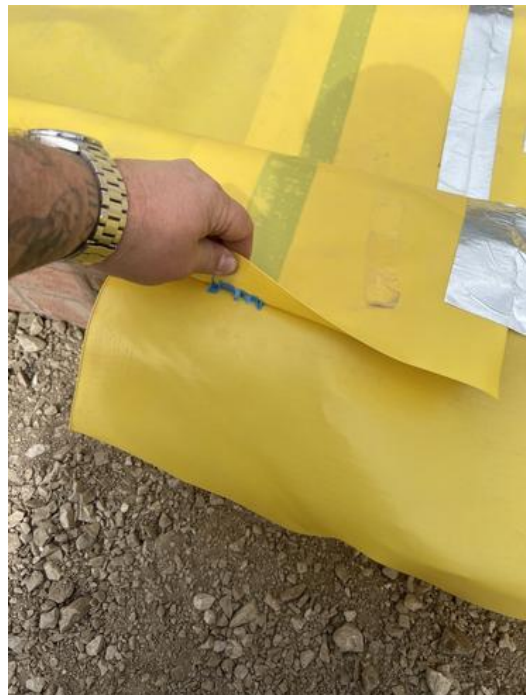
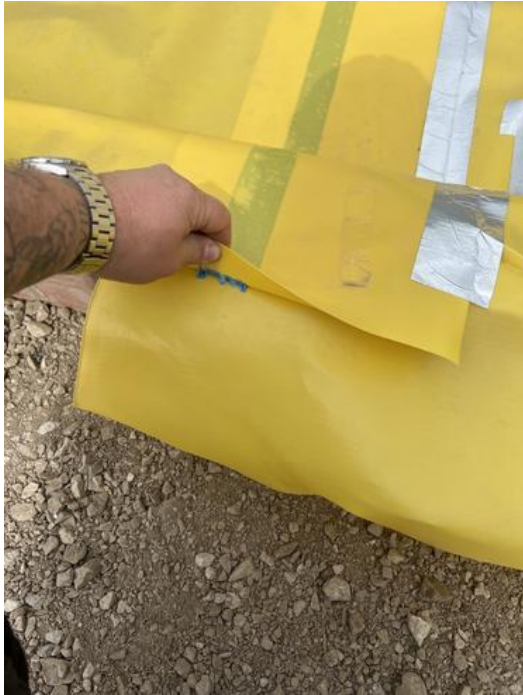
Laps, welds, and joints seals: Joints lapped and sealed in accordance with manufacturer's requirements/ specification? Minimum overlap insured? Sections taped twice? Are welds complete? Appropriate joining/double-sided tape used, Folds running in line with joints? (no joints cutting across folds)

Pass

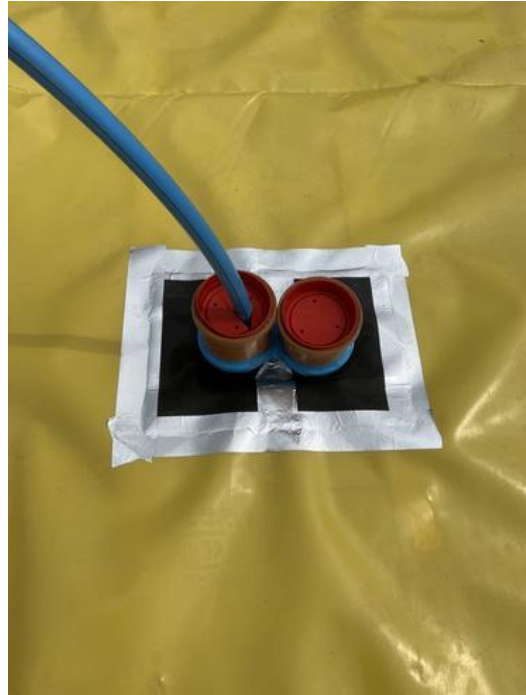
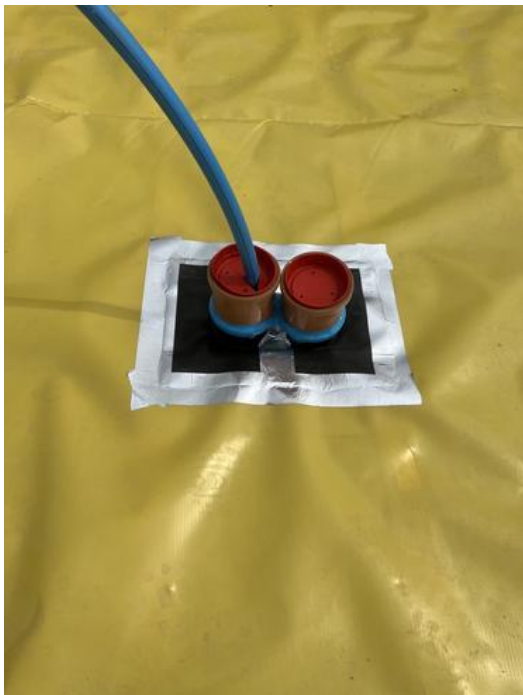
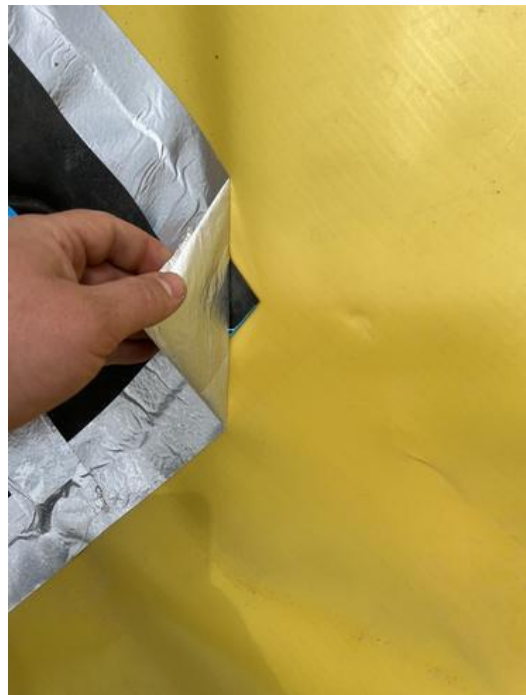
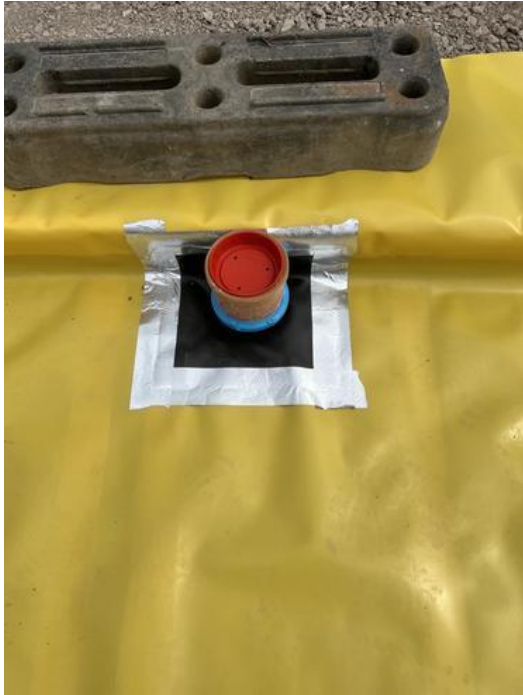
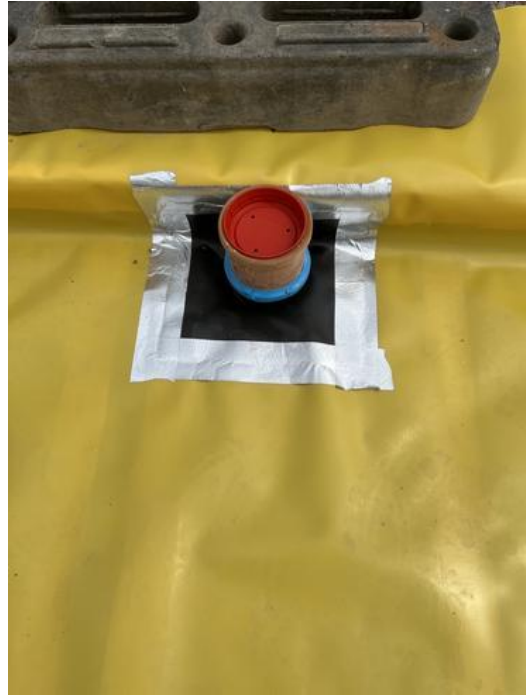
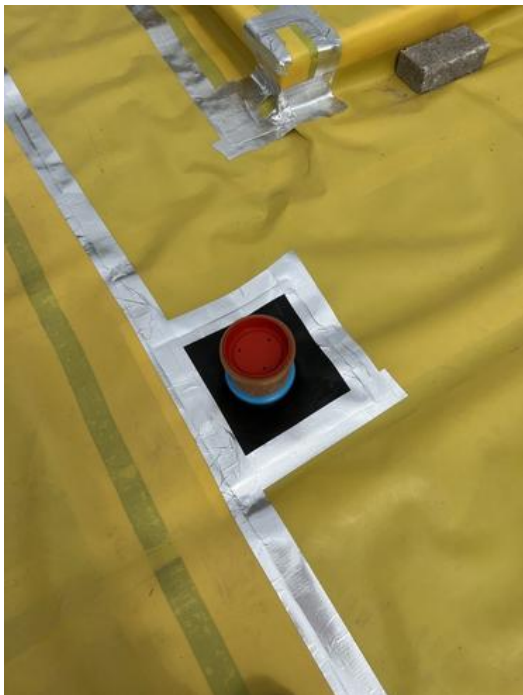
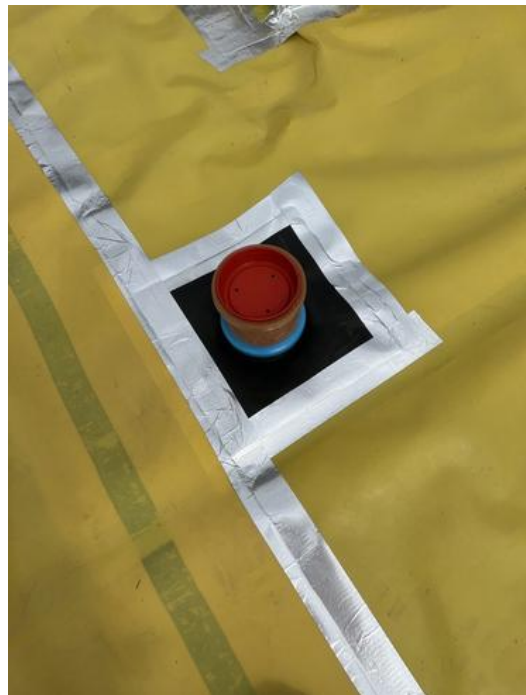
Service entries seals: Top hats seal arrangements fixed around service entries? Use of Jubilee clips?

Yes

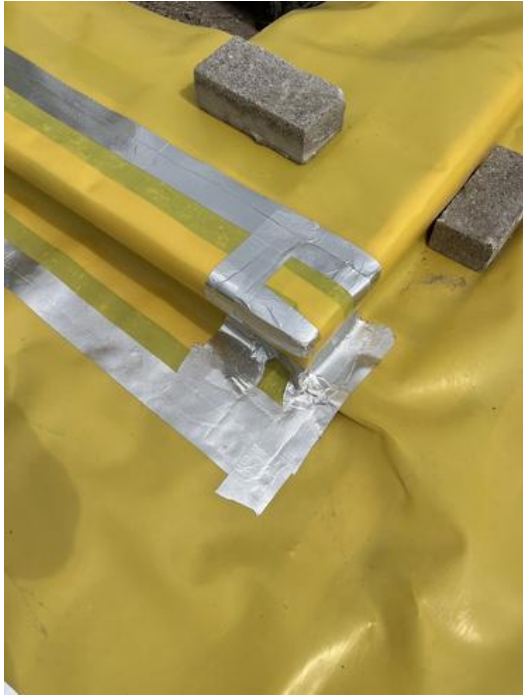
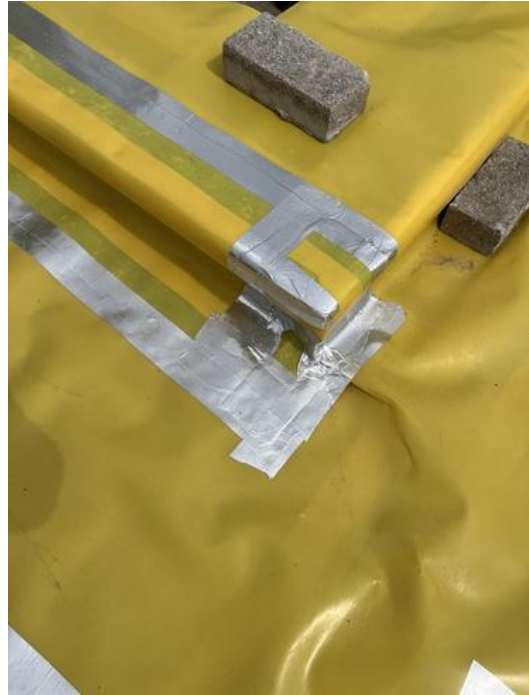
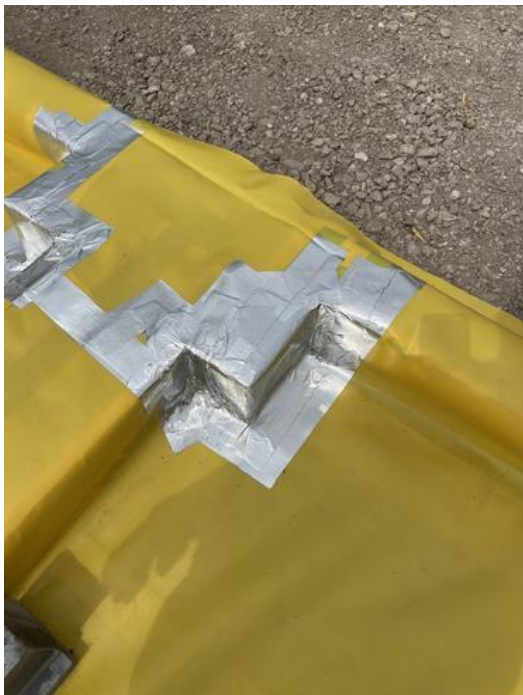
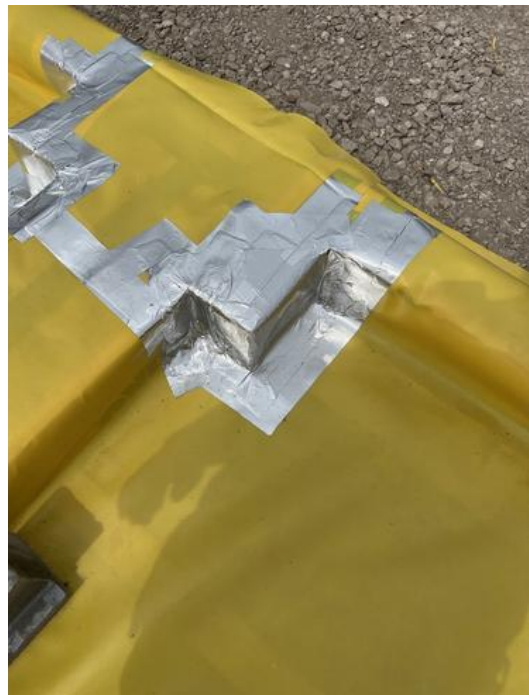
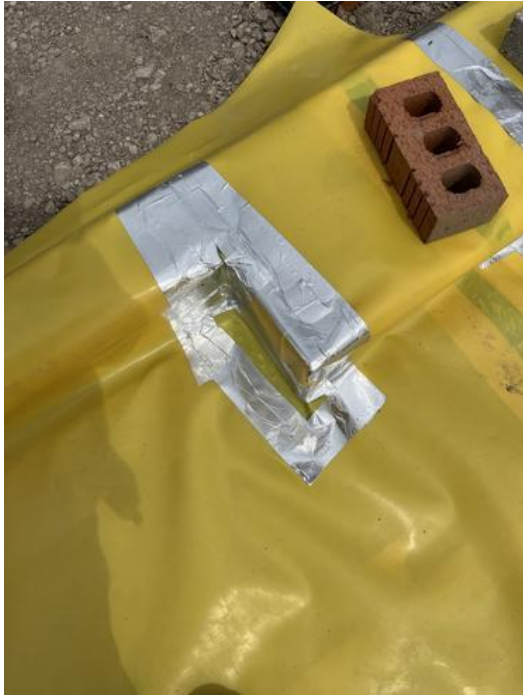
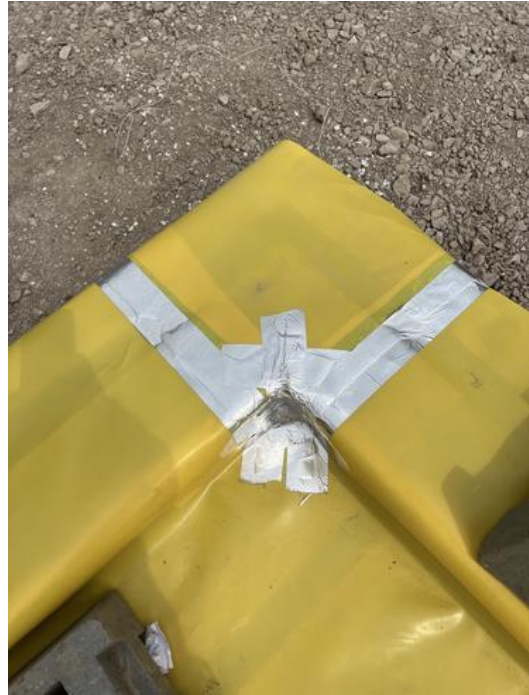
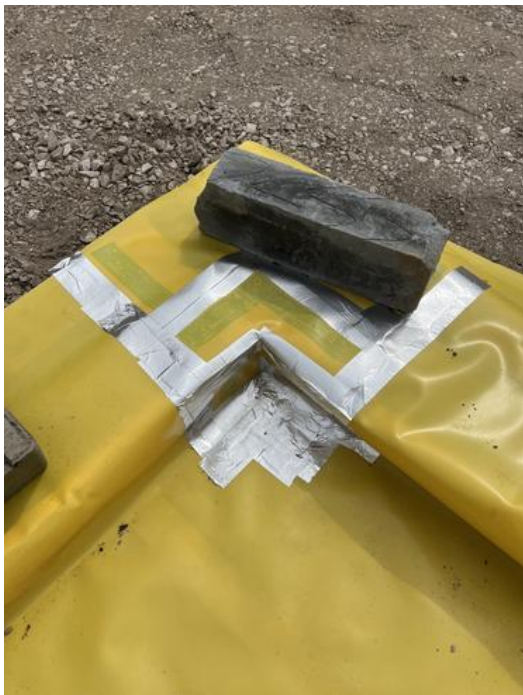
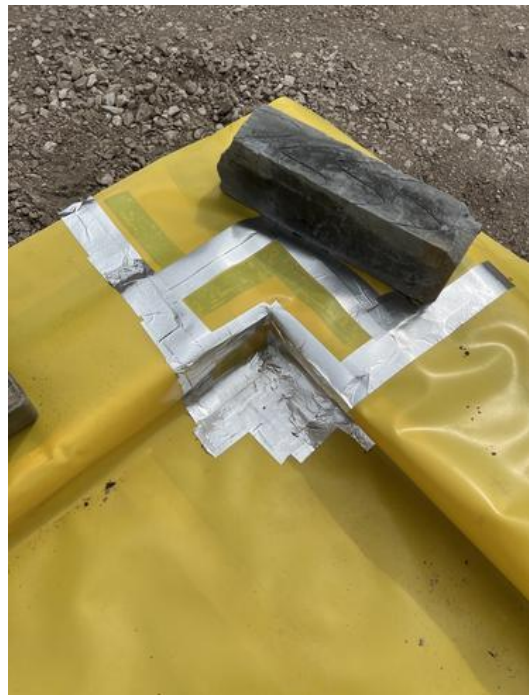
**Corners / Internal joints: Check all corners are correctly formed or contractor has used preformed corners.**

Pass

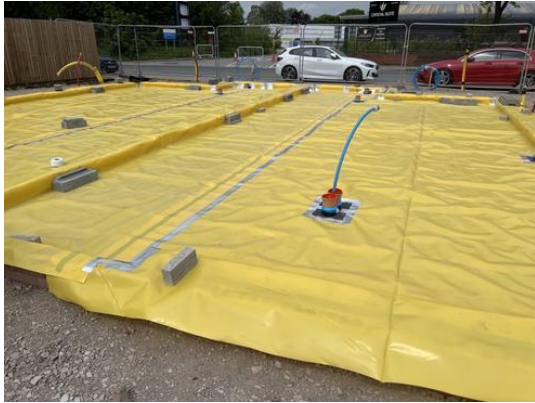
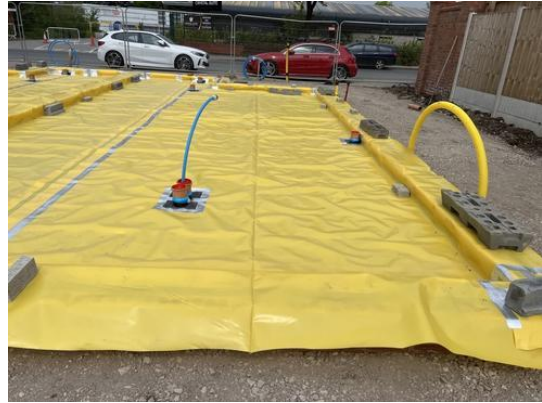
**Extent of Coverage: Is the membrane covering the entire plot? Does membrane span over outside walls?**

Yes

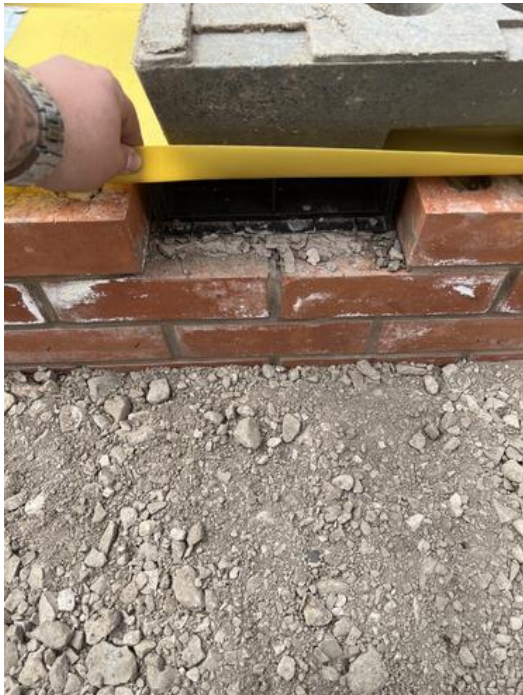
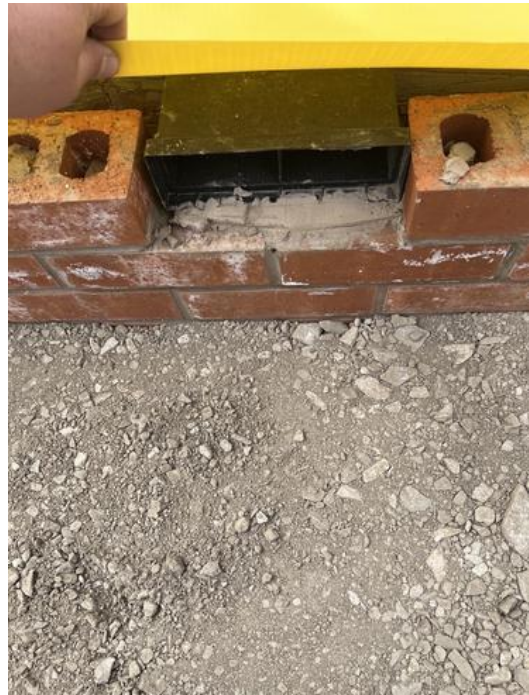
**External Wall Air bricks: Numbers, size. positions as design drawing? (Minimum of 3 walls)**

Pass
