**GAS MEMBRANE VALIDATION**

| Site Name: Belle Vue Stadium | Project Number: 12-123 |
| Company Name: Countryside | Date: 15-06-2022 |

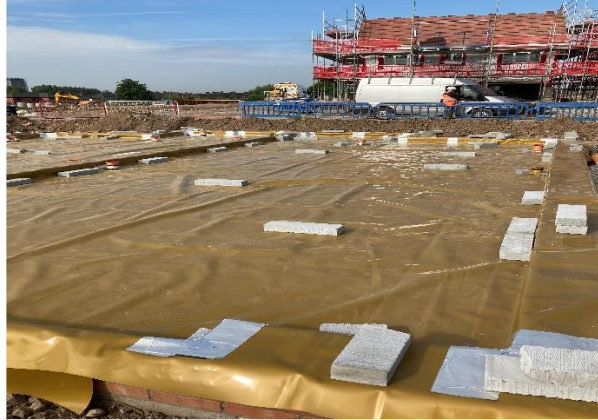
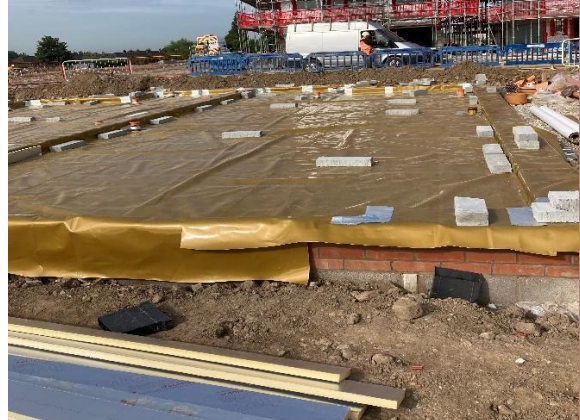
**Plot – 102**

**General Condition of Membrane-Good Condition**

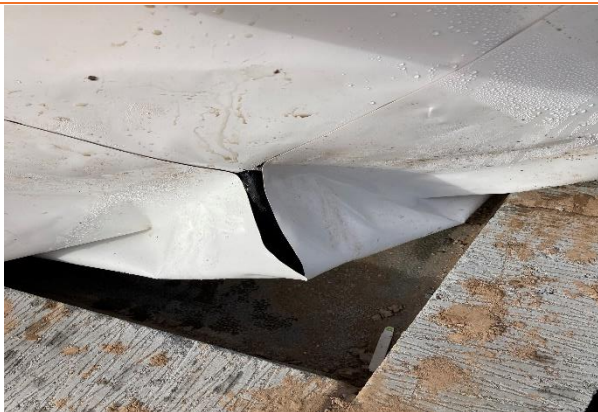
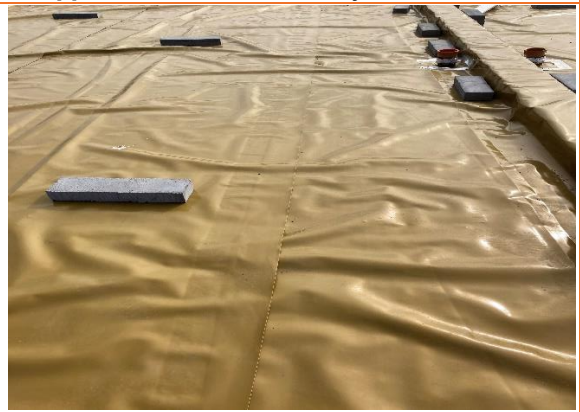
**Verification of Joints and Seals-Overlapped and sealed correctly**

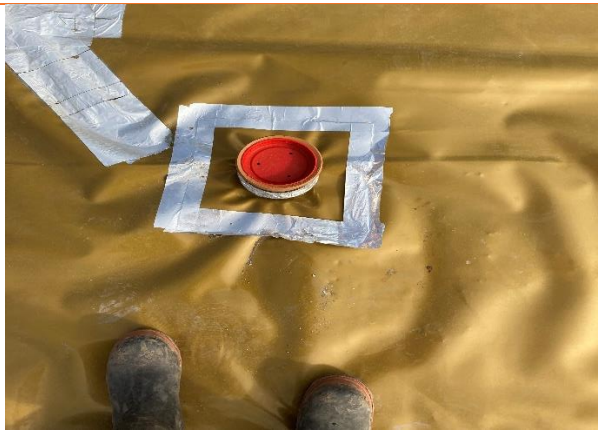
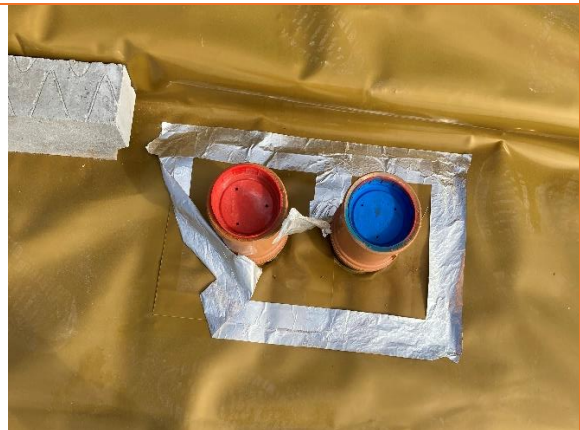
**Verification of Service Penetrations-Good Condition**

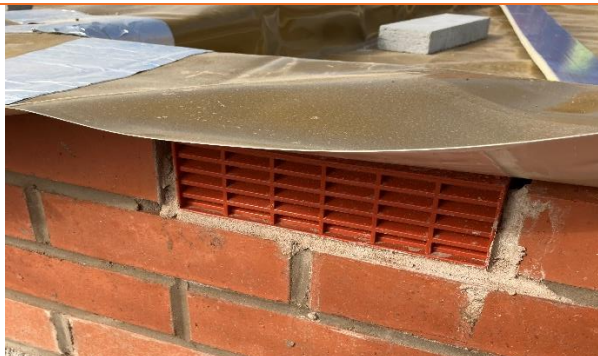
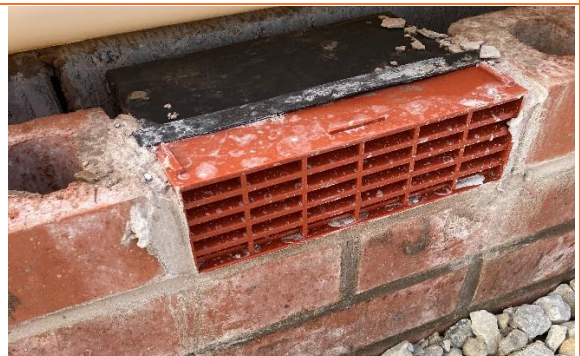
**Verification of Ventilation-Good Condition**

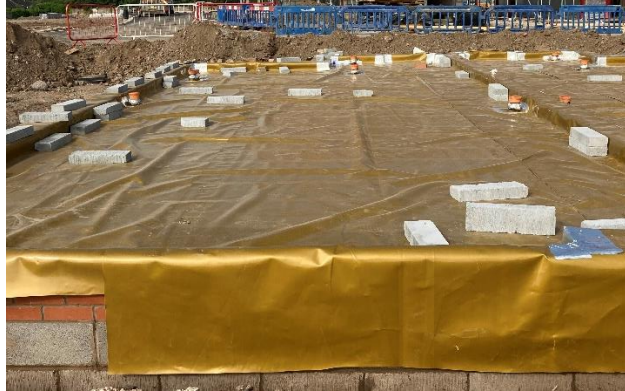
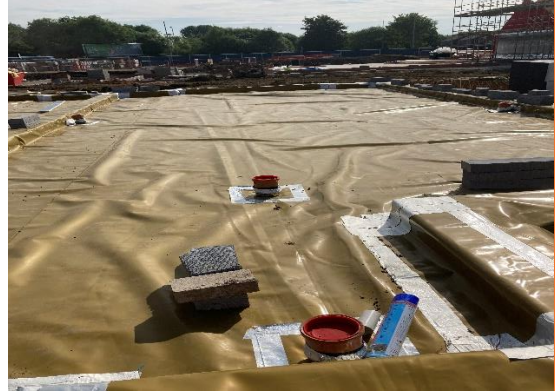
**Plot - 103**

**General Condition of Membrane-Good Condition**

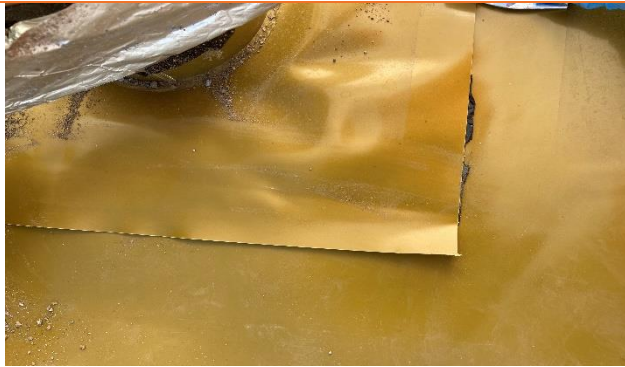
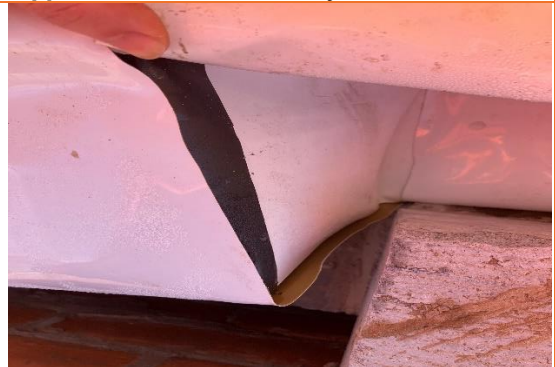
**Verification of Joints and Seals-Overlapped and sealed correctly**

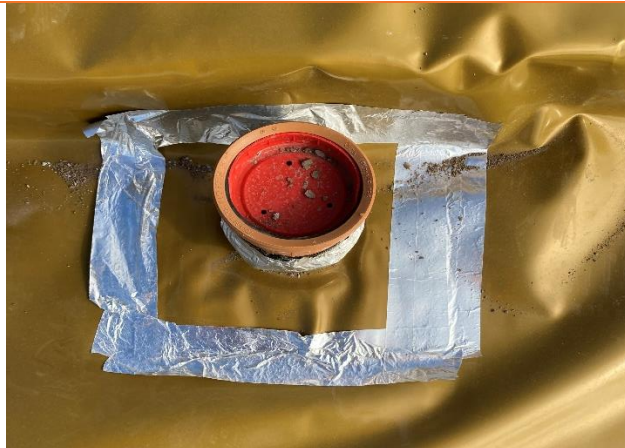
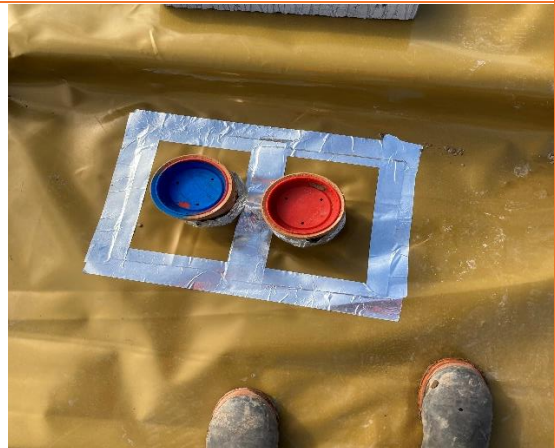
**Verification of Service Penetrations-Good Condition**

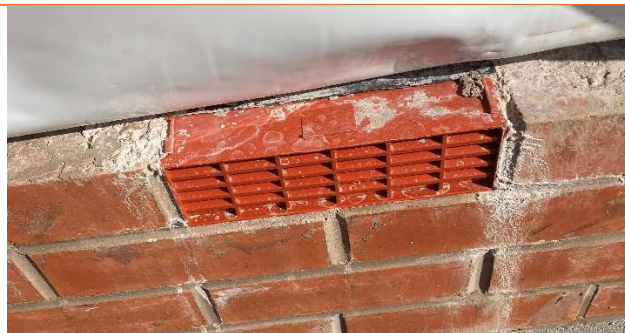
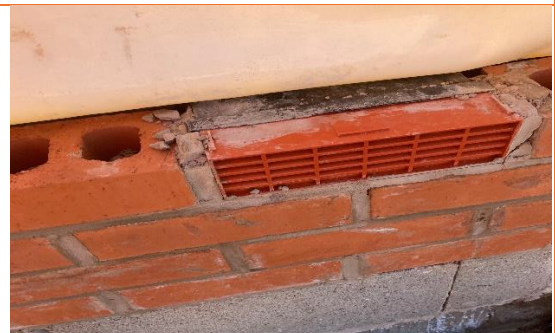
**Verification of Ventilation-Good Condition**
