**GAS MEMBRANE VALIDATION**

| <b>Site Name:</b> Belle Vue | <b>Project Number:</b> 12-123 |
| <b>Company Name:</b> Countryside Properties | <b>Date:</b> 24-09-2022 |
| Ground Gas Risk Assessment: <b>Characteristic Situation 2 / Amber 1</b> | |

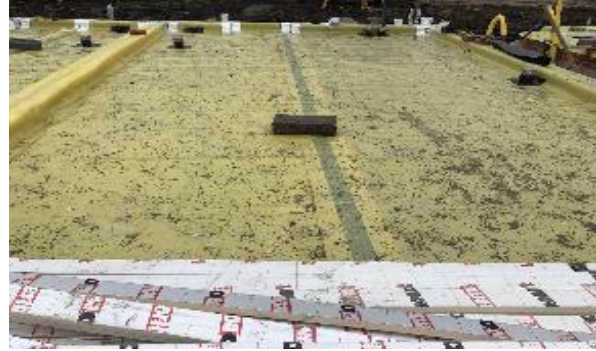
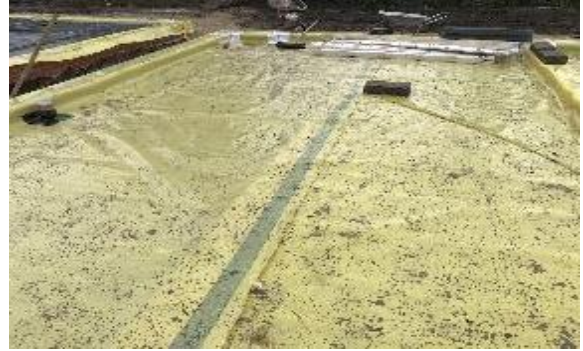
**Plot - 196**

**General Condition of Membrane-Good Condition**

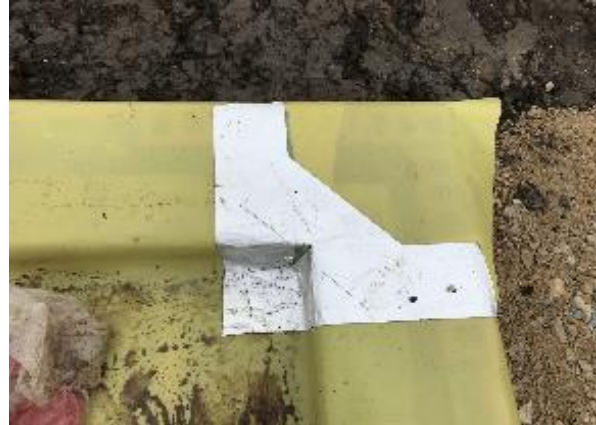
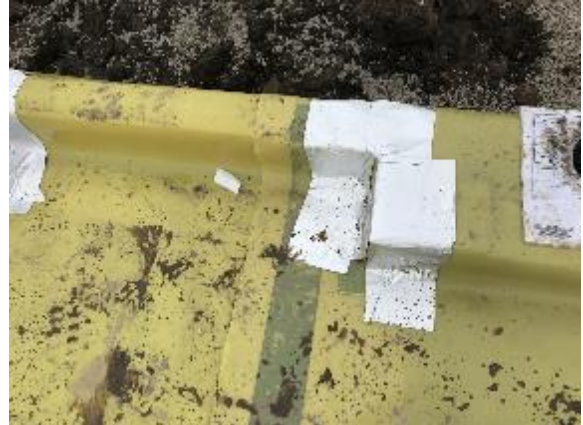
**Verification of Joints and Seals-Good Condition**

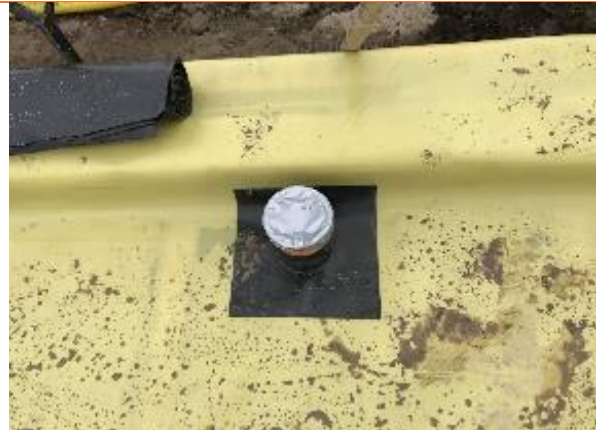
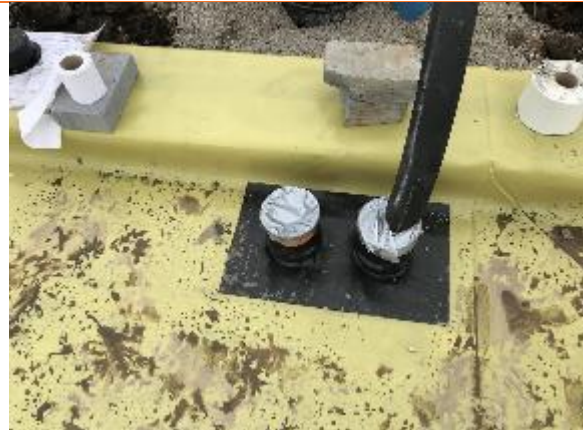
**Verification of Service Penetrations-Good Condition**

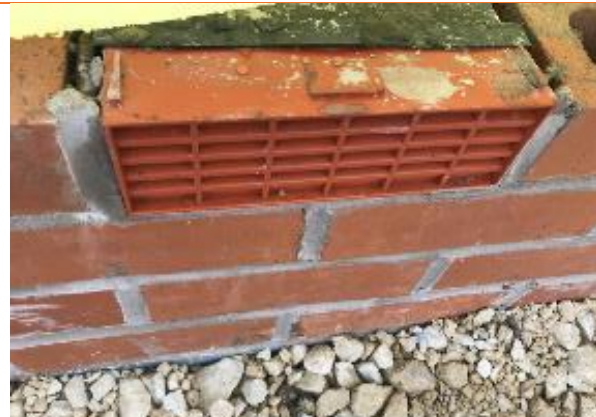
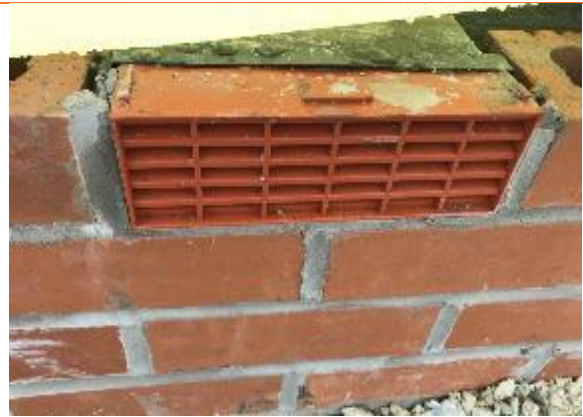
**Verification of Ventilation-Good Condition**

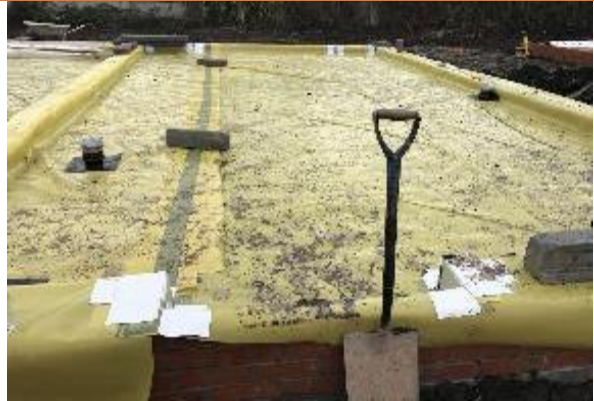
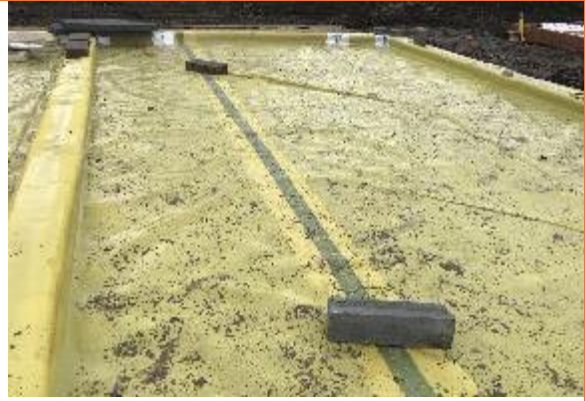
**Plot - 197**

**General Condition of Membrane-Good Condition**

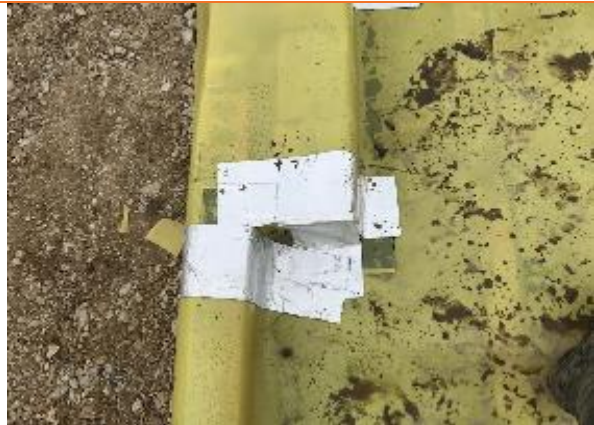
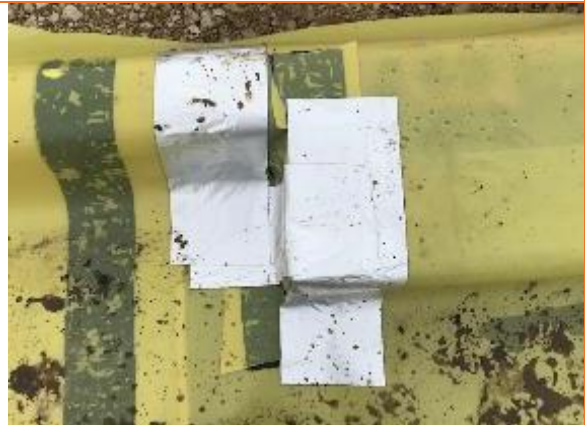
**Verification of Joints and Seals-Good Condition**

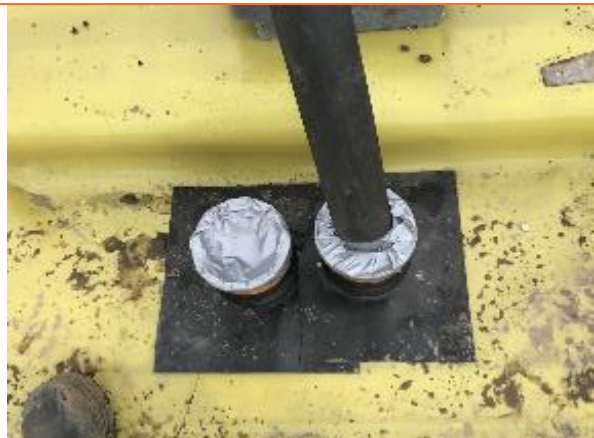
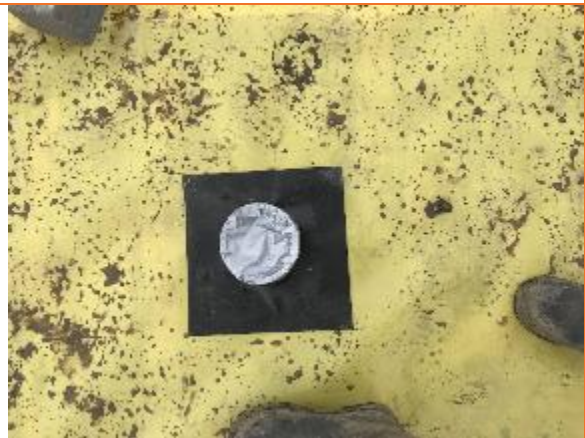
**Verification of Service Penetrations-Good Condition**

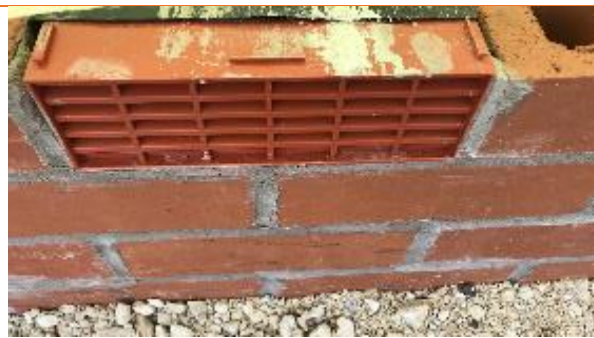
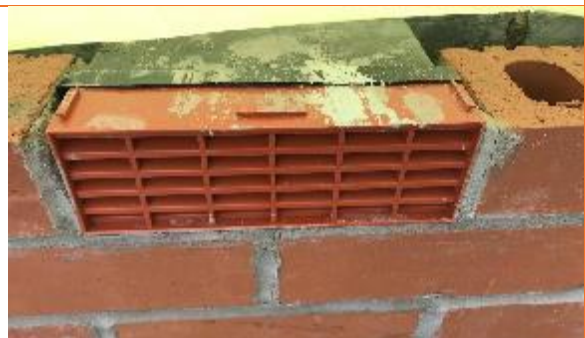
**Verification of Ventilation-Good Condition**
