### GAS MEMBRANE VALIDATION – BELLE VUE

**Project Name:** Belle Vue Stadium**Project Number:** 12-123**Client:** Countryside Properties**Date:** 30-10-2023**Project Manager & Qualifications:** N. Sellars – MSci (Hons), FGS, MEnvSc**E3P Engineer & Qualifications:** J. Newall – GGS Training**Gas Membrane Installer :** Chandos Civils**Ground Gas Risk Assessment:** Amber 1**Plots:** 214

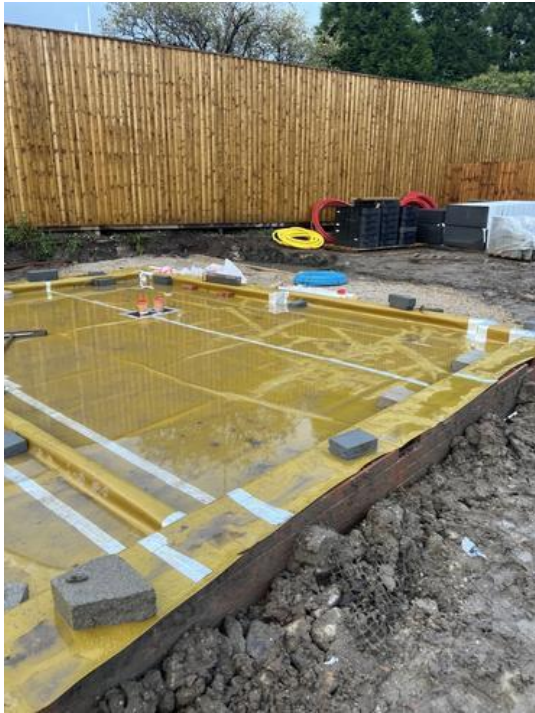
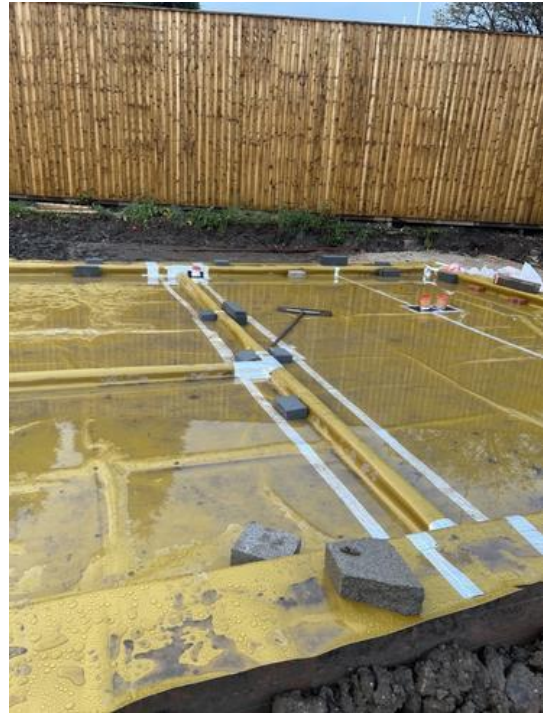
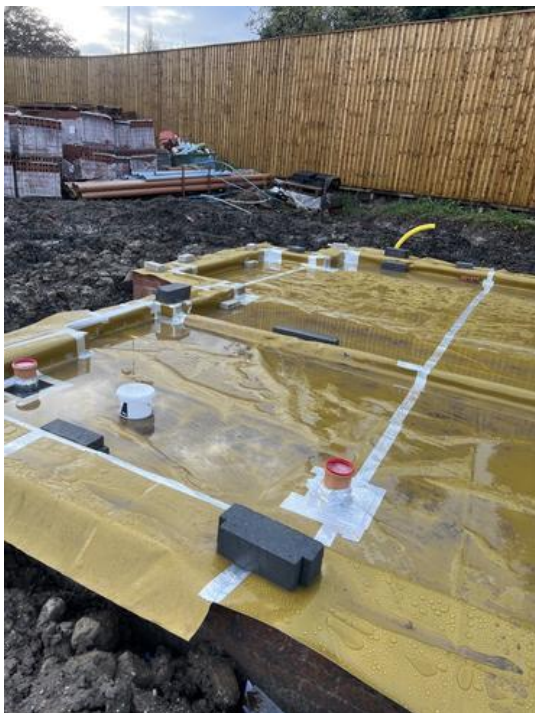
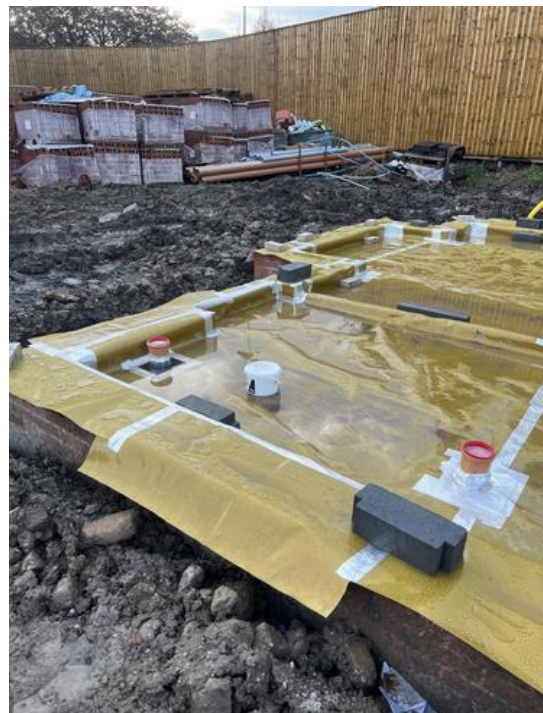
Gas Membrane Condition: Open punctures, tears, rips, stretching, Presence of debris, Repairs, Signs of weakness such as raised or sunken indentations, Protection plan in place to restrict access to lain gas membrane? IF FAIL DESCRIPTION IN ACTIONS AND PHOTOS REQUIRED

Pass

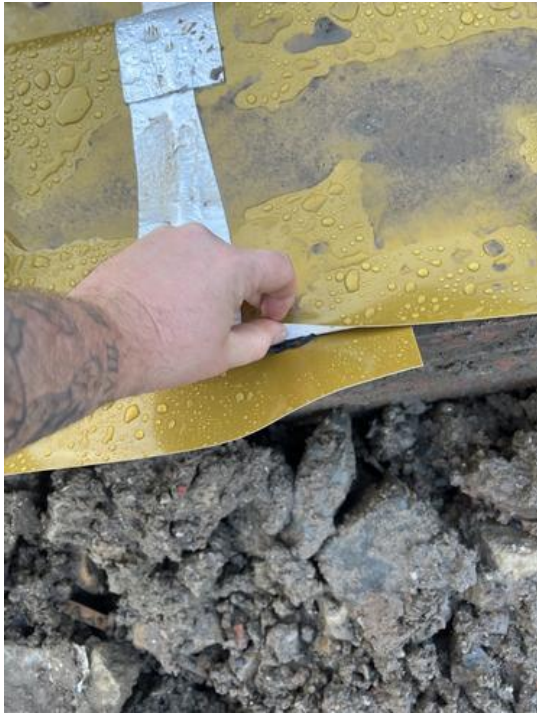
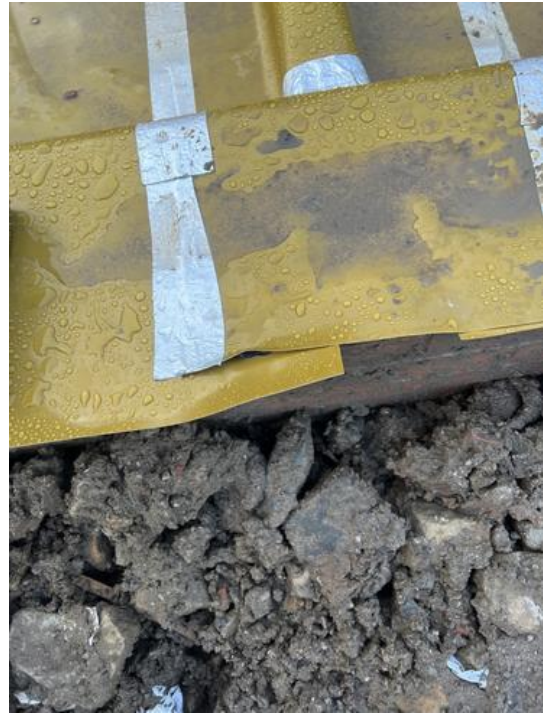
Laps, welds, and joints seals: Joints lapped and sealed in accordance with manufacturer's requirements/ specification? Minimum overlap insured? Sections taped twice? Are welds complete? Appropriate joining/double-sided tape used, Folds running in line with joints? (no joints cutting across folds)

Pass

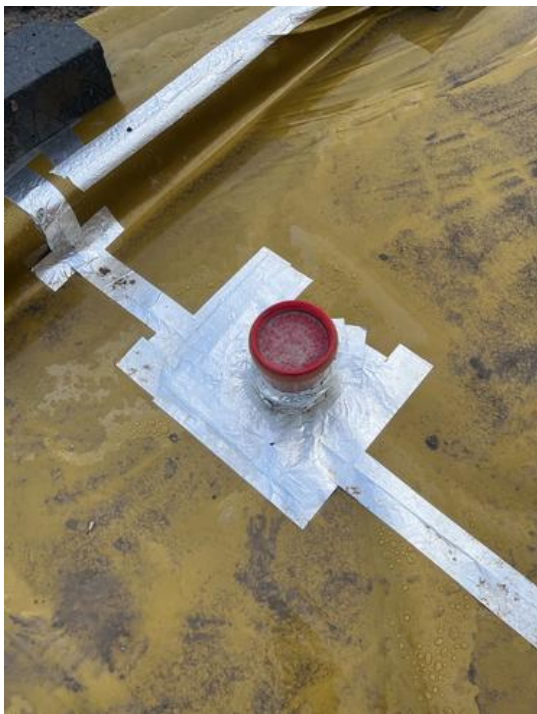
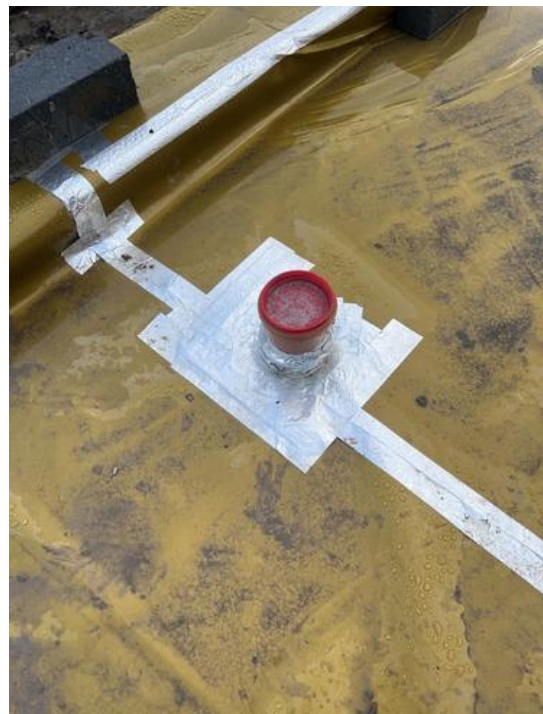
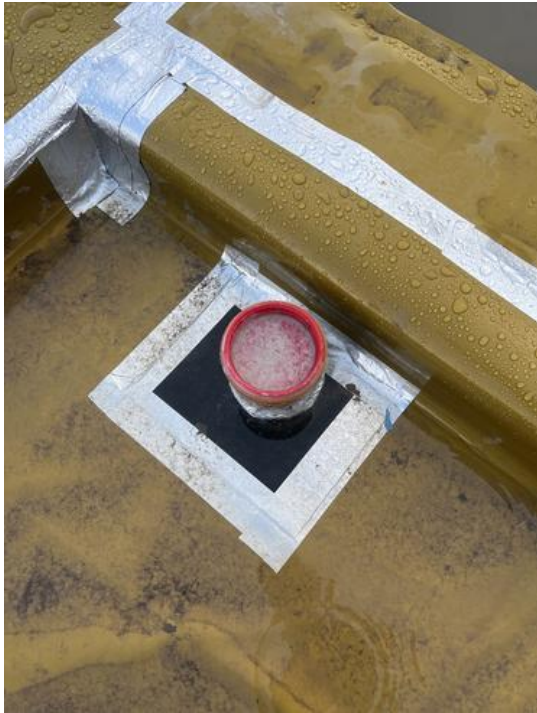
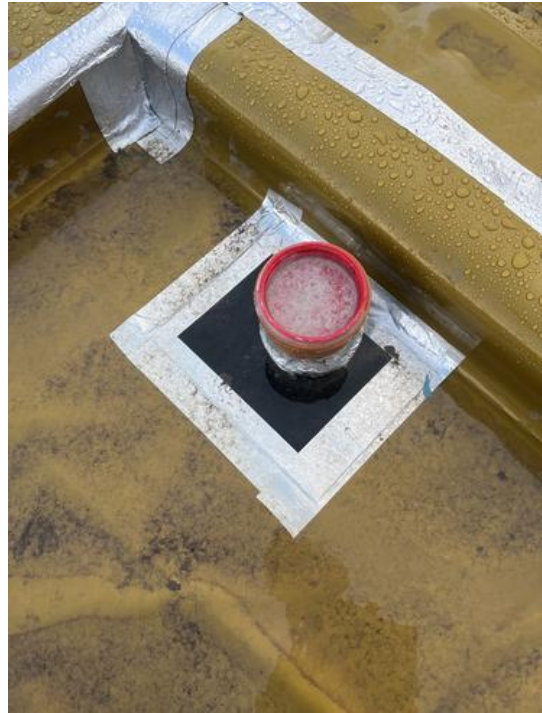
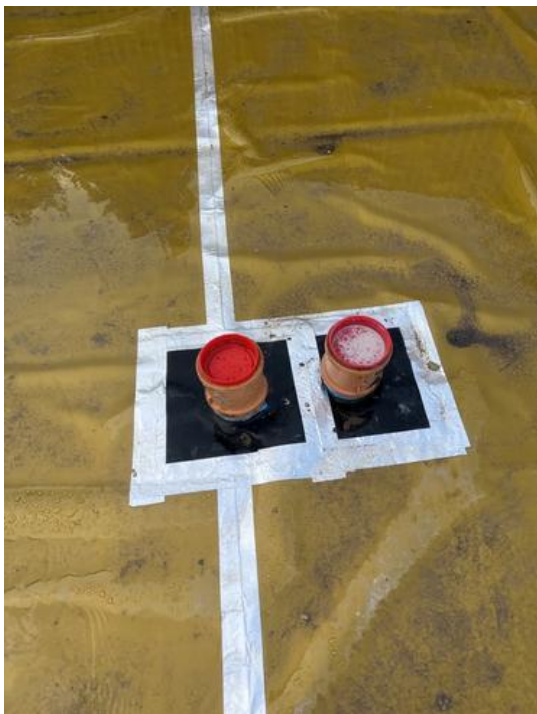
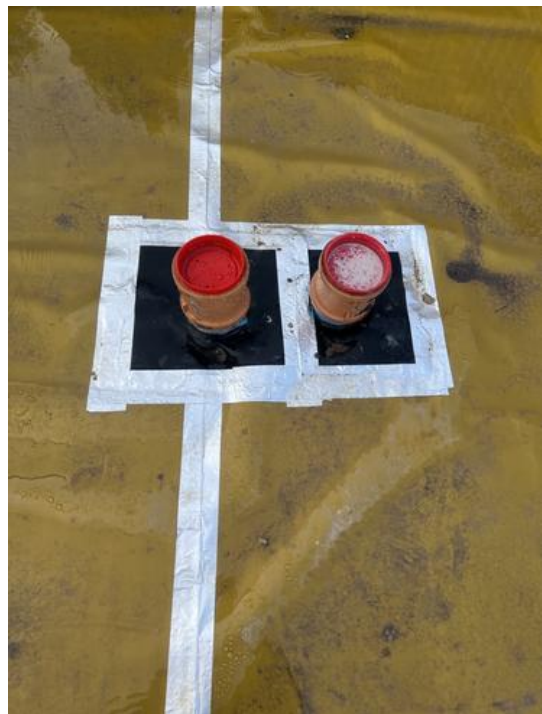
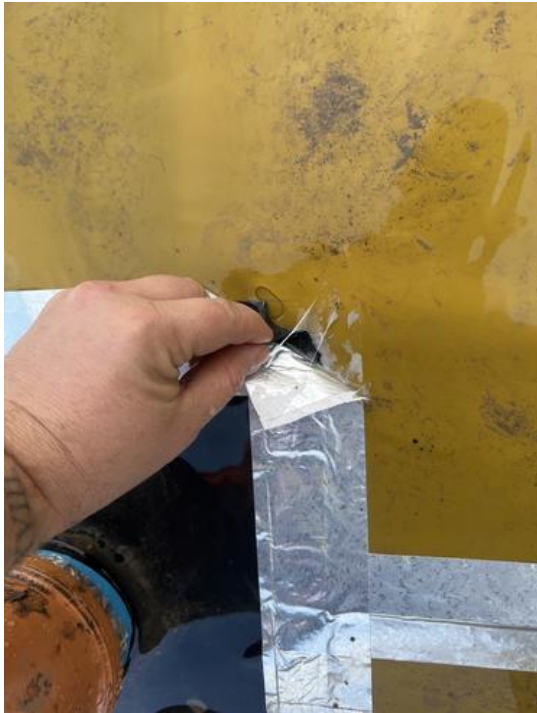
Service entries seals: Top hats seal arrangements fixed around service entries? Use of Jubilee clips?

Yes

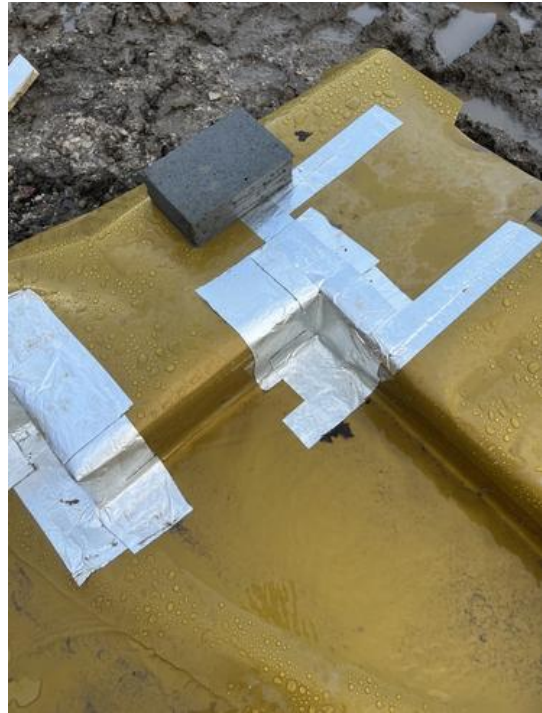
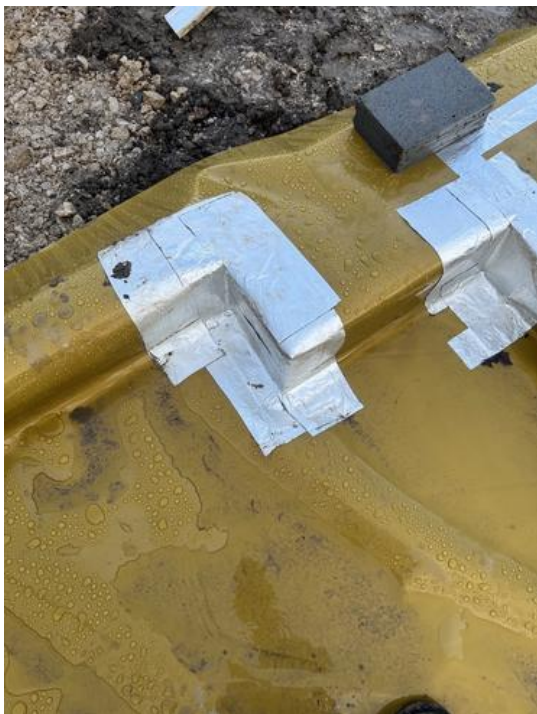
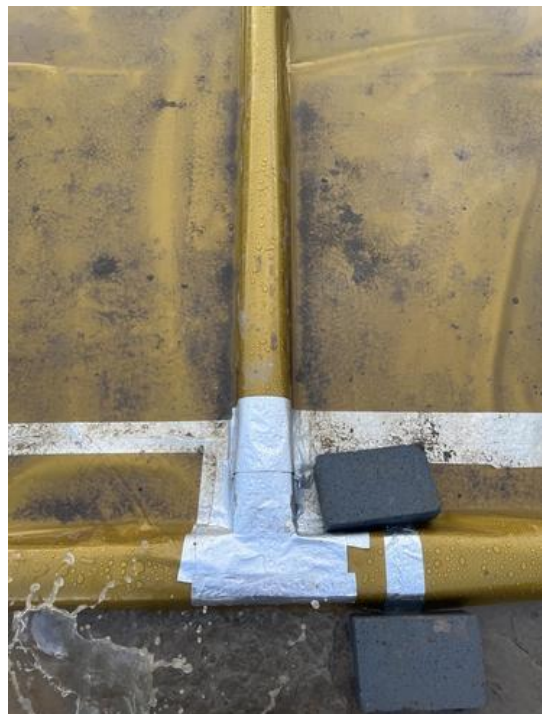
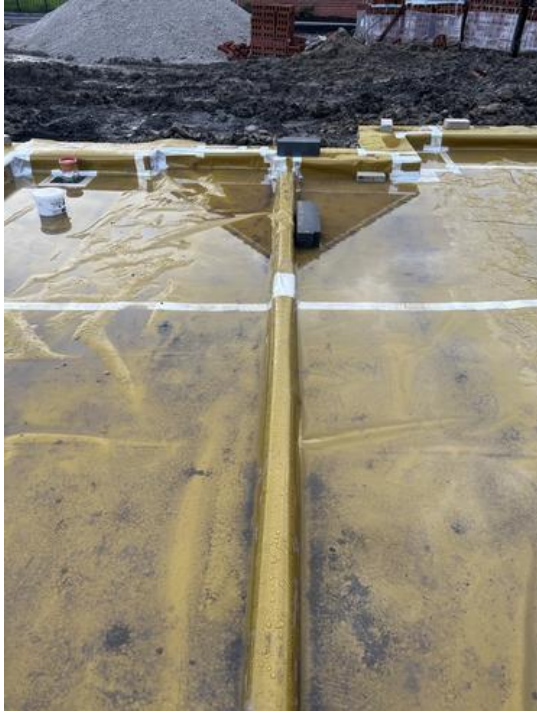
Corners / Internal joints: Check all corners are correctly formed or contractor has used preformed corners.

Pass

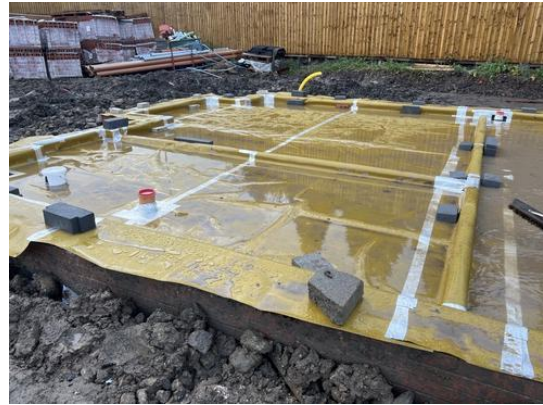
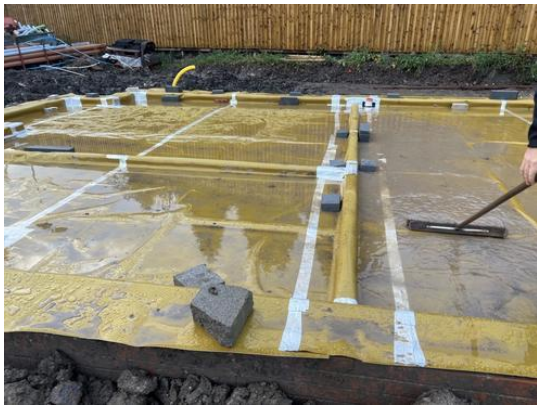
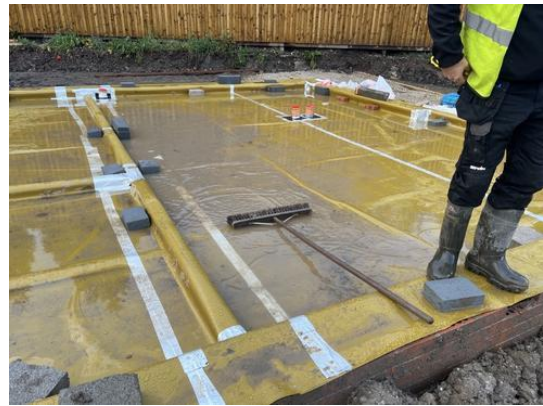
Extent of Coverage: Is the membrane covering the entire plot?  
Does membrane span over outside walls?

Yes

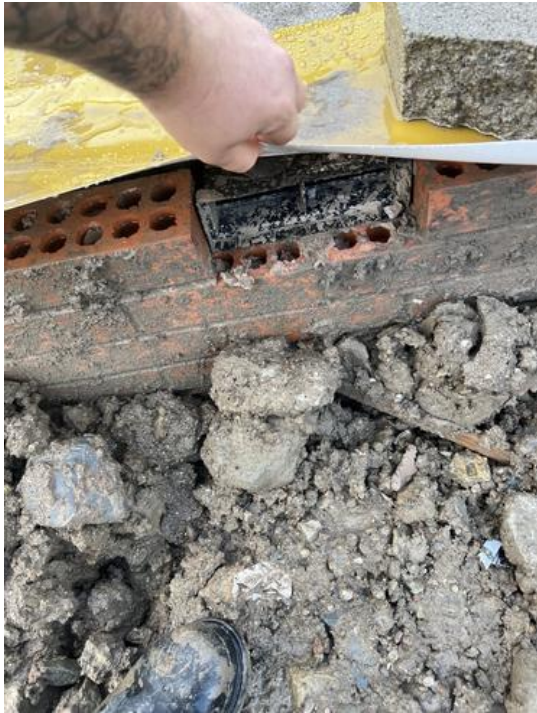
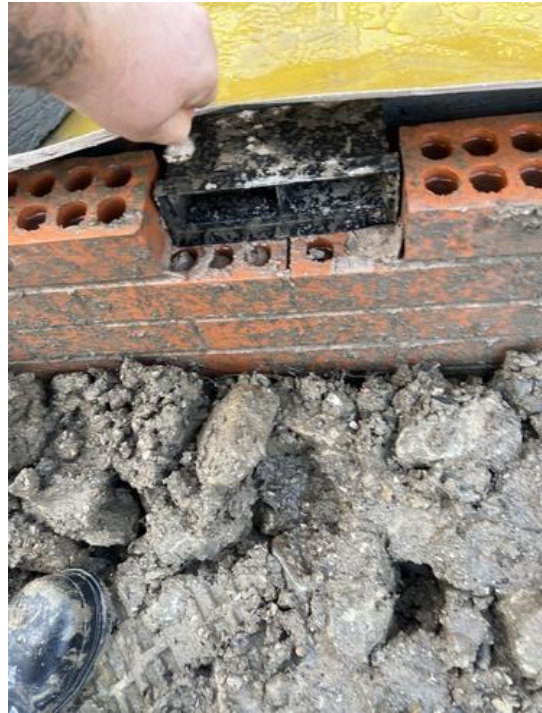
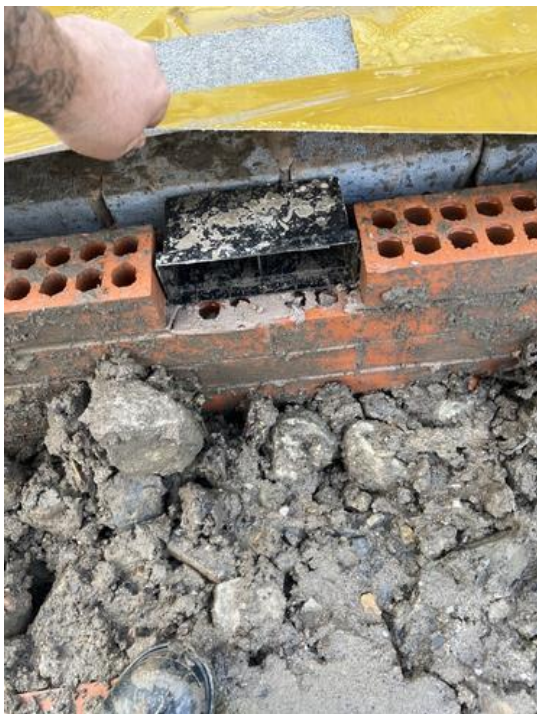
External Wall Air bricks: Numbers, size. positions as design drawing? (Minimum of 3 walls)

Pass
