## GAS MEMBRANE VALIDATION

| Site Name: Belle Vue Stadium | Project Number: 12-123 |
| Company Name: Countryside | Date: 01-09-2022 |

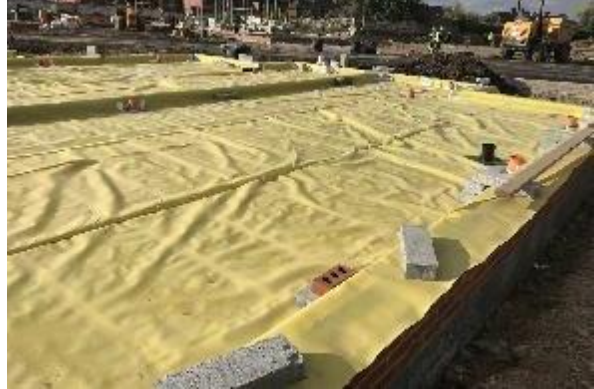
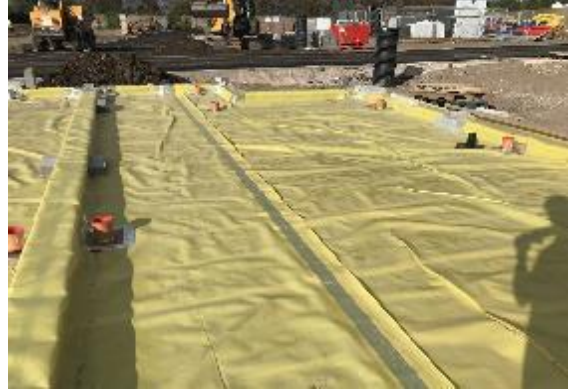
**Plot – 191**

**General Condition of Membrane-Good Condition**

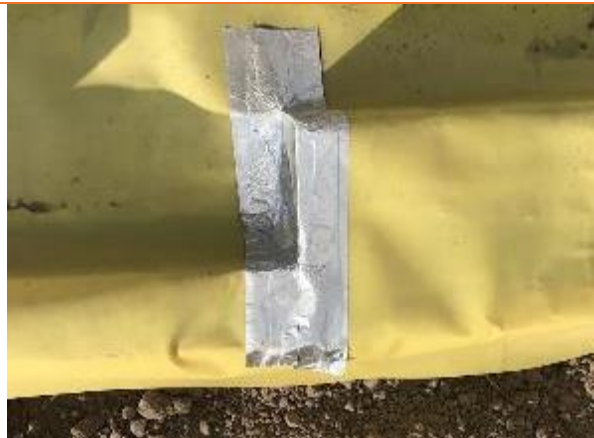
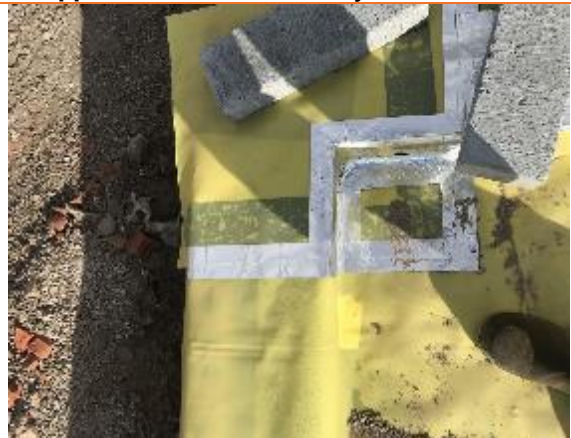
**Verification of Joints and Seals-Overlapped and sealed correctly**

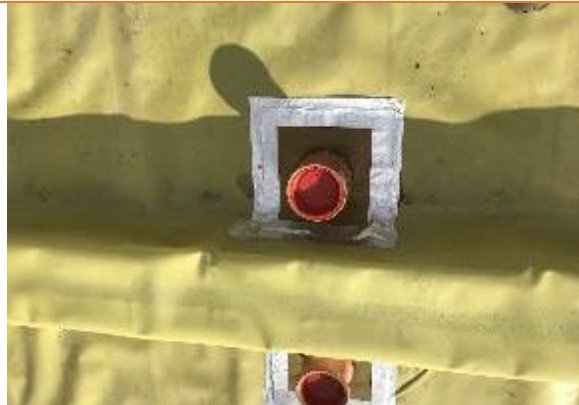
**Verification of Service Penetrations-Good Condition**

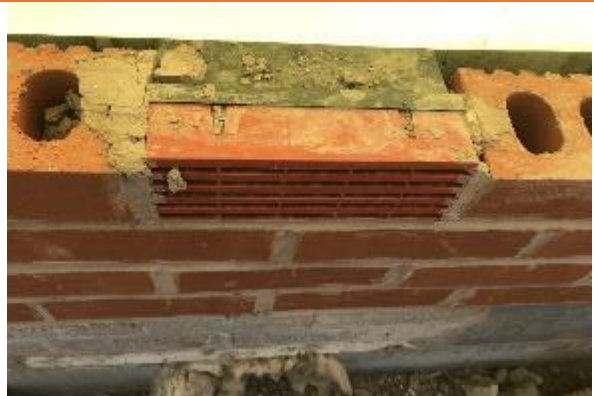
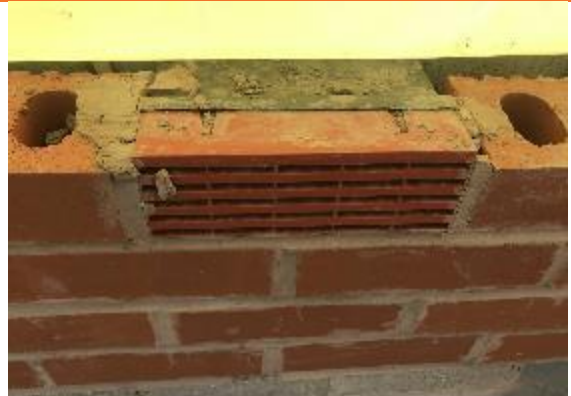
**Verification of Ventilation-Good Condition**

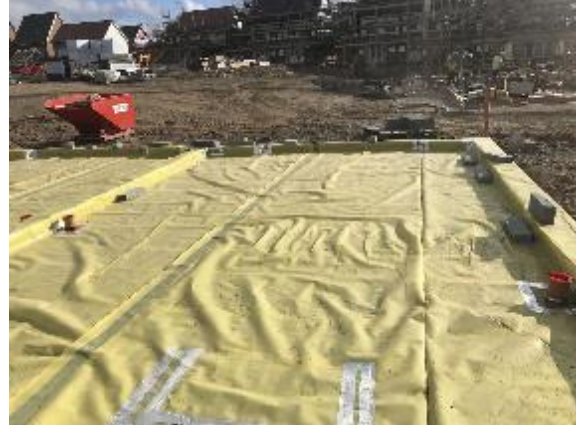
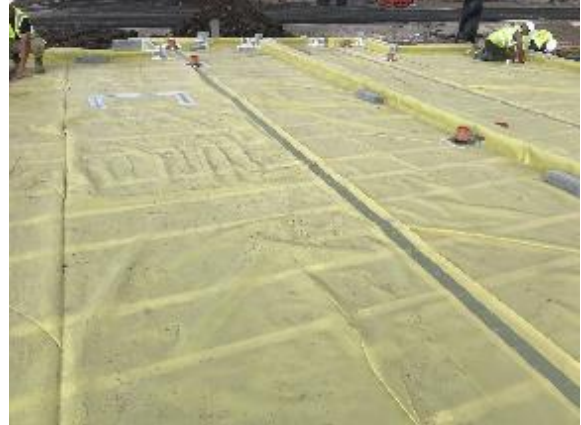
**Plot – 192**

**General Condition of Membrane-Good Condition**

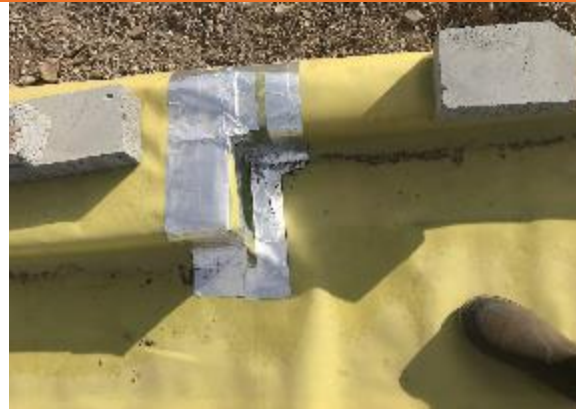
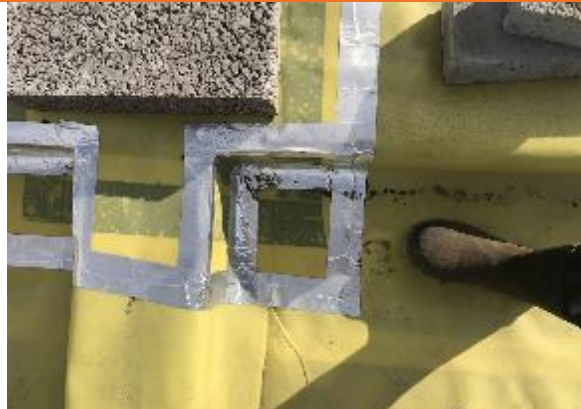
**Verification of Joints and Seals-Overlapped and sealed correctly**

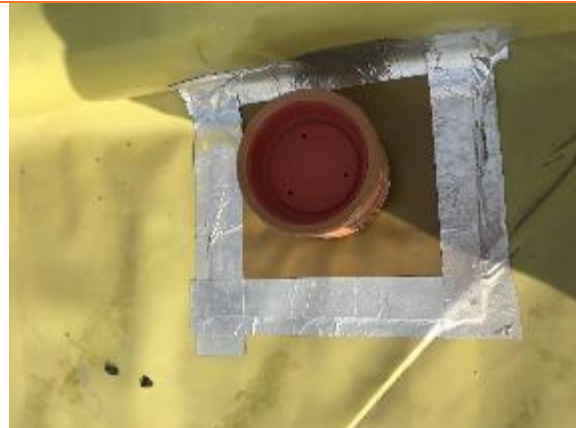
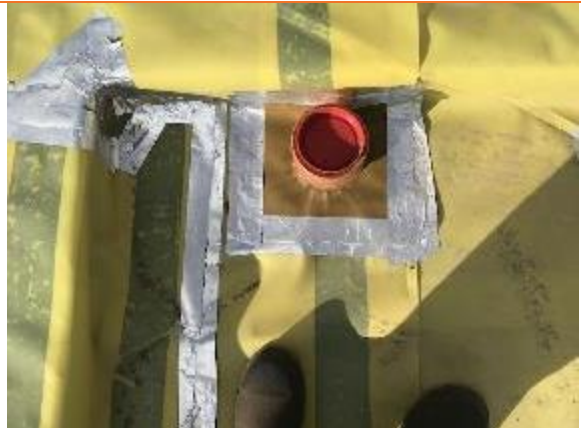
**Verification of Service Penetrations-Good Condition**

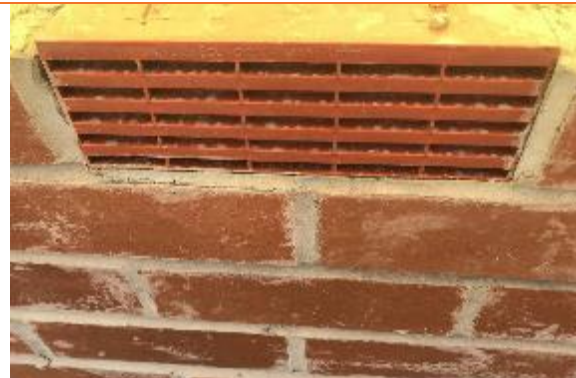
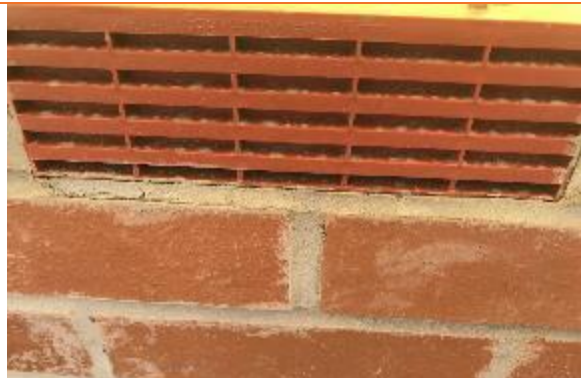
**Verification of Ventilation-Good Condition**

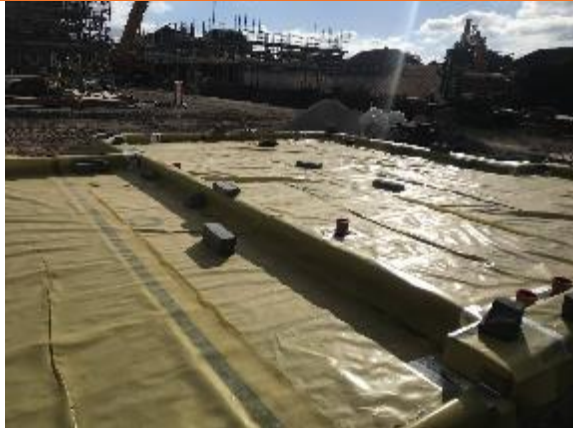
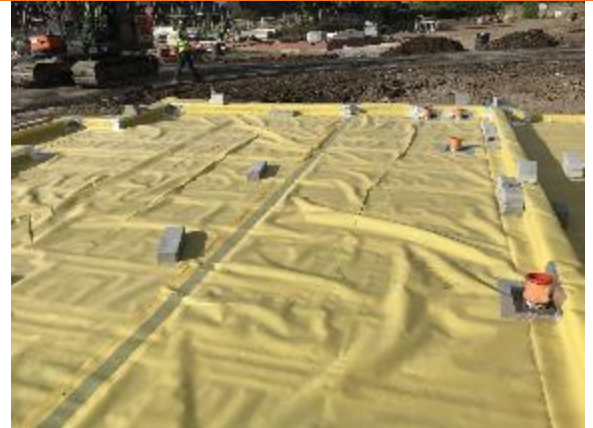
**Plot – 193**

**General Condition of Membrane-Good Condition**

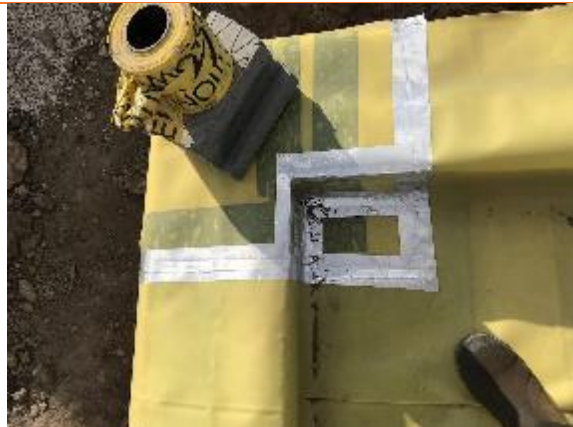
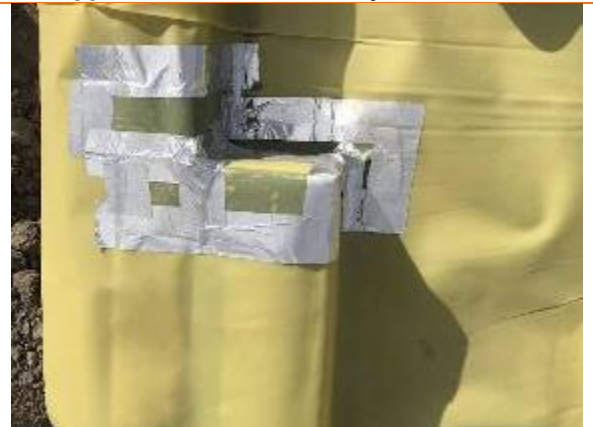
**Verification of Joints and Seals-Overlapped and sealed correctly**

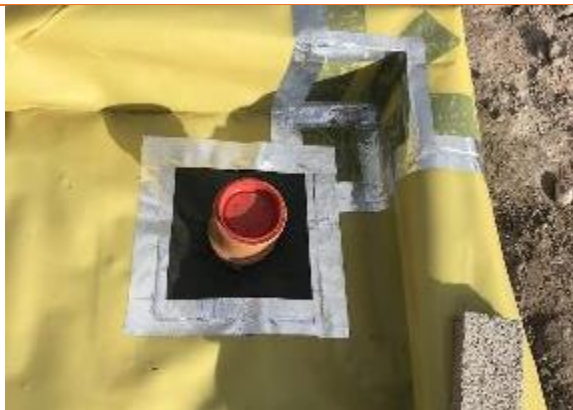
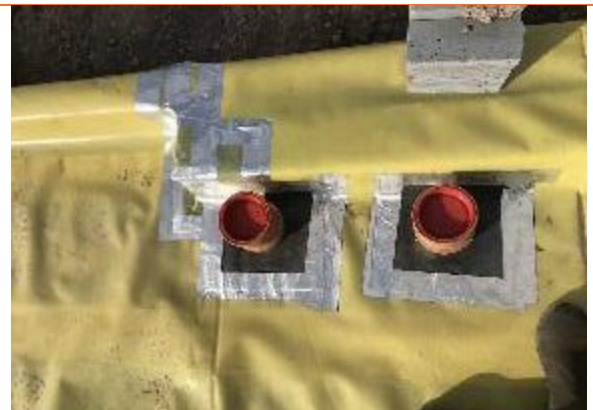
**Verification of Service Penetrations-Good Condition**

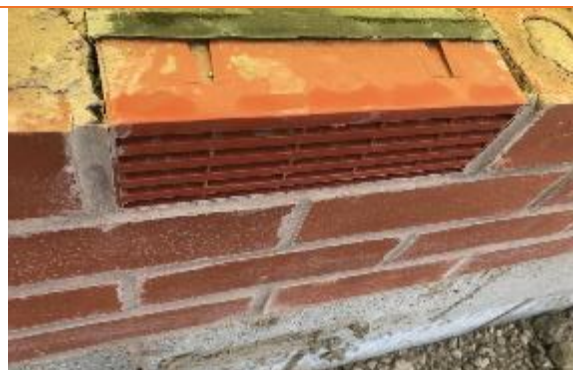
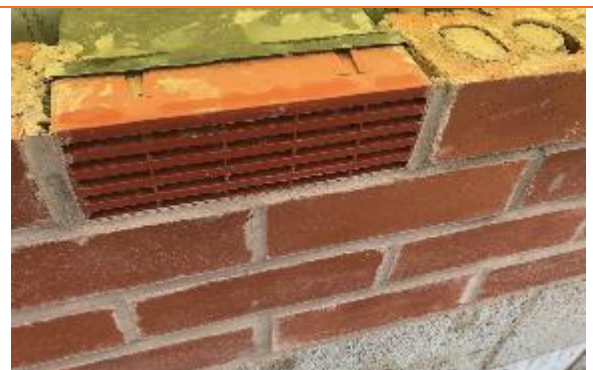
**Verification of Ventilation-Good Condition**
