## GAS MEMBRANE VALIDATION

| <b>Site Name: Belle Vue</b> | <b>Project Number: 12-123</b> |
| <b>Company Name: Countryside Properties</b> | <b>Date: 22-09-2022</b> |
| Ground Gas Risk Assessment: <b>Characteristic Situation 2 / Amber 1</b> | |

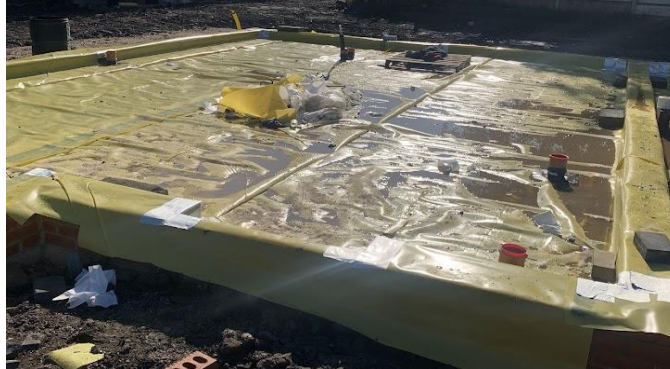
**Plot - 194**

**General Condition of Membrane-Good Condition**

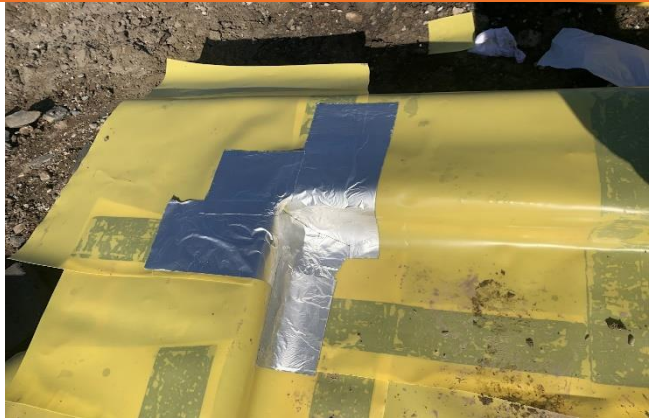
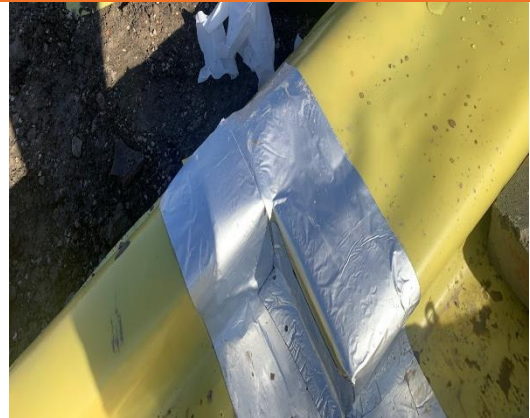
**Verification of Joints and Seals-Good Condition**

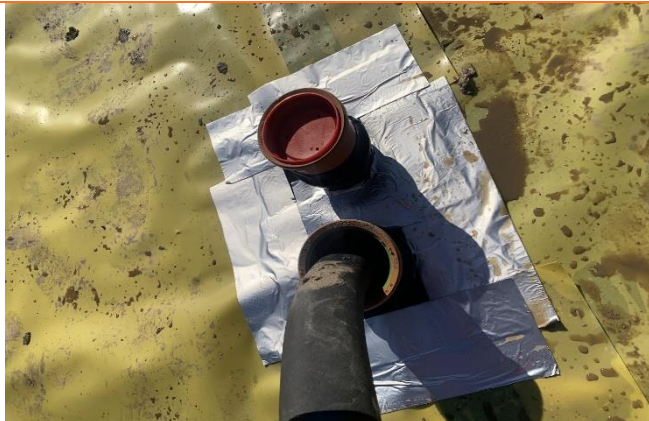
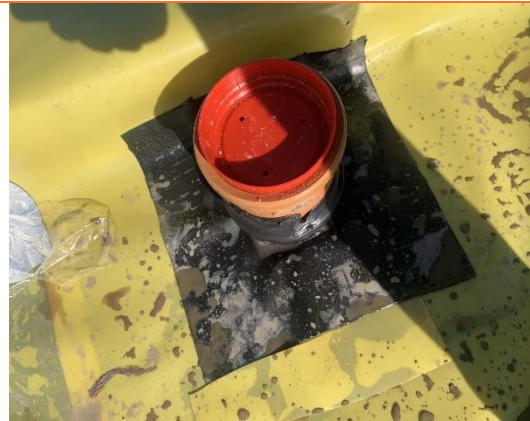
**Verification of Service Penetrations-Good Condition**

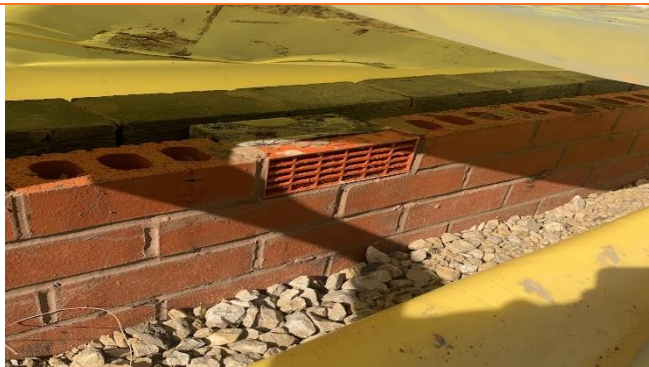
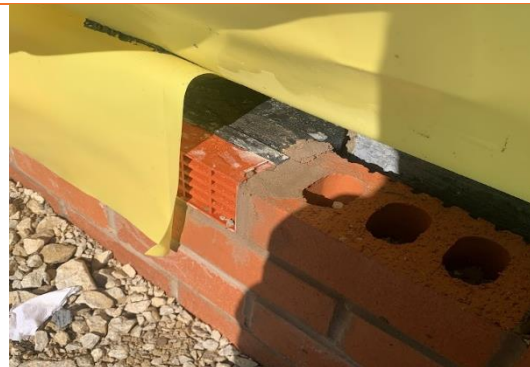
**Verification of Ventilation-Good Condition**

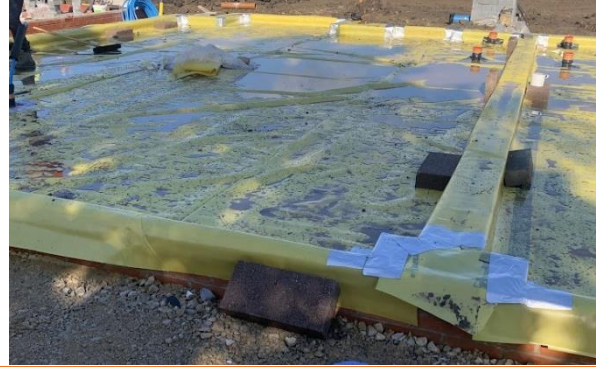
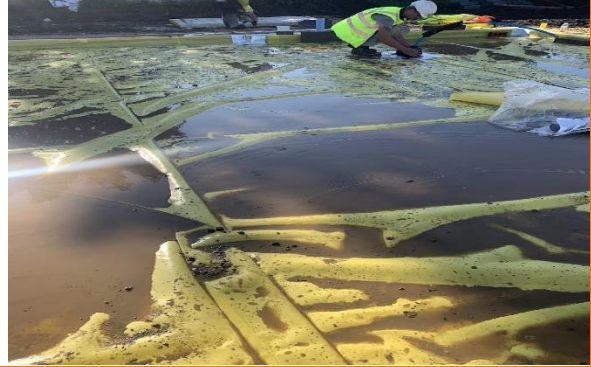
**Plot - 195**

**General Condition of Membrane-Good Condition**

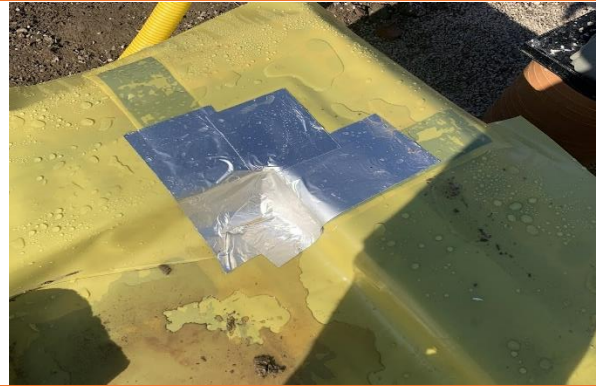
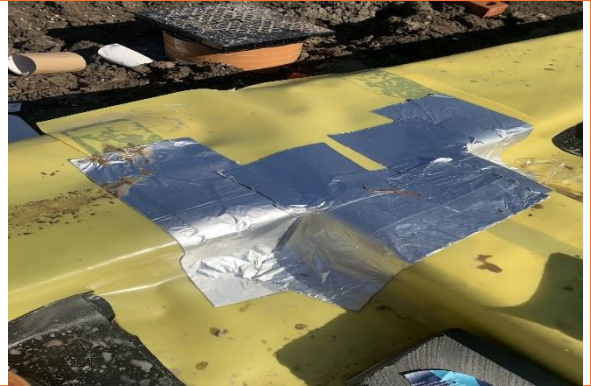
**Verification of Joints and Seals-Good Condition**

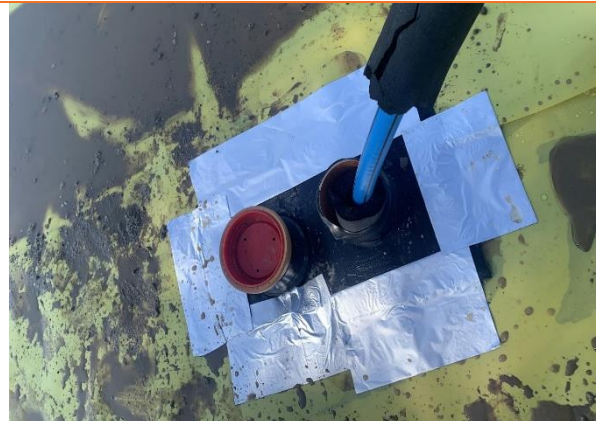
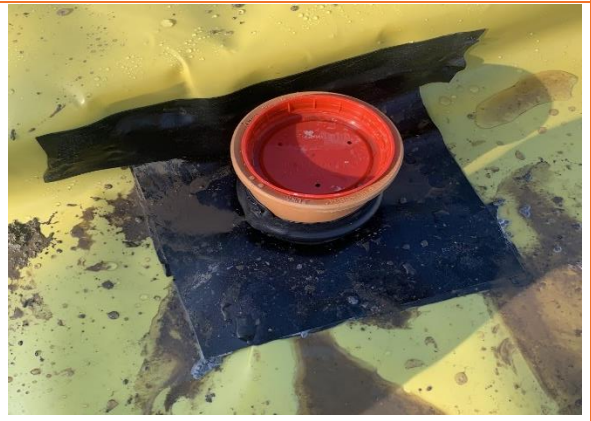
**Verification of Service Penetrations-Good Condition**

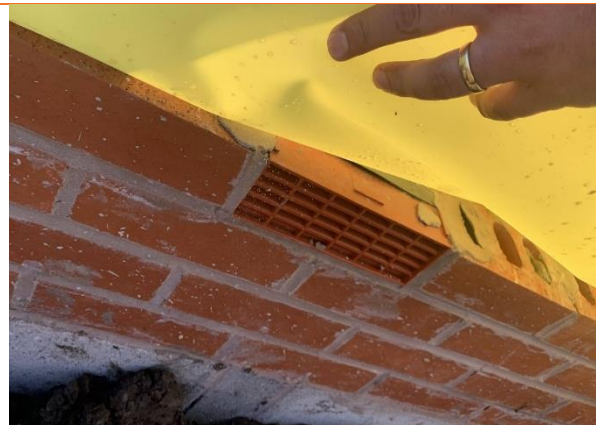
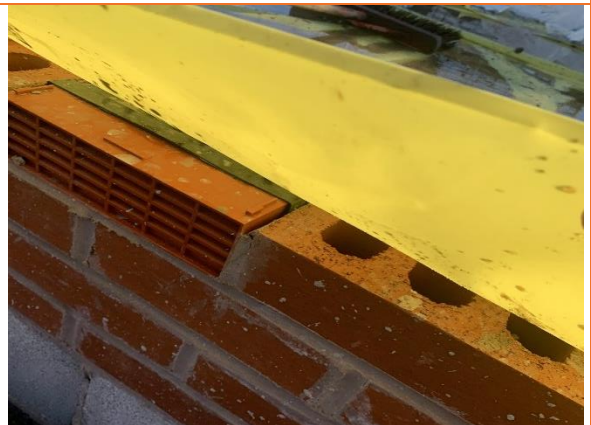
**Verification of Ventilation-Good Condition**

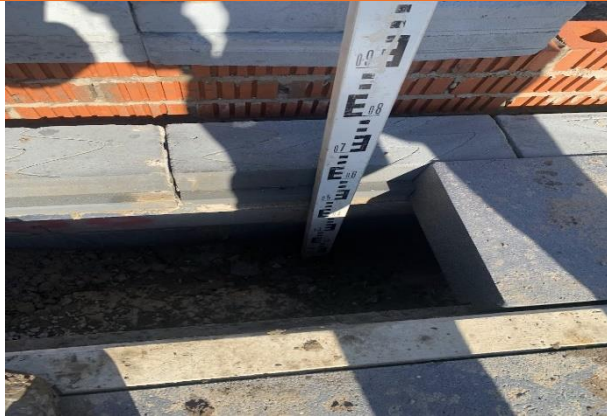
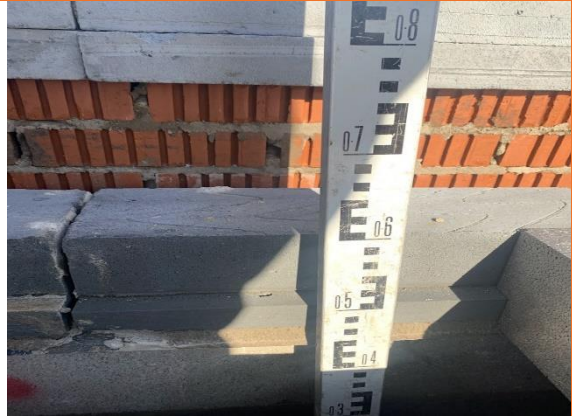
**Plot - 192**

**Picture of Sub Floor Voids**
