### GAS MEMBRANE VALIDATION – BELLE VUE

**Project Name: Belle Bue Stadium****Project Number: 12-123****Client: Countryside Properties****Date: 02-08-2023****Project Manager: S. Ellis – FGS, CEnv****E3P Engineer: P. Lavelle****Gas Membrane Installers Chandos Civils****Ground Gas Risk Assessment: Amber 1****Plots: 161**

## GAS MEMBRANE VALIDATION

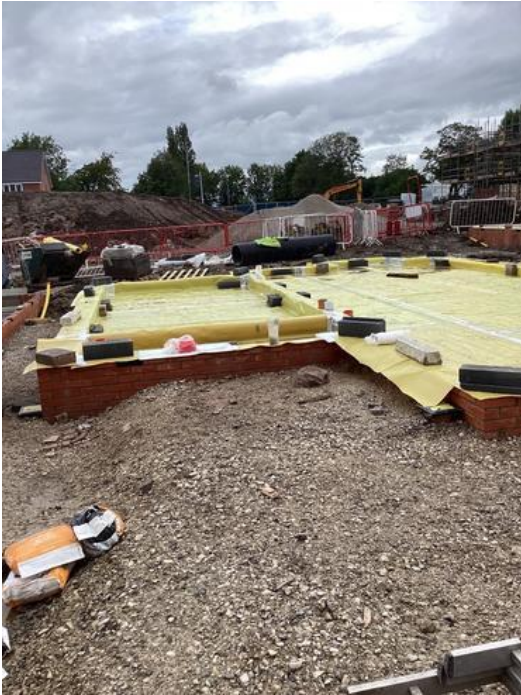
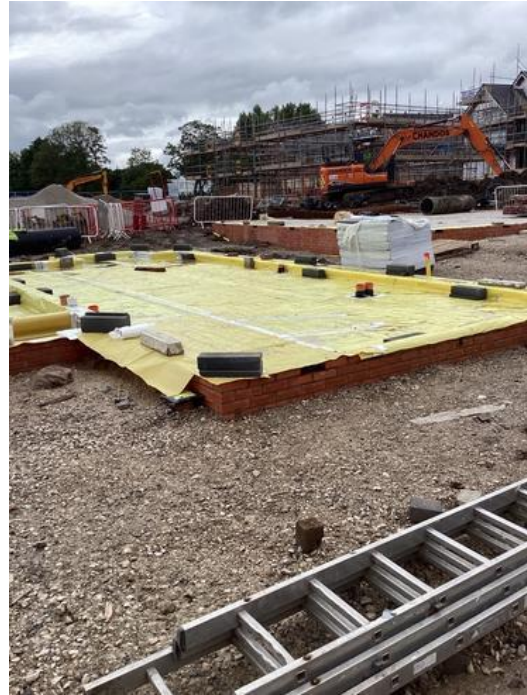
Type of Development: Other add note

House

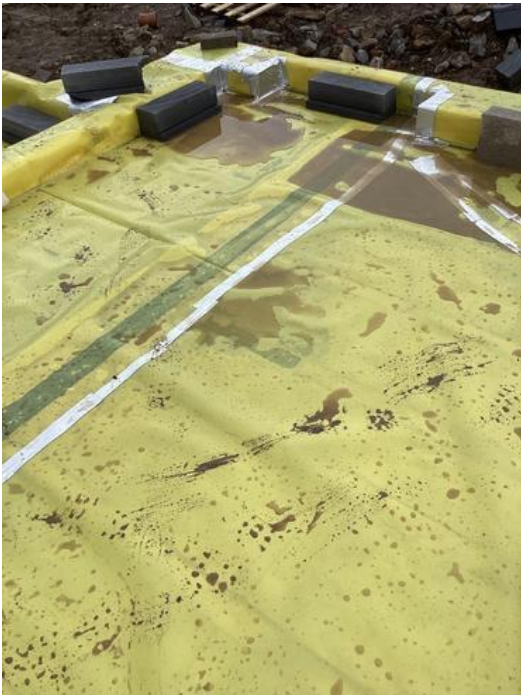
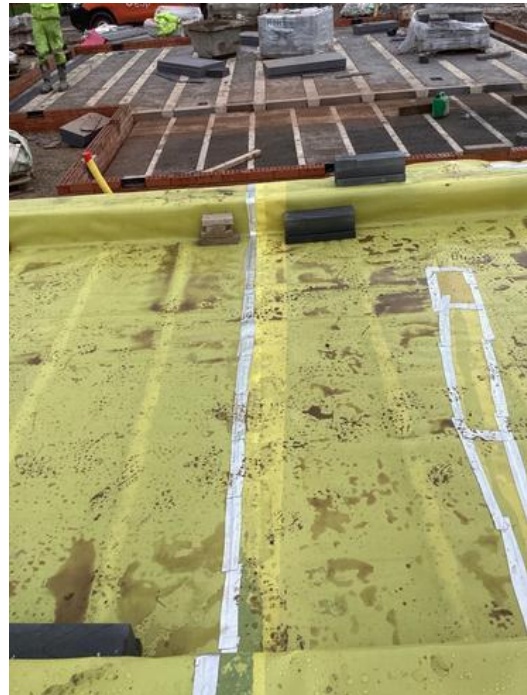
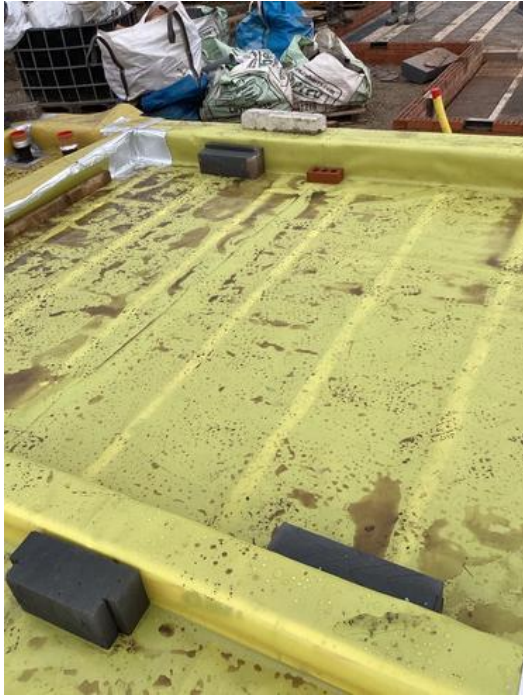
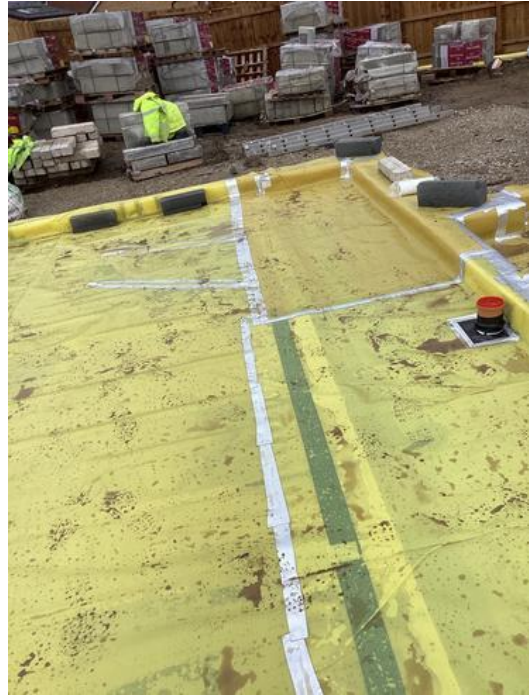
Gas Membrane Condition: Open punctures, tears, rips, stretching, Presence of debris, Repairs, Signs of weakness such as raised or sunken indentations, Protection plan in place to restrict access to lain gas membrane? IF FAIL DESCRIPTION IN ACTIONS AND PHOTOS REQUIRED

Pass

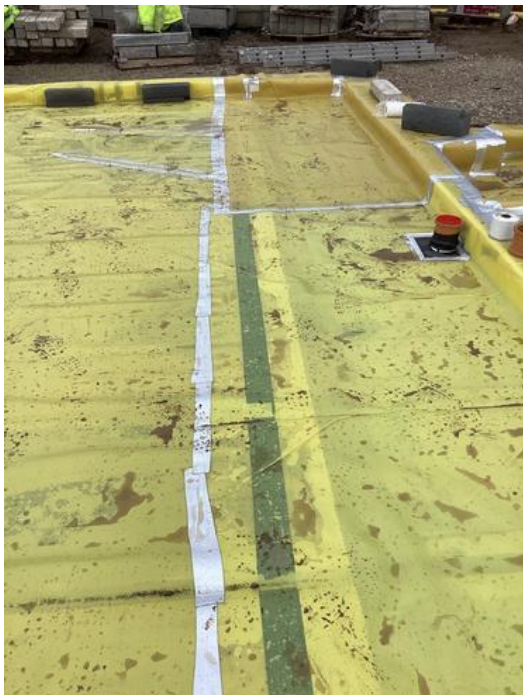
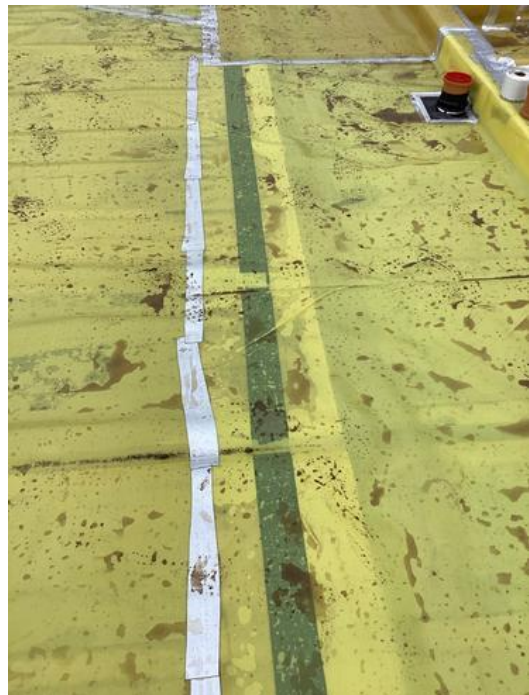
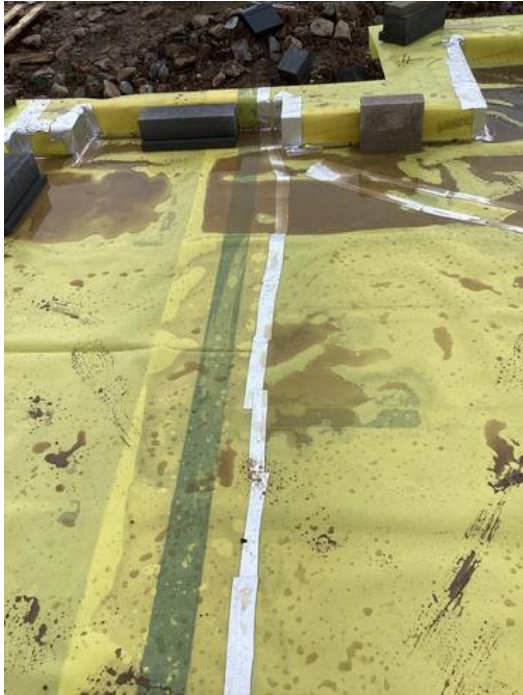
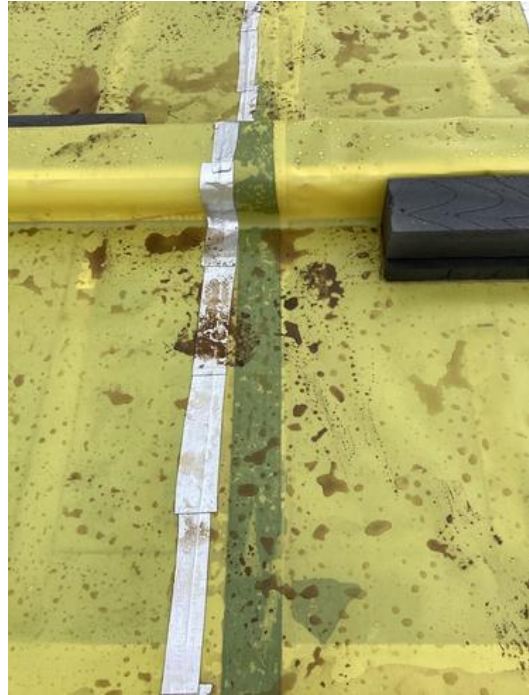
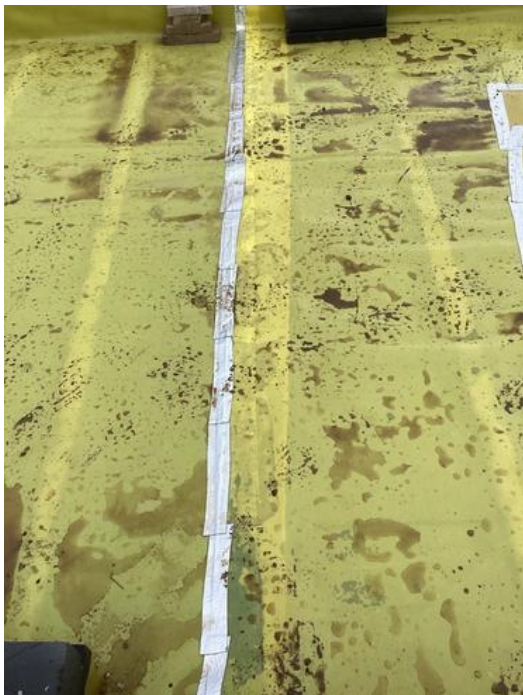
Laps, welds, and joints seals: Joints lapped and sealed in accordance with manufacturer's requirements/ specification? Minimum overlap insured? Sections taped twice? Are welds complete? Appropriate joining/double-sided tape used, Folds running in line with joints? (no joints cutting across folds)

Pass

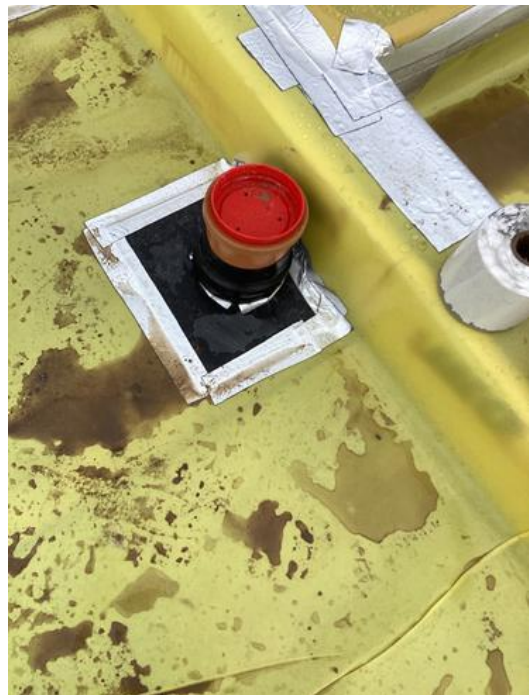
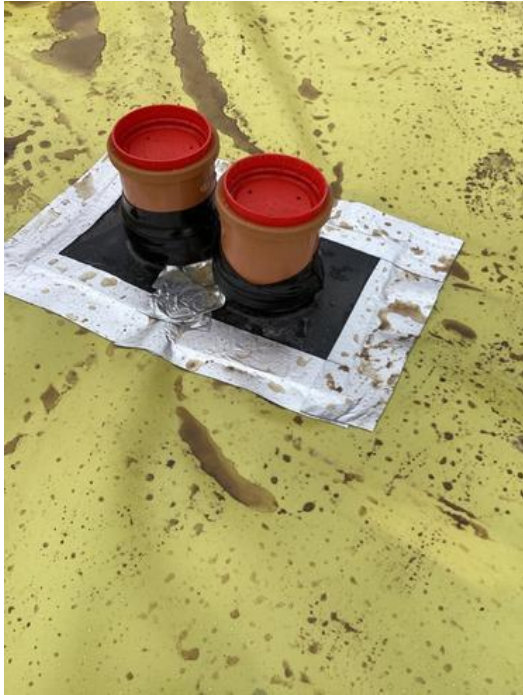
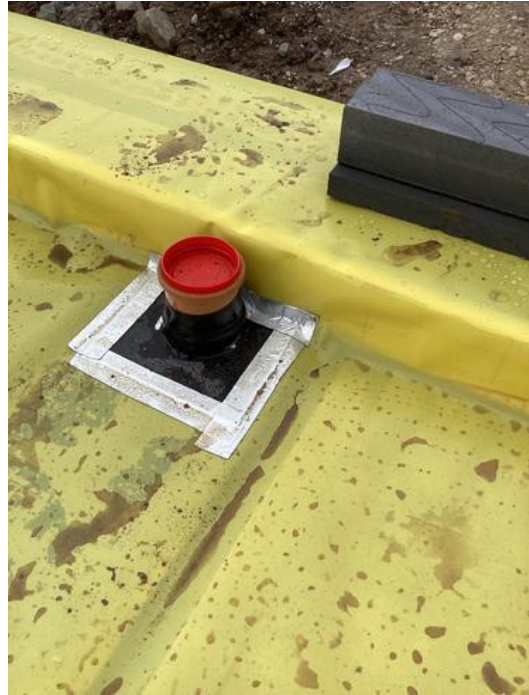
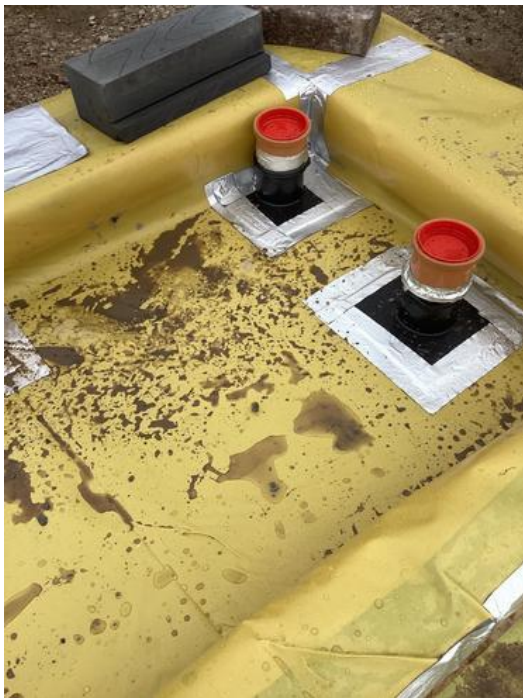
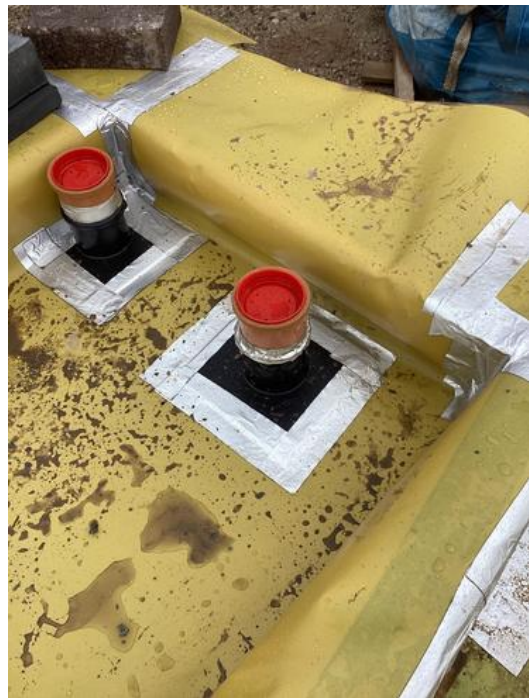
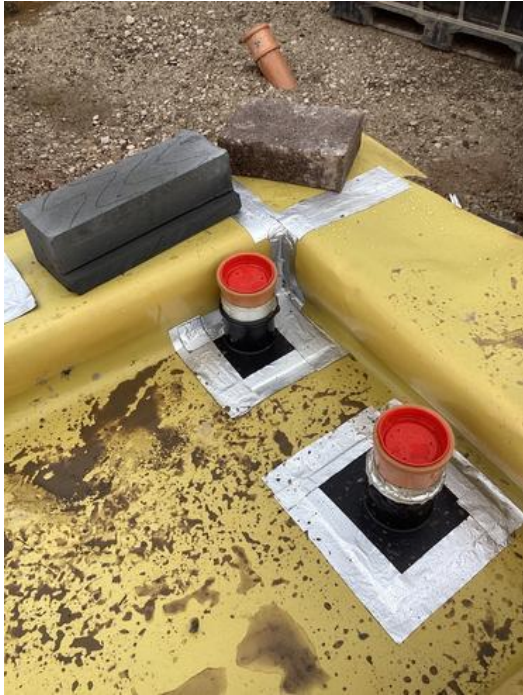
**Service entries seals: Top hats seal arrangements fixed around service entries? Use of Jubilee clips?**

Yes

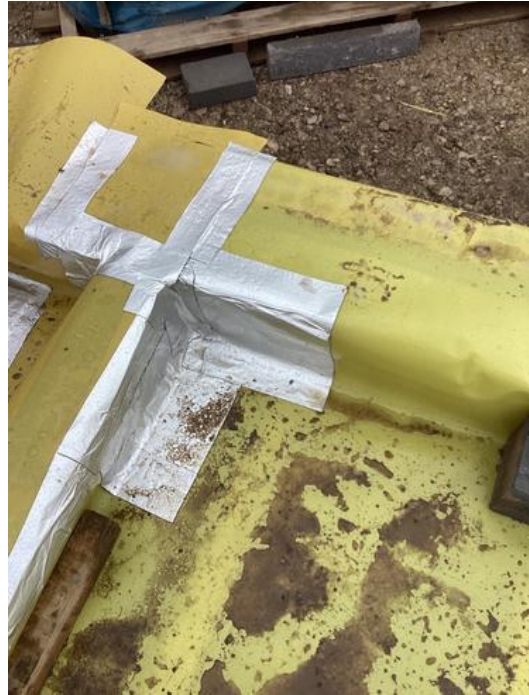
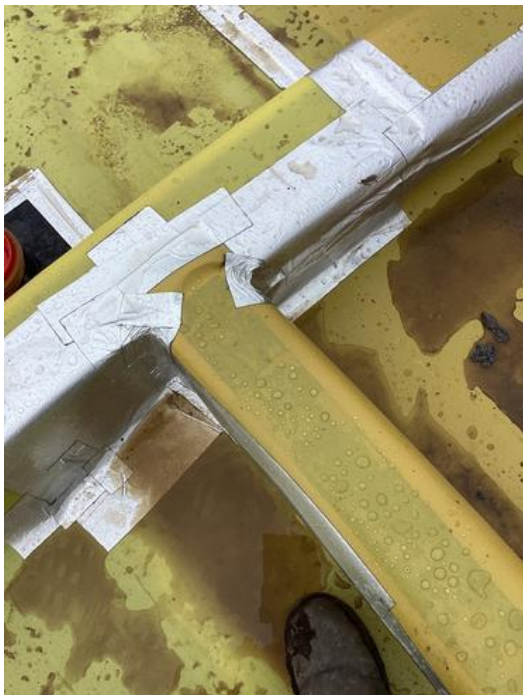
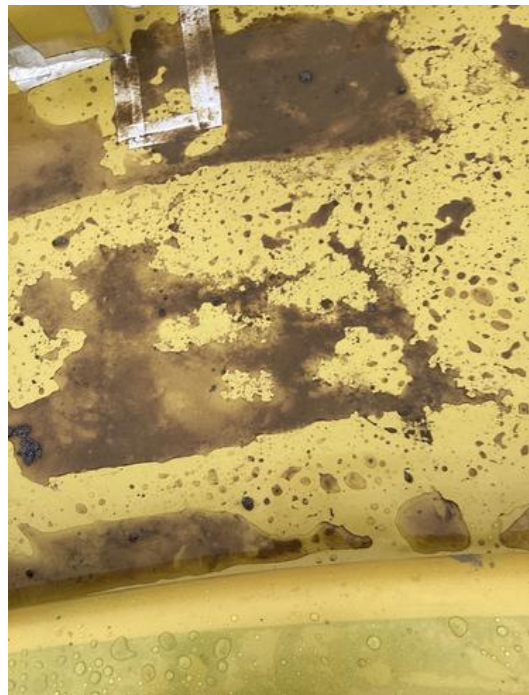
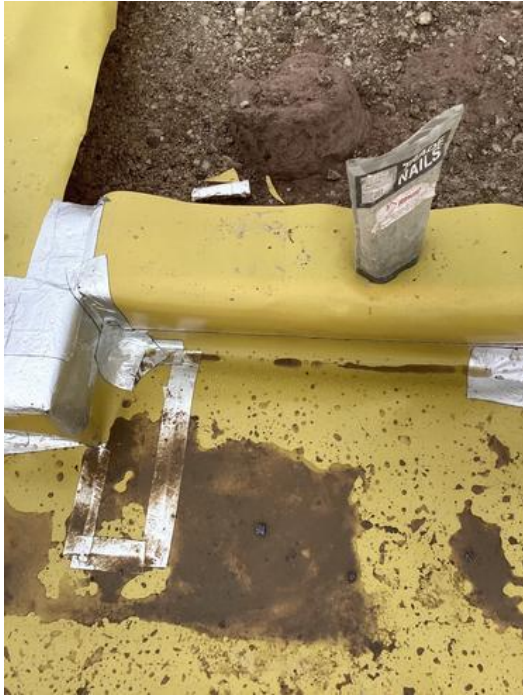
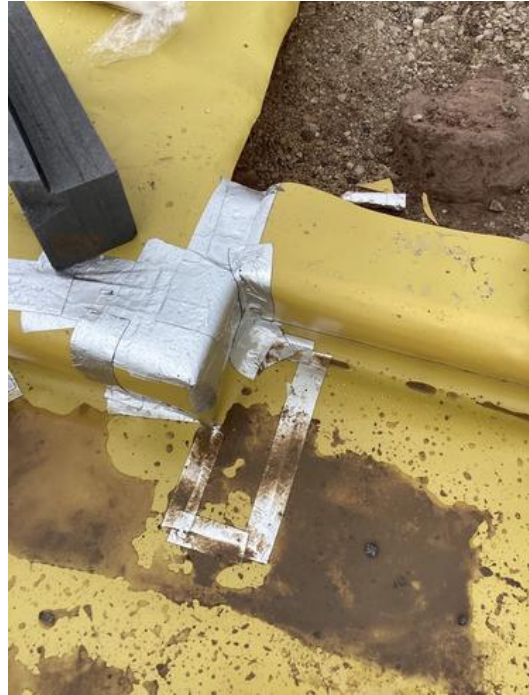
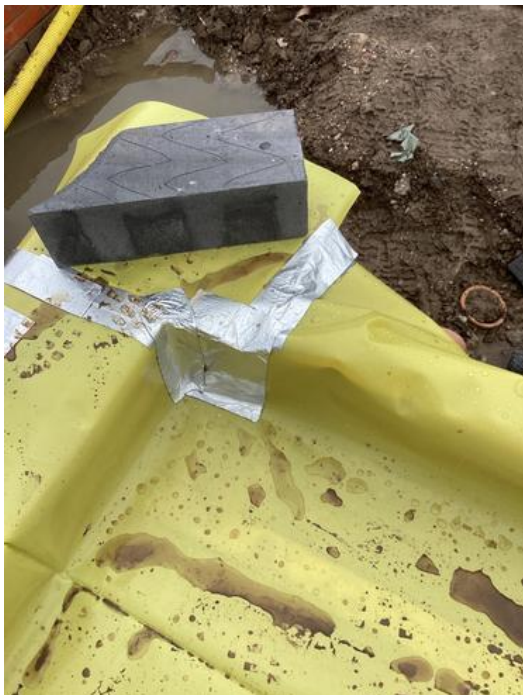
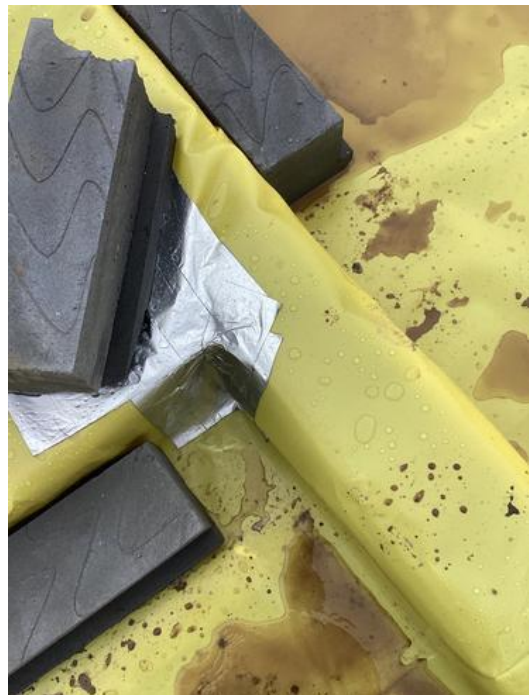
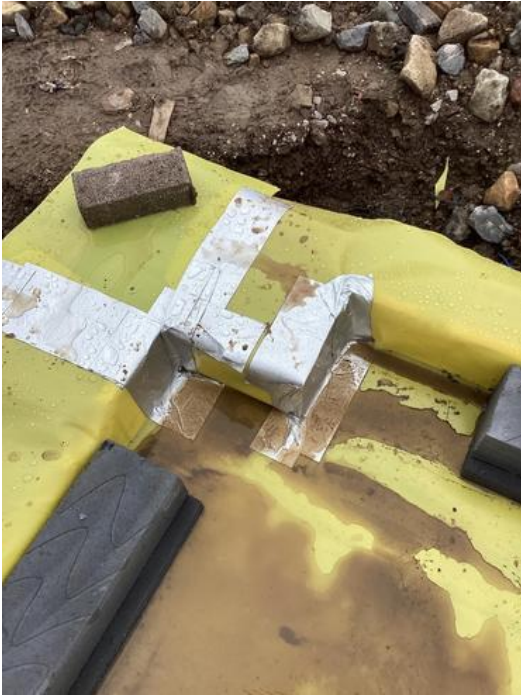
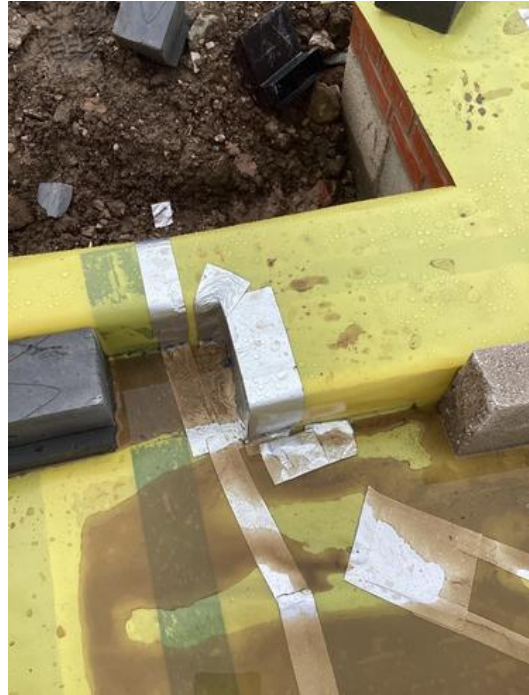
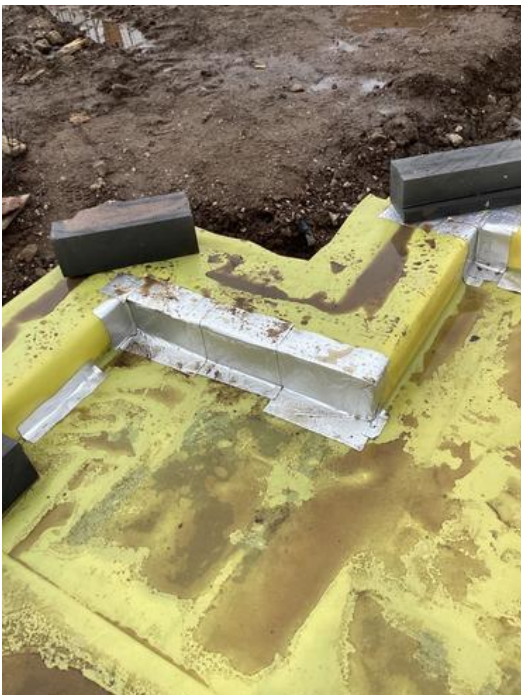
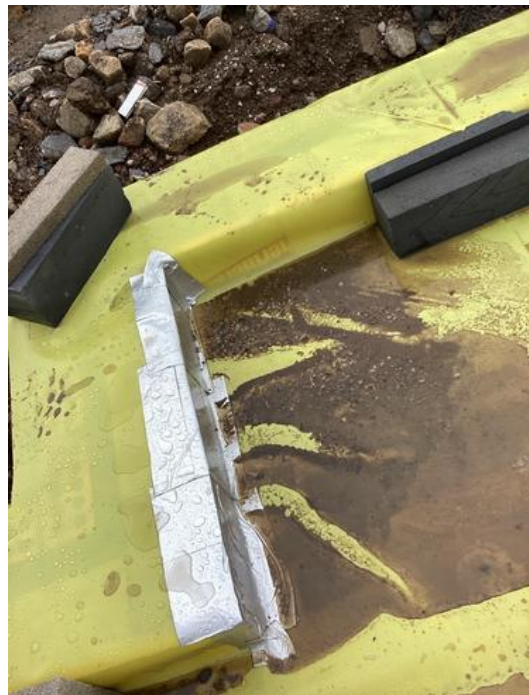
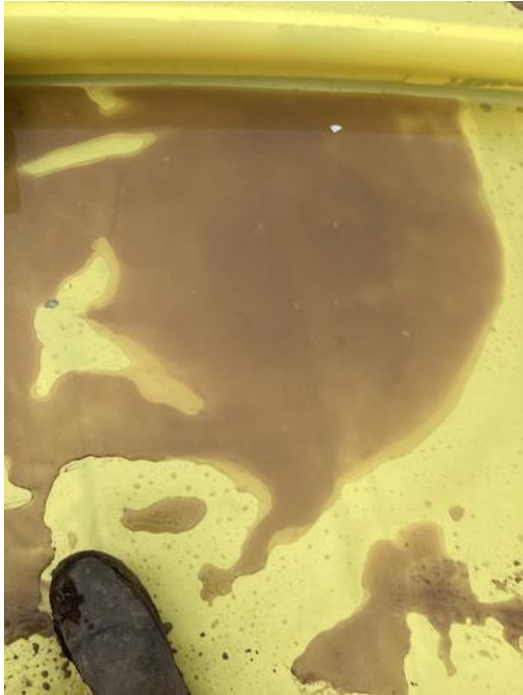
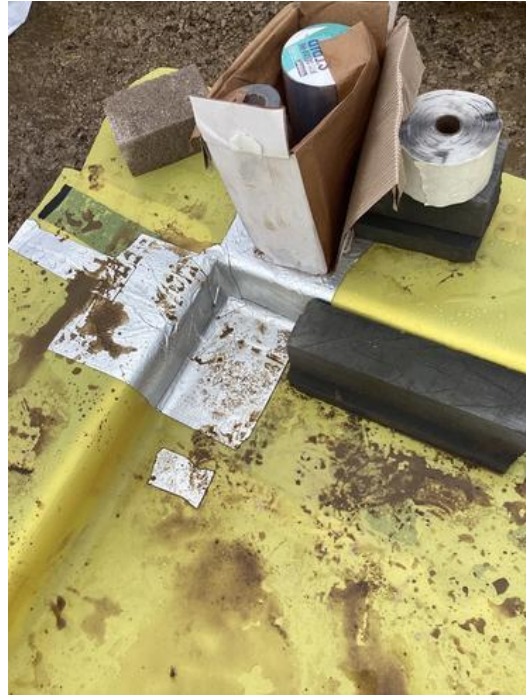
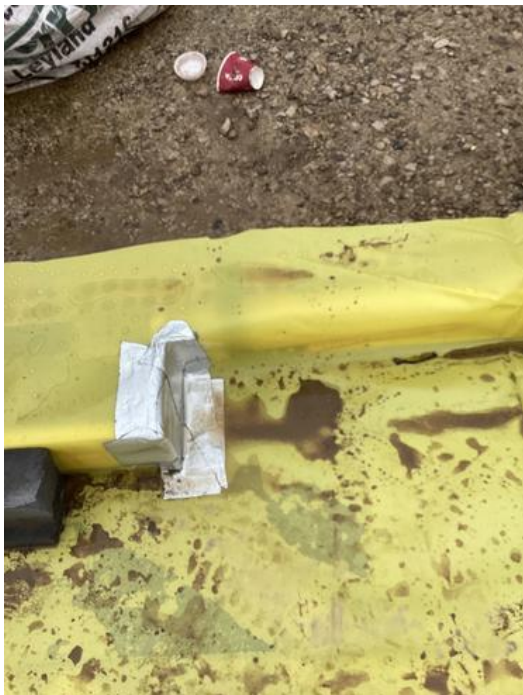
**Corners / Internal joints: Check all corners are correctly formed or contractor has used preformed corners.**

Pass

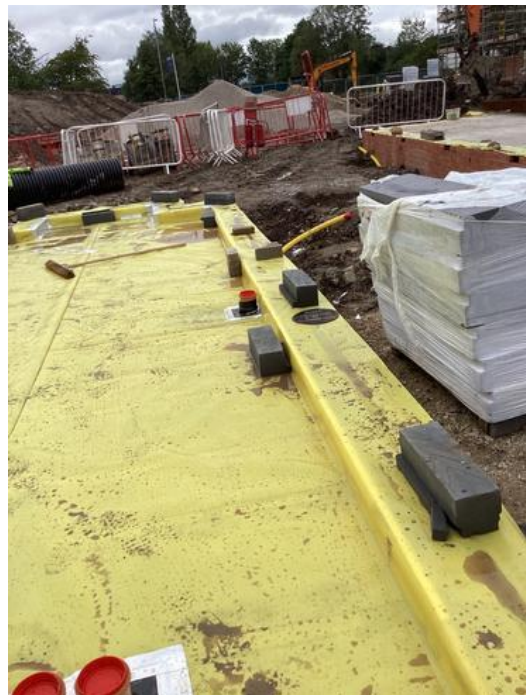
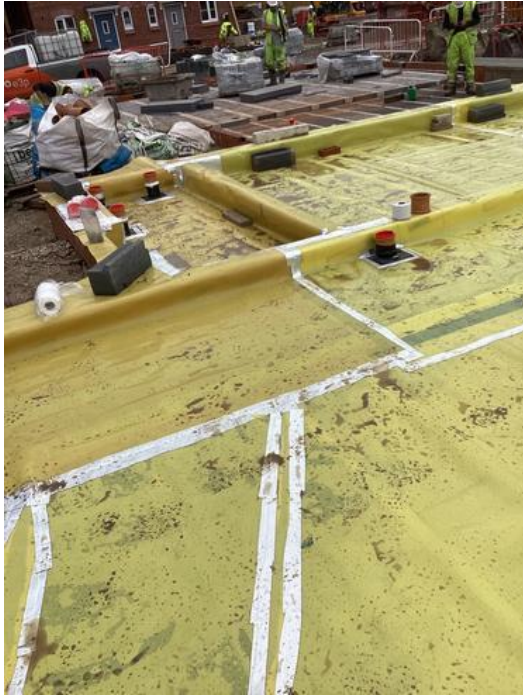
**Extent of Coverage: Is the membrane covering the entire plot? Does membrane span over outside walls?**

Yes

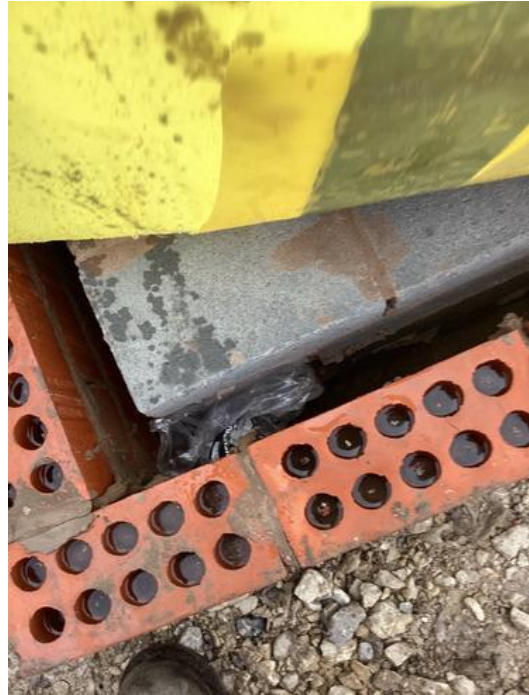
Photo 34

**Condition of sub-grade and underside of gas membrane: Check that the subgrade does not contain rough/uneven surfaces, is appropriately clean and that there are no hard/sharp objects. That protective sand blinding or geotextile (if specified) is present and meets the design criteria.**

Pass

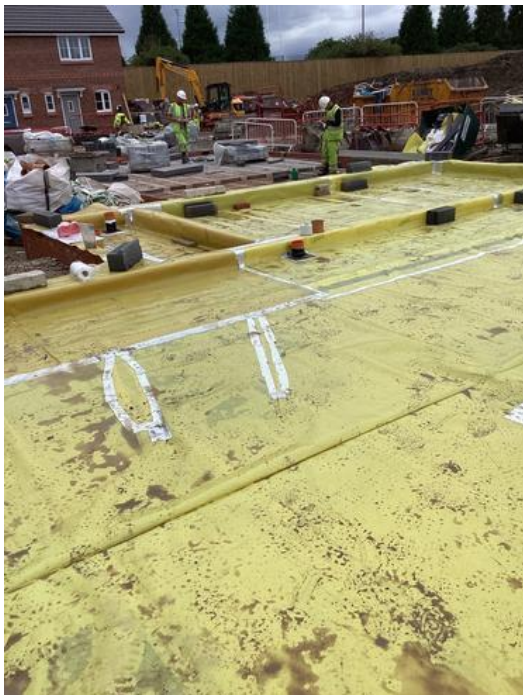
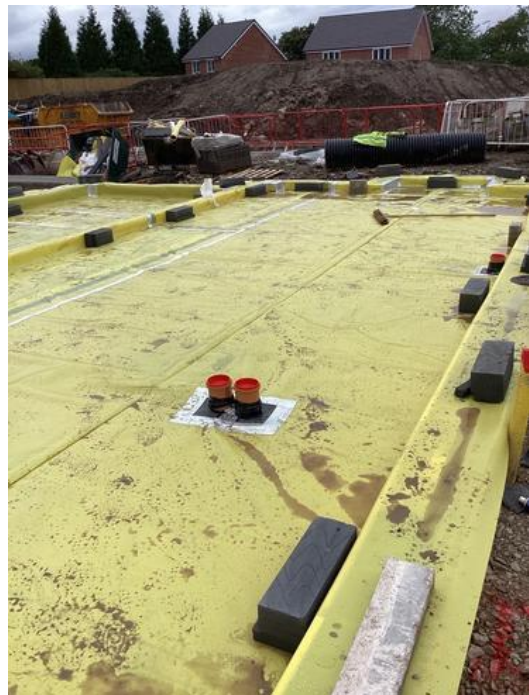
**Slab / membrane condition (is membrane clear of debris or insulation): Can membrane be fully seen and photographed – ask contractor to remove an debris so membrane can be fully seen and inspected – this is a requirement of NHBC and local authorities.**

Pass

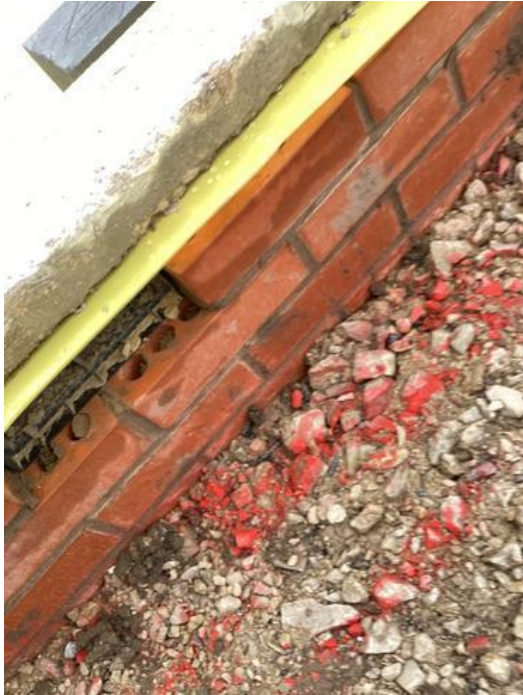
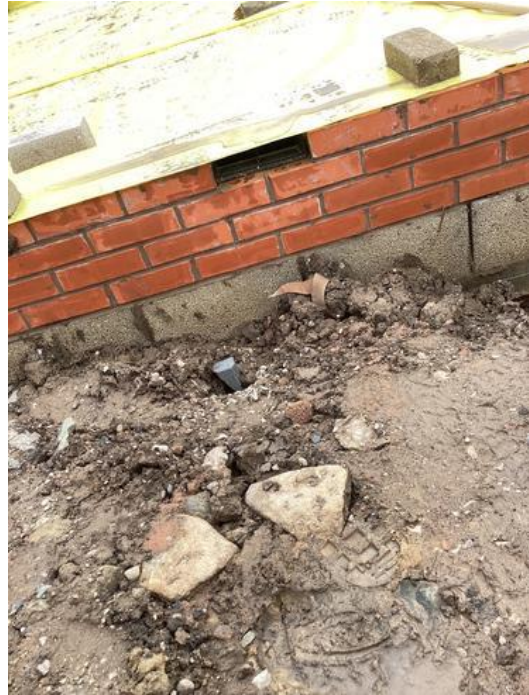
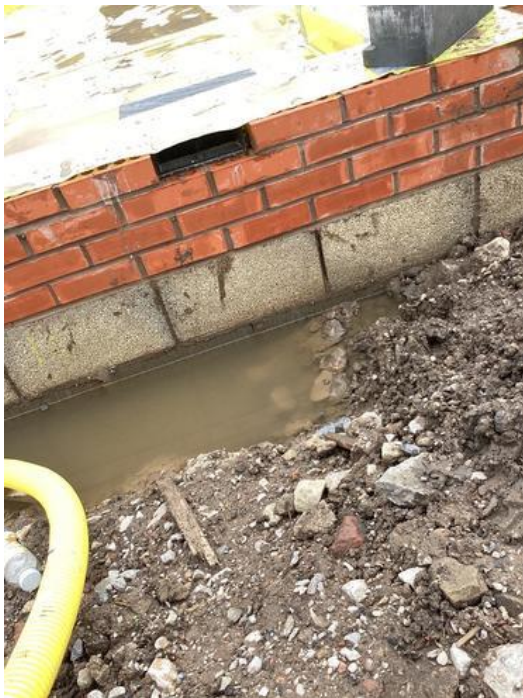
**External Wall Air bricks: Numbers, size. positions as design drawing? (Minimum of 3 walls)**

Pass
