### GAS MEMBRANE VALIDATION – BELLE VUE

**Project Name: Belle Bue Stadium**

**Plots: Block 1 Stairwell 1**

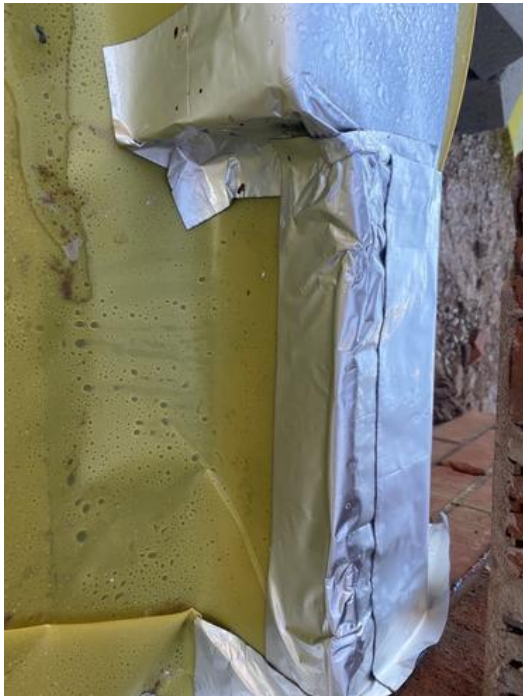
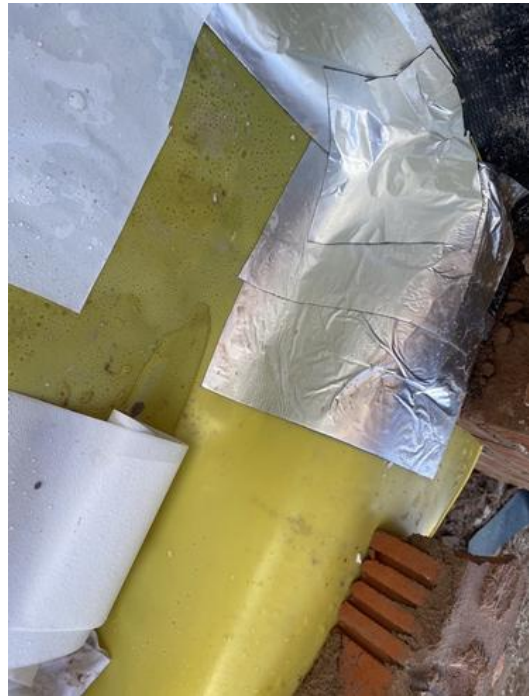
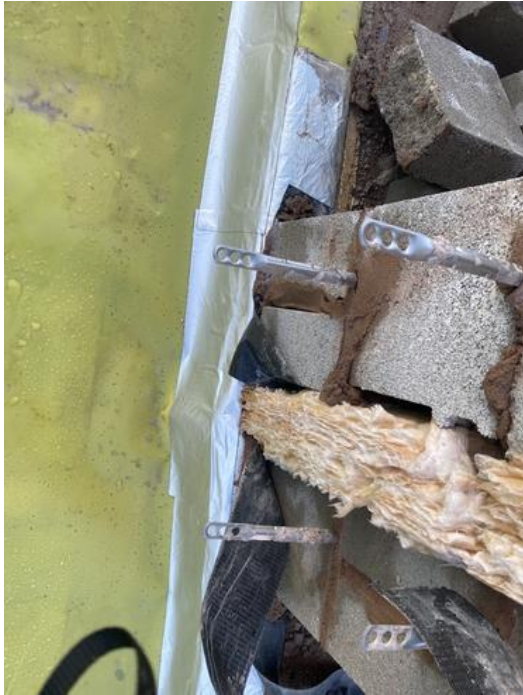
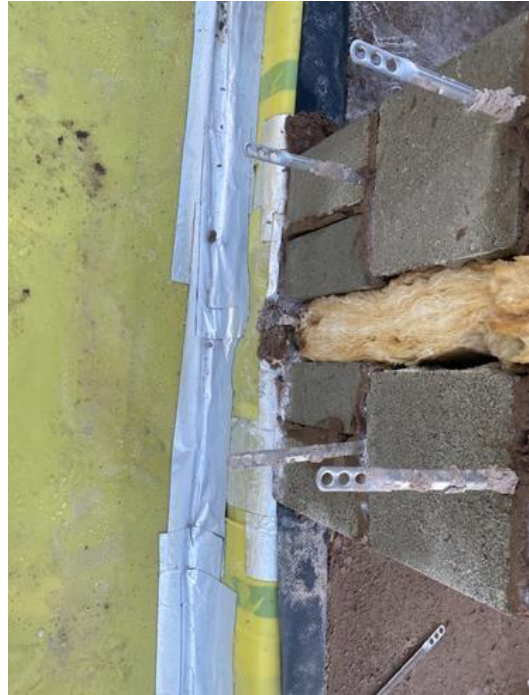
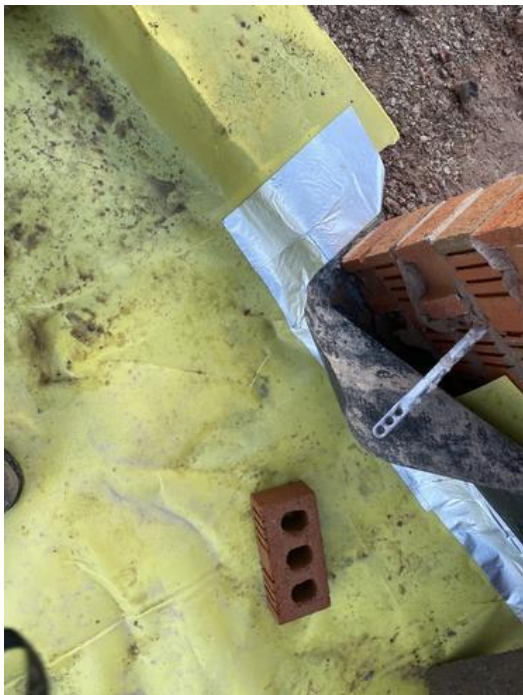
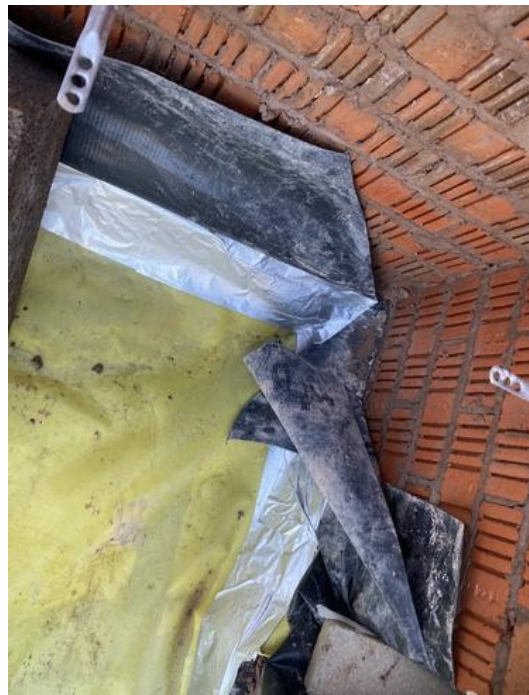
**Corners / Internal joints: Check all corners are correctly formed or contractor has used performed corners.** Pass
