### GAS MEMBRANE VALIDATION – BELLE VUE

**Project Name: Belle Bue Stadium****Project Number: 12-123****Client: Countryside Properties****Date: 09-05-2023****Project Manager: S. Ellis – FGS, CEnv****E3P Engineer: T. Newall****Gas Membrane Installers Chandos Civils****Ground Gas Risk Assessment: Amber 1****Plots: 151-152**

**GAS MEMBRANE VALIDATION**

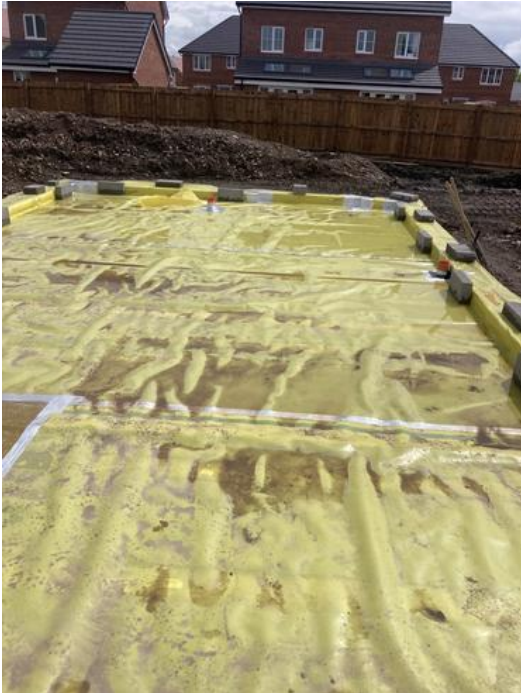
Photo 1

Gas Membrane Condition: Open punctures, tears, rips, stretching, Presence of debris, Repairs, Signs of weakness such as raised or sunken indentations, Protection plan in place to restrict access to lain gas membrane? IF FAIL DESCRIPTION IN ACTIONS AND PHOTOS REQUIRED

Pass

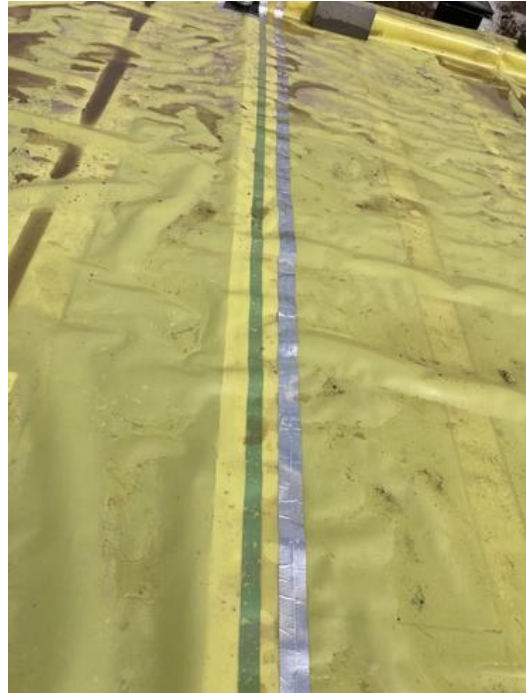
Photo 2

Laps, welds, and joints seals: Joints lapped and sealed in accordance with manufacturer's requirements/ specification? Minimum overlap insured? Sections taped twice? Are welds complete? Appropriate joining/double-sided tape used, Folds running in line with joints? (no joints cutting across folds)

Pass

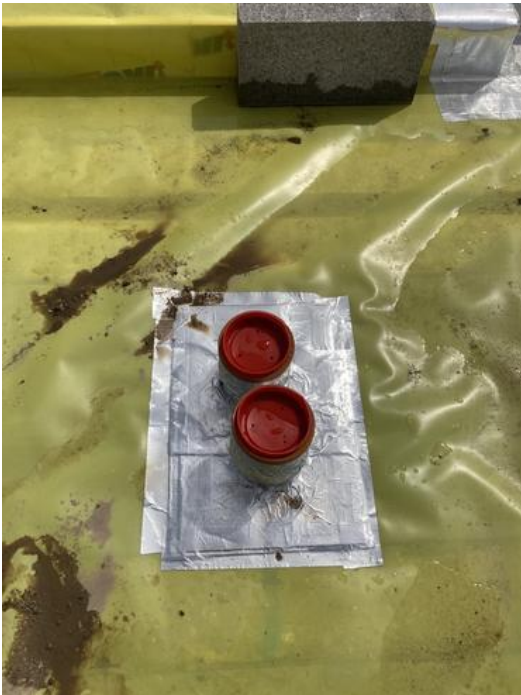
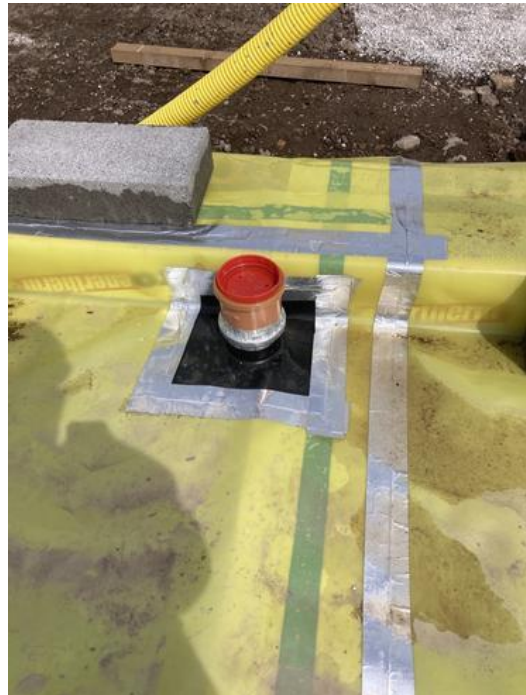
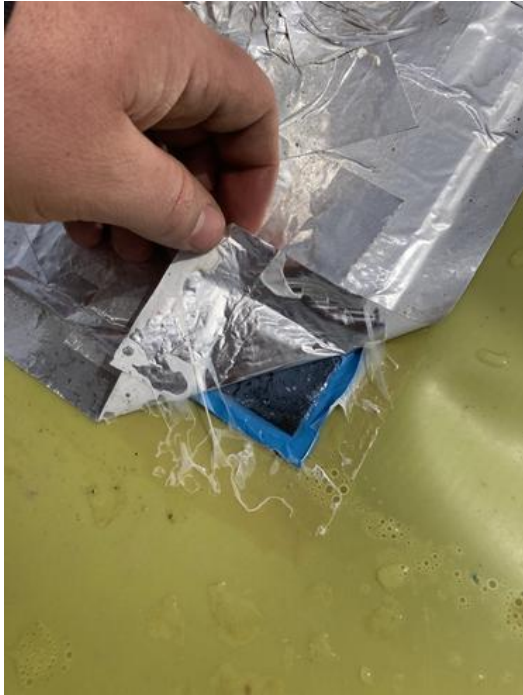
**Service entries seals: Top hats seal arrangements fixed around service entries? Use of Jubilee clips?**

Yes

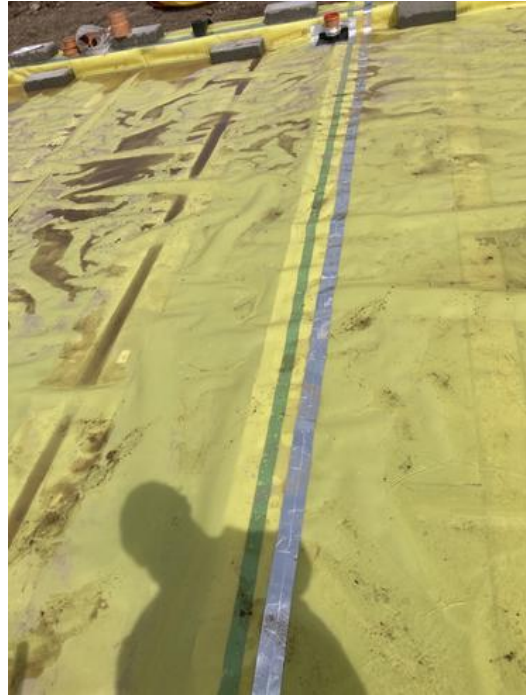
Photo 6

**Type of joints/ Lapping**

Taped

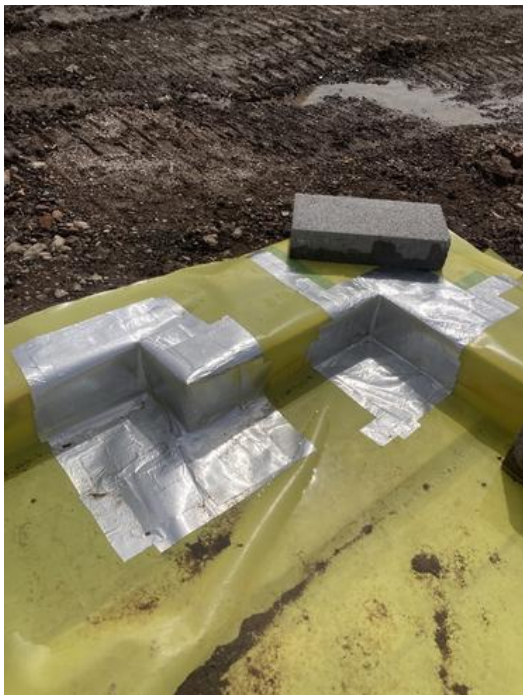
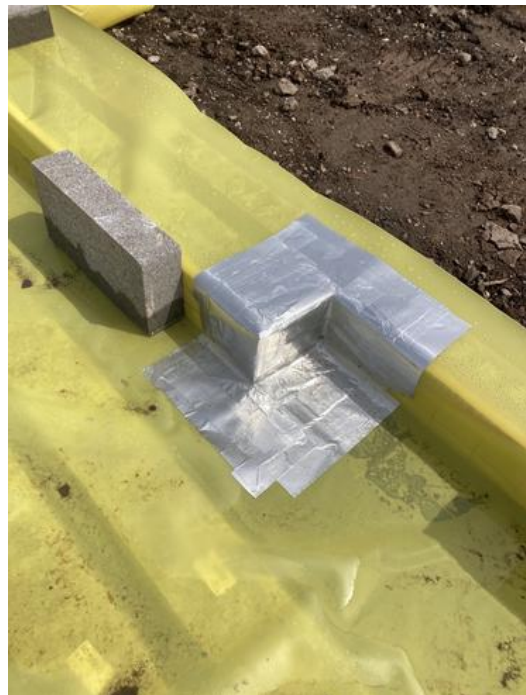
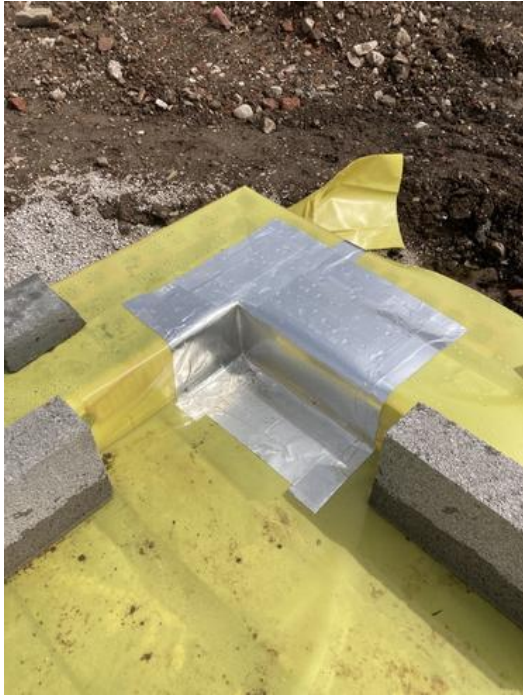
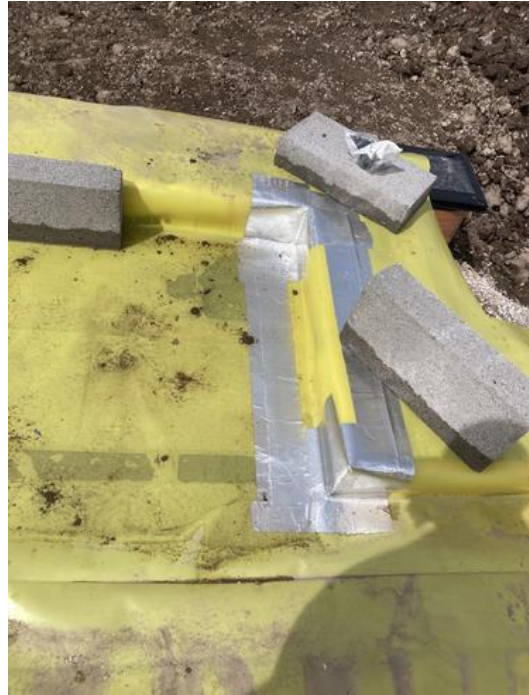
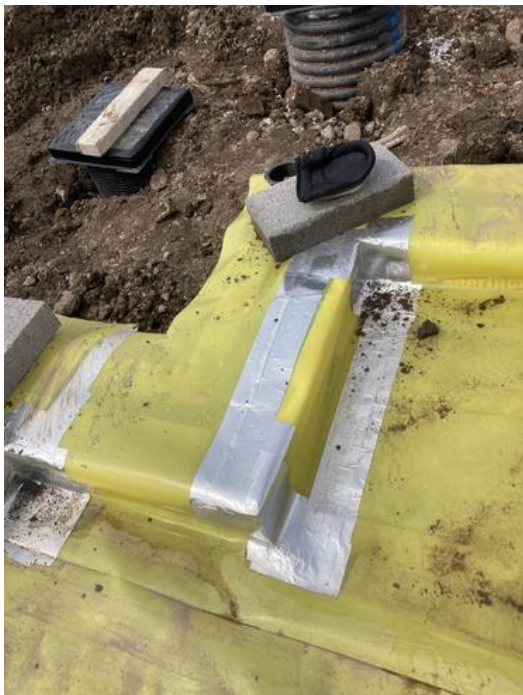
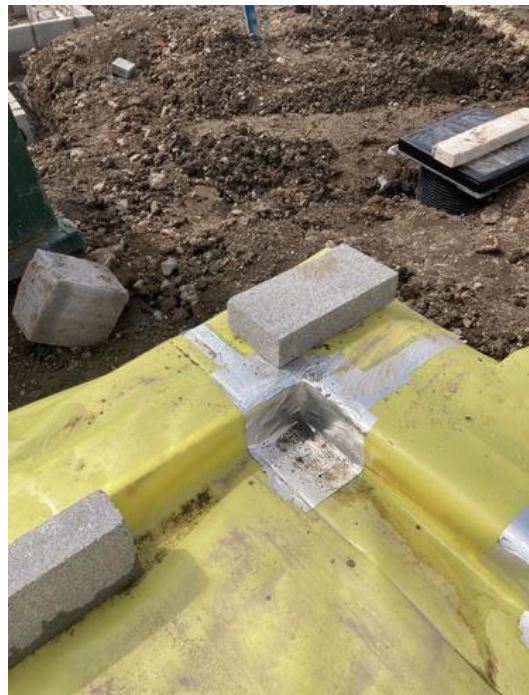
**Corners / Internal joints: Check all corners are correctly formed or contractor has used preformed corners.**

Pass

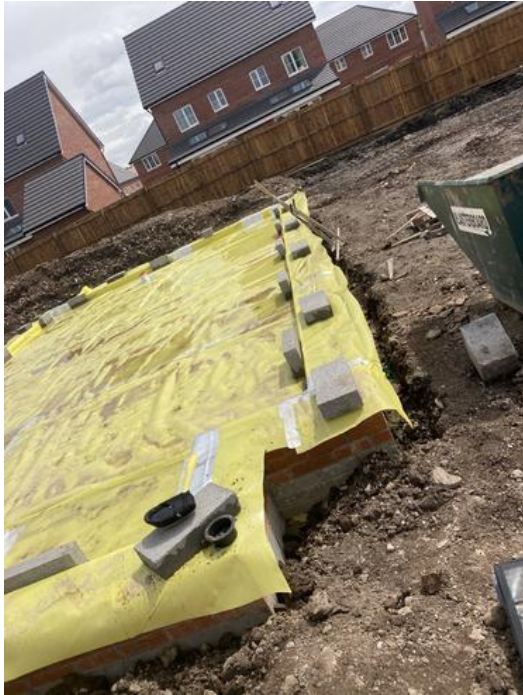
Photo 13

**Extent of Coverage: Is the membrane covering the entire plot? Does membrane span over outside walls?**

Yes

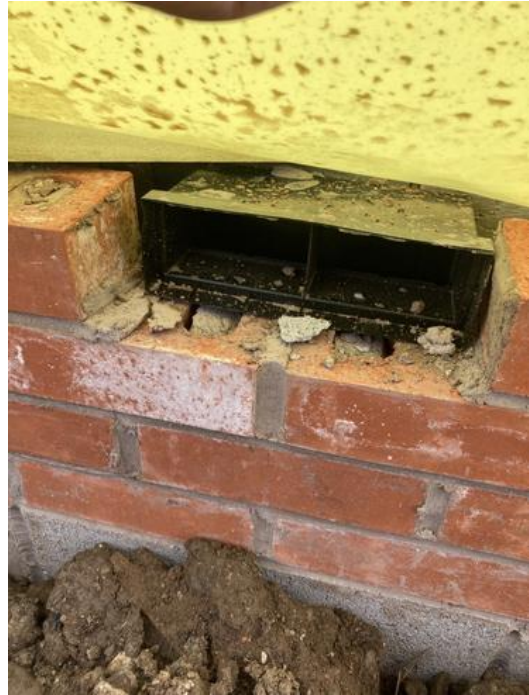
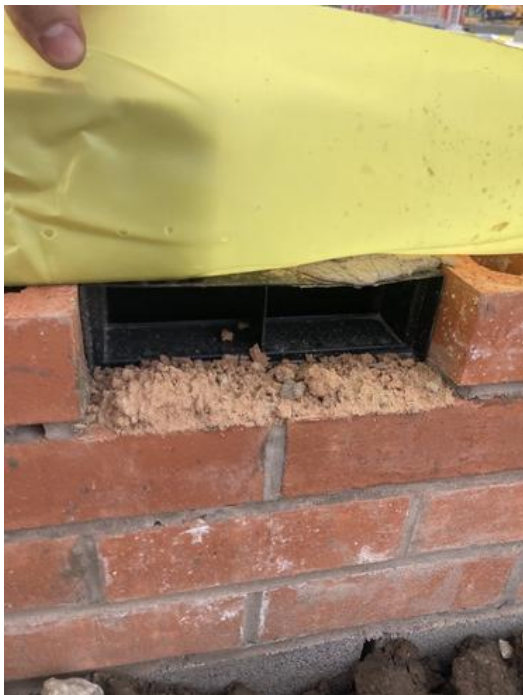
**External Wall Air bricks: Numbers, size, positions as design drawing? (Minimum of 3 walls)**

Pass

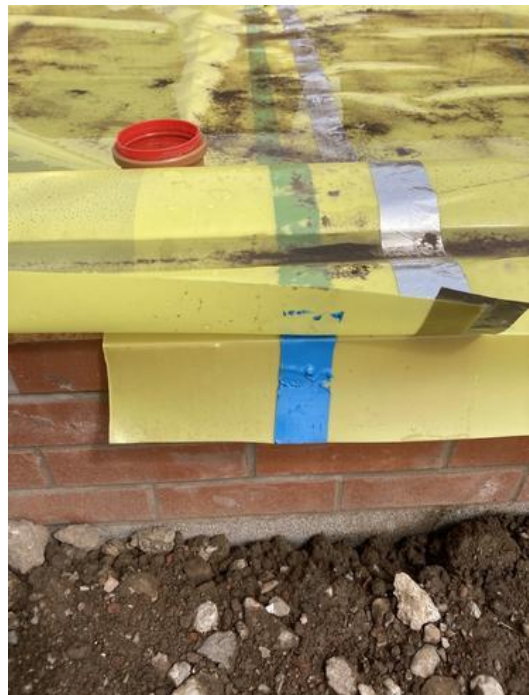
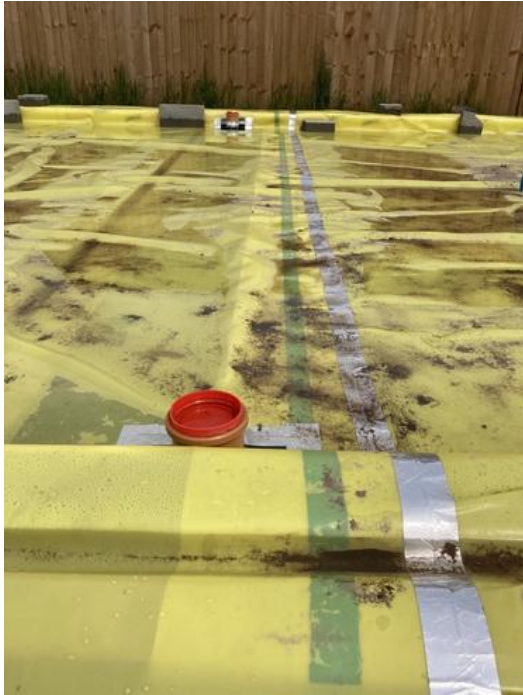
Laps, welds, and joints seals: Joints lapped and sealed in accordance with manufacturer's requirements/ specification? Minimum overlap insured? Sections taped twice? Are welds complete? Appropriate joining/double-sided tape used, Folds running in line with joints? (no joints cutting across folds) Pass

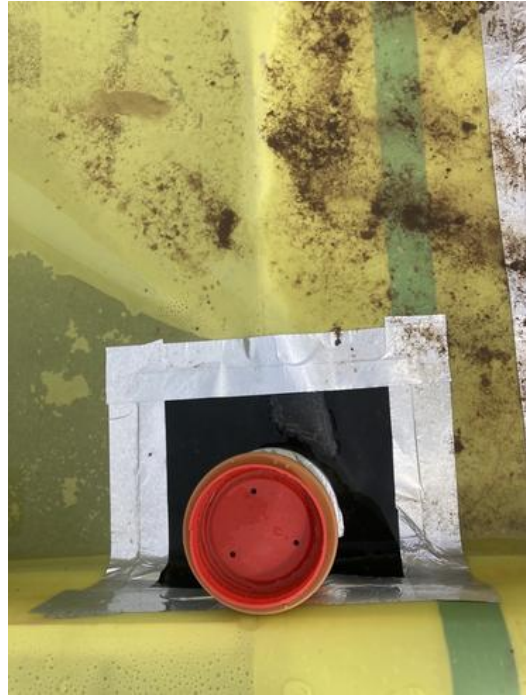
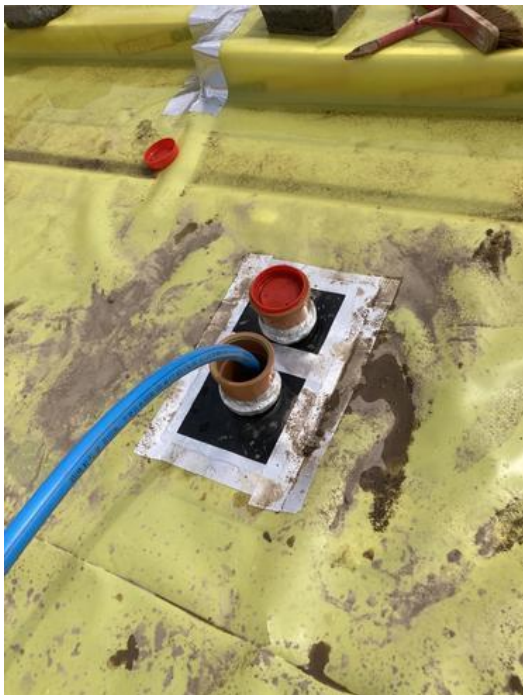
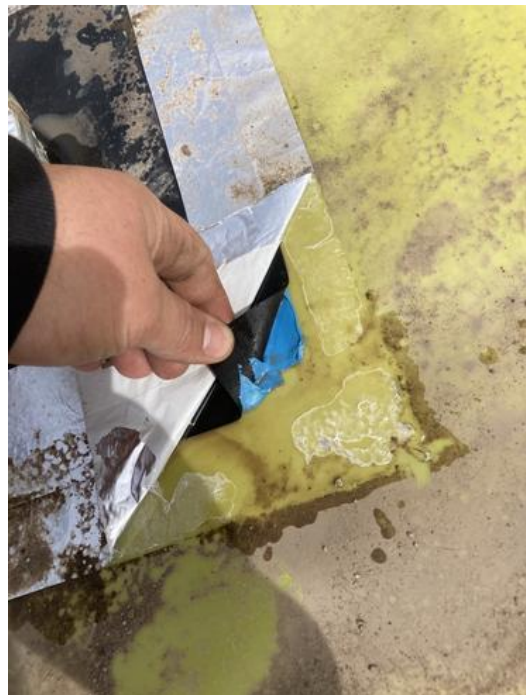
Service entries seals: Top hats seal arrangements fixed around service entries? Use of Jubilee clips? Yes

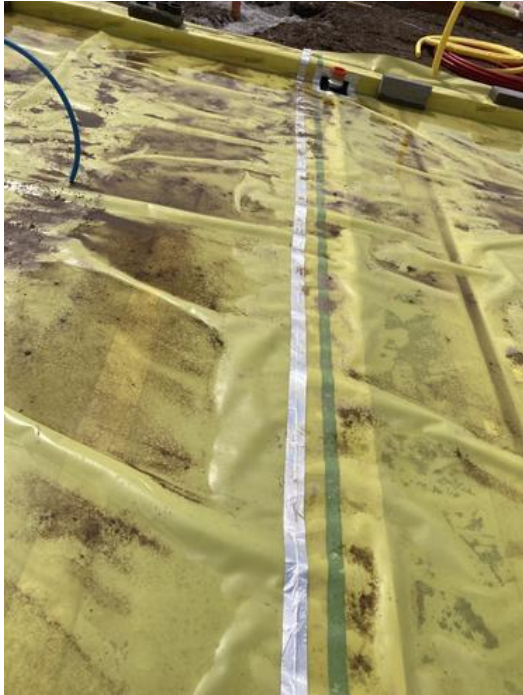
Photo 21

Type of joints/ Lapping Taped

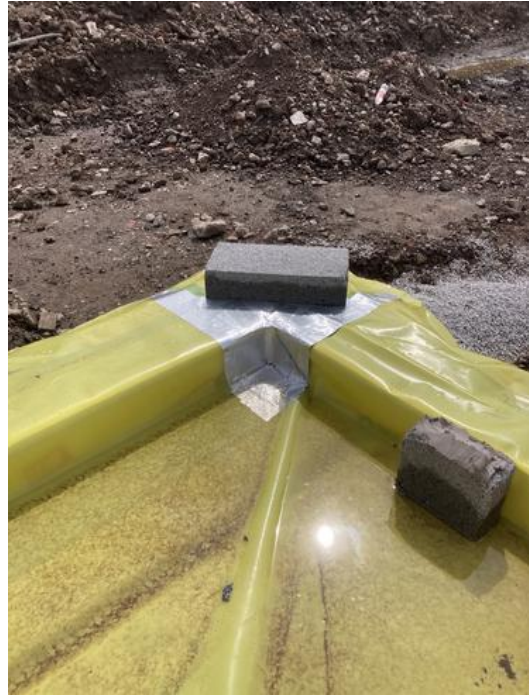
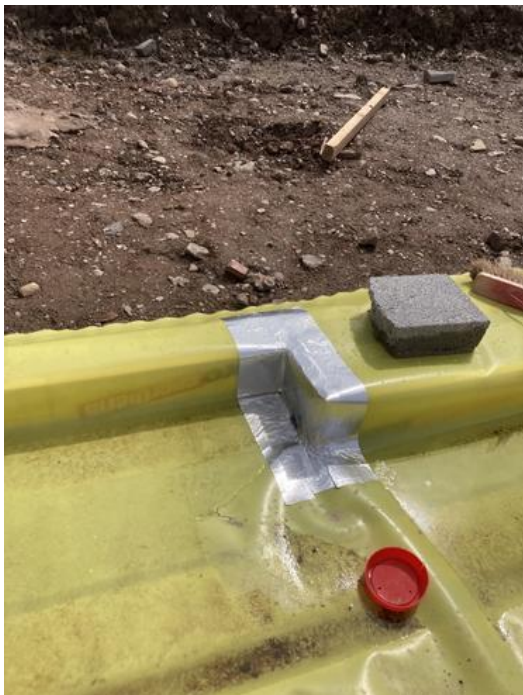
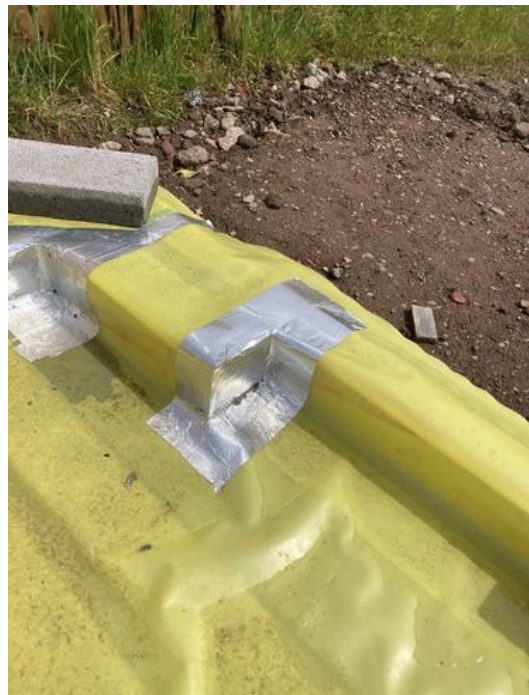
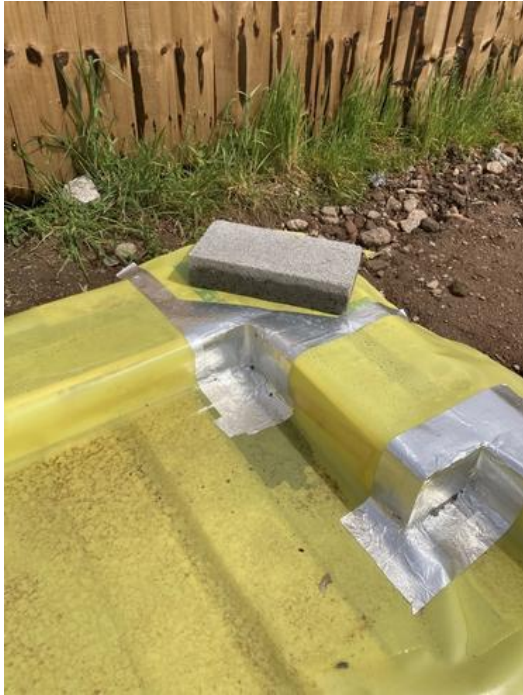
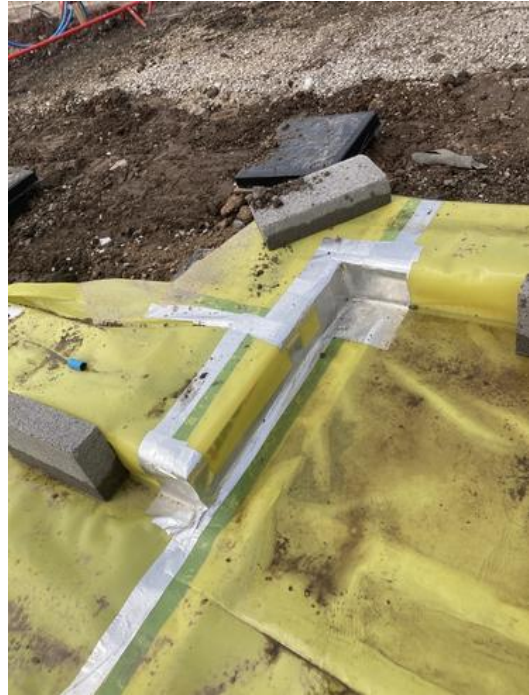
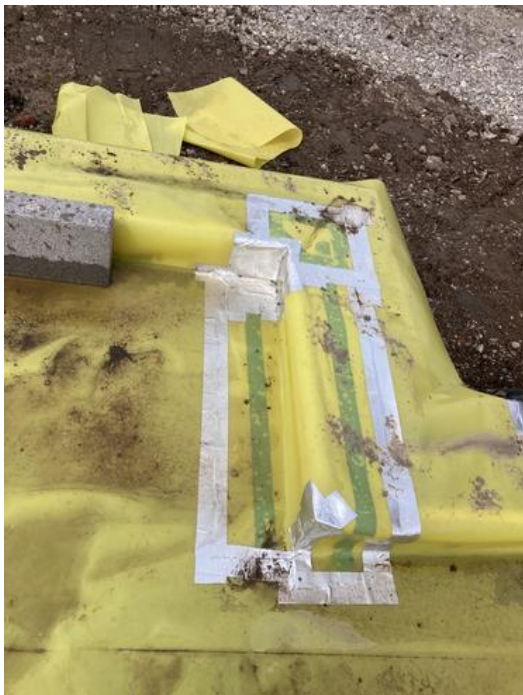
**Corners / Internal joints: Check all corners are correctly formed or contractor has used preformed corners.**

Pass

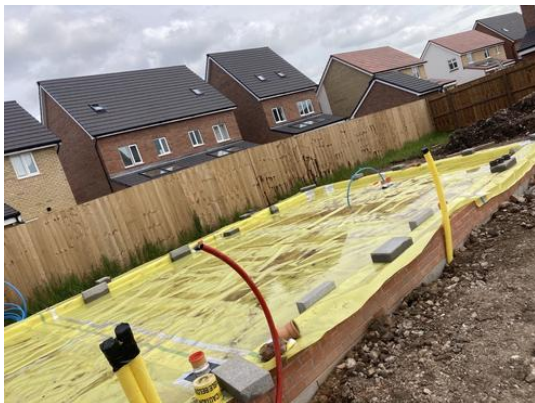
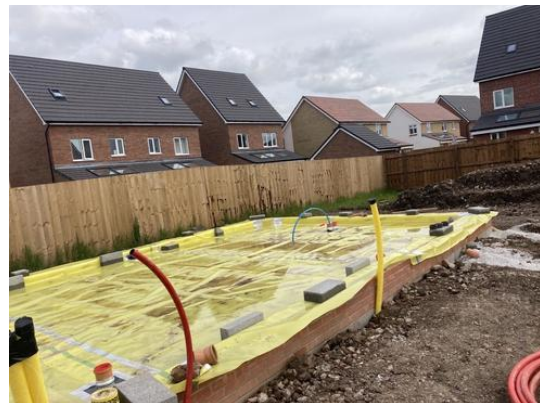
**Extent of Coverage: Is the membrane covering the entire plot? Does membrane span over outside walls?**

Yes

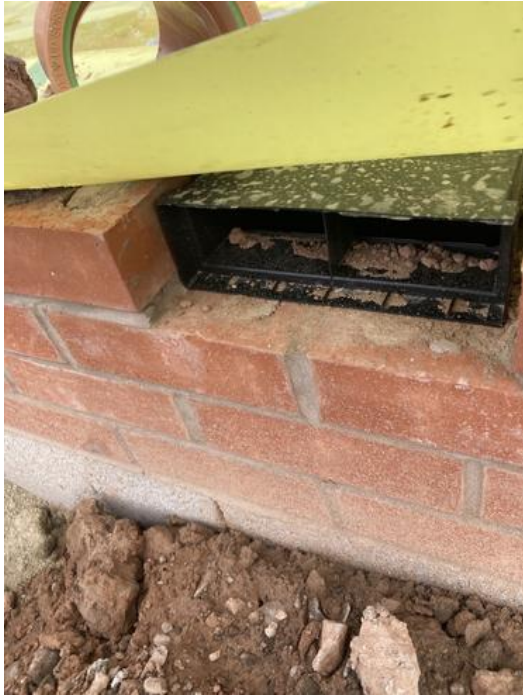
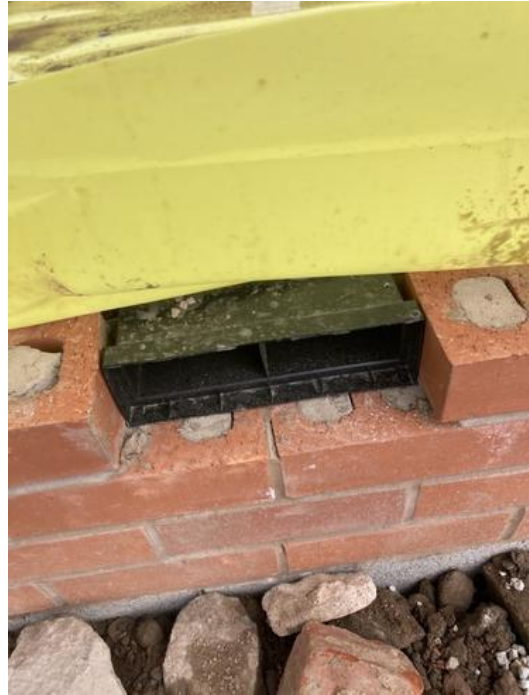
**External Wall Air bricks: Numbers, size. positions as design drawing? (Minimum of 3 walls)**

Pass
