## GAS MEMBRANE VALIDATION

| Site Name: Belle Vue Stadium | Project Number: 12-123 |
| Company Name: Countryside | Date: 08-09-2022 |

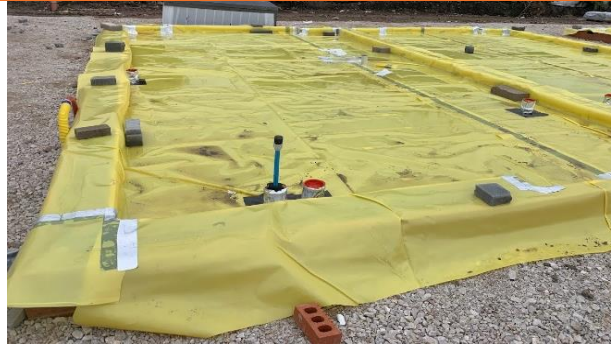
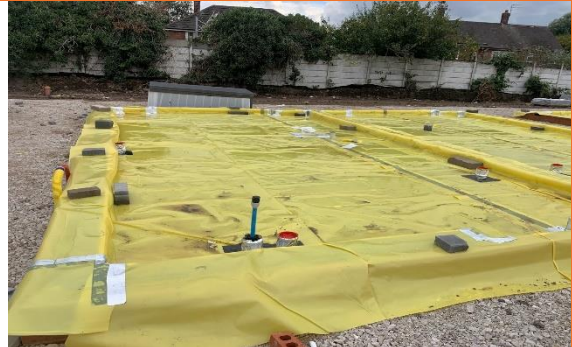
**Plot – 125**

**General Condition of Membrane-Good Condition**

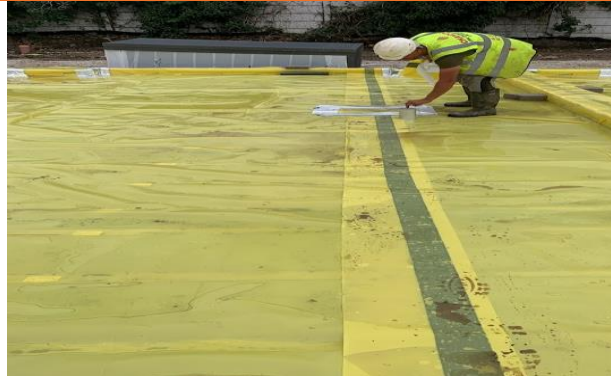
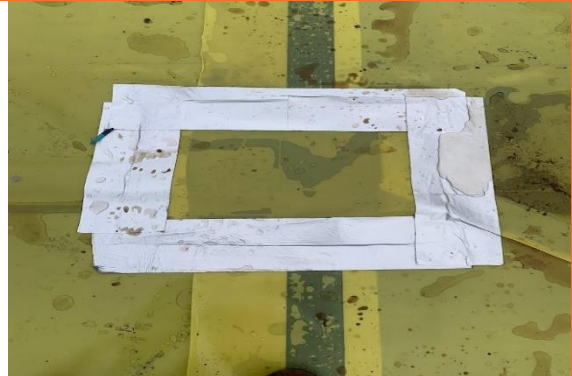
**Verification of Joints and Seals-Overlapped and sealed correctly**

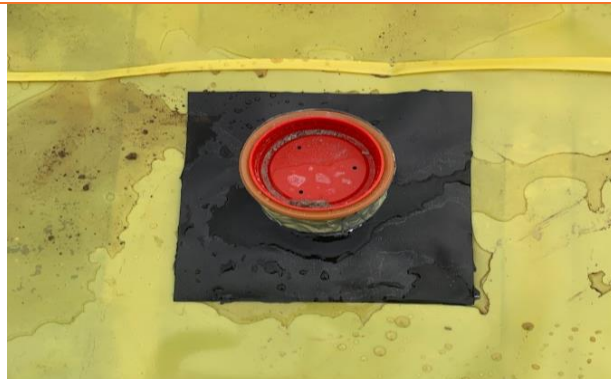
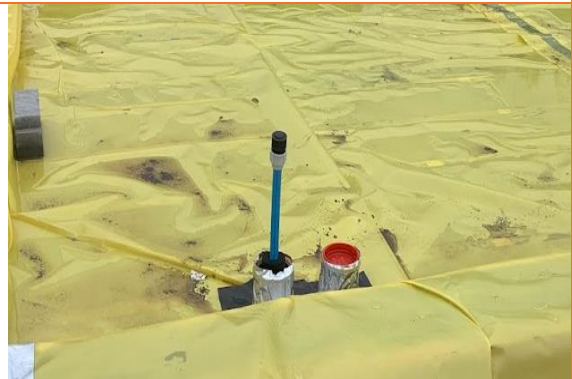
**Verification of Service Penetrations-Good Condition**

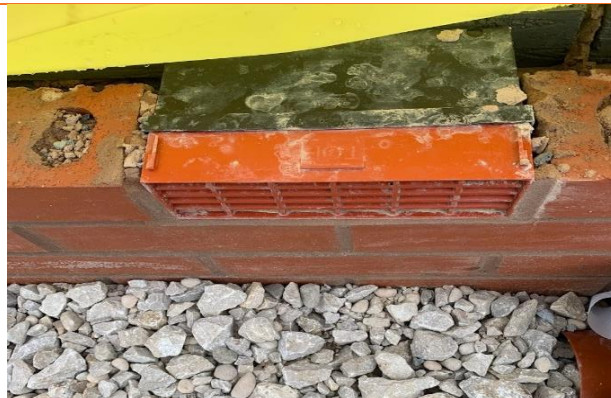
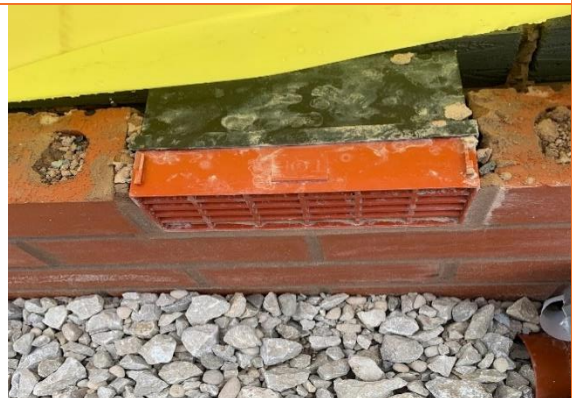
**Verification of Ventilation-Good Condition**

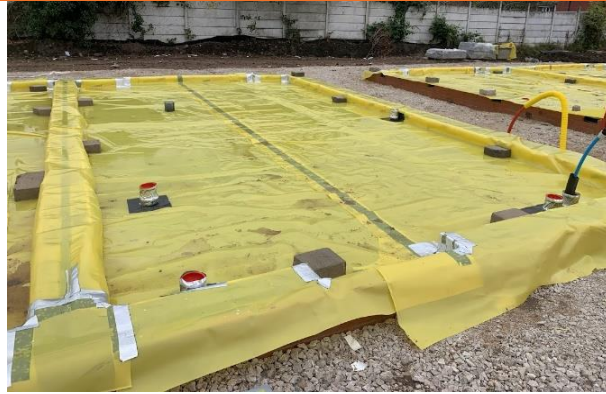
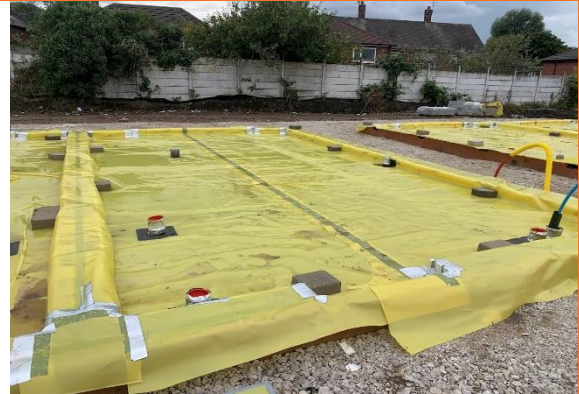
**Plot – 126**

**General Condition of Membrane-Good Condition**

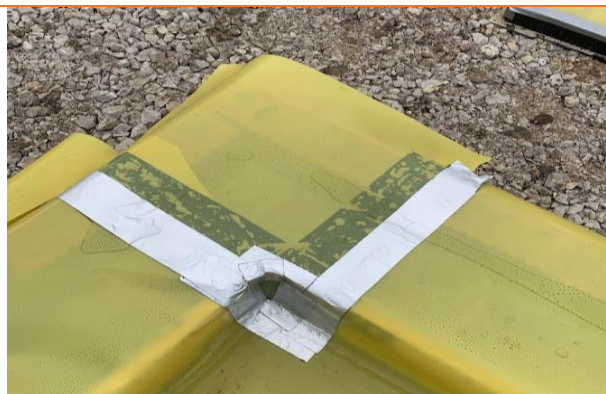
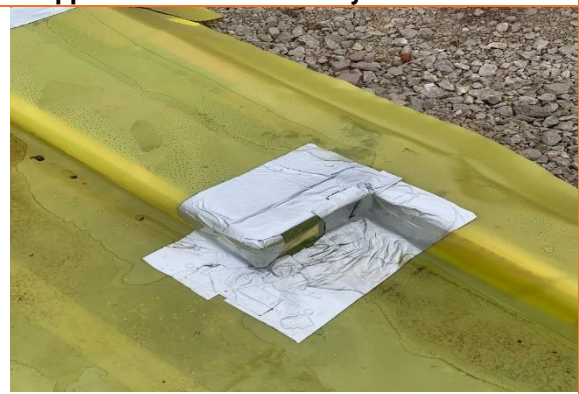
**Verification of Joints and Seals-Overlapped and sealed correctly**

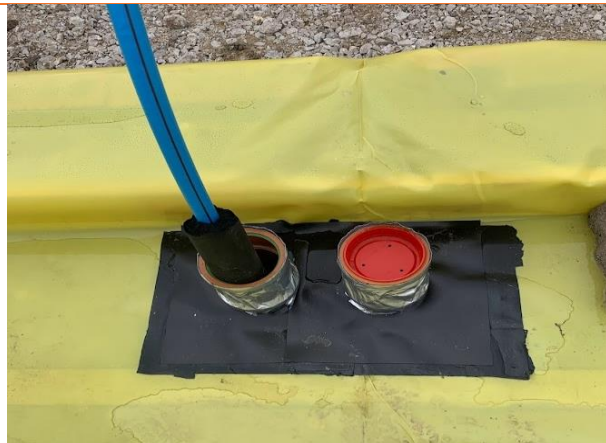
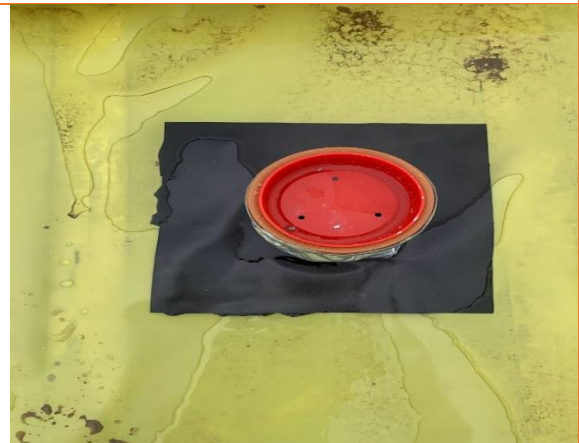
**Verification of Service Penetrations-Good Condition**

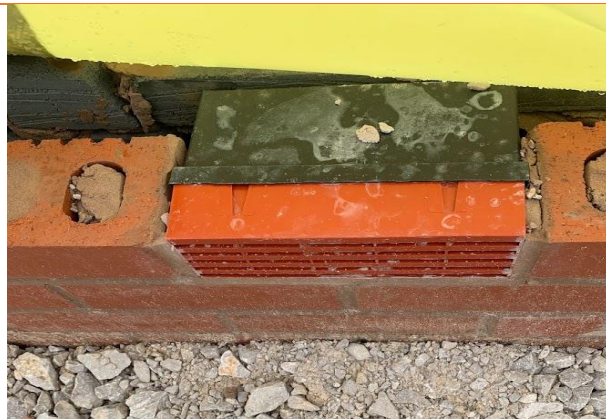
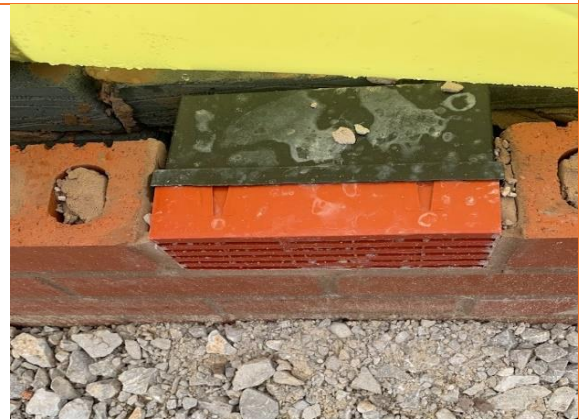
**Verification of Ventilation-Good Condition**

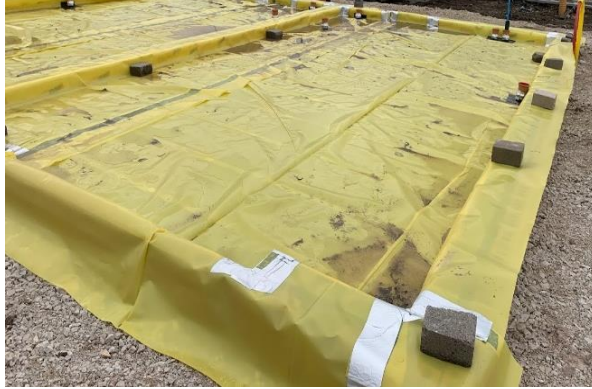
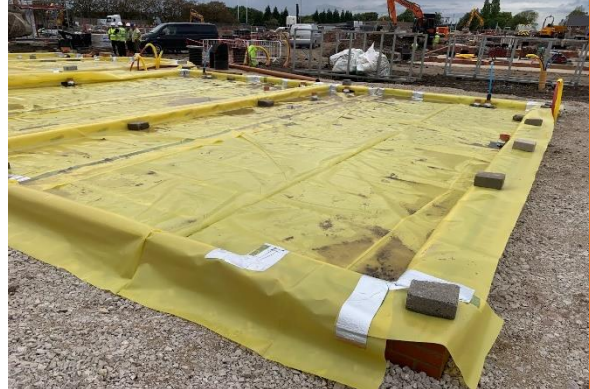
**Plot – 127**

**General Condition of Membrane-Good Condition**

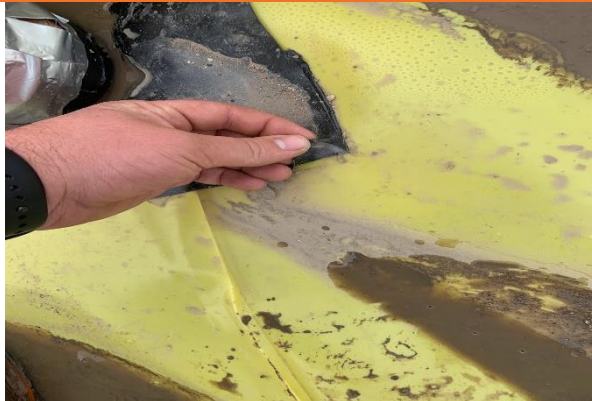
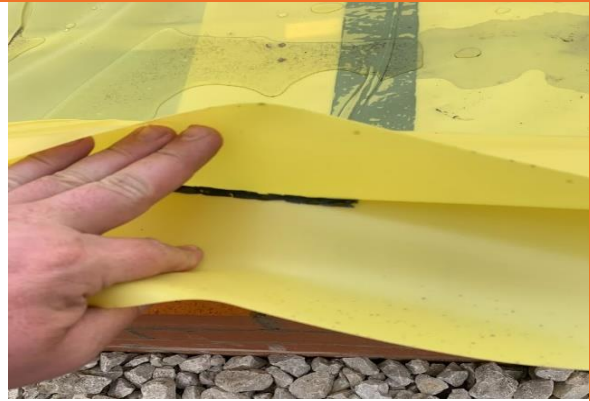
**Verification of Joints and Seals-Overlapped and sealed correctly**

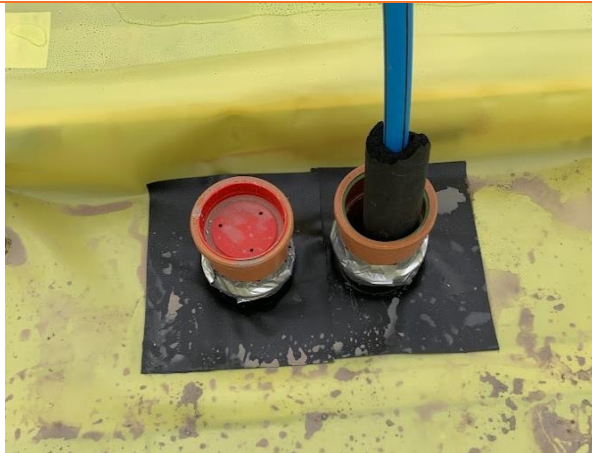
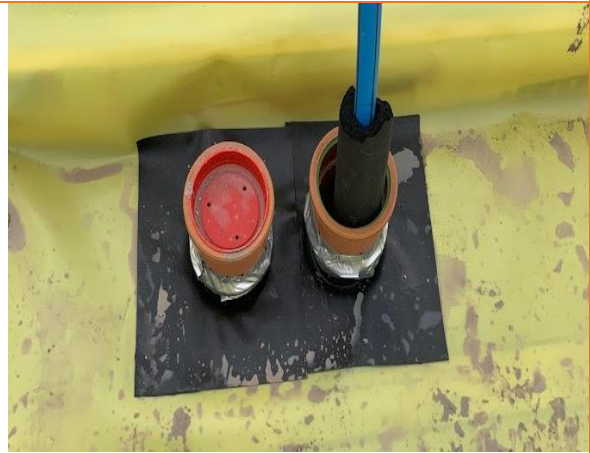
**Verification of Service Penetrations-Good Condition**

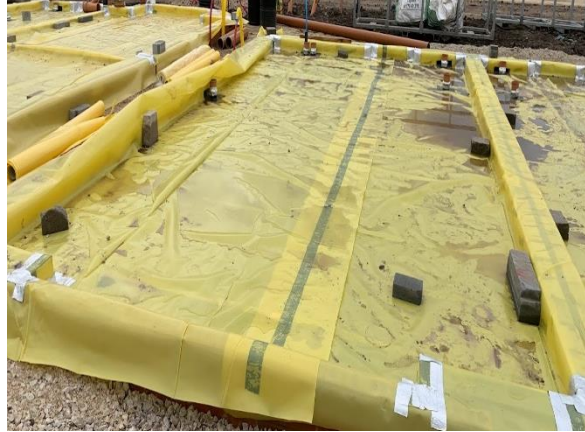
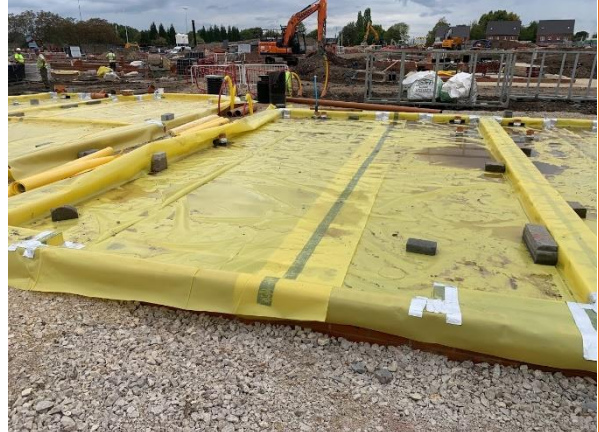
**Plot – 128**

**General Condition of Membrane-Good Condition**

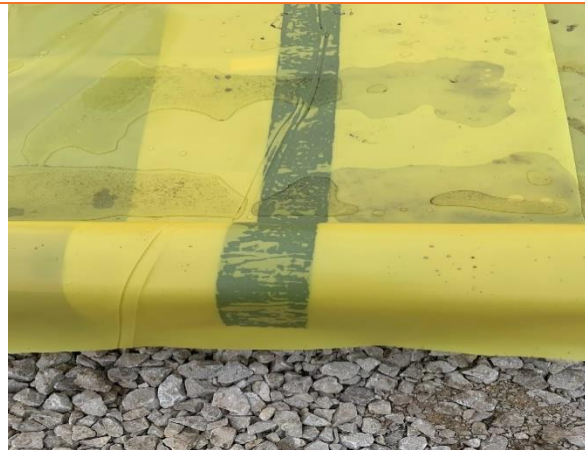
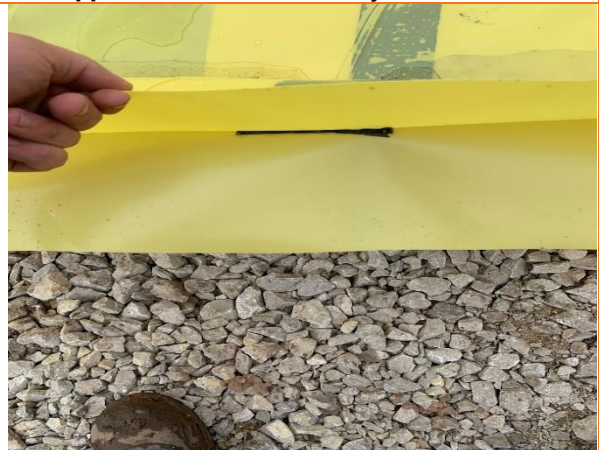
**Verification of Joints and Seals-Overlapped and sealed correctly**

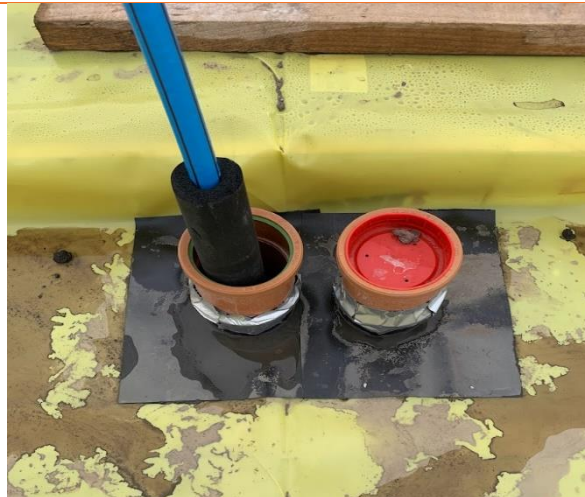
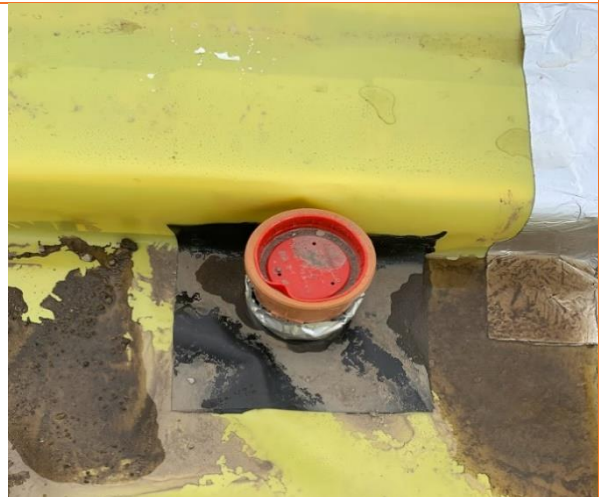
**Verification of Service Penetrations-Good Condition**

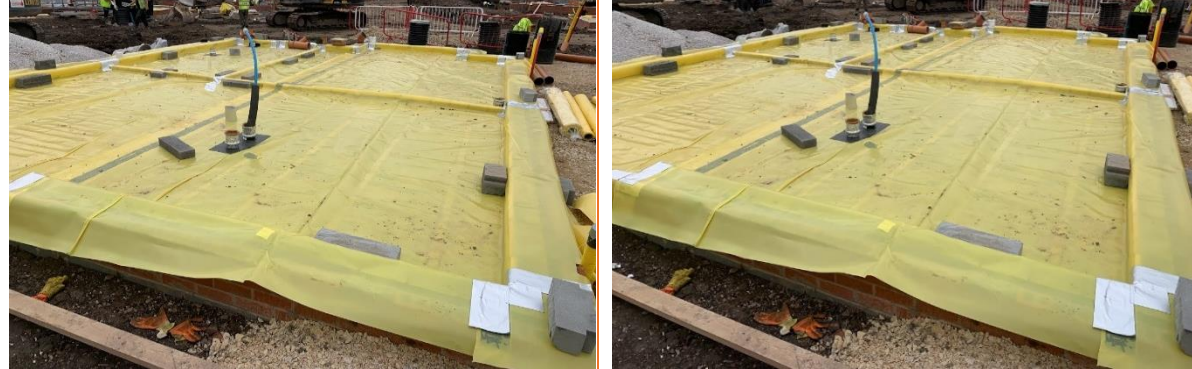
**Plot – 129**

**General Condition of Membrane-Good Condition**

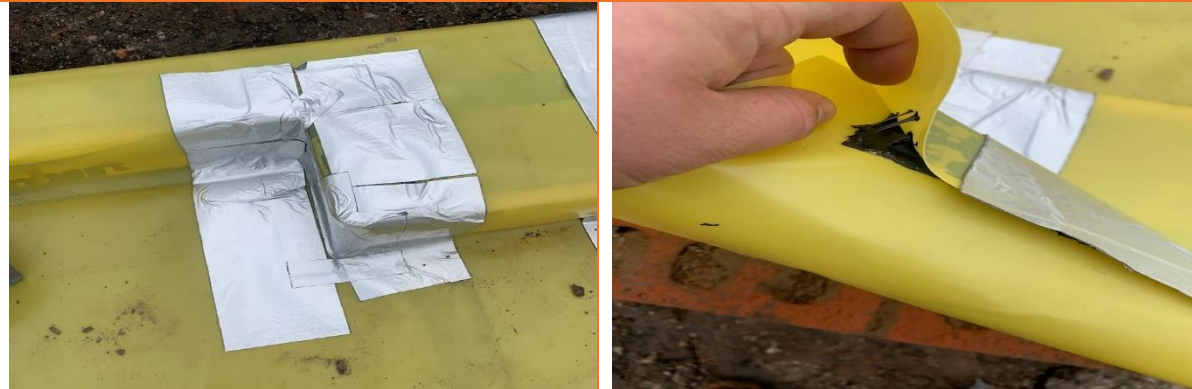
**Verification of Joints and Seals-Overlapped and sealed correctly**

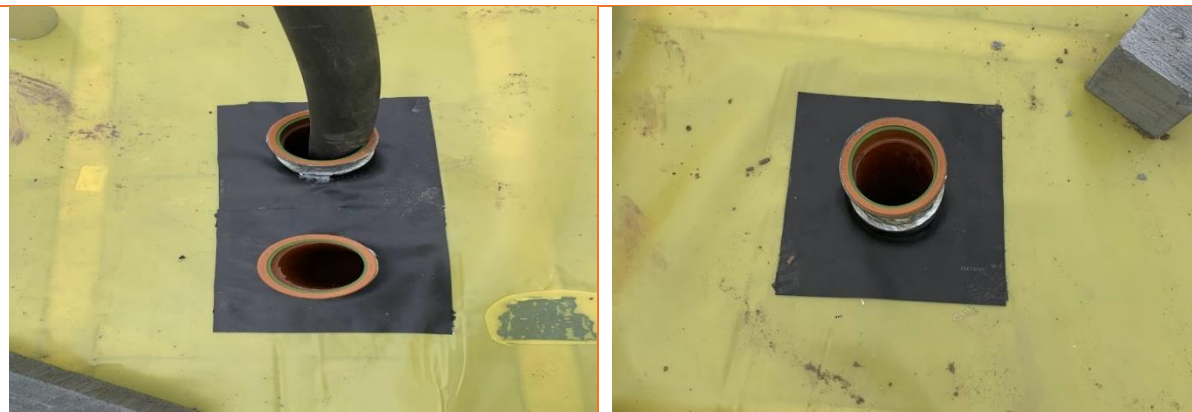
**Verification of Service Penetrations-Good Condition**

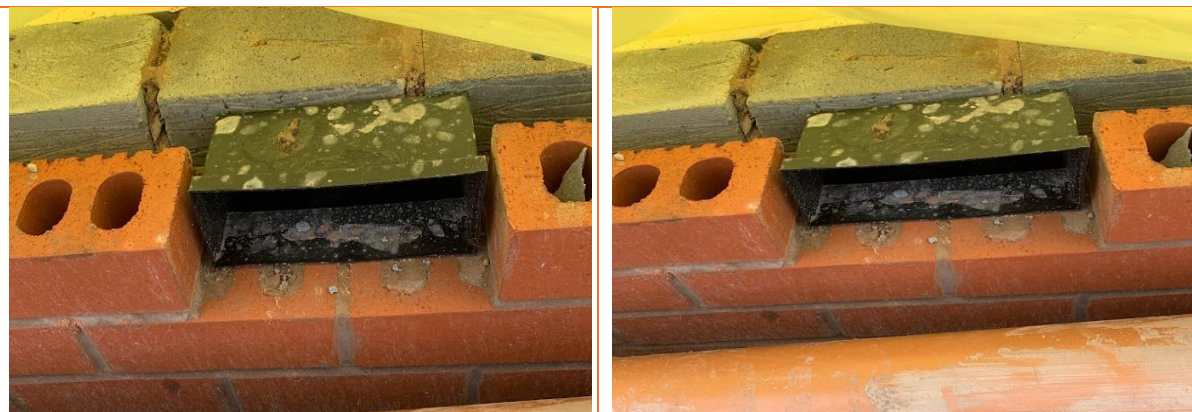
**Verification of Ventilation-Good Condition**
