**DXH/45506 – Barrass Street - Structural survey of boundary wall**

**Address: Barrass Street, Manchester, M11 1WP**

**Property Type: Boundary wall to former Varna Street Primary School grounds**

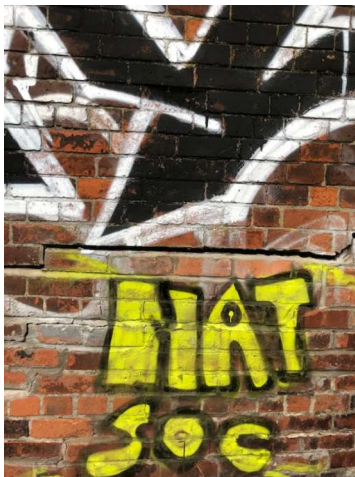
**Photo No. 3**

- Horizontal crack approximately 3 metres long at 900mm above ground level. **(Ref photo 3)**
- Stepped cracking with the cracks extending through the wall and visible on each side. The crack width varies from 20mm up to 50mm wide in places. **(Ref photo 4-7)**
- Horizontal crack approximately 2 metres long at 2250mm above ground level. **(Ref photo 8)**

It is therefore proposed to take down and rebuild this section of the wall. As the wall is over 3 metres high and is also retaining soil and vegetation it would not be suitable to rebuild the wall using the same detail as the existing 225mm thick wall with 325mm thick piers, as this is not adequate to resist the lateral loads applied. It is therefore proposed to rebuild the wall as a 325mm thick grouted cavity wall with a reinforced cavity. The new grouted cavity wall will be supported on a new reinforced concrete strip foundation. The existing brickwork can be retained and reused where possible, with matching brickwork used where new brickwork is required. New coping stones will be required over the rebuilt wall and should be laid on bedding mortar.

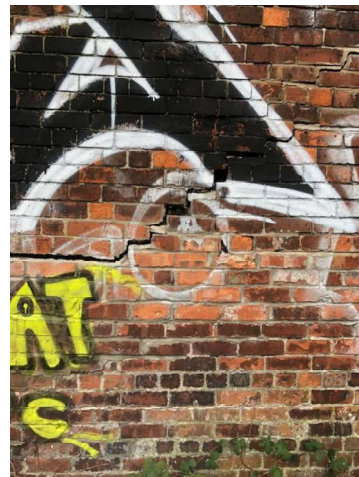
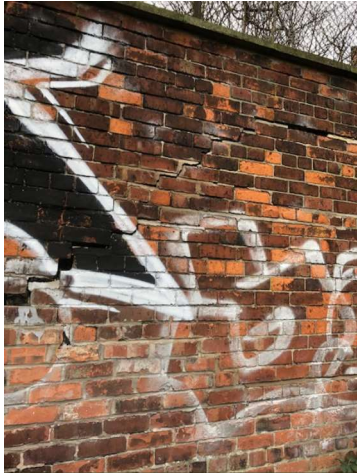
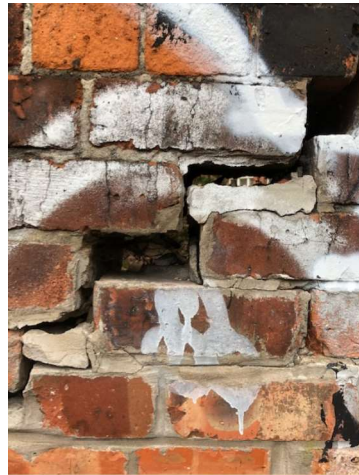
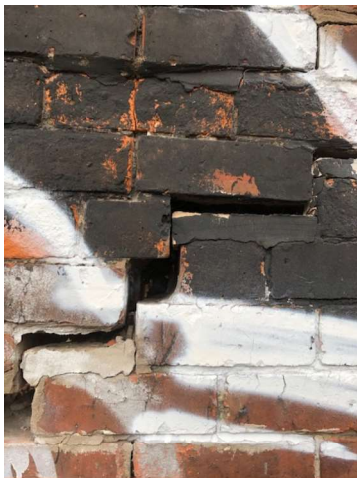
The existing wall is in poor condition with extensive cracking and significant deformation to the section adjacent to the vegetation within the playground. The movement evident has been caused by lateral pressure from the retained soil behind and pressure from adjacent tree roots. The cracking is visible on both sides of the wall with gaps of up to 50mm in places, such that it is not possible to repair the brickwork and a rebuild is required.

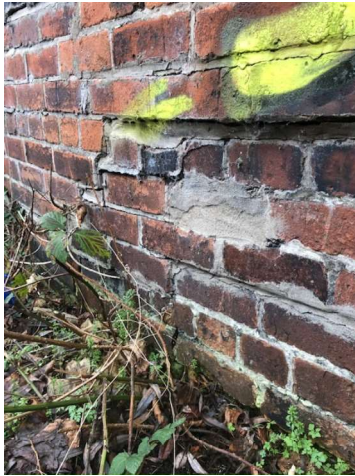
**Photo No. 11**

- Horizontal crack at lower level with a 30mm step across the crack indicating lateral movement. **(Ref photo 11)**
- Visible bulge in the masonry at lower level adjacent to the cracking and vegetation behind. An out of plumb measurement of 70mm was noted in this area. **(Ref photo 12)**

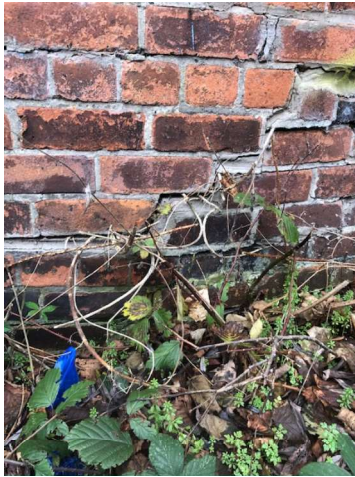
**Photo No. 13**

- Settlement at ground level below the area of bulging brickwork, with rotation of the base course brickwork at ground level. **(Ref photo 13)**
- Visible bulge in the masonry at lower level at the west end of the 18m section of wall inspected, where the wall changes direction. **(Ref photo 15)**

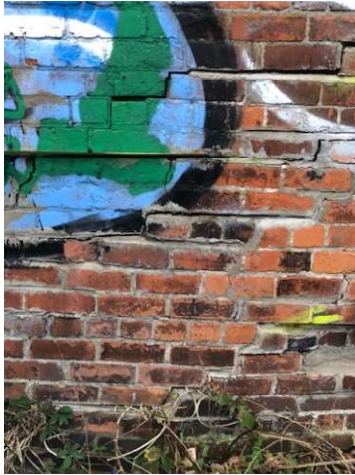
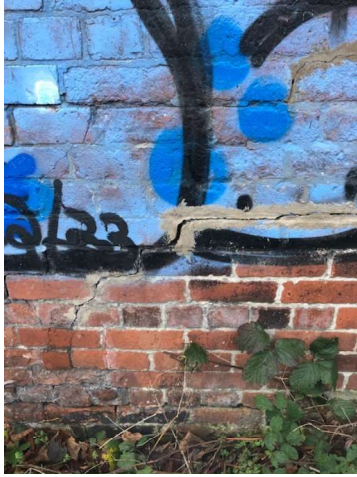
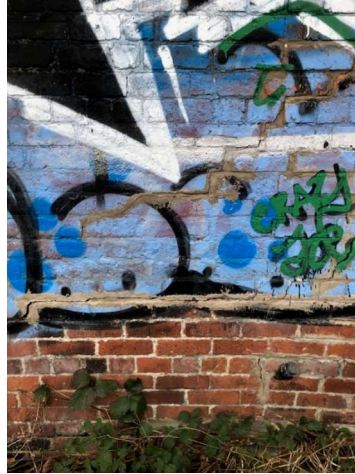
- General Evidence of previous repairs to the wall with locally repaired brickwork and repointing. **(Ref photo 17, 9-10)**
- Spalling brickwork generally and crumbling mortar/defective mortar joints. **(Ref photo 20-23)**

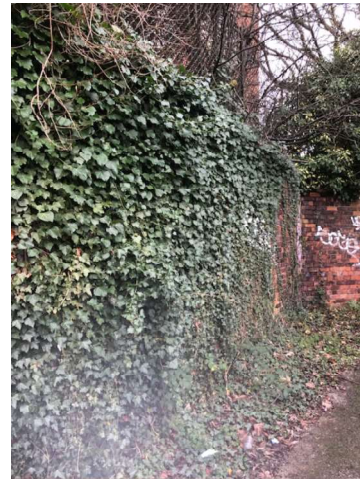
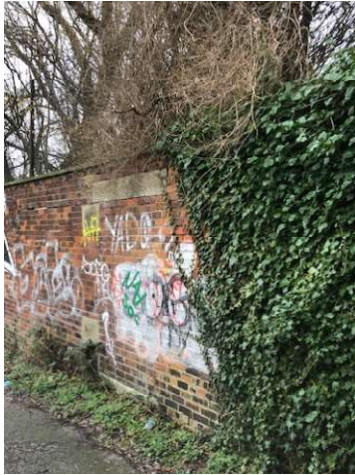
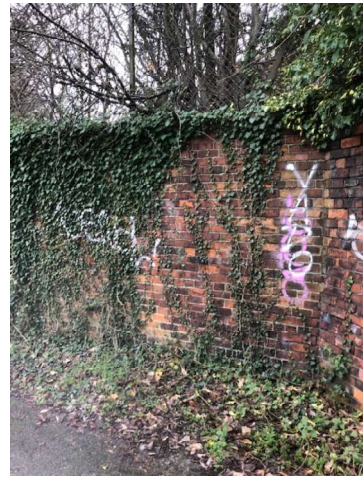
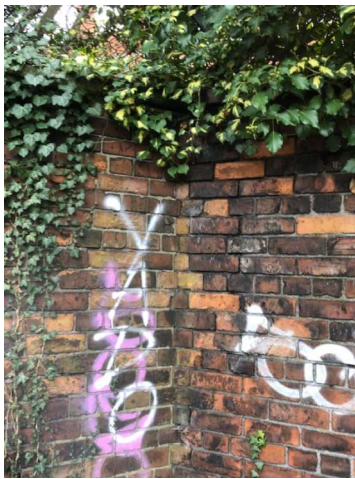
- There is ivy growth on the footpath side of the wall from approximately 11m chainage to 18m chainage. **(Ref photo 24-27)**
- There is loss of render to the rear of the wall and as noted above the cracking seen on the footpath side is mirrored on the rear side brickwork. **(Ref photo 31-36)**

Over the remaining section of wall the vegetation should be removed to allow an inspection of the rest of the brickwork. Local replacement of spalling brickwork and repointing mortar joints will also be required.

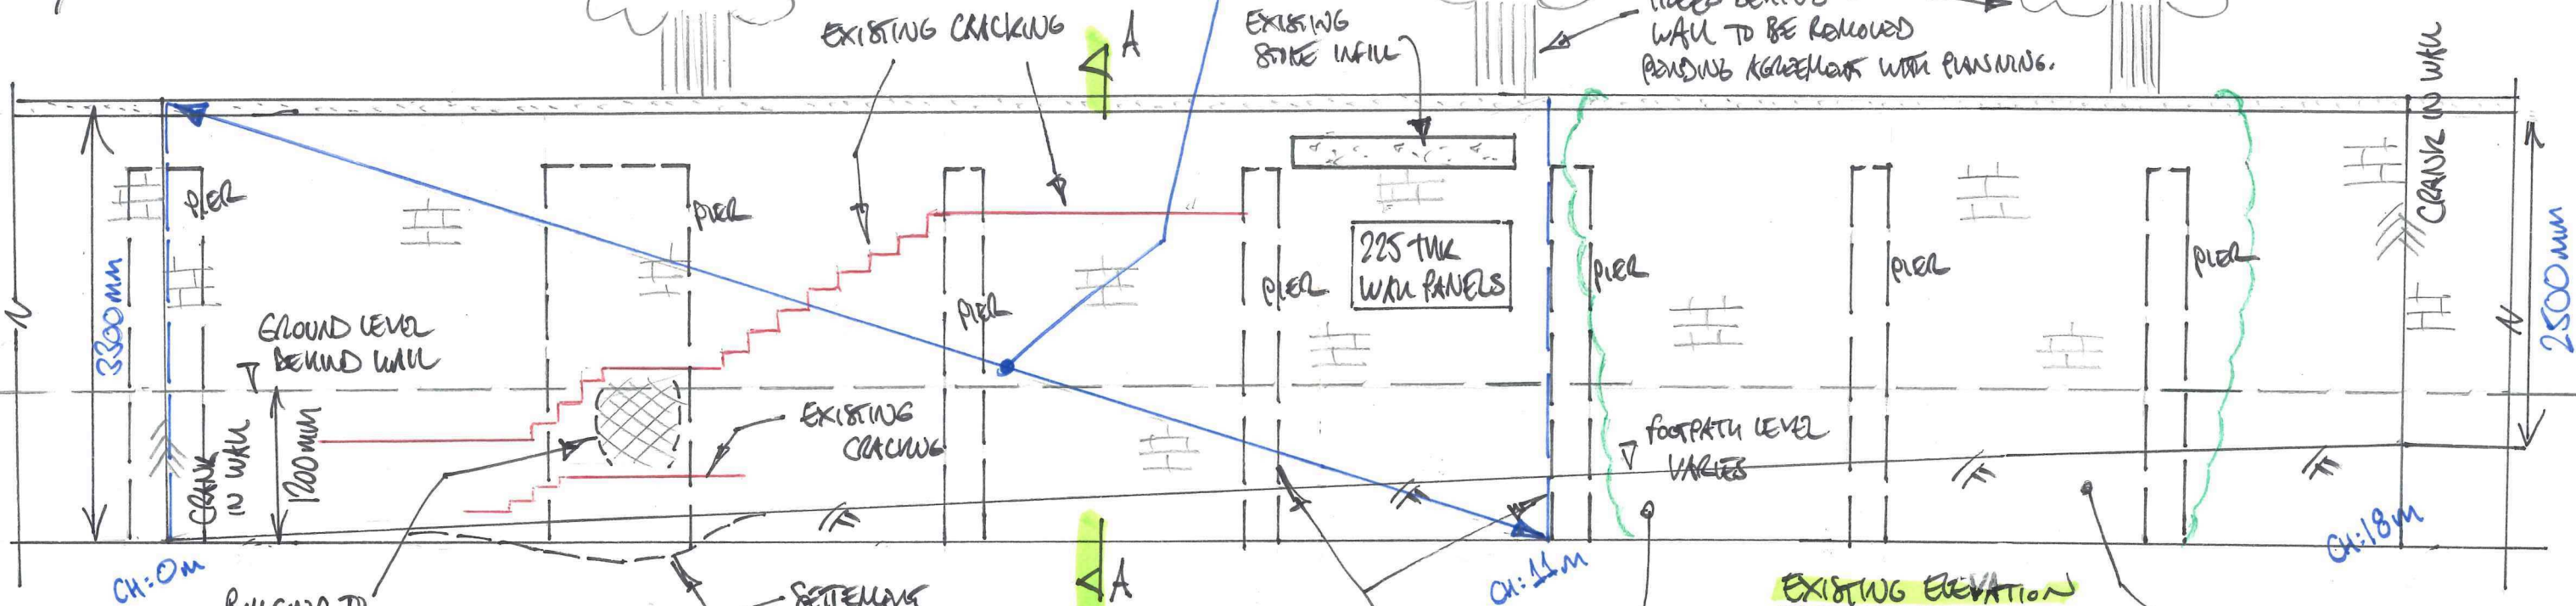
EXISTING ELEVATION FROM FOOTPATH SIDE

IVY GROWTH FROM CH 11m TO CH 18m TO BE REMOVED AND BRICKWORK BEHIND INSPECTED.

CONSTRUCTION TO PROVIDE TEMPORARY PROPPING TO ADJACENT SECTION OF WALL TO MAINTAIN WALL STABILITY DURING DOWNTAKING & CONSTRUCTION OF NEW SECTION OF WALL

EXISTING 225mm THK BRICK BOUNDARY WALL WITH 325mm THK PIERS AT APPROX 2m CENTRES TYPICALLY.  
- EXISTING WALL DOWNTAKEN OVER 11m LENGTH AS SHOWN ON ELEVATION
