**GAS MEMBRANE VALIDATION**

| <b>Site Name: Belle Vue Stadium</b> | <b>Project Number: 12-123</b> |
| <b>Company Name: Countryside</b> | <b>Date: 08-06-2022</b> |

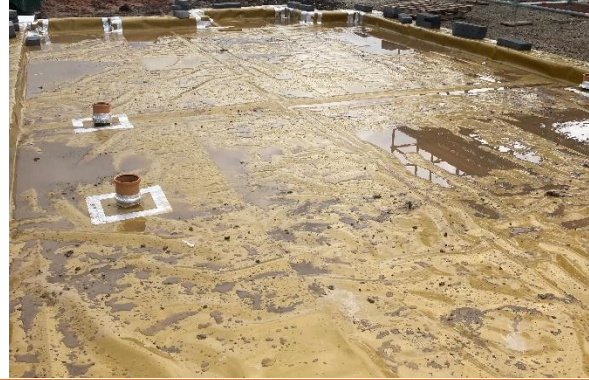
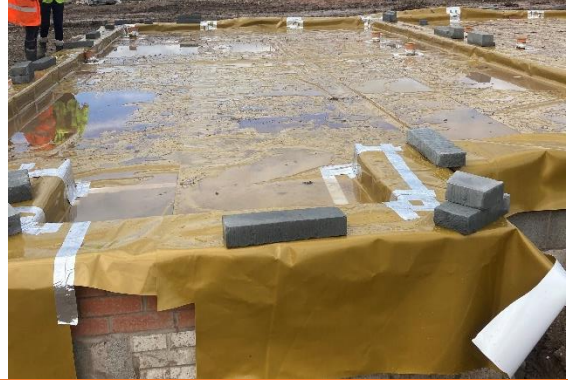
**Plot - 92**

**General Condition of Membrane-Good Condition**

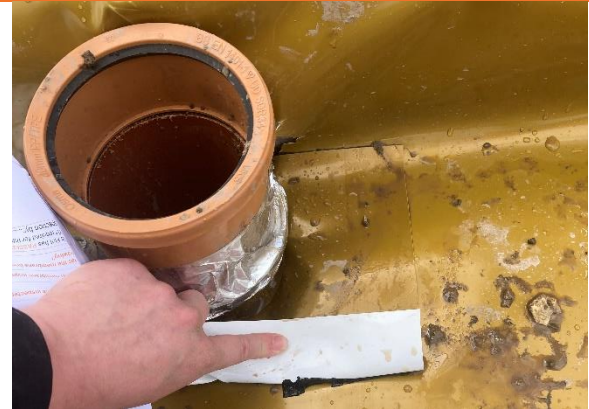
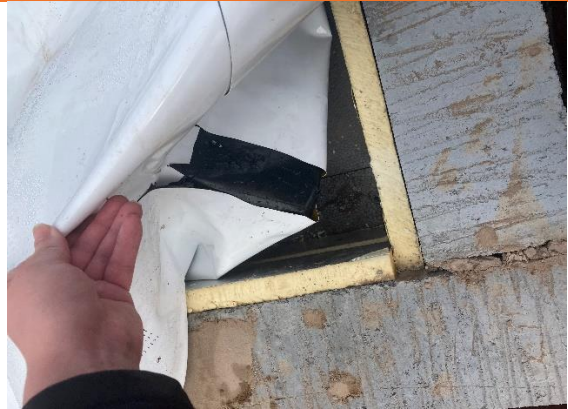
**Verification of Joints and Seals-Overlapped and sealed correctly**

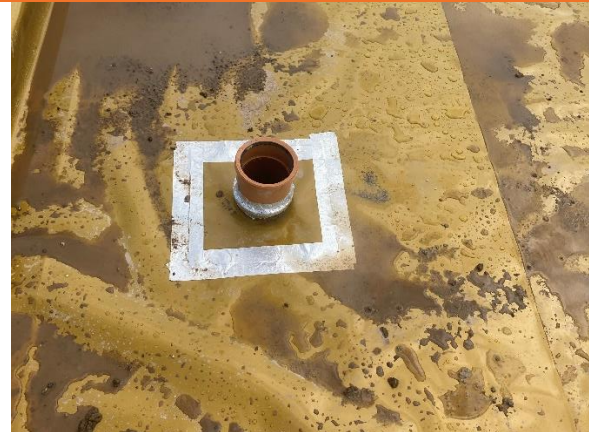
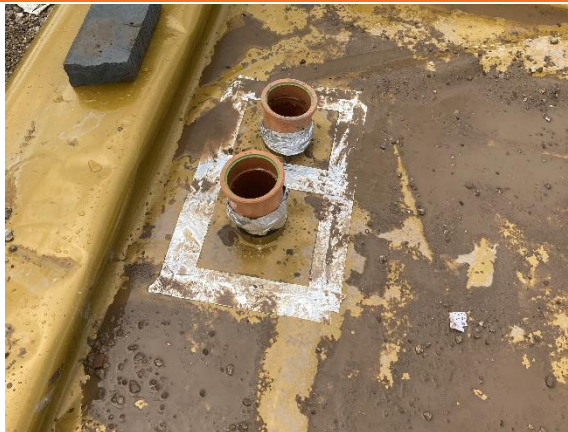
**Verification of Service Penetrations-Good Condition**

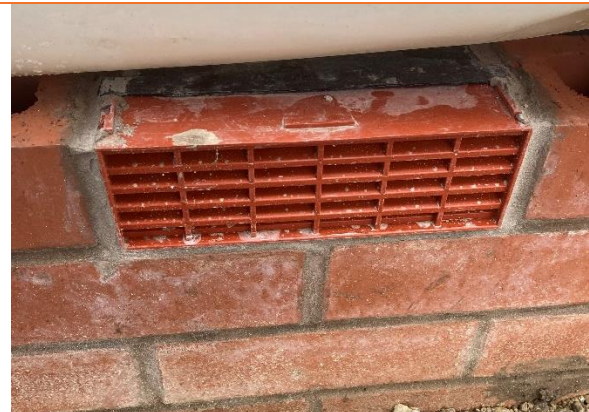
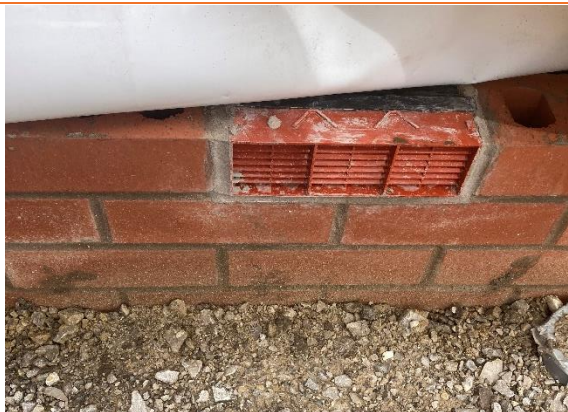
**Verification of Ventilation-Good Condition**

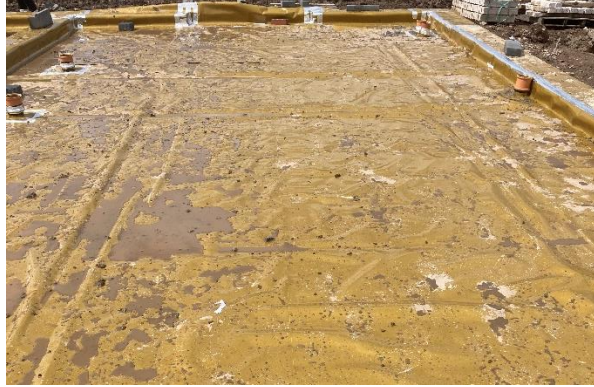
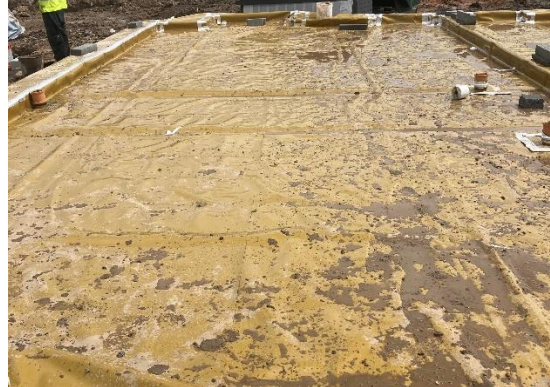
**Plot - 93**

**General Condition of Membrane-Good Condition**

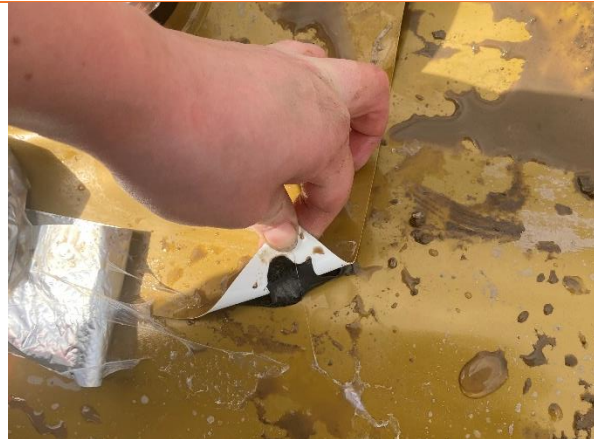
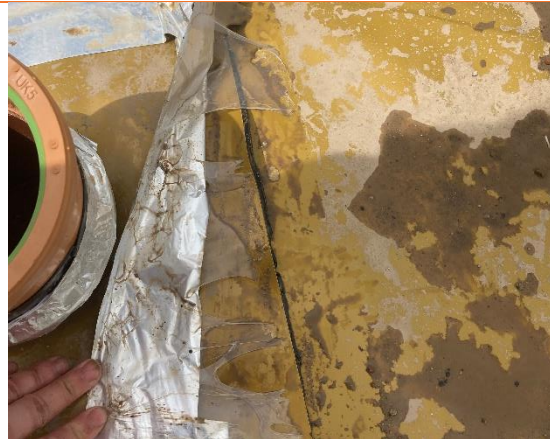
**Verification of Joints and Seals-Overlapped and sealed correctly**

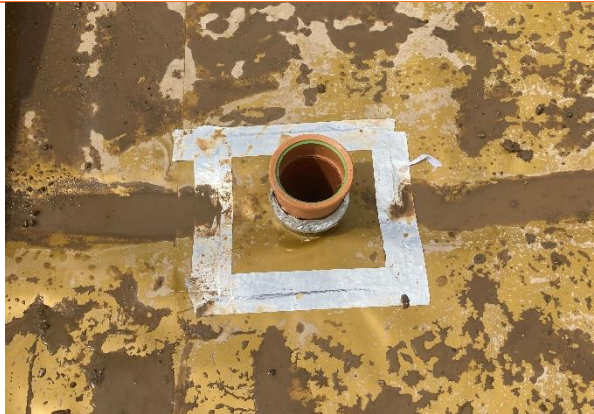
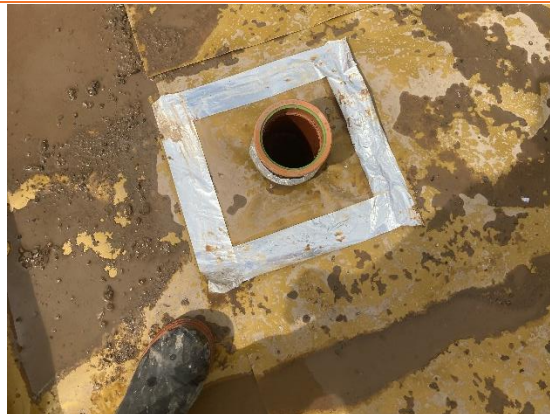
**Verification of Service Penetrations-Good Condition**

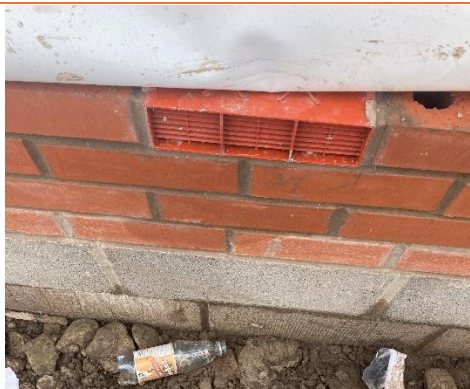
**Verification of Ventilation-Good Condition**
