### GAS MEMBRANE VALIDATION – BELLE VUE

| <b>Project Name: Belle Bue Stadium</b> |
| <b>Plots: 208-209</b> |

## GAS MEMBRANE VALIDATION

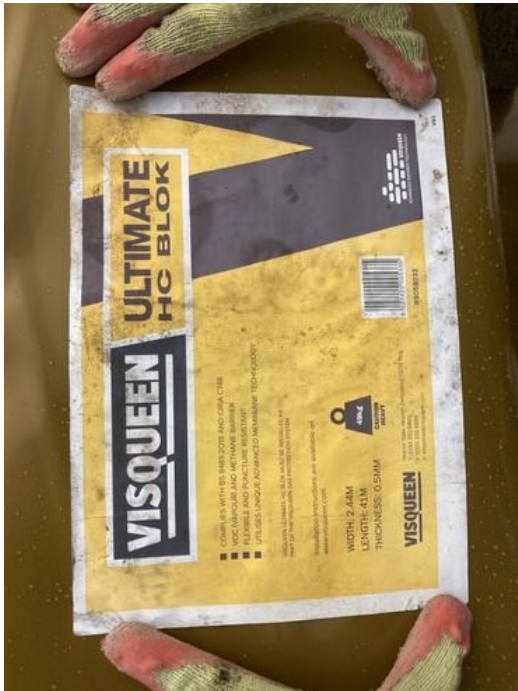
Photo 1

**Gas Membrane Condition:** Open punctures, tears, rips, stretching, Presence of debris, Repairs, Signs of weakness such as raised or sunken indentations, Protection plan in place to restrict access to lain gas membrane? IF FAIL DESCRIPTION IN ACTIONS AND PHOTOS REQUIRED

Pass

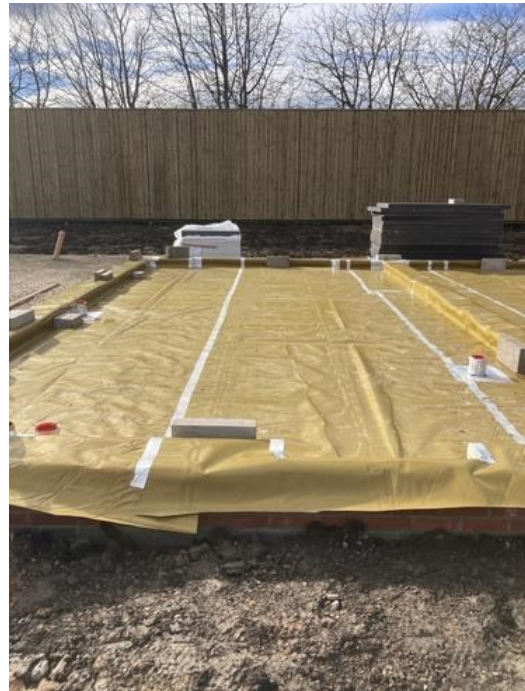
Photo 2

**Laps, welds, and joints seals:** Joints lapped and sealed in accordance with manufacturer's requirements/ specification? Minimum overlap insured? Sections taped twice? Are welds complete? Appropriate joining/double-sided tape used, Folds running in line with joints? (no joints cutting across folds)

Pass

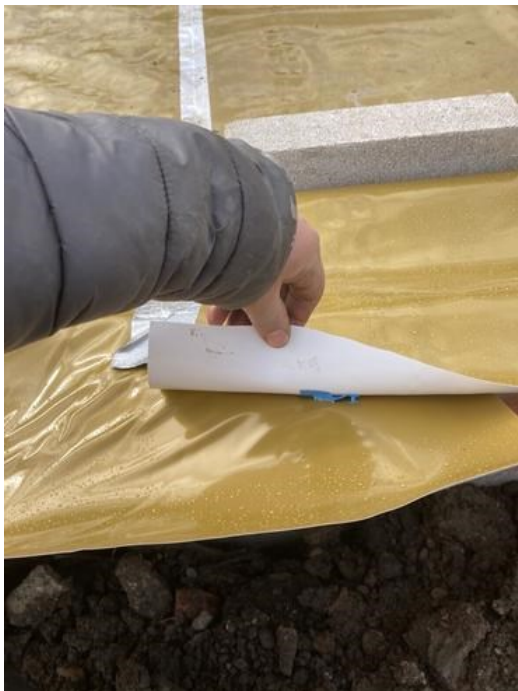
Photo 3

**Service entries seals: Top hats seal arrangements fixed around service entries? Use of Jubilee clips?**

Yes

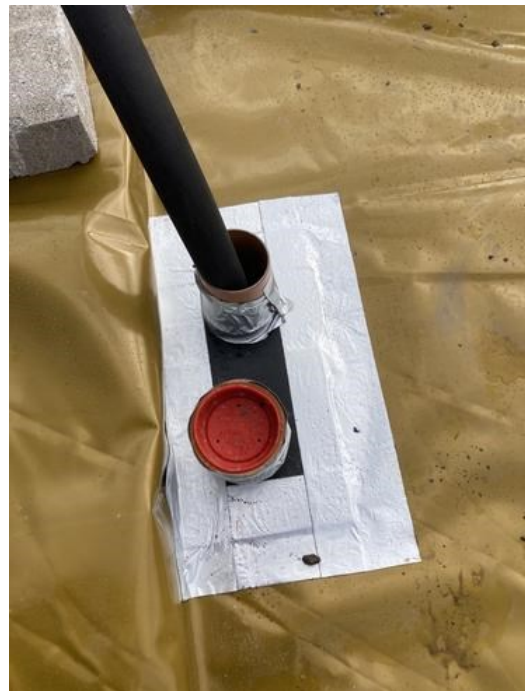
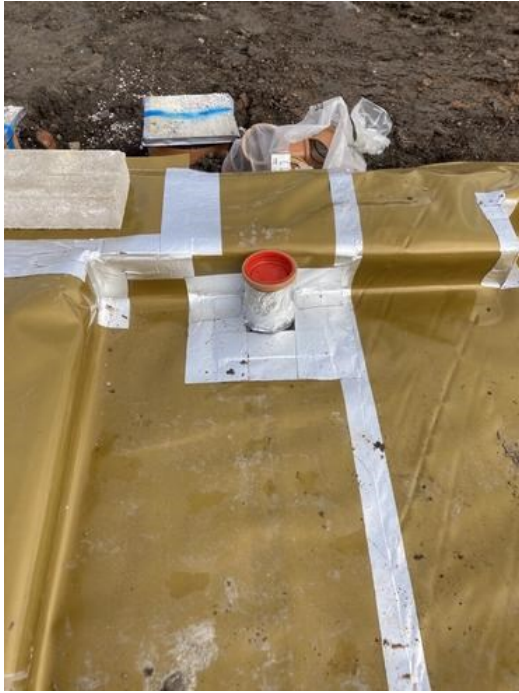
**Type of joints/ Lapping**

Taped

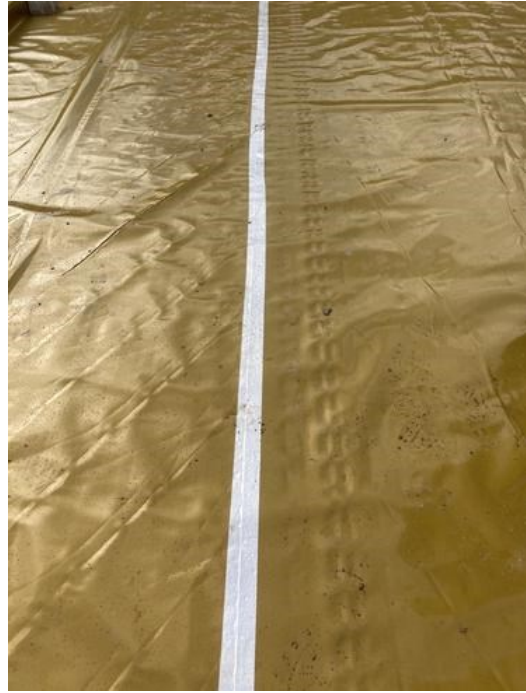
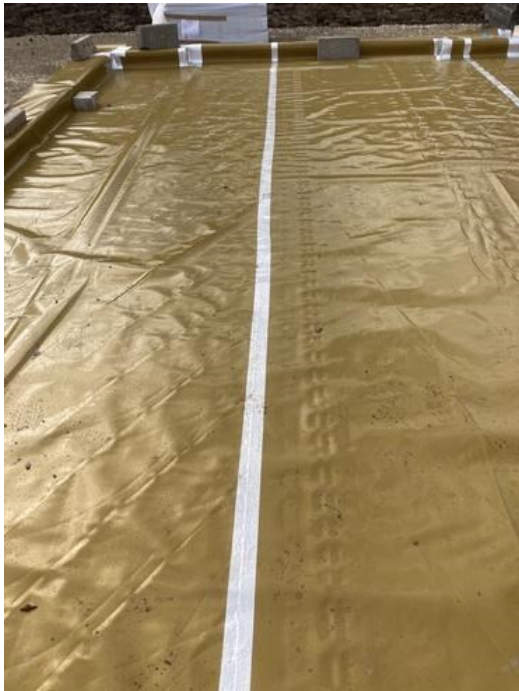
**Corners / Internal joints: Check all corners are correctly formed or contractor has used performed corners.**

Pass

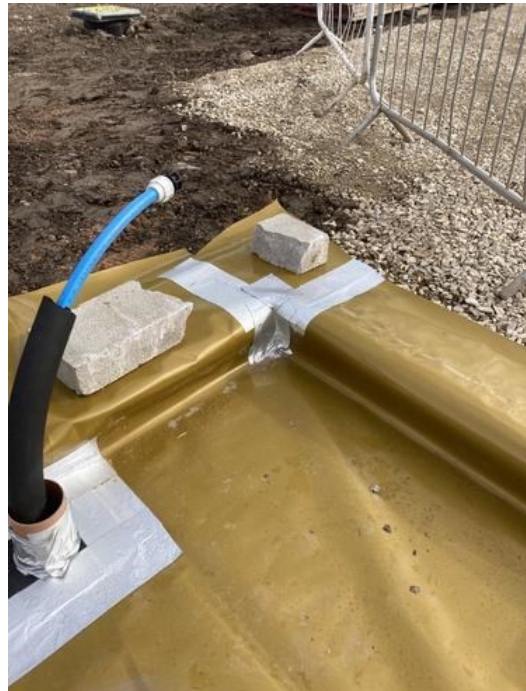
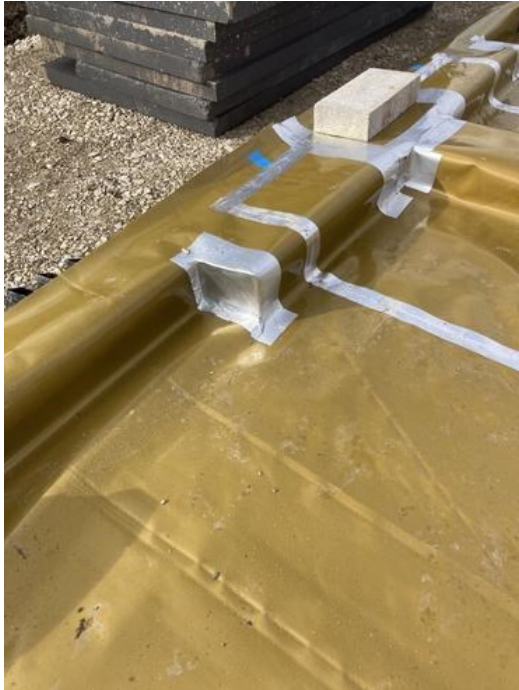
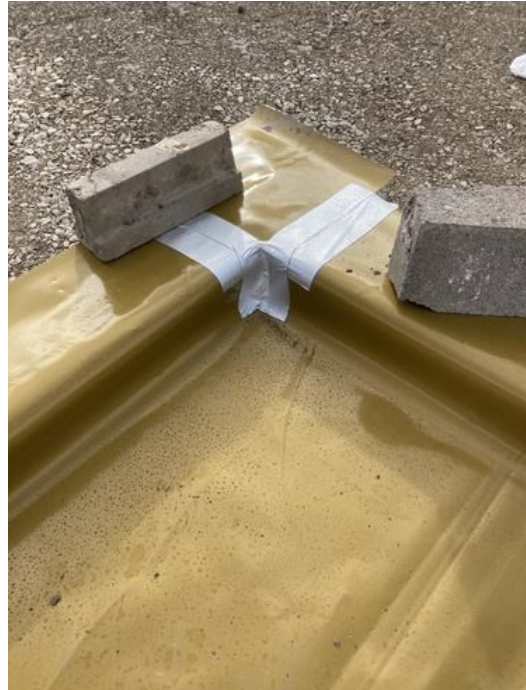
**Extent of Coverage: Is the membrane covering the entire plot? Does membrane span over outside walls?**

Yes

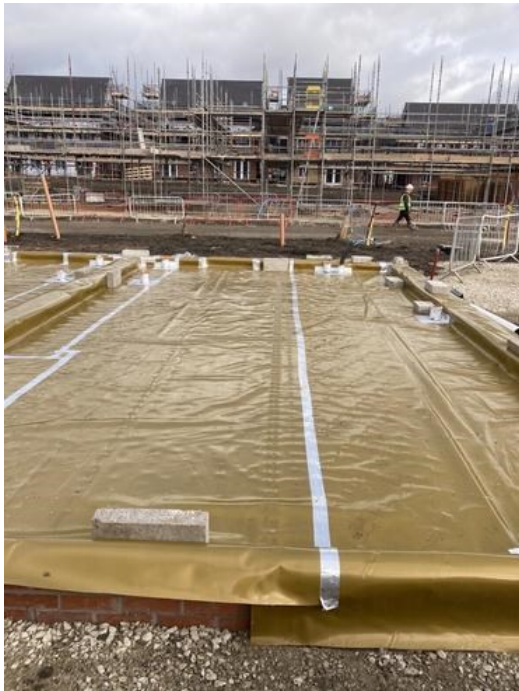
Photo 11

**Condition of sub-grade and underside of gas membrane: Check that the subgrade does not contain rough/uneven surfaces, is appropriately clean and that there are no hard/sharp objects. That protective sand blinding or geotextile (if specified) is present and meets the design criteria.**

Pass

**Slab / membrane condition (is membrane clear of debris or insulation): Can membrane be fully seen and photographed – ask contractor to remove an debris so membrane can be fully seen an inspected – this is a requirement of NHBC and local authorities.**

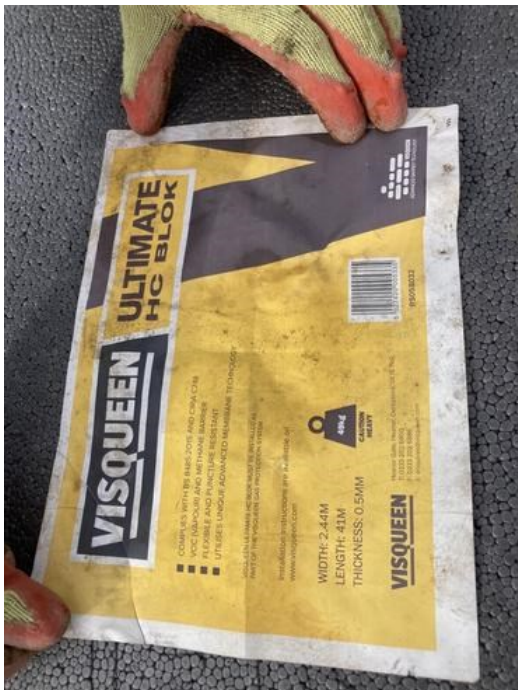
Photo 15

**Gas Membrane Condition: Open punctures, tears, rips, stretching, Presence of debris, Repairs, Signs of weakness such as raised or sunken indentations, Protection plan in place to restrict access to lain gas membrane? IF FAIL DESCRIPTION IN ACTIONS AND PHOTOS REQUIRED**

Pass

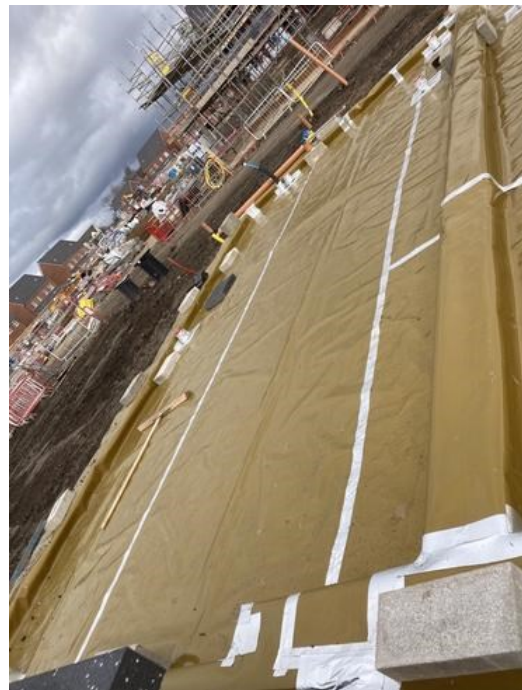
Photo 16

**Laps, welds, and joints seals: Joints lapped and sealed in accordance with manufacturer's requirements/ specification? Minimum overlap insured? Sections taped twice? Are welds complete? Appropriate joining/double-sided tape used, Folds running in line with joints? (no joints cutting across folds)**

Pass

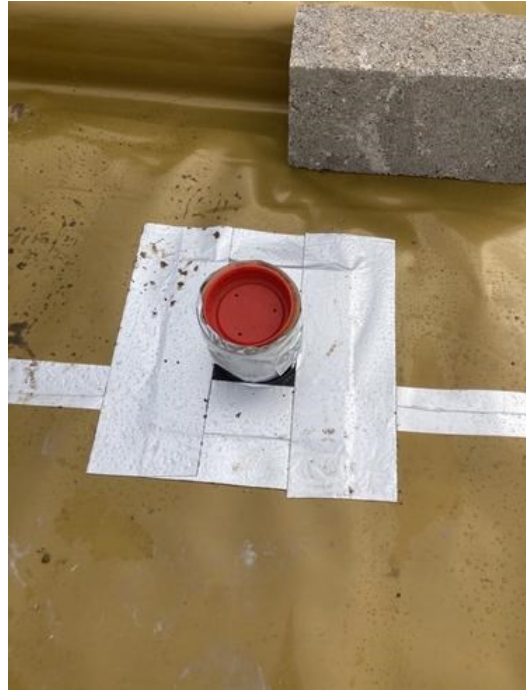
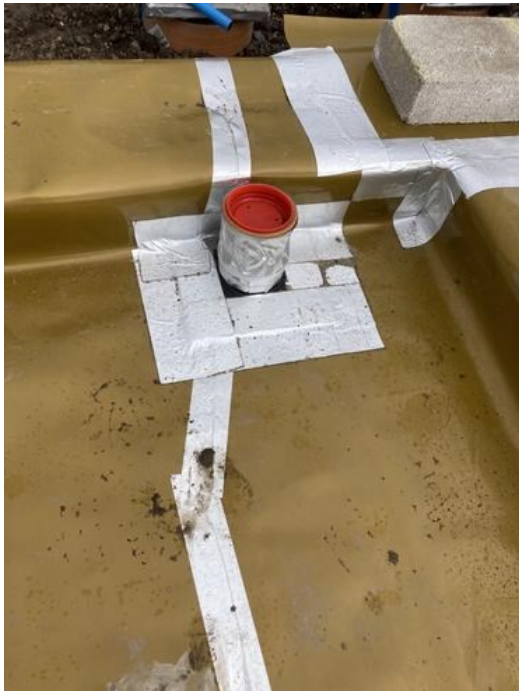
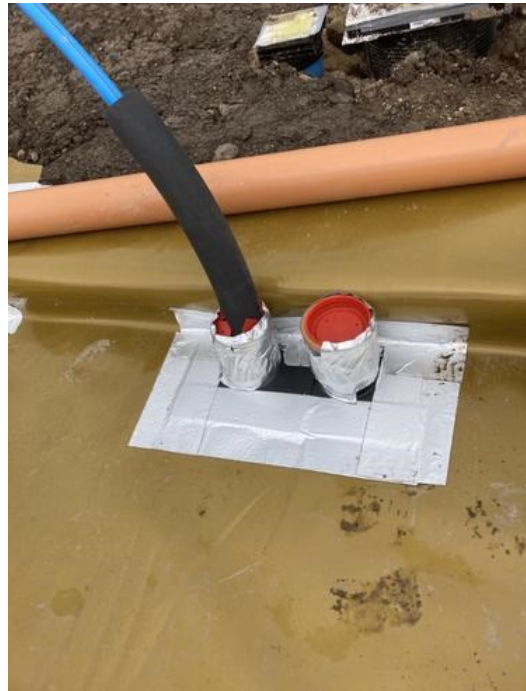
#### Type of joints/ Lapping

Taped

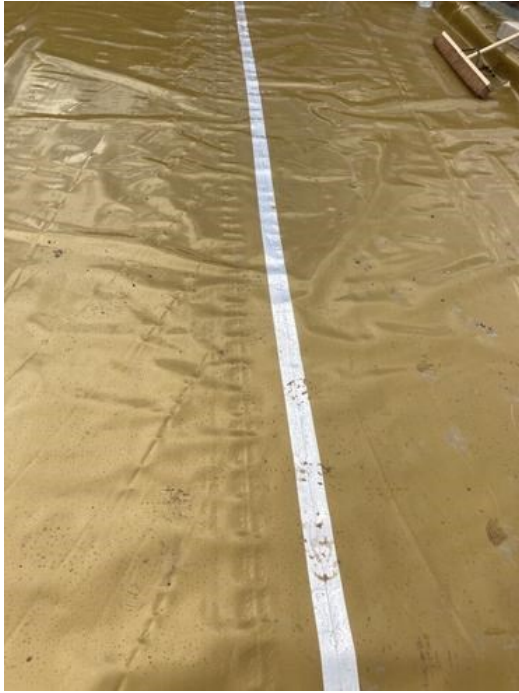
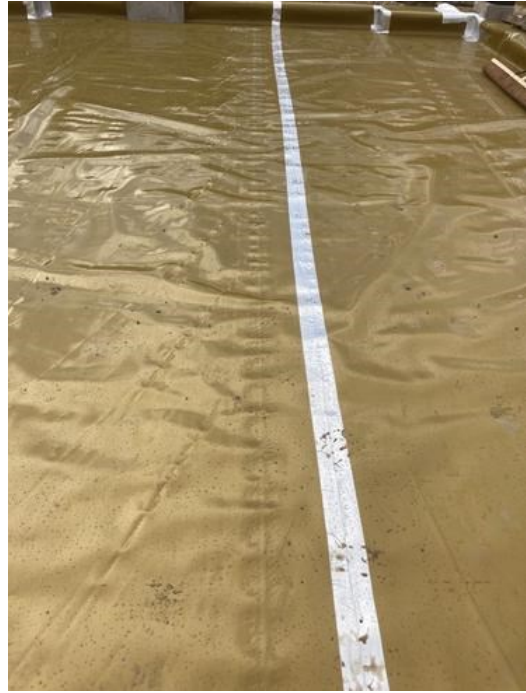
**Corners / Internal joints:** Check all corners are correctly formed or contractor has used performed corners.

Pass

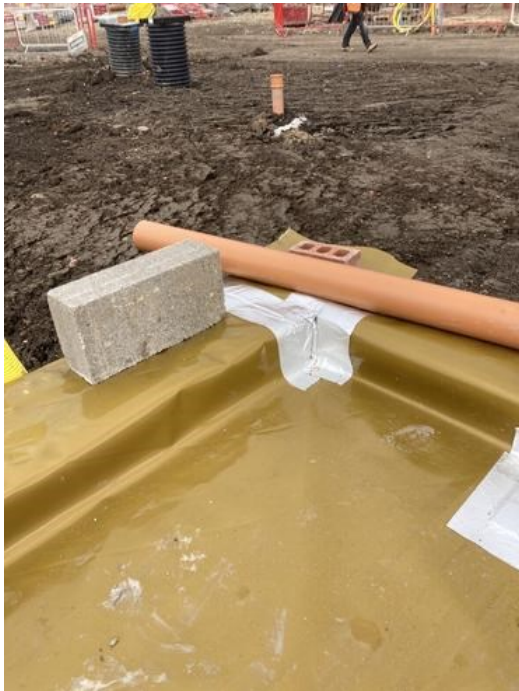
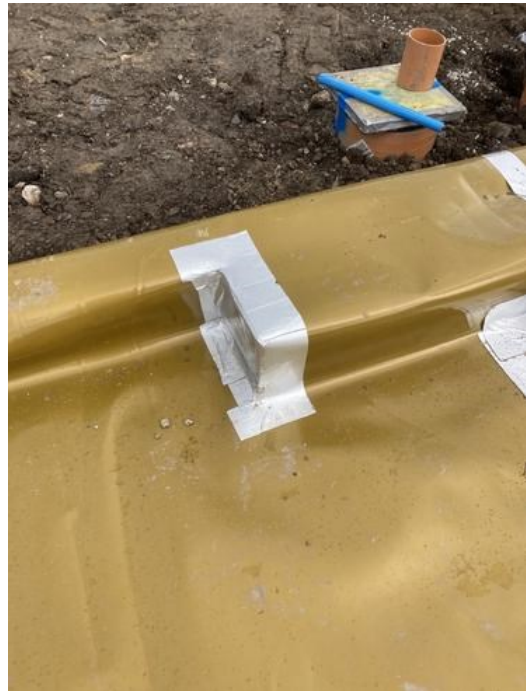
**Extent of Coverage:** Is the membrane covering the entire plot? Does membrane span over outside walls?

Yes

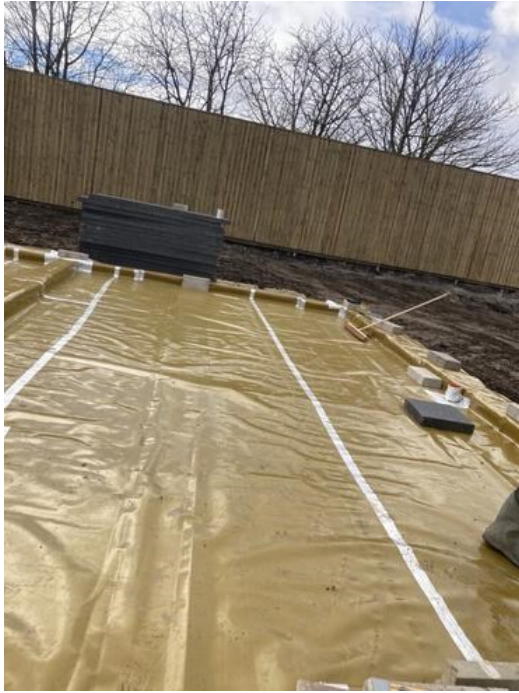
Photo 25

**Condition of sub-grade and underside of gas membrane:** Check that the subgrade does not contain rough/uneven surfaces, is appropriately clean and that there are no hard/sharp objects. That protective sand blinding or geotextile (if specified) is present and meets the design criteria.

Pass

**Slab / membrane condition** (is membrane clear of debris or insulation): Can membrane be fully seen and photographed – ask contractor to remove an debris so membrane can be fully seen an inspected – this is a requirement of NHBC and local authorities.

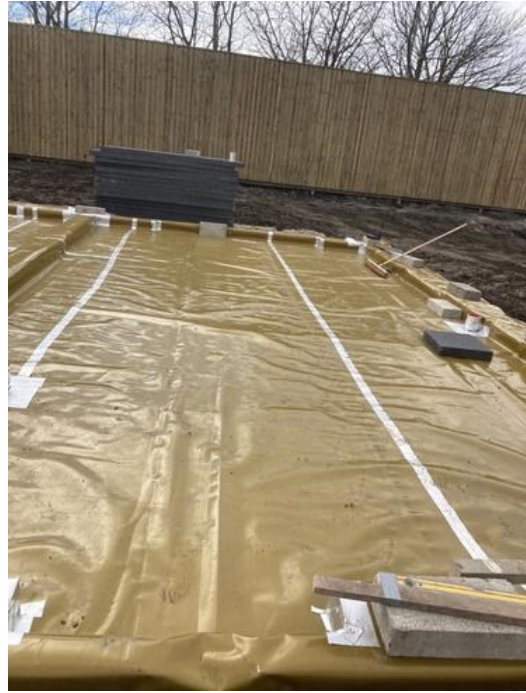
Photo 26

**External Wall Air bricks: Numbers, size. positions as design drawing? (Minimum of 3 walls)**

Pass
