## GAS MEMBRANE VALIDATION

| <b>Site Name:</b> Belle Vue | <b>Project Number:</b> 12-123 |
| <b>Company Name:</b> Countryside Properties | <b>Date:</b> 23-11-2022 |

173

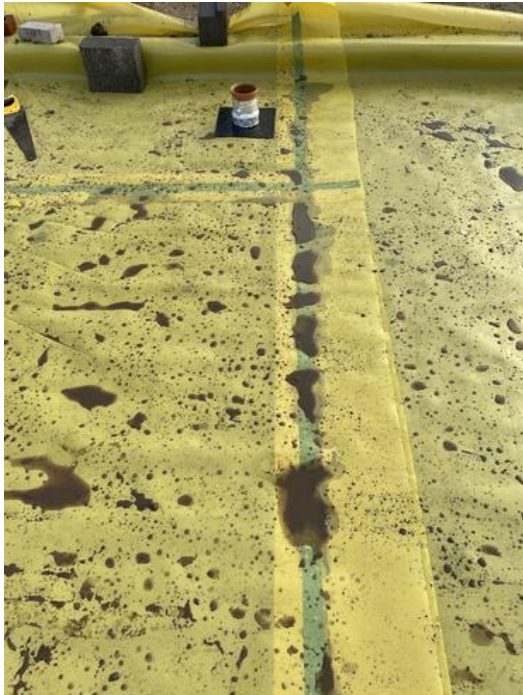
Photo 1

Laps, welds, and joints seals: Joints lapped and sealed in accordance with manufacturer's requirements/ specification? Minimum overlap insured? Sections taped twice? Are welds complete? Appropriate joining/double-sided tape used, Folds running in line with joints? (no joints cutting across folds)

Pass

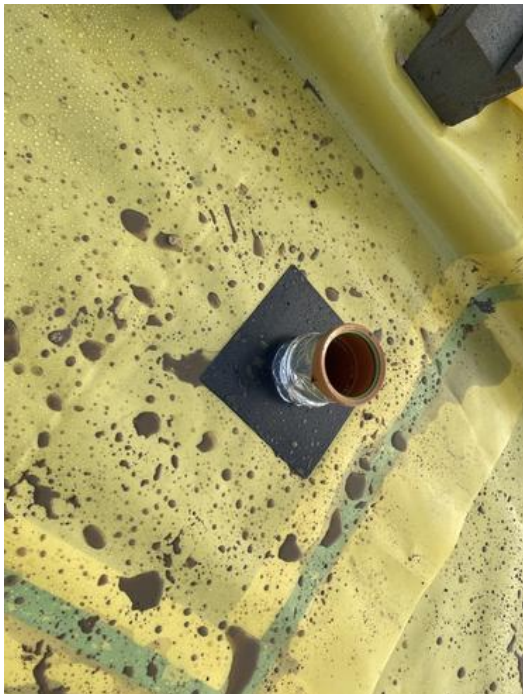
Photo 3

Service entries seals: Top hats seal arrangements fixed around service entries? Use of Jubilee clips?

Yes

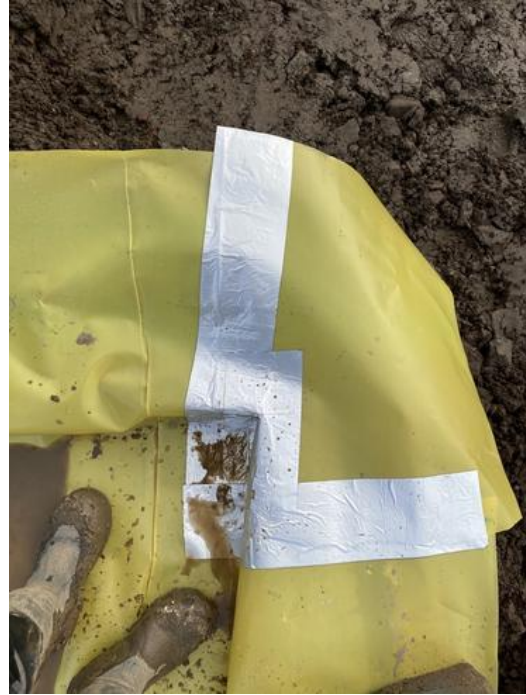
Photo 6

**Corners / Internal joints: Check all corners are correctly formed or contractor has used performed corners.**

Pass

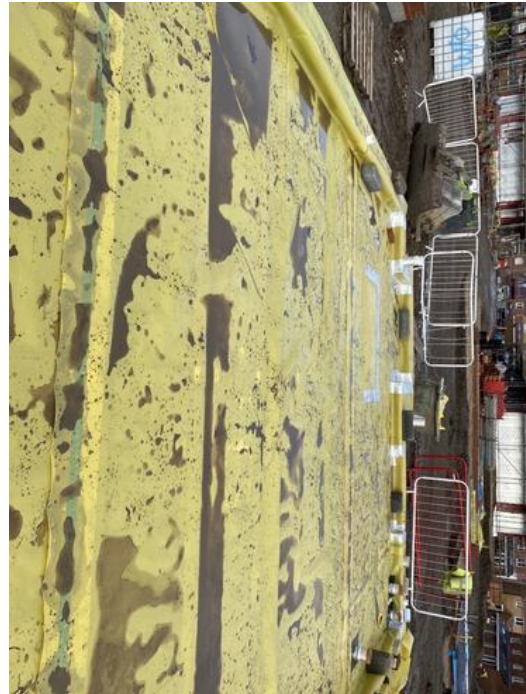
Photo 16

**Extent of Coverage: Is the membrane covering the entire plot? Does membrane span over outside walls?**

Yes

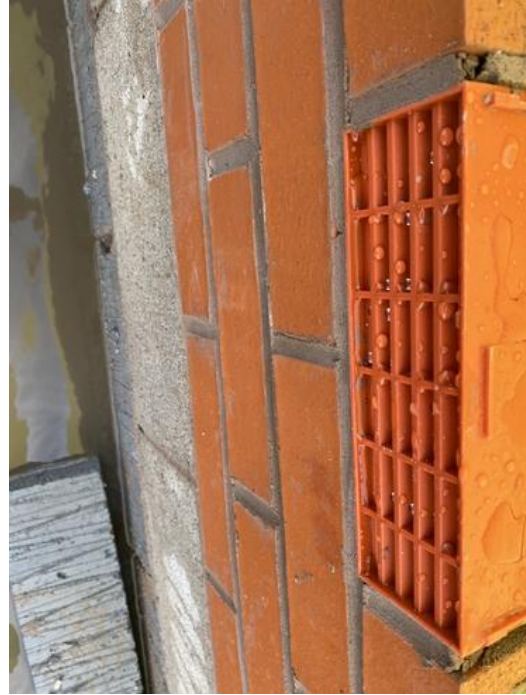
Photo 18

**External Wall Air bricks: Numbers, size. positions as design drawing? (Minimum of 3 walls)**

Pass
