### GAS MEMBRANE VALIDATION – BELLE VUE

**Project Name:** Belle Vue Stadium

**Project Number:** 12-123

**Date:** 04-04-2023

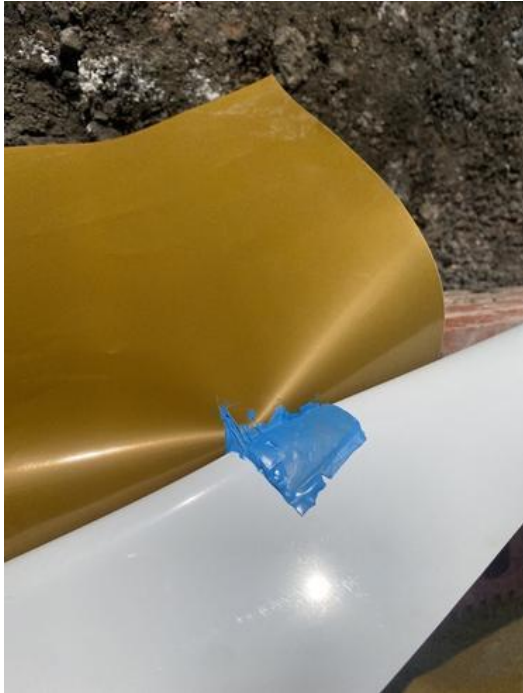
Photo 1

**Laps, welds, and joints seals: Joints lapped and sealed in accordance with manufacturer's requirements/ specification? Minimum overlap insured? Sections taped twice? Are welds complete? Appropriate joining/double-sided tape used, Folds running in line with joints? (no joints cutting across folds)** Pass

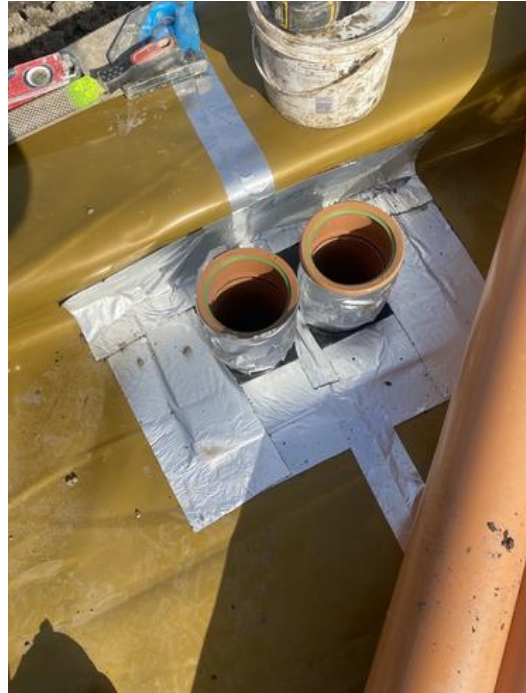
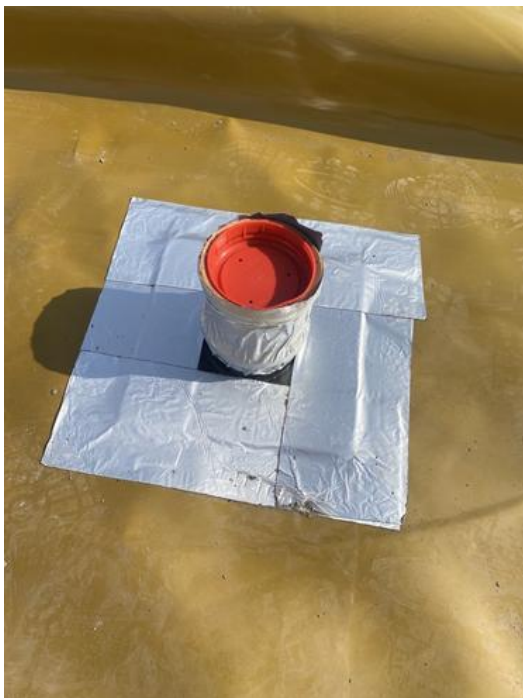
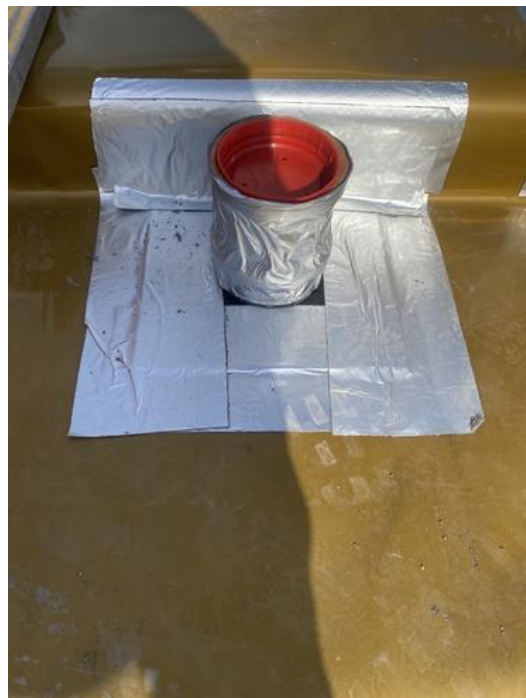
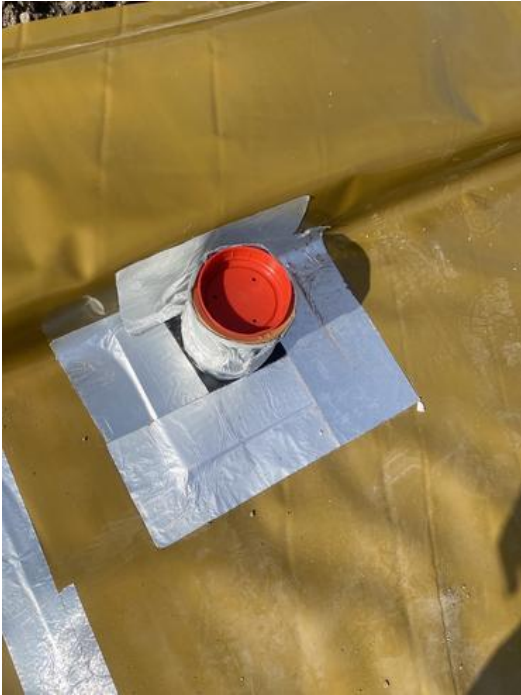
**Service entries seals: Top hats seal arrangements fixed around service entries? Use of Jubilee clips?** Yes

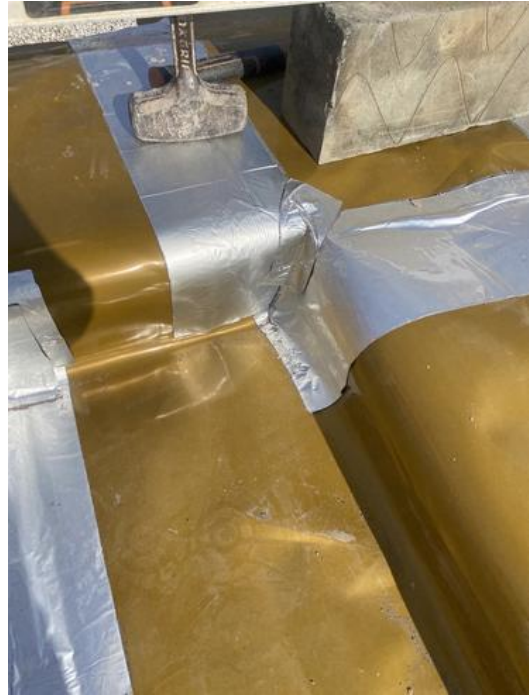
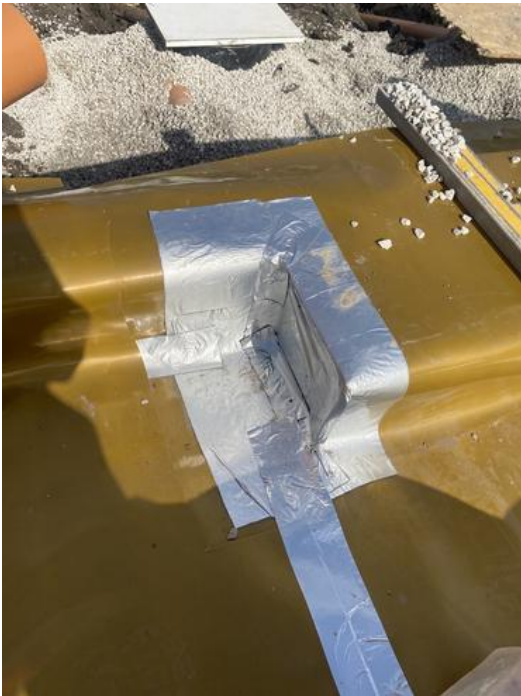
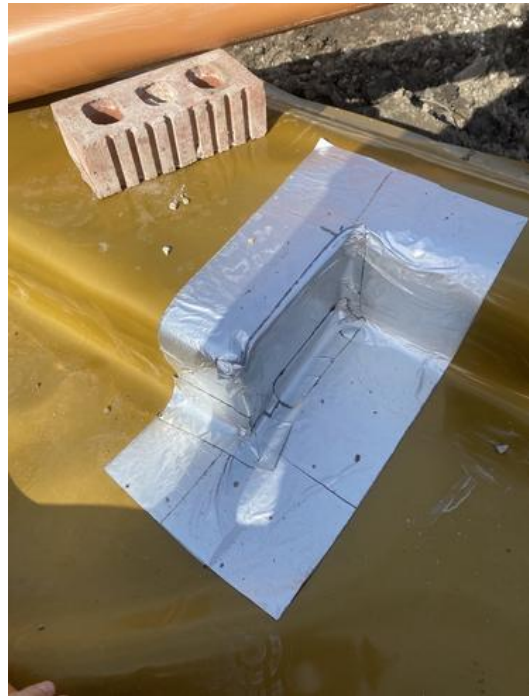
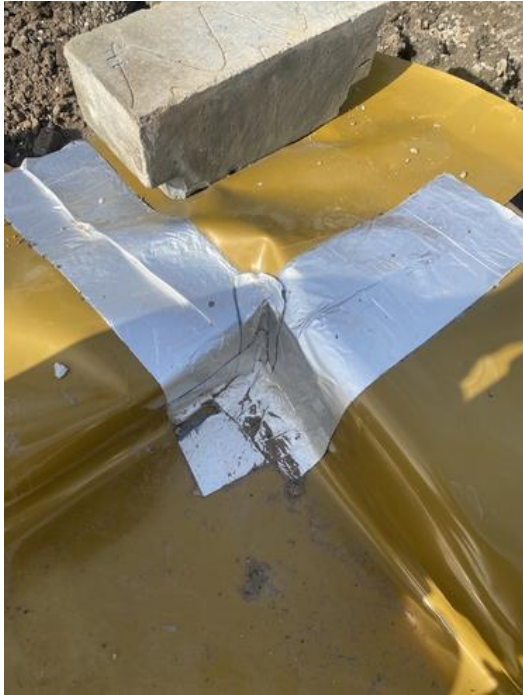
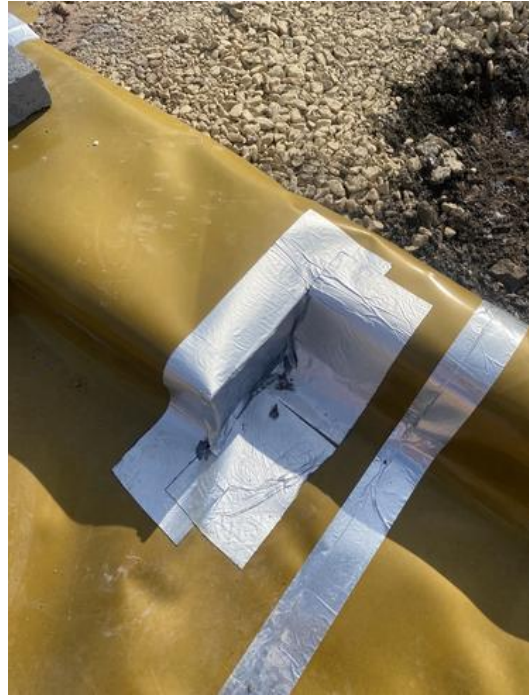
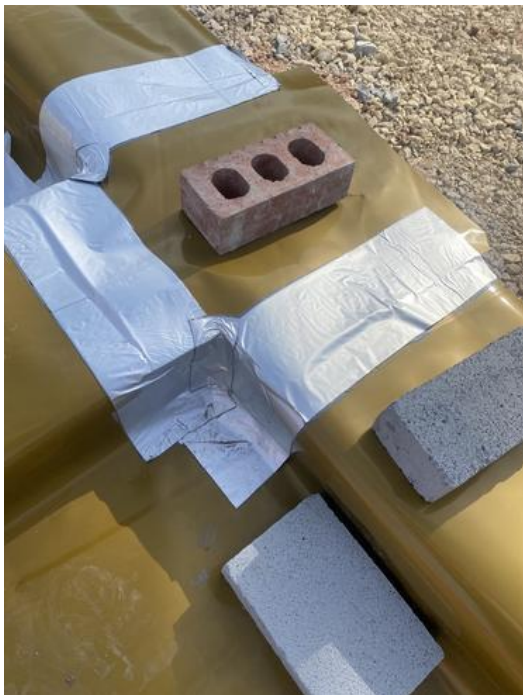
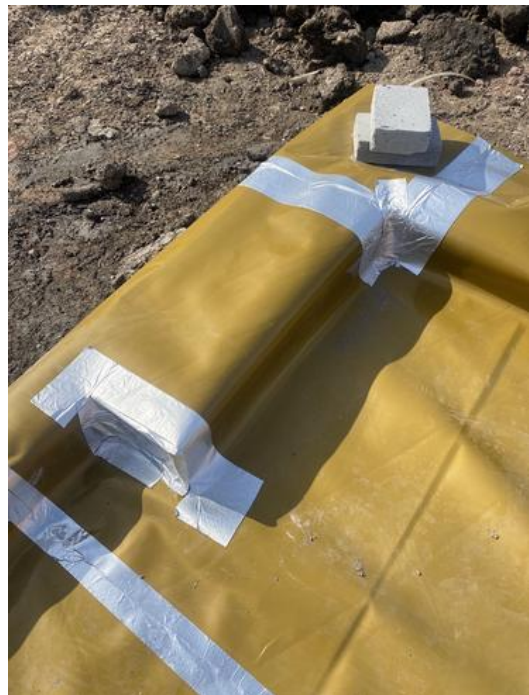
**Corners / Internal joints: Check all corners are correctly formed or contractor has used preformed corners.** Pass

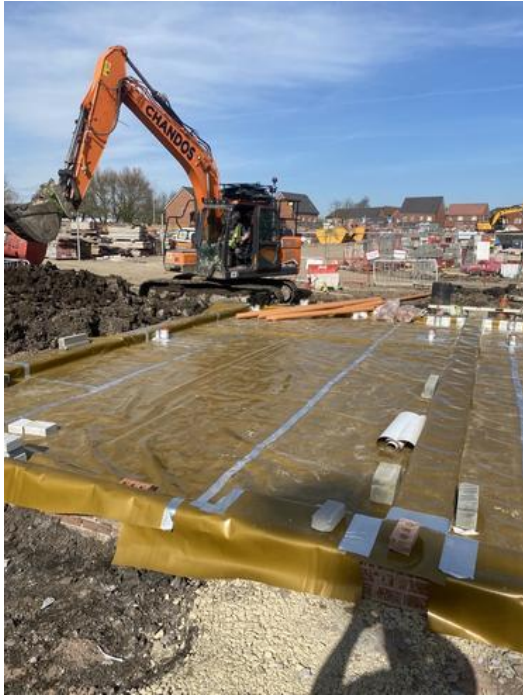
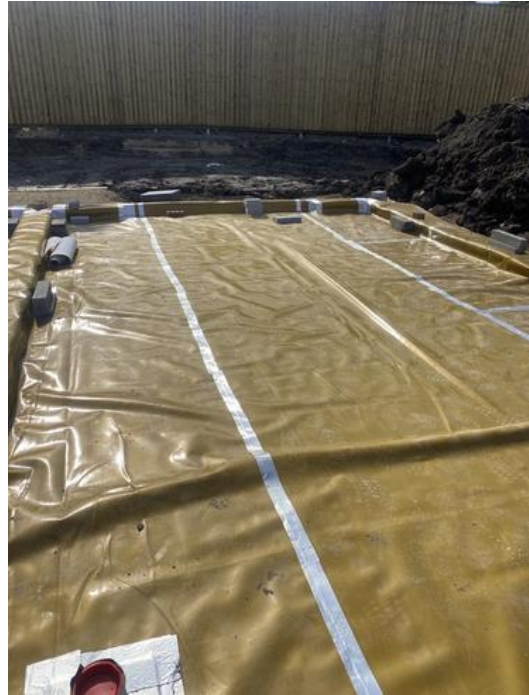
**Extent of Coverage: Is the membrane covering the entire plot? Does membrane span over outside walls?**

Yes

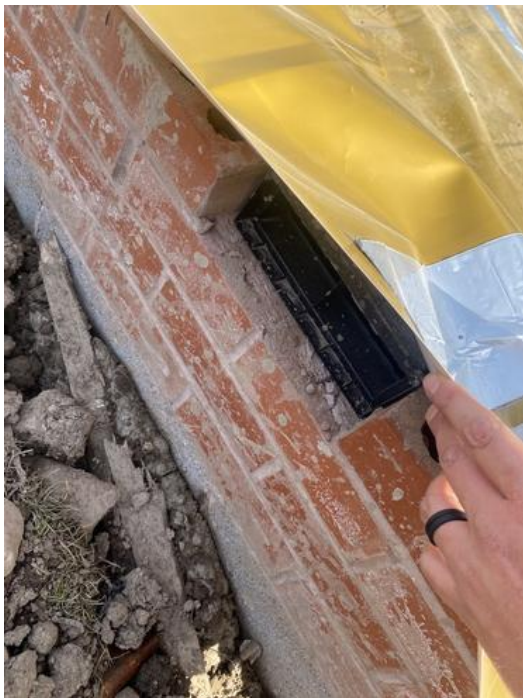
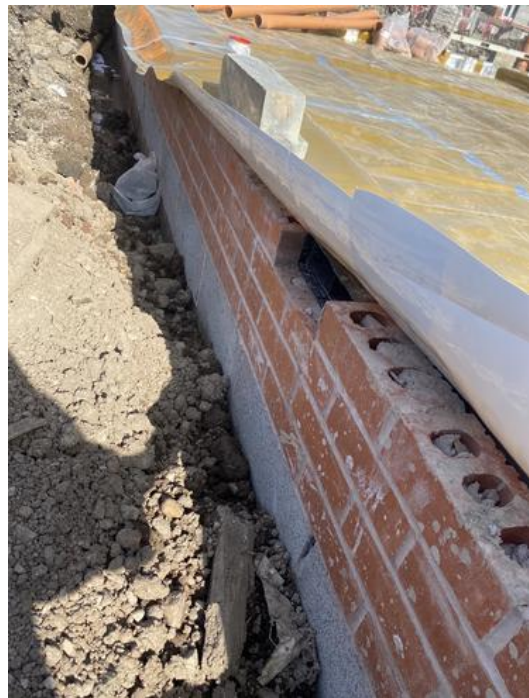
**External Wall Air bricks: Numbers, size. positions as design drawing? (Minimum of 3 walls)**

Pass

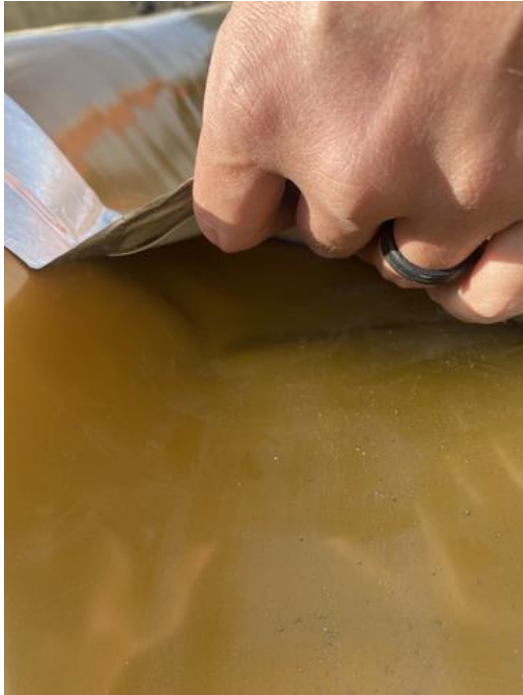
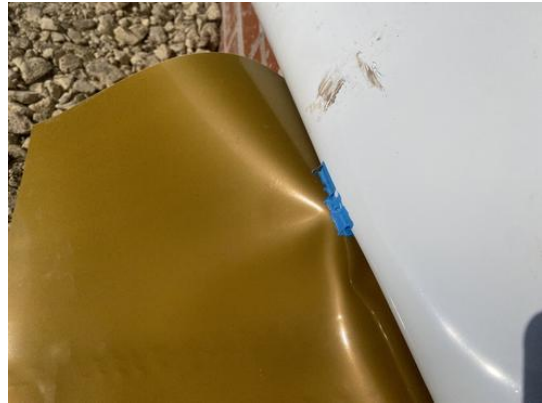
**Laps, welds, and joints seals: Joints lapped and sealed in accordance with manufacturer's requirements/ specification? Minimum overlap insured? Sections taped twice? Are welds complete? Appropriate joining/double-sided tape used, Folds running in line with joints? (no joints cutting across folds)** Pass

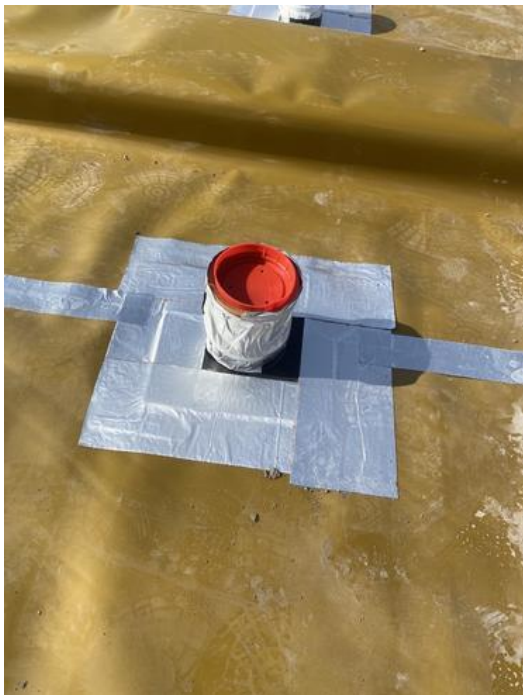
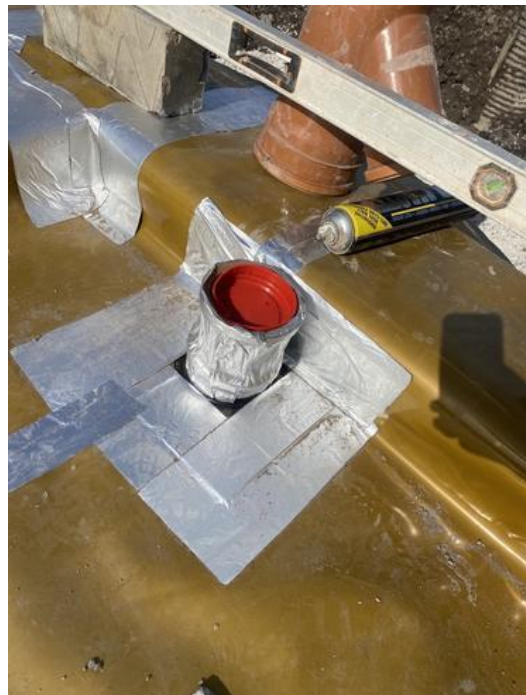
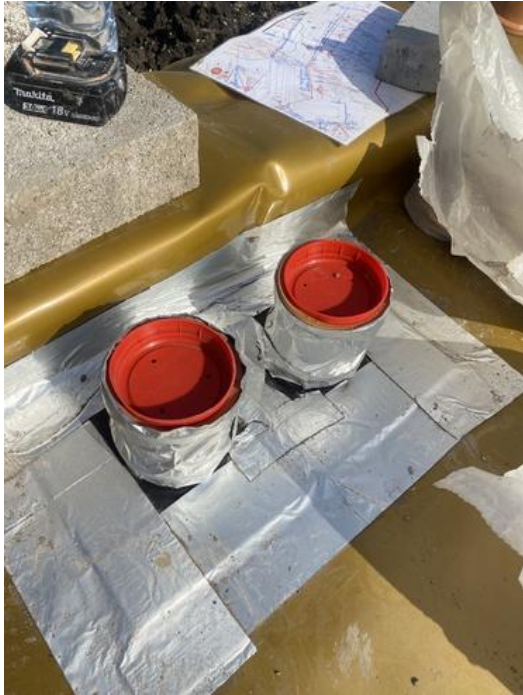
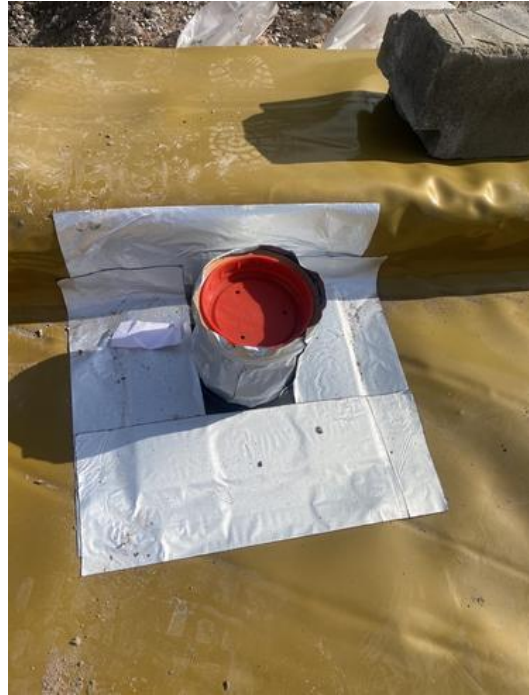
**Service entries seals: Top hats seal arrangements fixed around service entries? Use of Jubilee clips?** Yes

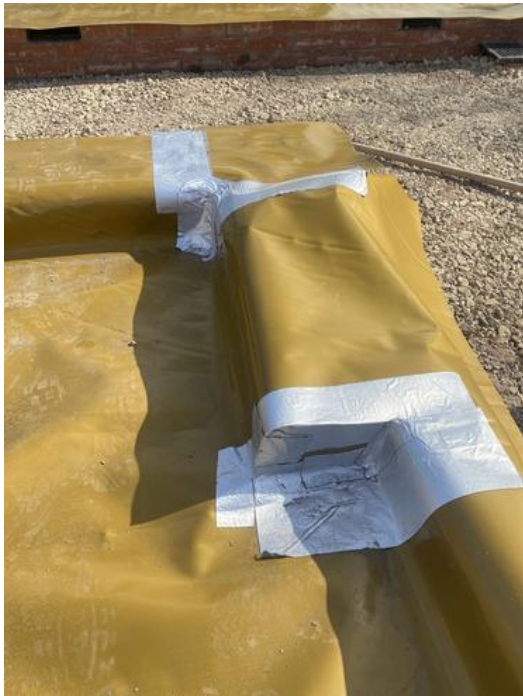
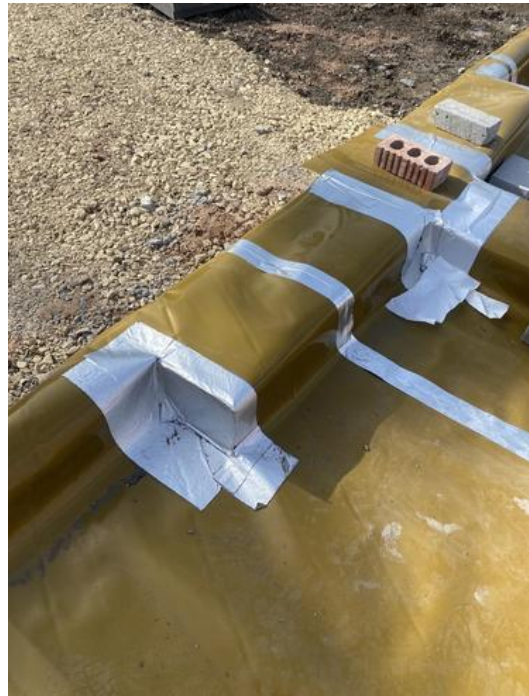
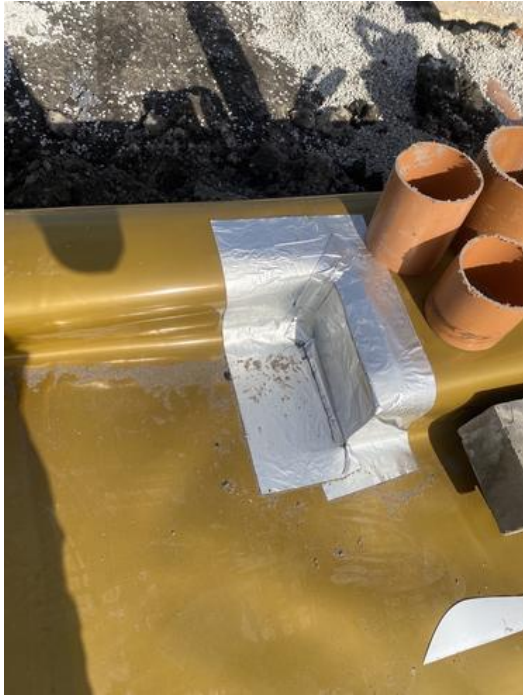
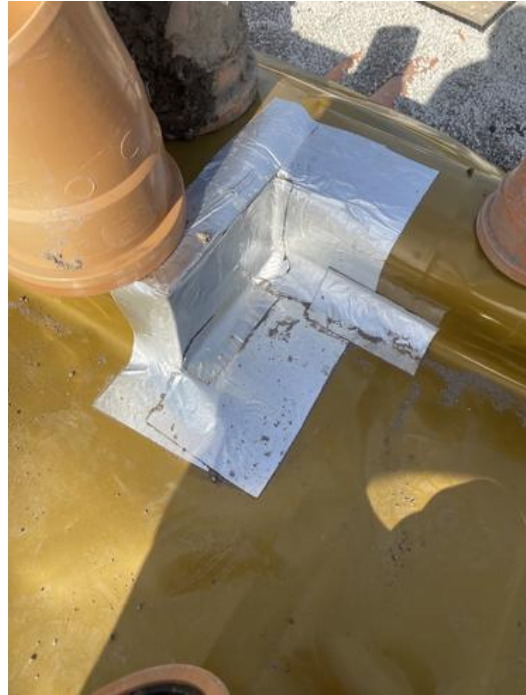
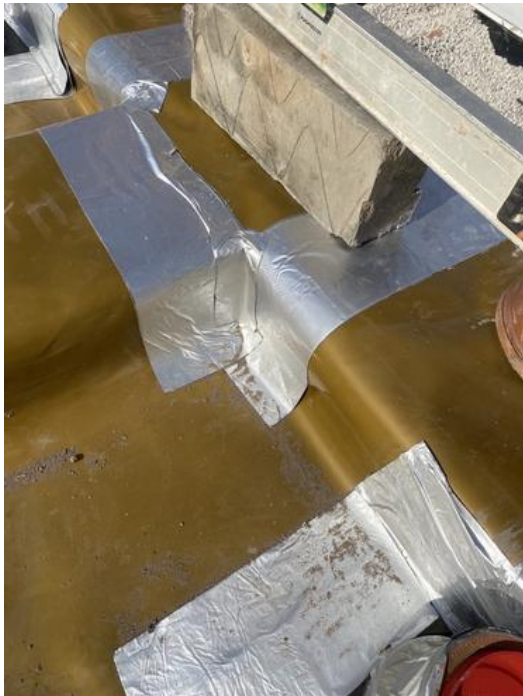
**Corners / Internal joints: Check all corners are correctly formed or contractor has used preformed corners.** Pass

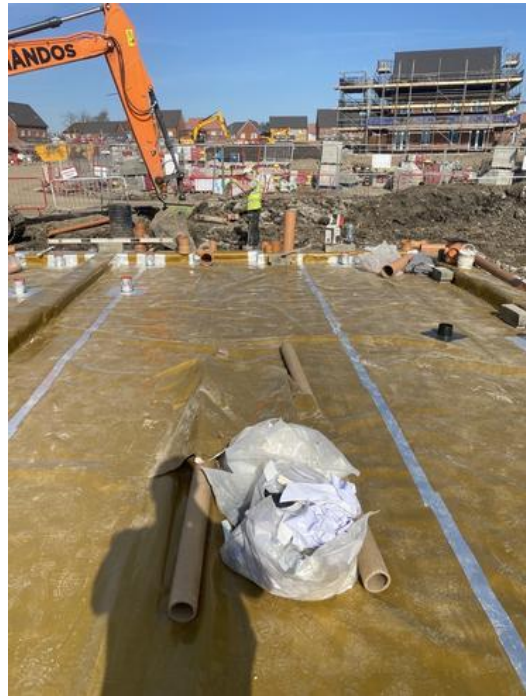
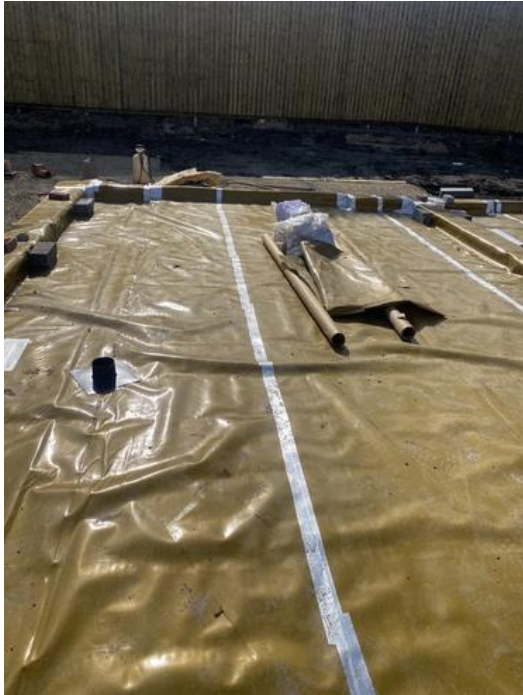
**Extent of Coverage: Is the membrane covering the entire plot? Does membrane span over outside walls?**

Yes

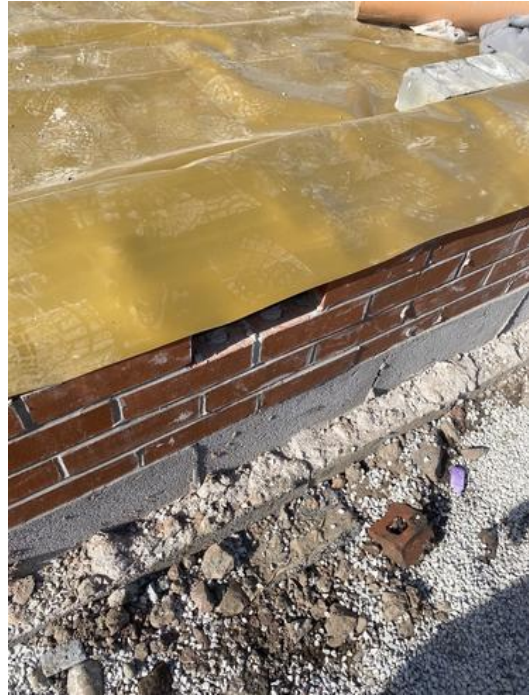
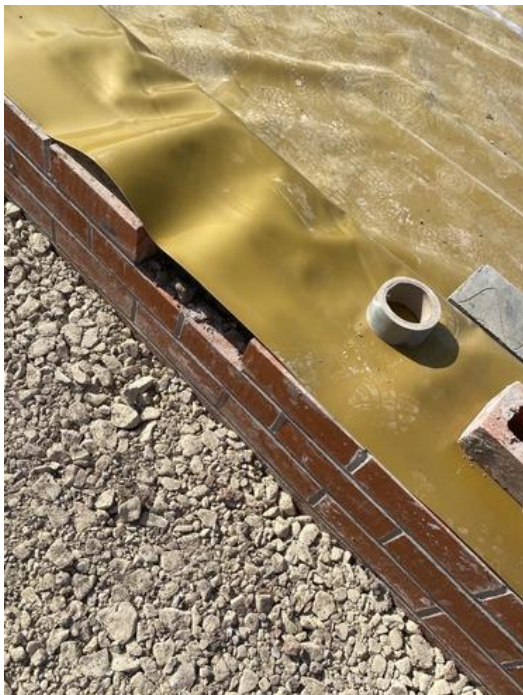
**External Wall Air bricks: Numbers, size. positions as design drawing? (Minimum of 3 walls)**

Pass

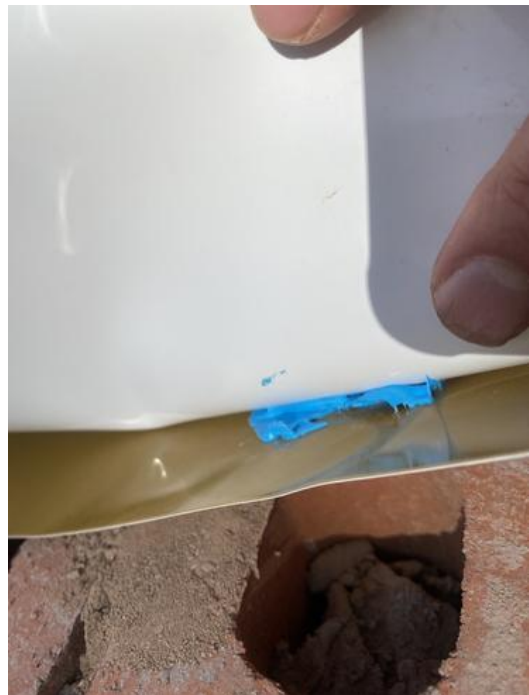
Photo 32

**Laps, welds, and joints seals: Joints lapped and sealed in accordance with manufacturer's requirements/ specification? Minimum overlap insured? Sections taped twice? Are welds complete? Appropriate joining/double-sided tape used, Folds running in line with joints? (no joints cutting across folds)** Pass

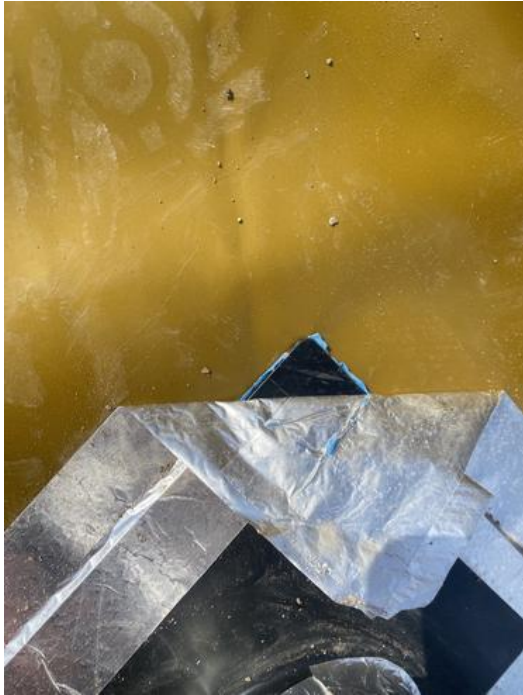
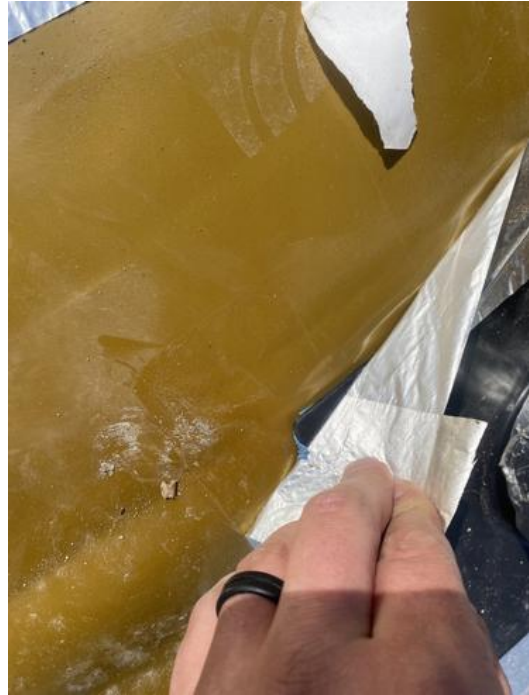
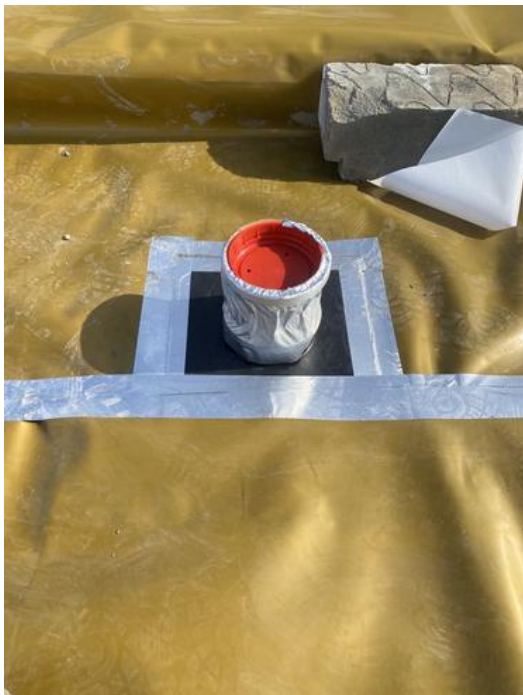
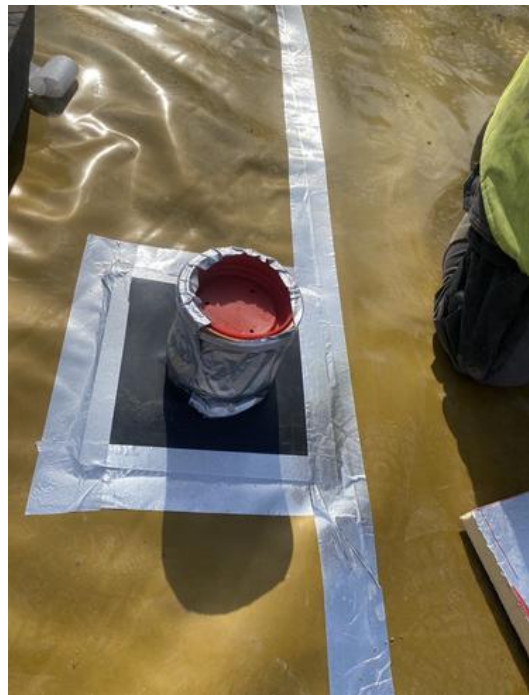
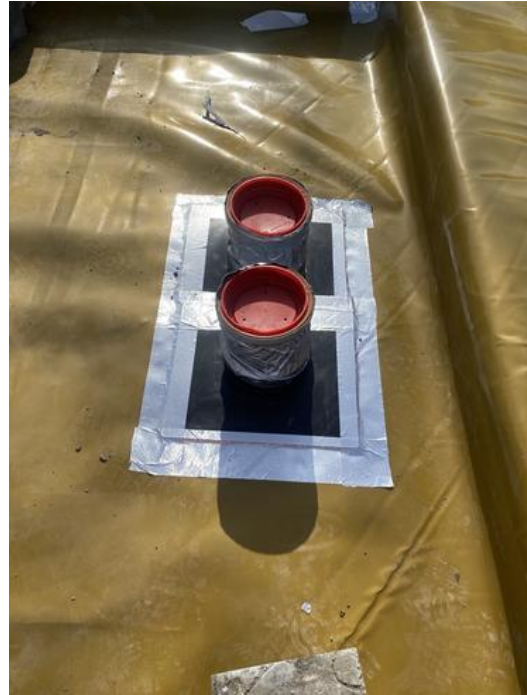
**Service entries seals: Top hats seal arrangements fixed around service entries? Use of Jubilee clips?** Yes

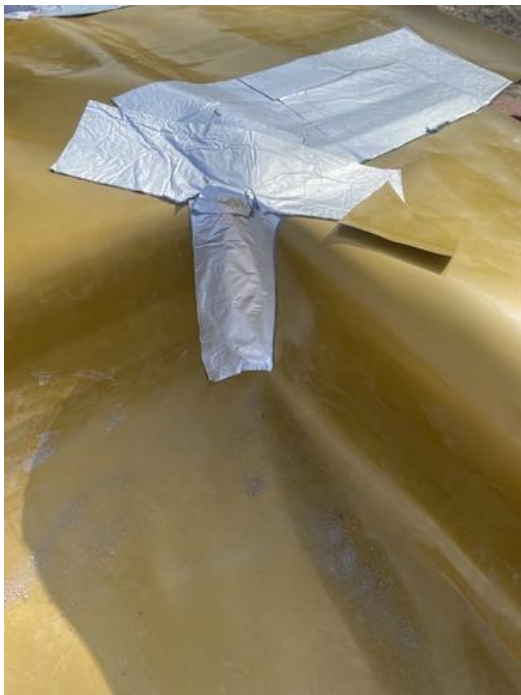
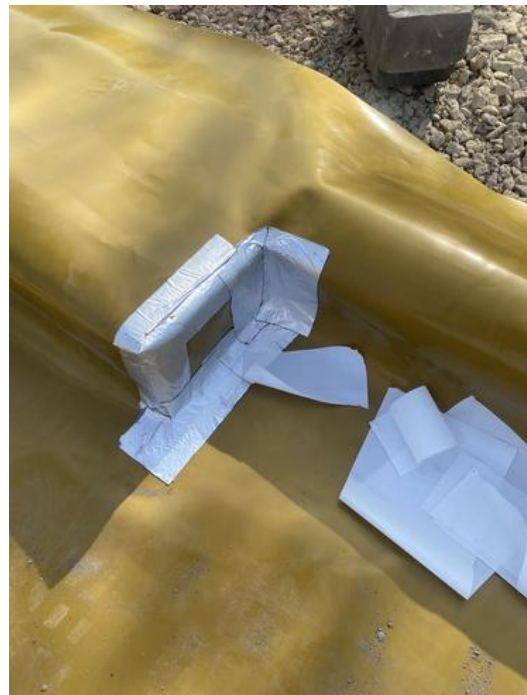
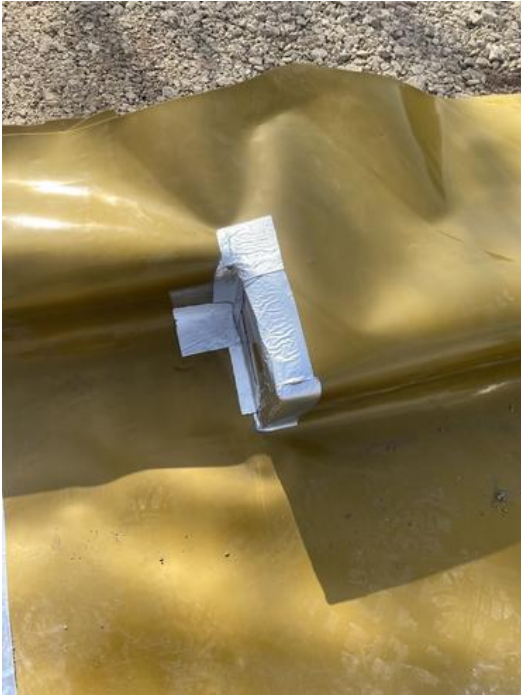
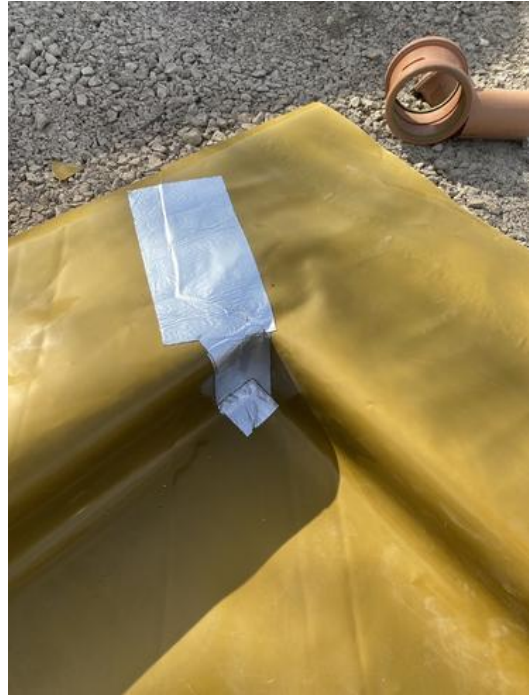
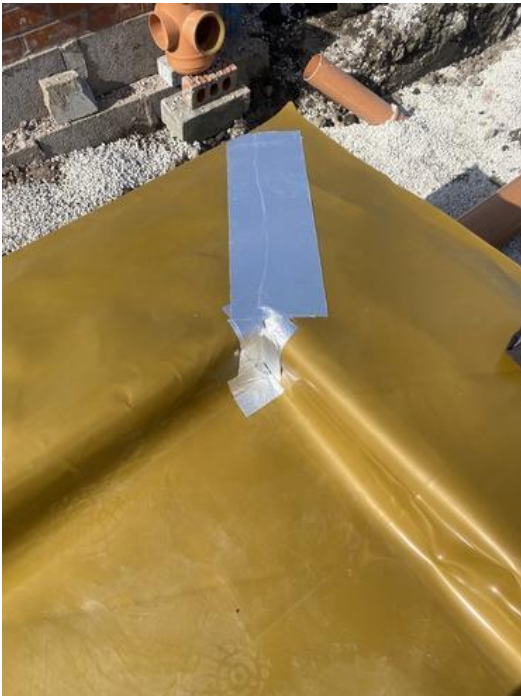
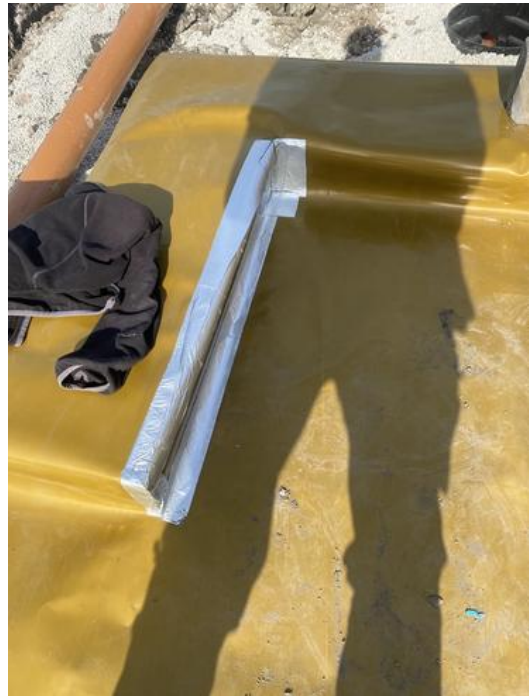
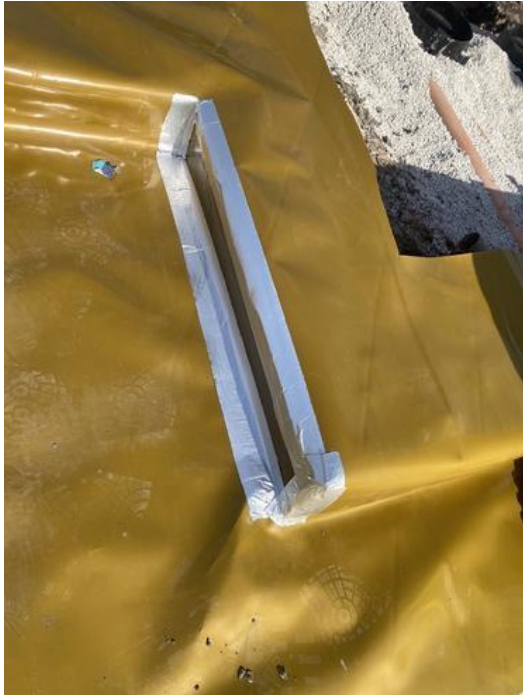
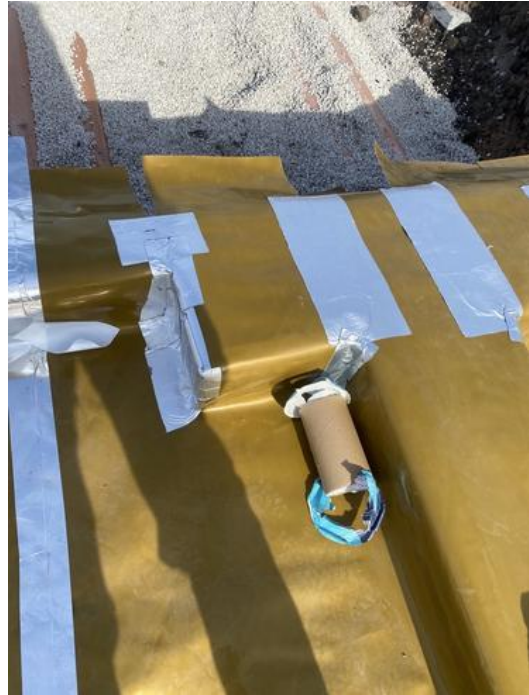
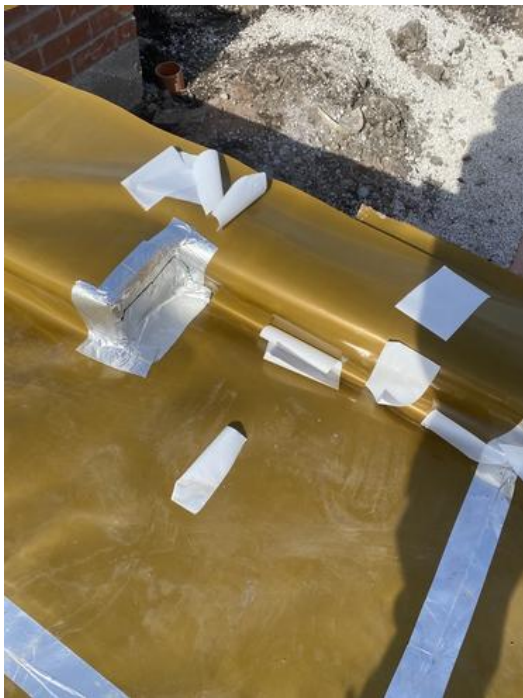
**Corners / Internal joints: Check all corners are correctly formed or contractor has used preformed corners.** Pass

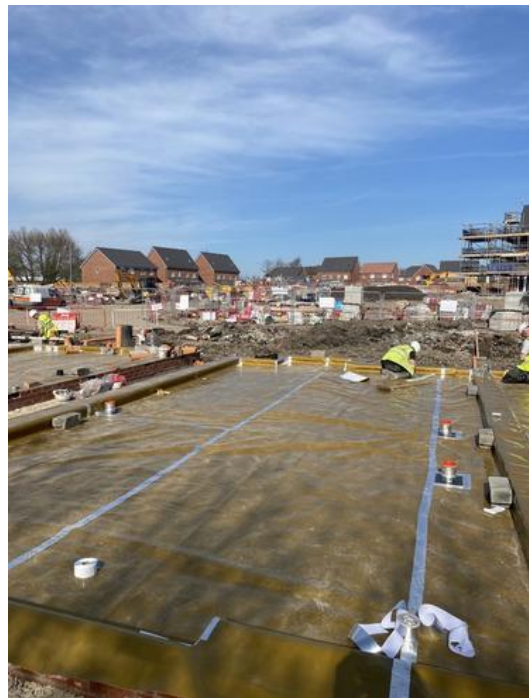
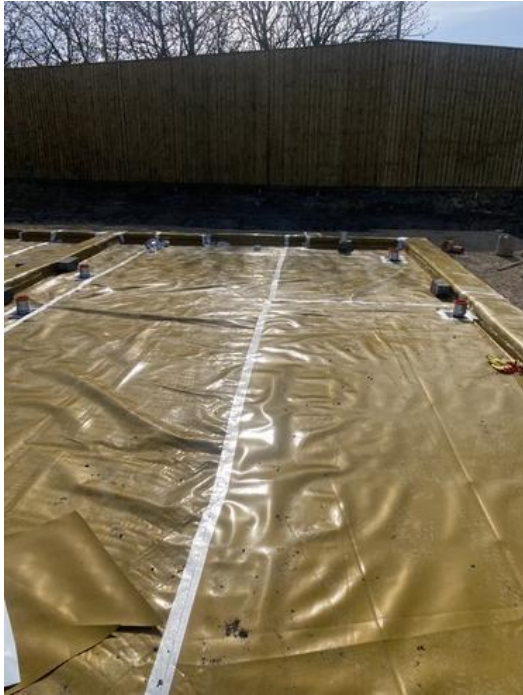
**Extent of Coverage: Is the membrane covering the entire plot? Does membrane span over outside walls?**

Yes

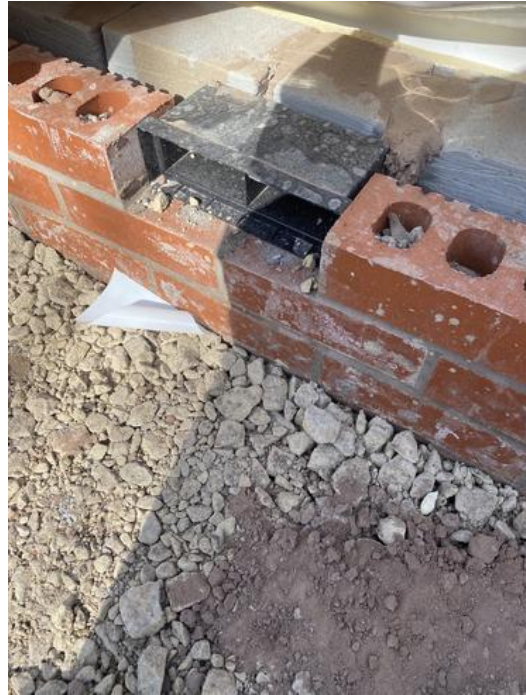
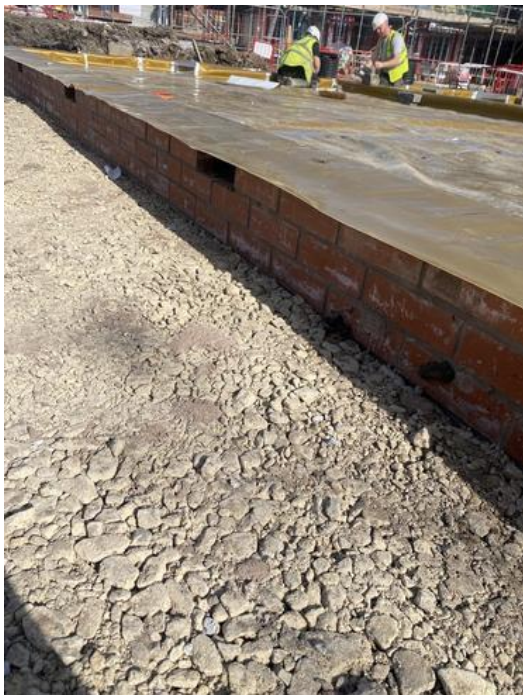
**External Wall Air bricks: Numbers, size. positions as design drawing? (Minimum of 3 walls)**

Pass

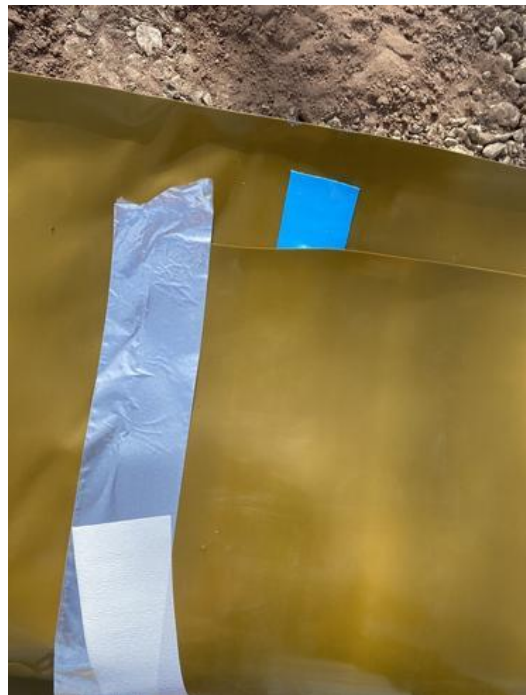
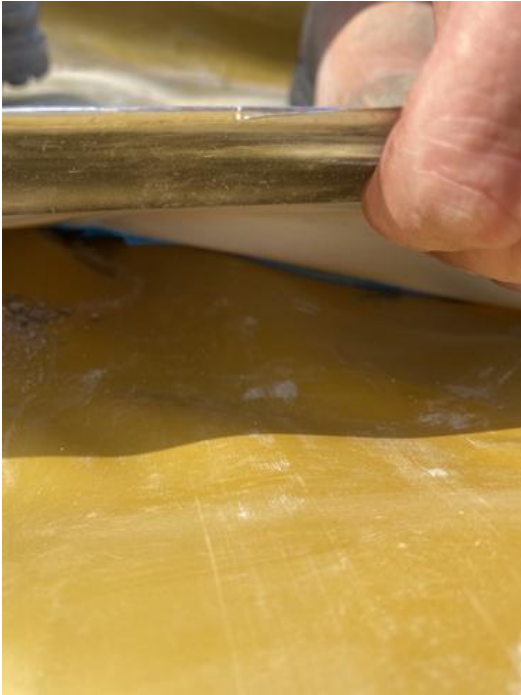
**Laps, welds, and joints seals: Joints lapped and sealed in accordance with manufacturer's requirements/ specification? Minimum overlap insured? Sections taped twice? Are welds complete? Appropriate joining/double-sided tape used, Folds running in line with joints? (no joints cutting across folds)** Pass

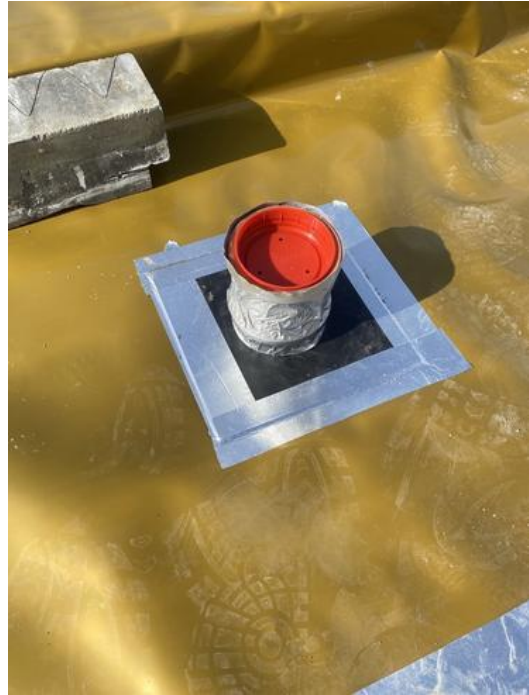
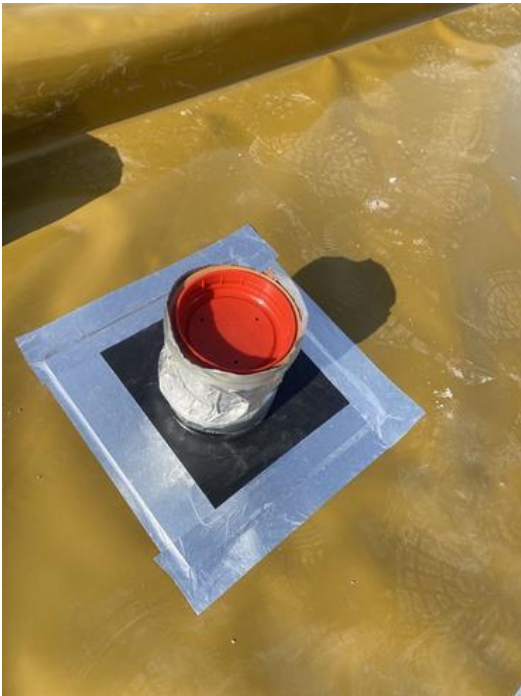
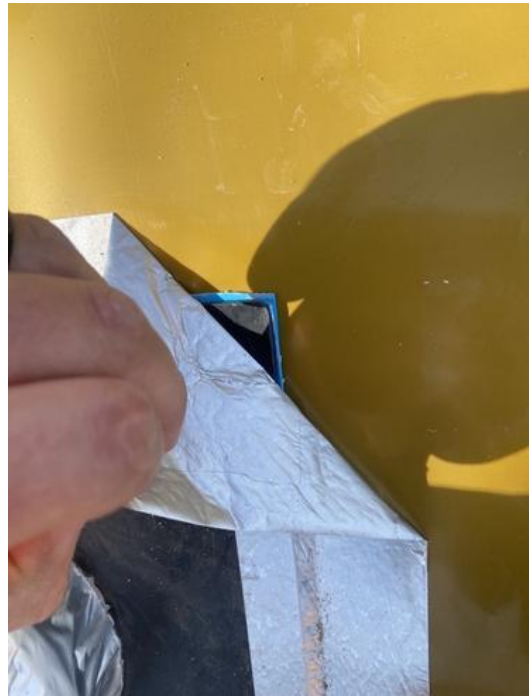
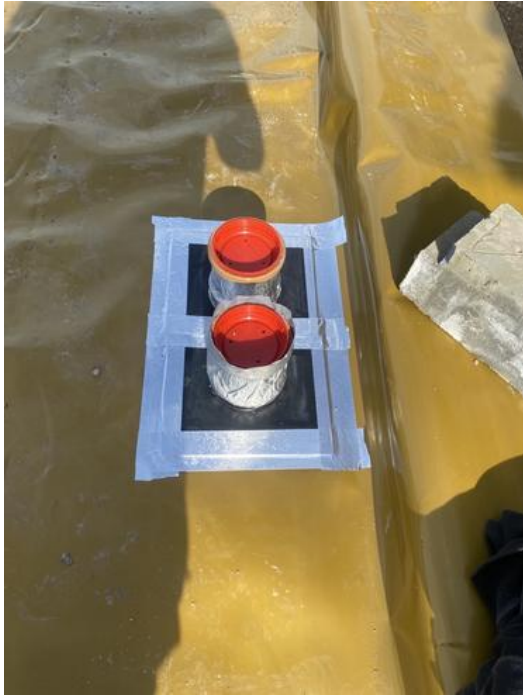
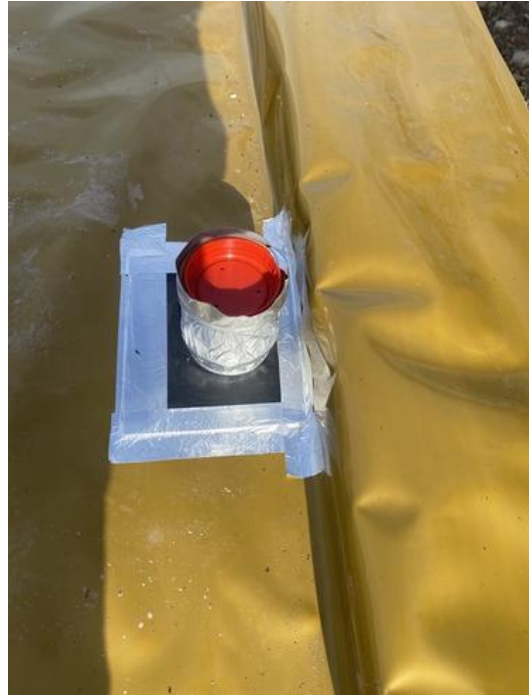
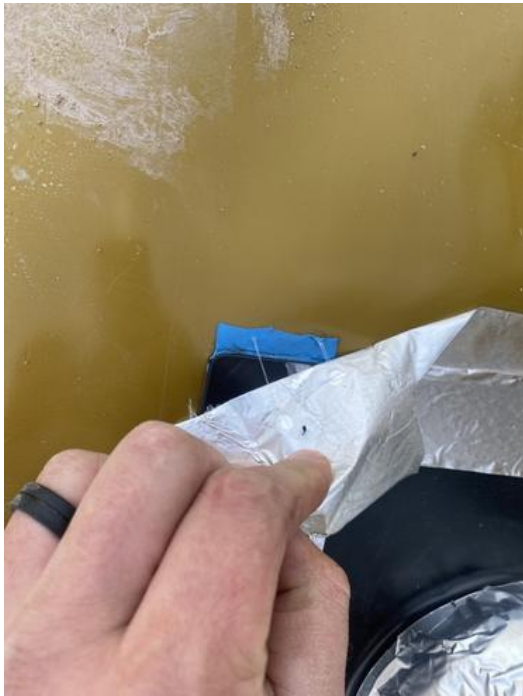
**Service entries seals: Top hats seal arrangements fixed around service entries? Use of Jubilee clips?** Yes
