## GAS MEMBRANE VALIDATION

| Site Name: Belle Vue Stadium | Project Number: 12-123 |

**Apartment Block 1- Visit 2**

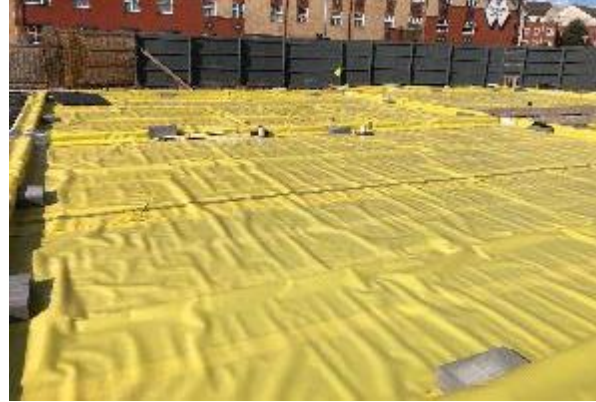
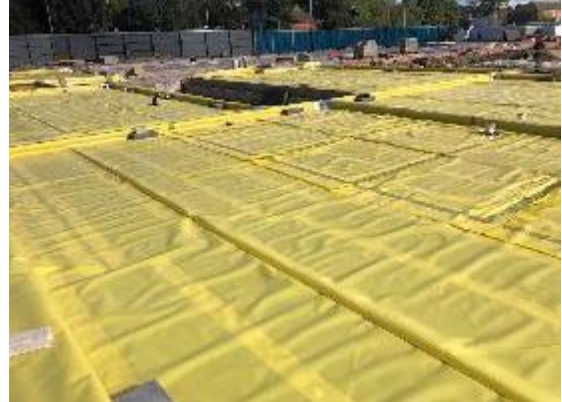
**General Condition of Membrane-Good Condition**

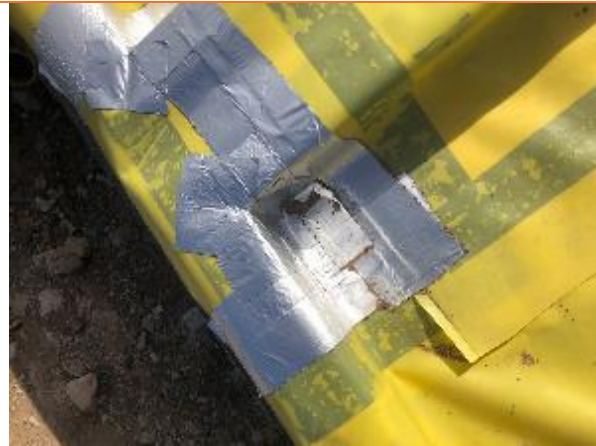
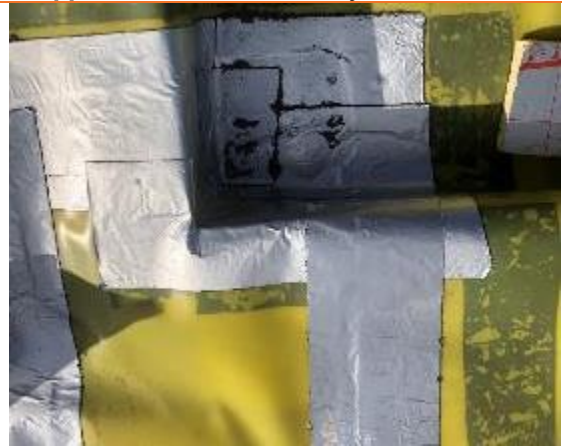
**Verification of Joints and Seals-Overlapped and sealed correctly**

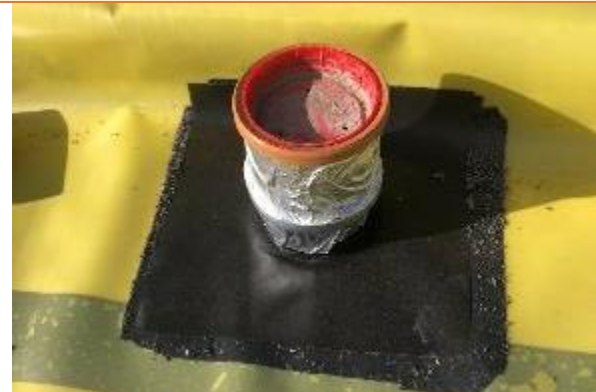
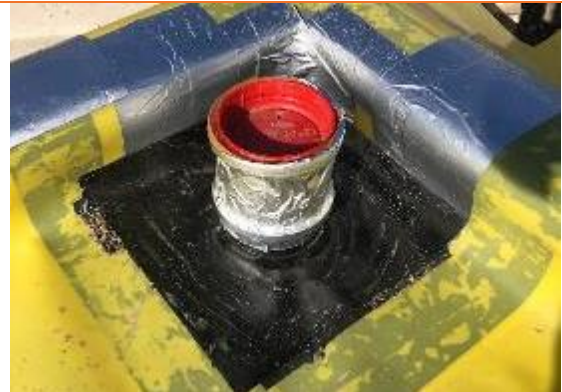
**Verification of Service Penetrations-Good Condition**

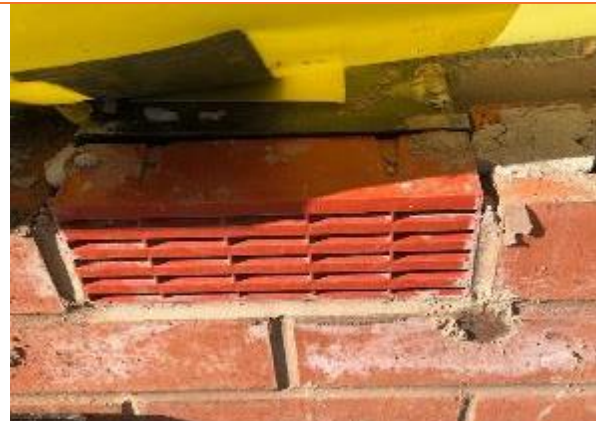
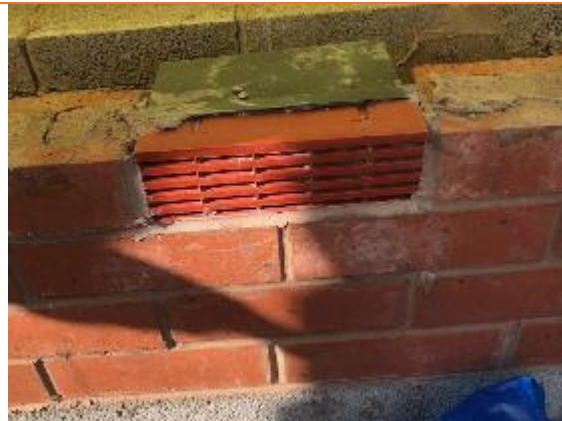
**Verification of Ventilation-Good Condition**
