## Asbestos Survey

18 Kenyon Lane, Manchester. M40 9JQ

| Report No. | QC/12691/1 |

**Refurbishment and Demolition (specified areas)**  
**Asbestos Survey**  
at  
**18 Kenyon Lane, Manchester. M40 9JQ**

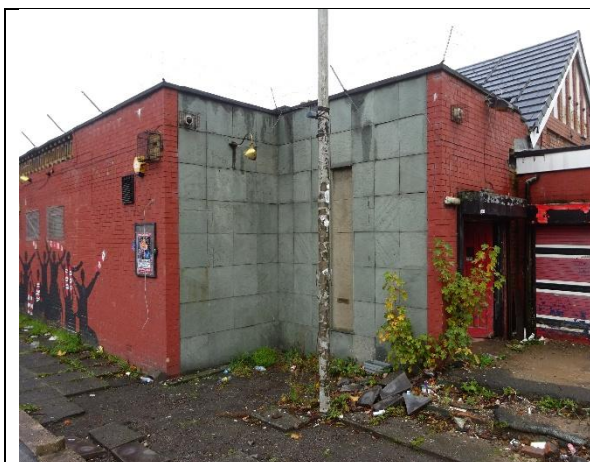
Area 1 to front of building – due for demolition

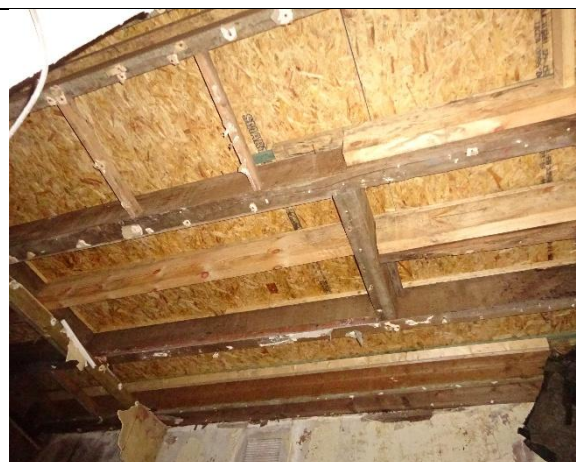
Area 1 – oriented strand board to flat roof

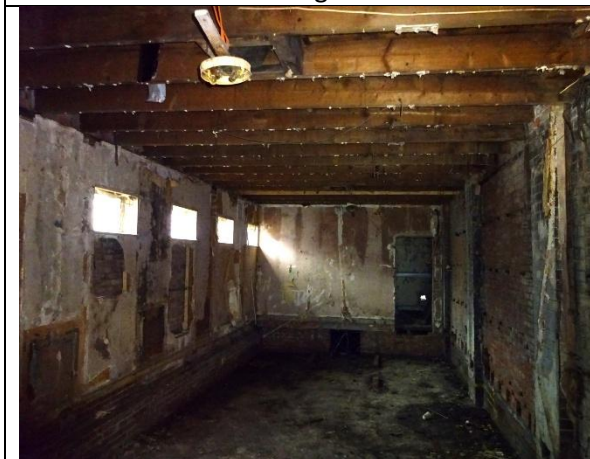
Area 1, GF1 interior – wooden floor and plasterboard ceiling removed

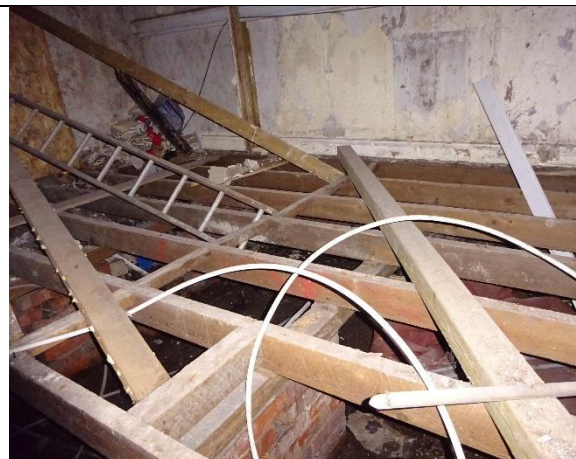
Area 1, GF2 interior – wooden floor removed revealing floor joists
