## Castlefield Viaduct – Phase 2

Truss End Support Boxes – Remedial Options Appraisal

| Document verification | | | | | |
|---|---|---|---|---|---|
| Document title | | Truss End Support Boxes – Options Appraisal | | | 282210 |
| Revision | Date | Filename | CVI-ARUP-ZZ-ZZ-RP-S-000003 | | |

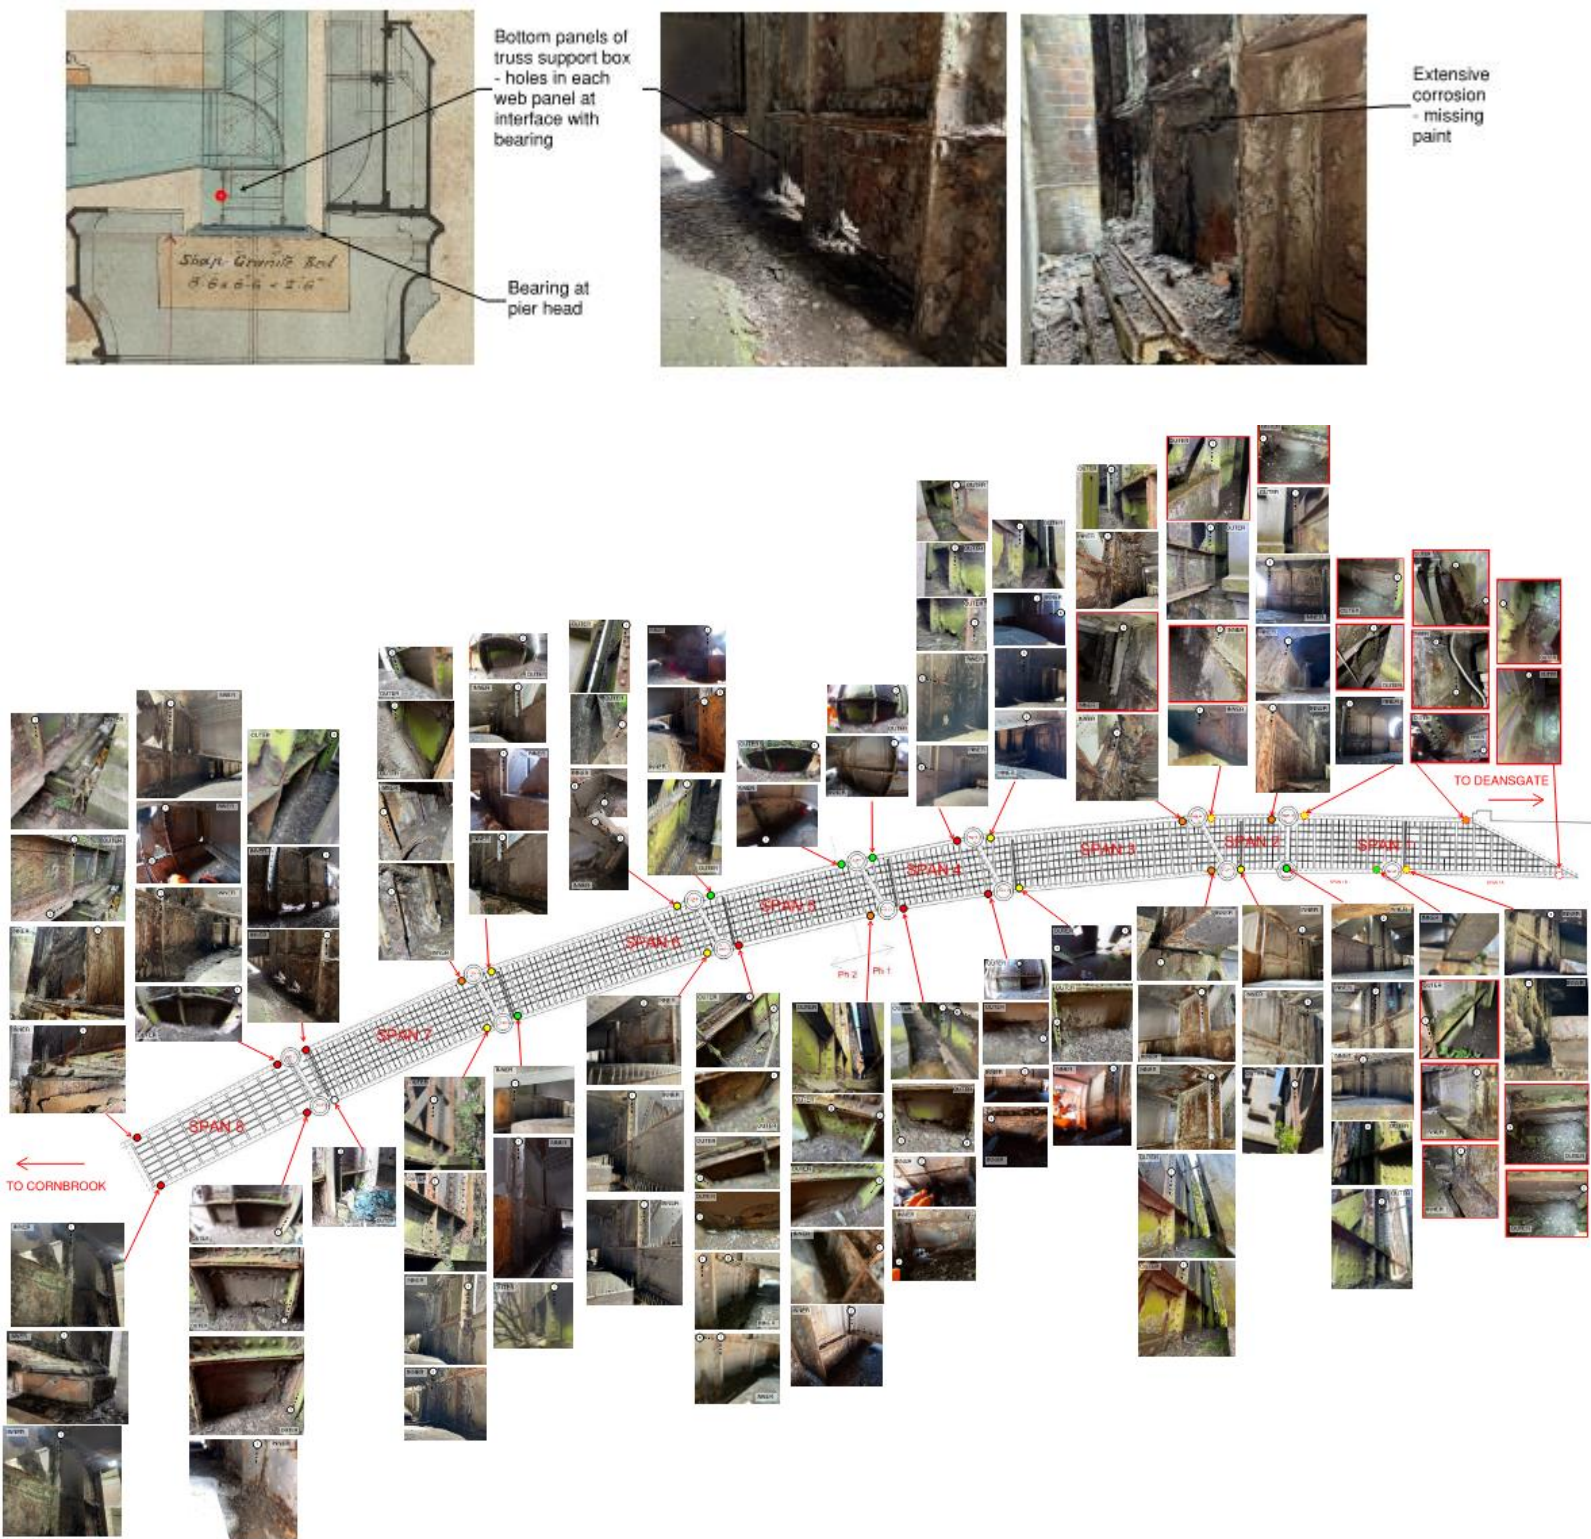
- The surveys found the **bottom panels of the support boxes, below the deck, to be in a very poor condition**. These areas are prone to water attack from driven rain running down the outside of the outer plane. Some will also collect water overflowing from the truss bottom chords, which acts as gutters and are unable to discharge in some locations. Maintenance may also have been neglected through the life of the structure given the challenging access to both support box planes.

- An end-by-end survey was carried out for all trusses, for both the inner and outer planes. Significant corrosion was found at several locations, with complete paint absence and loss of thickness to the 5/8" steel web plate. Some panels were found to be deteriorated such that large holes were evident. At other locations, however, the condition was found to be more acceptable, with paint present and negligible corrosion.

- A qualitative rating was ascribed to each truss end in Appendix B.2 of the Principal Inspection (CVI-ARUP-ZZ-ZZ-RP-S-000001), extracted opposite. The ratings are coloured red, amber, yellow, green (RAYG) in decreasing order of deterioration. This Condition Summary helps to show spatially where the defects occur.

- The Arup Principal Inspection + Assessment recommended that the most deteriorated support boxes should be remediated. These are those rated ‘red’ in the Condition Summary: there are 9No. ‘red’ truss ends across the viaduct.

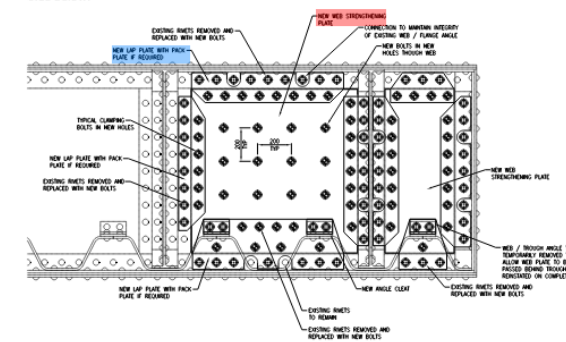
A typical example of a proposed bolted web plate strengthening arrangement can be seen in Figure 0.18 below.

The designer is to confirm the existing condition / thickness of remaining web plate in order to size the strengthening plate accordingly, taking account of any corrosion or holing that may exist. Particular attention should be made to avoid having bolted connections where holing or thinning of plates exist as the integrity of the connection may be in doubt.

New web plates either side of existing  
- provides symmetric remedial  
with no eccentricities

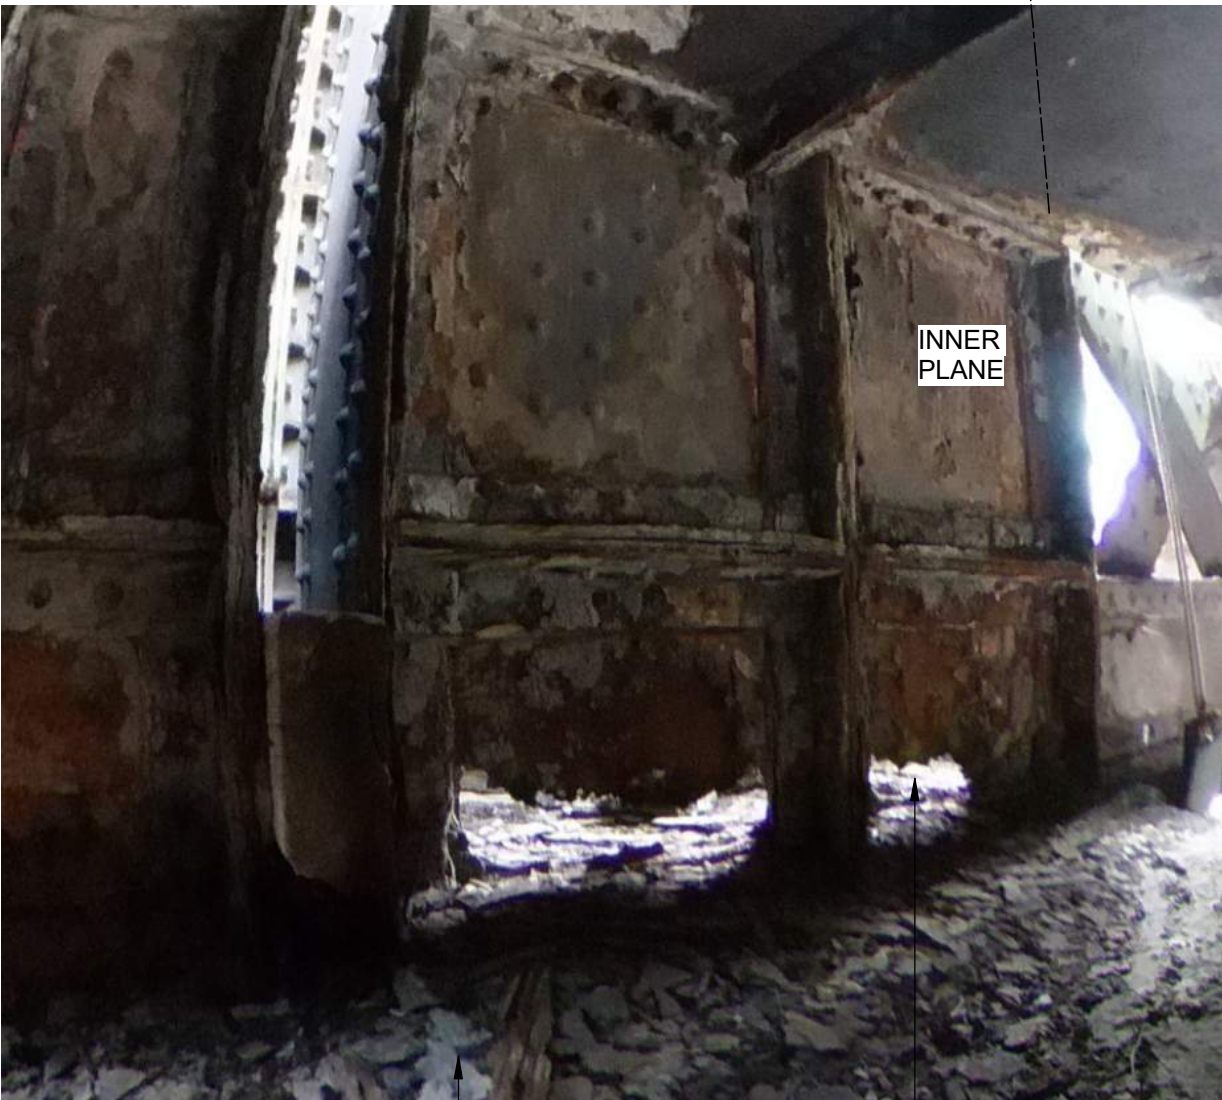
Span 7 North Elevation, Cornbrook End

Debris at pier head to be cleared to confirm extents/condition of bottom horizontal stiffener on GL A

Holes on both lower web panels, inner plane

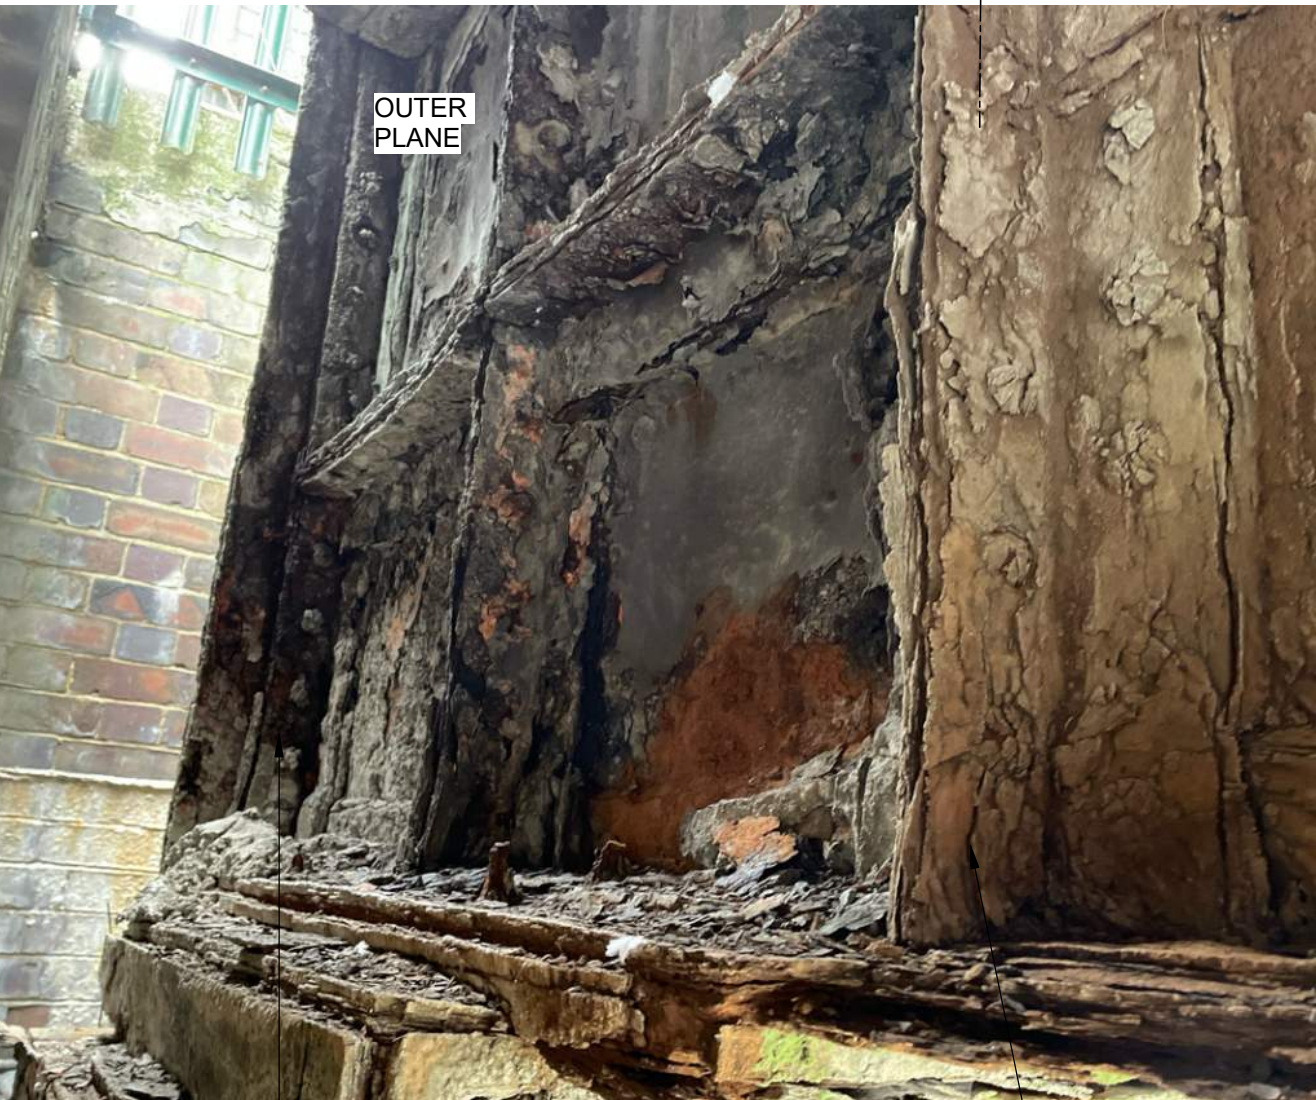
Span 8 North Elevation, Cornbrook End

Note: this is at the Cornbrook abutment; access further constrained by surrounding masonry bearing gallery

Configuration of existing bearing to be reviewed pending further debris clean and tactile survey

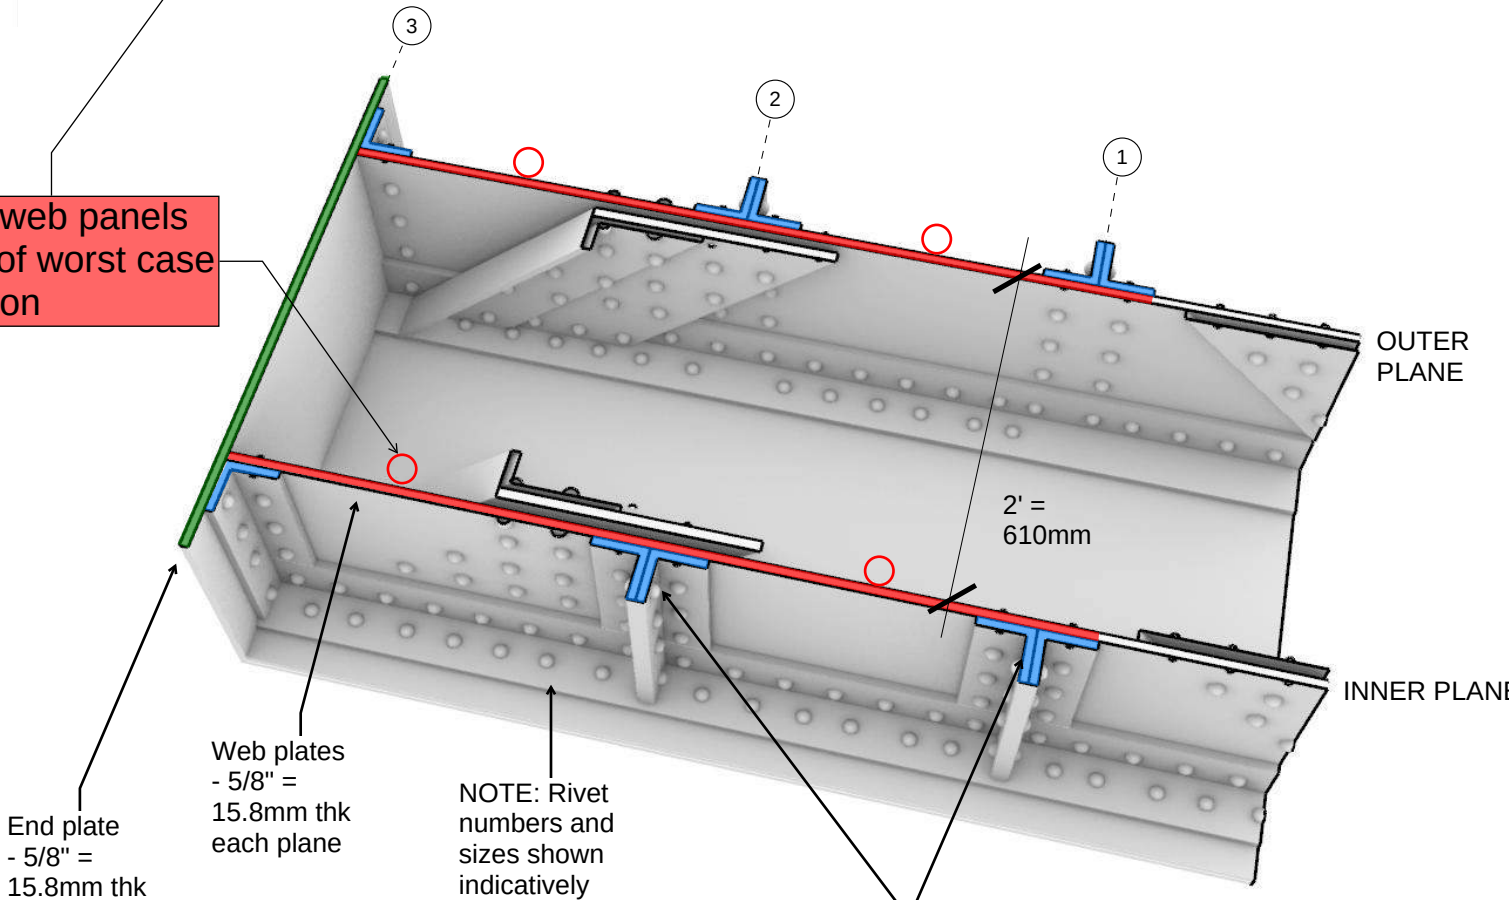
Lower web panels - area of worst case corrosion

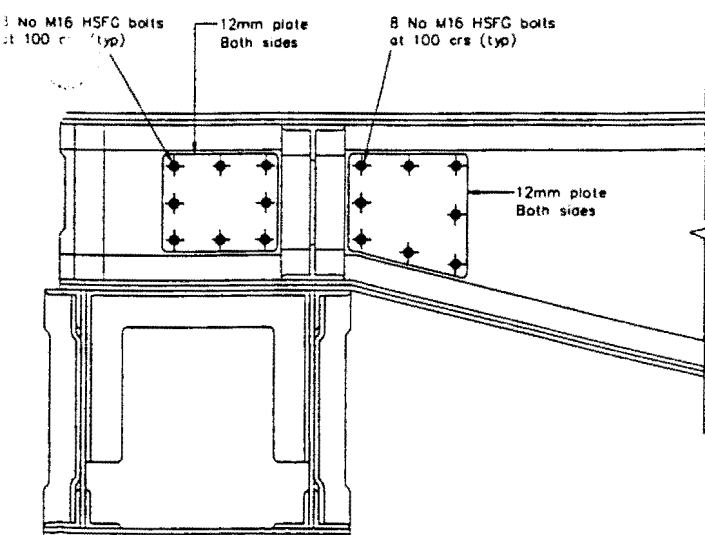
Elevation of Cross Girder  
MR18 : Repairs to web of  
Fish Belly Girders

Plating repairs required if web plate of cross girder is corroded >40% LOM.
