**GAS MEMBRANE VALIDATION**

| <b>Site Name: Belle Vue Stadium</b> | <b>Project Number: 12-123</b> |
| <b>Company Name: Countryside</b> | <b>Date: 25-05-2022</b> |

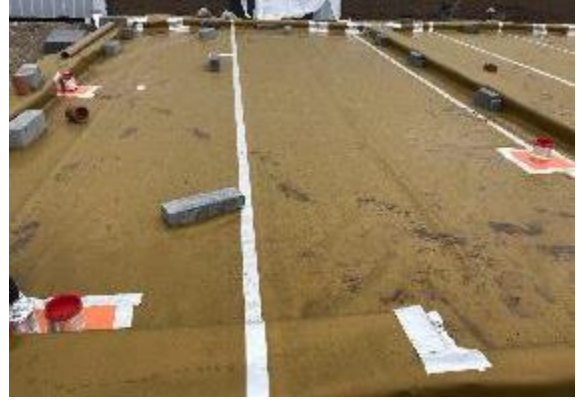
**Plot - 90**

**General Condition of Membrane-Good Condition**

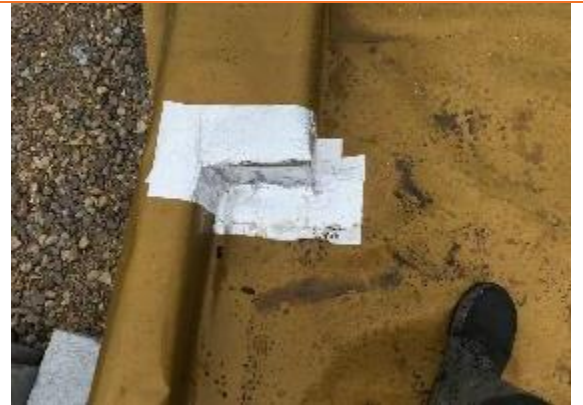
**Verification of Joints and Seals-Overlapped and sealed correctly**

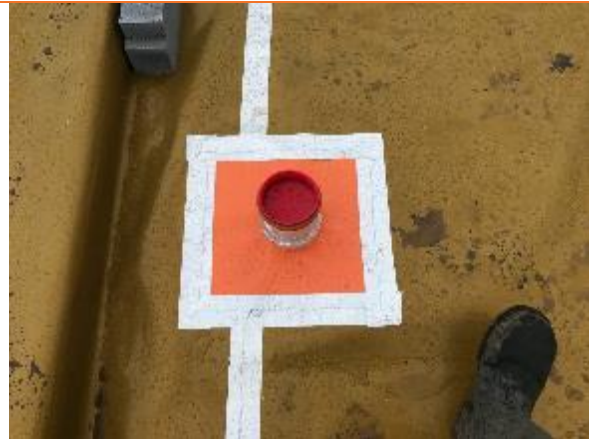
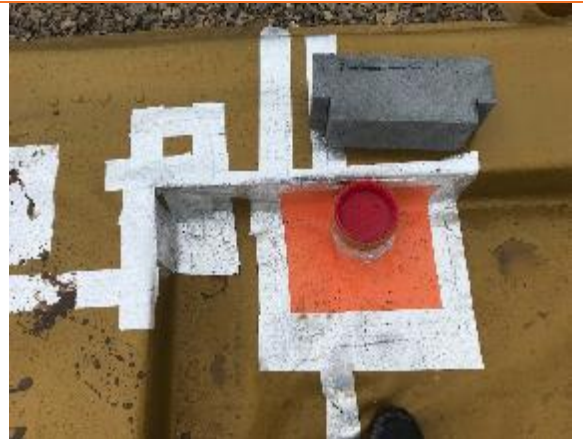
**Verification of Service Penetrations-Good Condition**

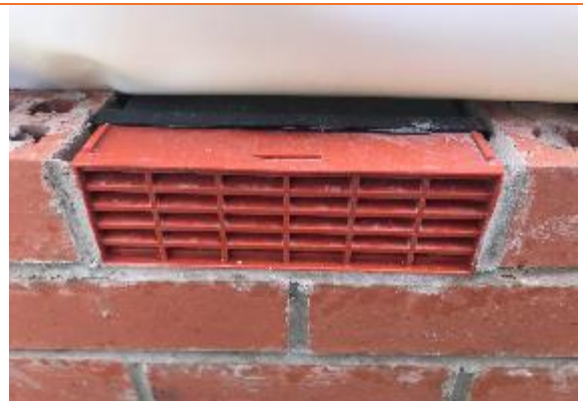
**Verification of Ventilation-Good Condition**

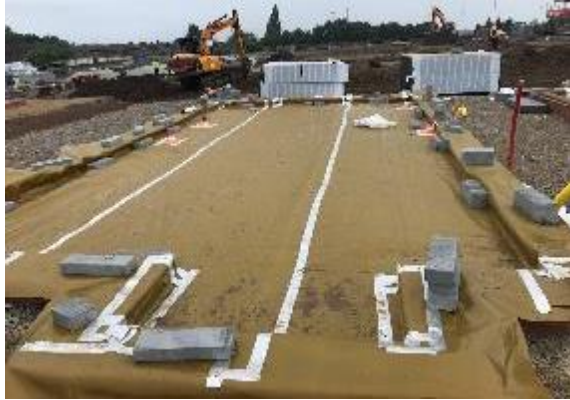
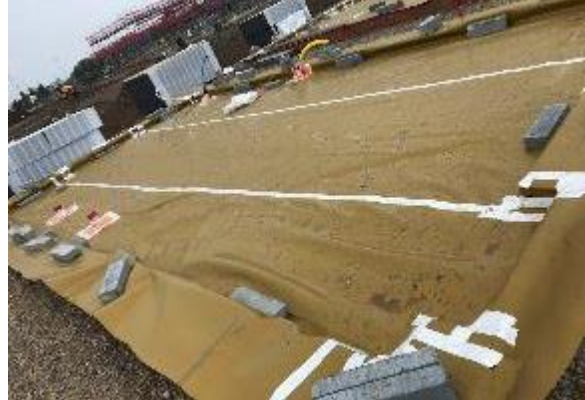
**Plot - 91**

**General Condition of Membrane-Good Condition**

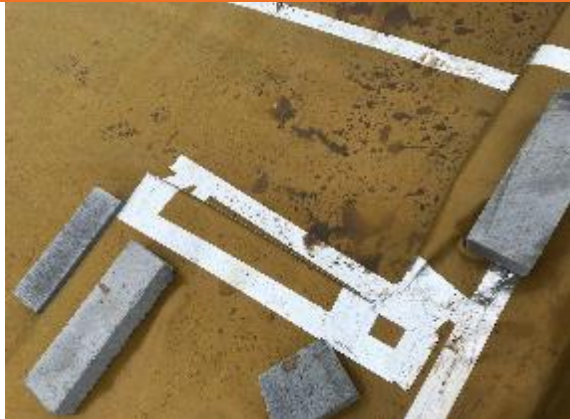
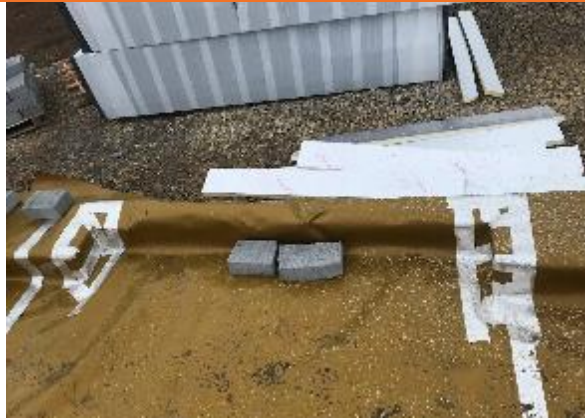
**Verification of Joints and Seals-Overlapped and sealed correctly**

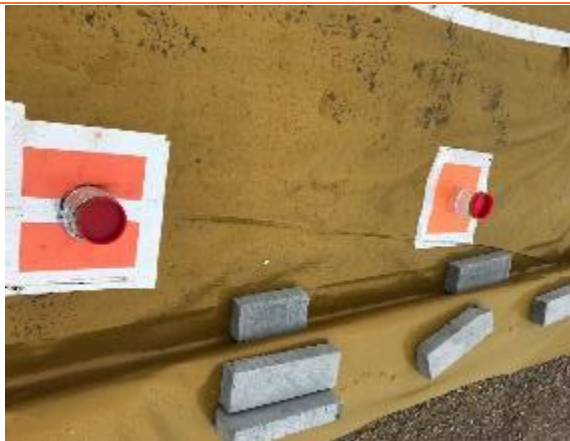
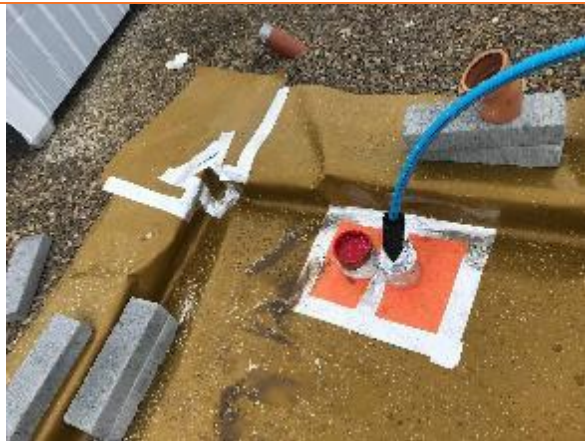
**Verification of Service Penetrations-Good Condition**

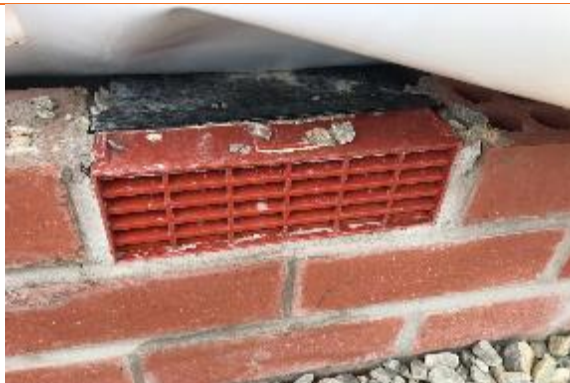
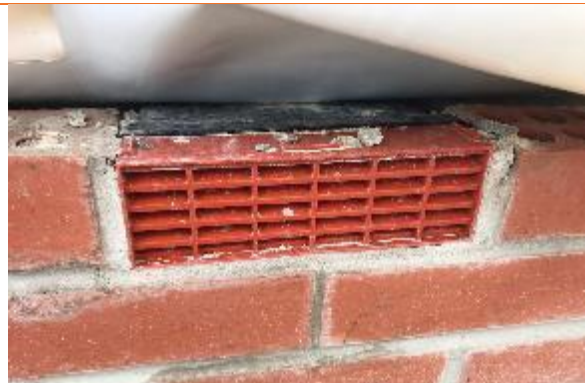
**Verification of Ventilation-Good Condition**
