**GAS MEMBRANE VALIDATION**

| Site Name: Belle Vue Stadium | Project Number: 12-123 |

**Plot – Apartment Block 2**

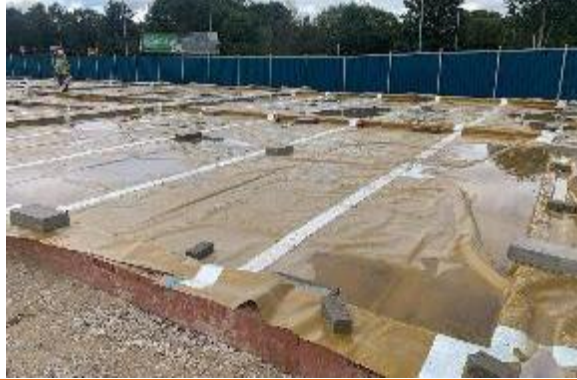
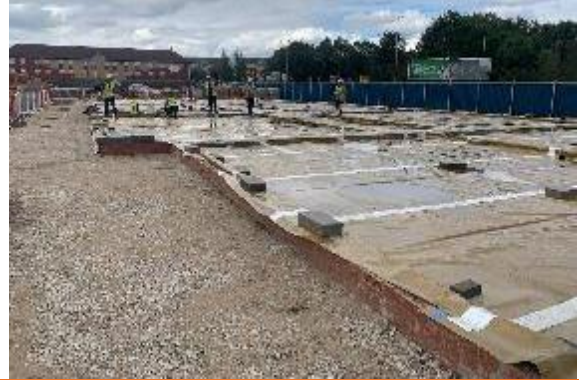
**General Condition of Membrane-Good Condition**

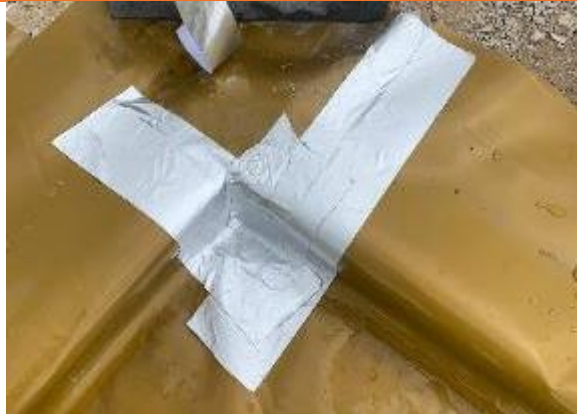
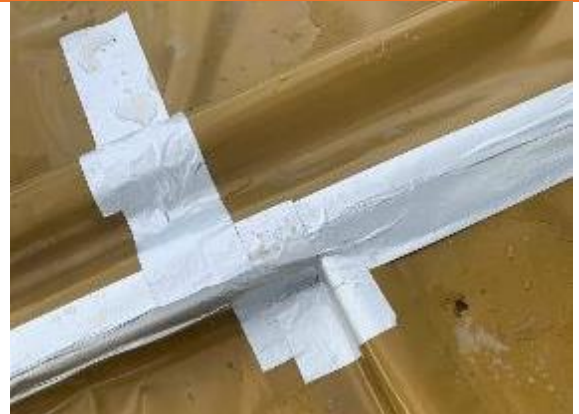
**Verification of Joints and Seals-Overlapped and sealed correctly**

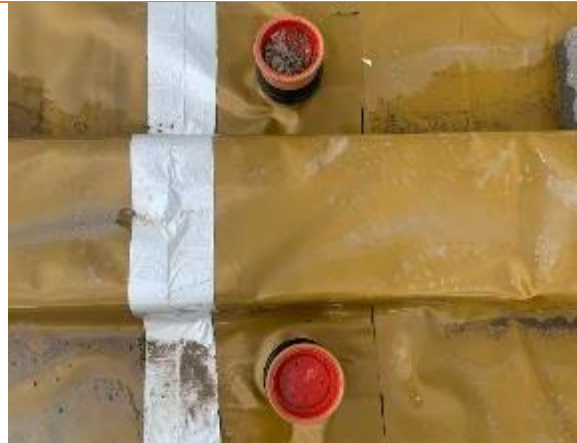
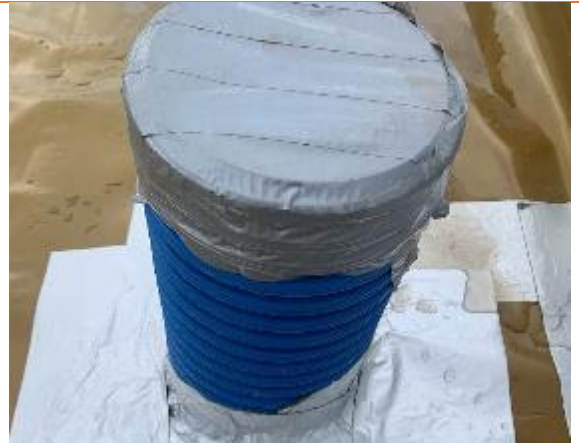
**Verification of Service Penetrations-Good Condition**

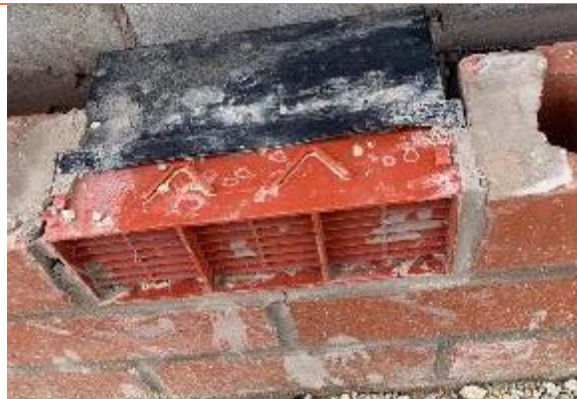
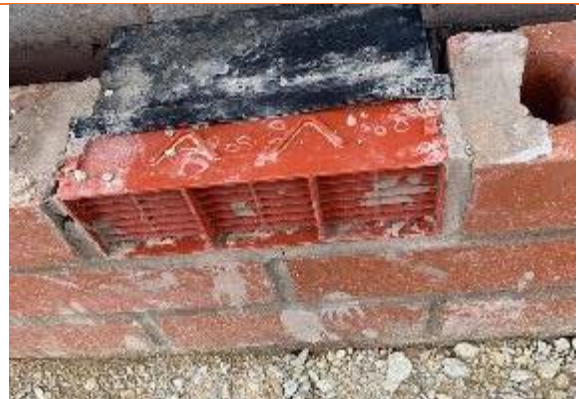
**Verification of Ventilation-Good Condition**
