**GAS MEMBRANE VALIDATION**

| Site Name: Belle Vue Stadium | Project Number: 12-123 |

Based on the information provided within this report, the site inspections and validation checklists, E3P can confirm that **Plot 140** has been installed with gas protection measures in accordance with Amber 1 to an acceptable level of workmanship.

**Plot – 140**

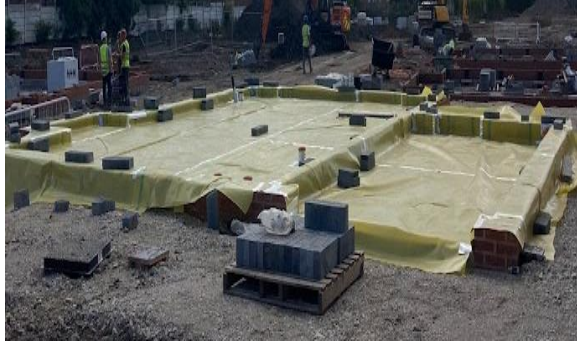
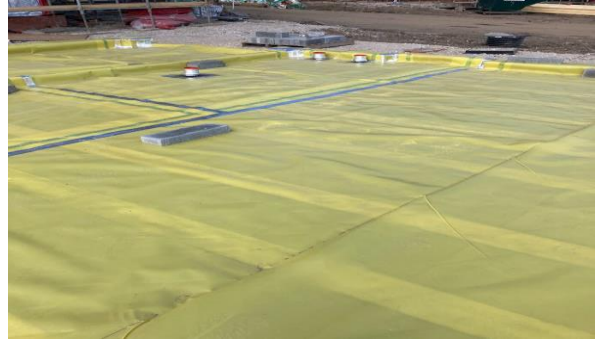
**General Condition of Membrane-Good Condition**

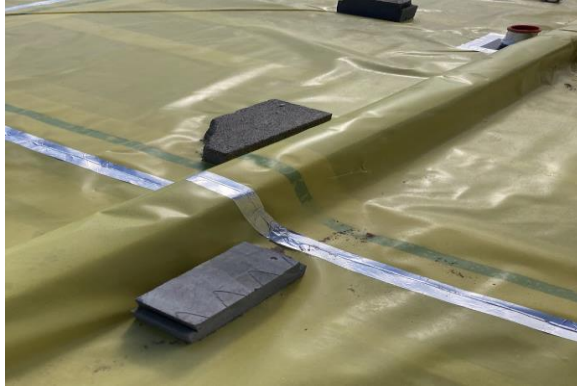
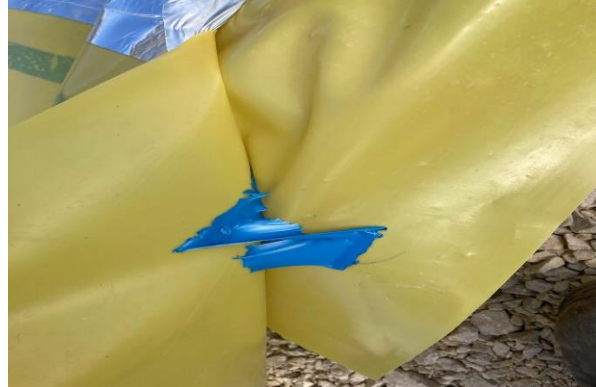
**Verification of Joints and Seals-Overlapped and sealed correctly**

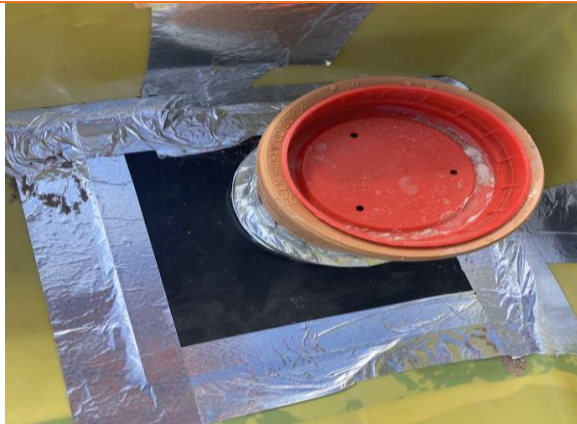
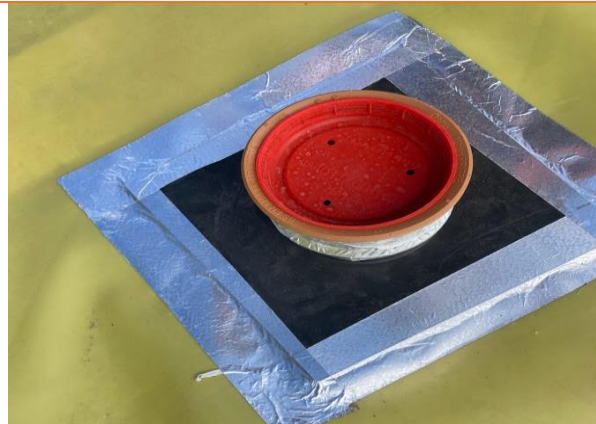
**Verification of Service Penetrations-Good Condition**

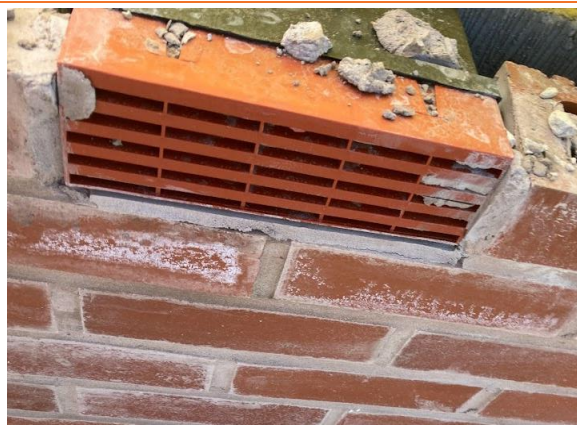
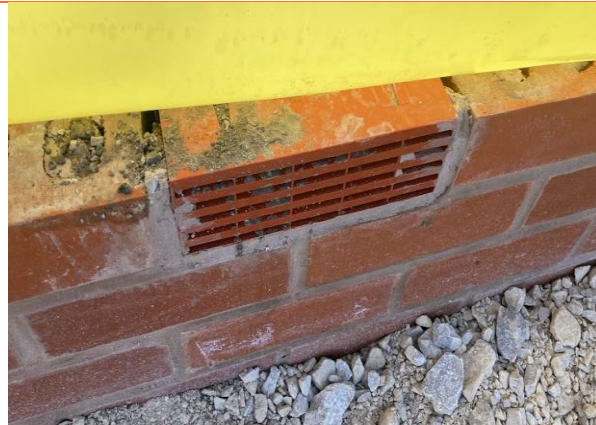
**Verification of Ventilation-Good Condition**
